Tidal Restriction Restoration at Wallace Shore Road

2016 Monitoring Report:
Year 2 of 5, Post-Project

<u>Project Name:</u>	Tidal Restriction Restoration at Wallace Shore Road
<u>MNRC ID:</u>	2013-CIM-Wallace Shore Rd-CBEP
<u>Project Location:</u>	Appletree Marsh, Harpswell
<u>Project Sponsor:</u>	Casco Bay Estuary Partnership (CBEP)
<u>Contractor and/or Consultant:</u>	Shaw Brothers Construction; Wright Pierce
<u>Start and Completion Dates:</u>	12/15/2014 – 12/29/2014.
<u>Corps and DEP Permit Numbers:</u>	Corps Permit #: NAE-2014-01922; State ID#: NRPA/PBR #58778

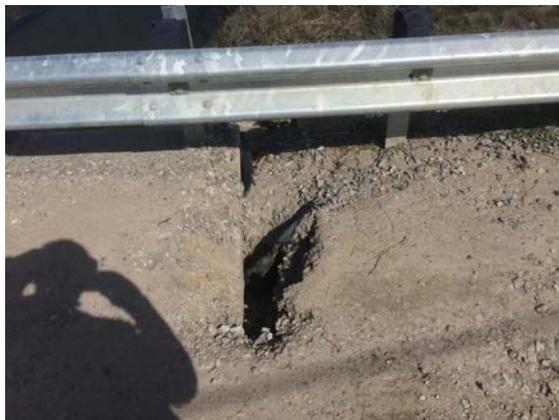
Year 2: On the morning of 4/25/2016, M. Craig CBEP was contacted by a representative from the Harpswell Conservation Commission about erosion adjacent to structure 9079. The information was provided to Project Engineer Joseph McLean of Wright Pierce, who visited the site on the afternoon of 4/25/16. In a memo dated 4/26/16 (Appendix E), McLean noted “piping” erosion of the roadway subgrade adjacent to the bridge, resulting from surficial road runoff conveyed by the roadway to the bridge site. The memo provided recommendations for addressing the erosion and redirecting runoff. Craig forwarded the memo to residents of the area who addressed the erosion using 2” crushed rock in accordance with McLean’s recommendations. Routine spring road maintenance included regrading and crowning, resulting in redirected flow. The road is graded twice annually, according to landowners.

Erosion at 9079 documented on 4/25/16 (photo: Wright Pierce)

Date(s)	Observation	Corrective Action
4/25/16	CBEP notified of erosion adjacent to 9079. Wright Pierce Project Engineer visited site, and prepared a memo about piping erosion dated 4/26/16, which described the issue and recommended remedial response.	Local residents implemented Wright Pierce recommendation to address piping erosion, including application of 2" crushed rock and road grading/crowning, in late April/early May 2016.
5/25/16	Several ~6" sized rocks were observed in a partial linear arrangement at the 9079 inlet. The rocks appeared to have been placed by hand or to have fallen into the channel from adjacent armoring. There was no evident impact to movement of water or sediments.	CBEP hand removed ~10 x 6" rocks from the channel and hand placed them atop similarly sized rocks that function as armoring adjacent to the bridge abutment.
August 2016	(See description in Table 3 of Year 1 report). Over the course of multiple visits in 2015 and spring 2016, CBEP observed water pooling in the excavated channel outlet of crossing 9078 due to a lack of channel development/scour. Probing indicated that coarse grained sediments are present and not mobilizing – or mobilizing slowly - due to a lack of sufficient velocity. Anecdotes from abutters that the culvert blew out several years ago, depositing road fill downstream, supports this assessment.	In low flow conditions during a neap tide phase, CBEP used small hand tools to remove a minimal volume of sediment/fill (>.05 yard ³) from the channel immediately downstream of 9078, which lowered water levels at the outlet of 9078 by a few inches. This activity was proposed in alternative 2 of Section 4.2 of the Year 1 report, Adaptive Management, and conducted under the original project PBR that expired on 9/25/16. The action was taken based on feedback from MNRCP reviewers provided to CBEP by K. Jensen on 3/14/16. Sediments were transported offsite in two partially filled 5 gallon buckets as needed. CBEP will continue to monitor drainage and channel formation in this area.

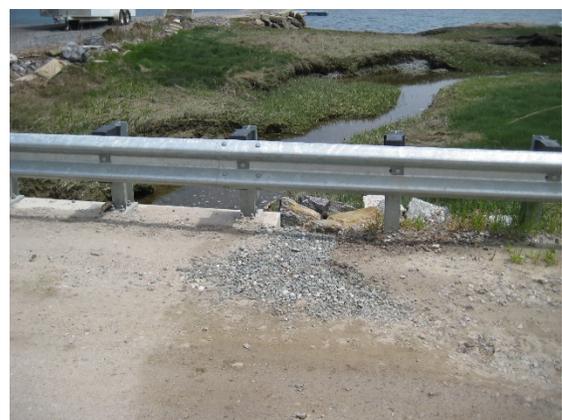
Repair by landowners, documented on 5/25/16 (photo: CBEP)

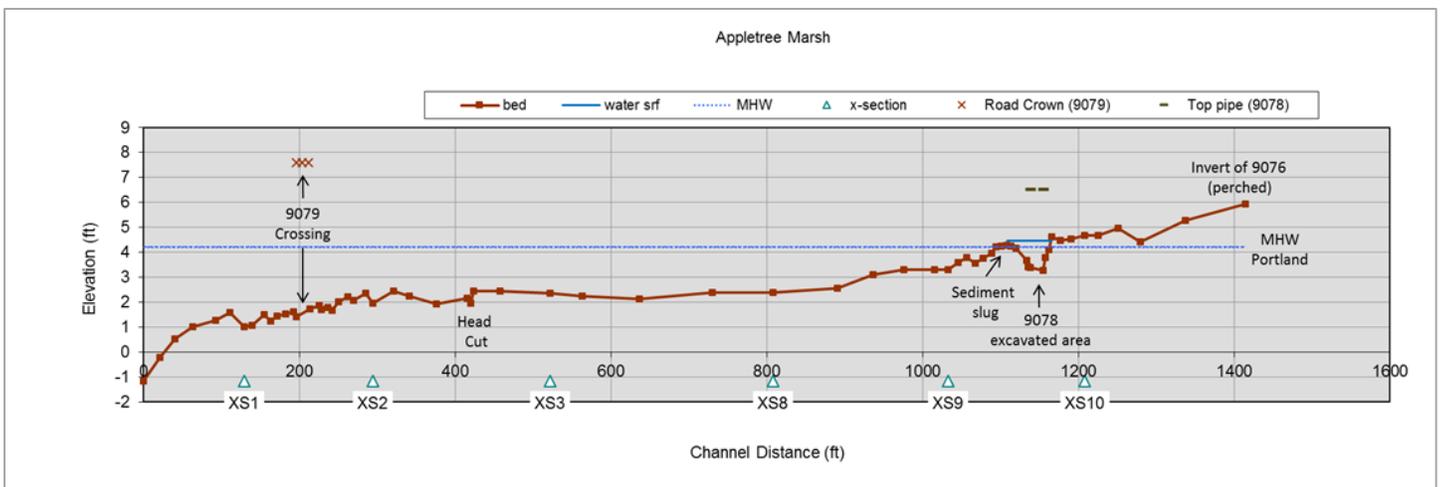
Figure 21. Post-project longitudinal profile of the tidal creek (2015). Mecklenburg 2006.

The channel bottom at 9079 is consistent with the channel grade upstream and downstream, and the accumulated sediment upstream is no longer evident. A series of shallow pools remains immediately downstream of 9079, and has formed immediately upstream in response to gradual movement of sediment. A small head cut was observed a little more than 400' upstream from the bay, with the channel bottom relatively flat until getting shallower between Station 8 and 9. The channel bottom at 800' (Fig. 21) has dropped by approximately 1' from the 2012 survey (50', Fig. 20). Further upstream, the channel becomes extremely shallow approaching 9078, where the slug of coarse-grained sediments (evident in both Fig. 20 and 21) sits on the marsh surface, resulting in a very shallow braided channel below the outlet of 9078. The sand is believed to have been deposited in this location during a culvert blow-out prior to any discussions about a restoration project. Local residents described a portion of the road bed washing onto the downstream marsh along with the culvert. Immediately upstream of the slug, and immediately downstream of the culvert outlet, is the area excavated during culvert installation. Here, water is pooled behind this grade control through the culvert into the excavated area upstream, above which a defined channel is no longer visible. This issue is discussed further in Section 4.2. The 2015 profile ends at the next culvert upstream (9076) beneath Shore Road.

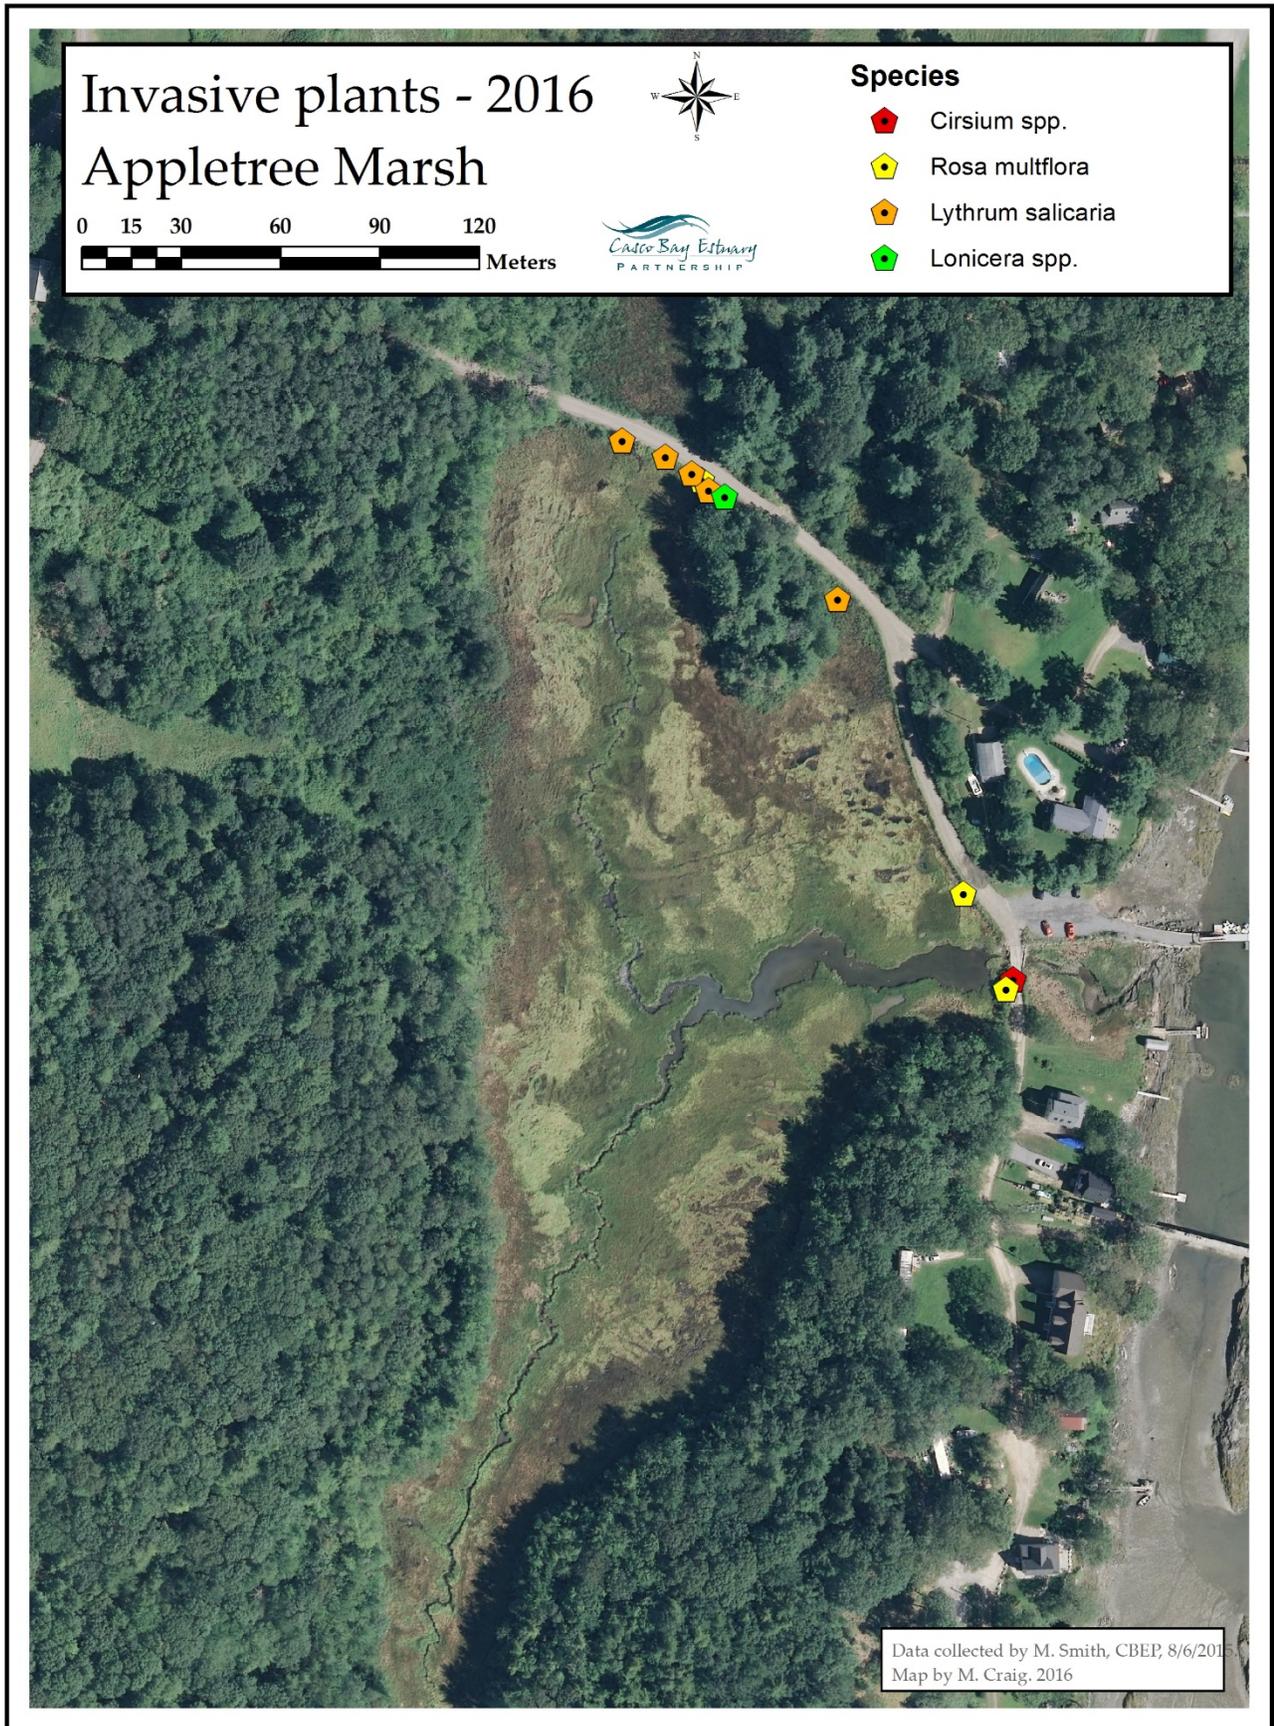
Figure 24. 2016 observations of plant species of concern.

The primary species of interest for performance standard monitoring, *Phragmites australis*, remains absent from the site. In 2015, the only invasive plant observed in the wetland footprint was Purple Loosestrife (*Lythrum salicaria*), which was found in several locations, typically in clusters of a few plants, along the perimeter (St. 2, St. 8, St. 10). Primarily, loosestrife was observed on or immediately adjacent to the road bank, and secondarily, in areas with obvious freshwater inputs (seeps or surface water). A large Japanese Barberry (*Berberis thunbergii*) was also observed on the road bank to the west of 9078 in 2014 and 2015 (Fig. 24), right at the wetland’s delineated edge. CBEP staff manually cut back the Barberry to the ground in 2015 in order to promote native vegetation and limit the potential for expansion, and will monitor future growth and repeat manual cuts until the plant is dead.

In 2016, a meander survey through the project area for non-native plants was conducted on July 26 by CBEP’s seasonal field crew. Similar to previous years, observations were limited to areas outside of, but immediately adjacent to, the project area, particularly along the edge of Wallace Shore Road. The number and distribution of loosestrife plants markedly declined since 2015. All *Lythrum* plants were carefully hand-pulled and rooted prior to going to seed, then bagged and destroyed offsite. The continued decline in plant species of concern is consistent with the drought, improved freshwater drainage out of the marsh, and increased salt delivery via tidal restoration. Monitoring for invasive plants will continue in 2017.

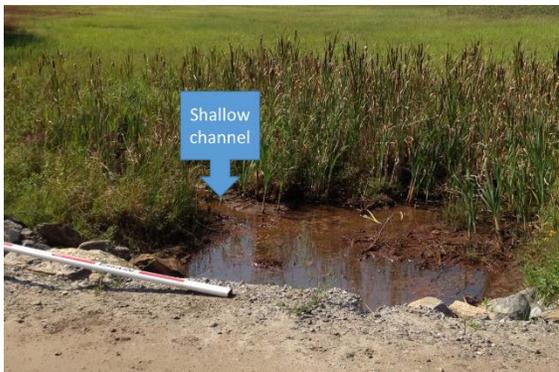
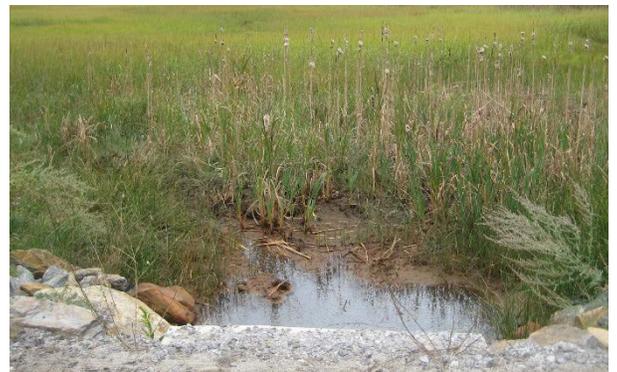
Figure 25. Pooled water at the outlet of crossing 9078 (2015 (l) and 2016 (r)).

Immediately upstream of Station 9 at the outlet of 9078 (see photos, Appendix A), individual cattails were extremely stressed or dead in 2016, consistent with the absence of glycophytes at Station 9. An abrupt transition in community composition remains evident between Stations 9 downstream of 9078, which has an abundance of halophytic vegetation, and 10 upstream of 9079, which lacks halophytes. However, the relative abundance of glycophytes decreased from 63% in 2015 to just 11% in 2016. This shift was accompanied by a decline in species richness within the surveyed plots from 27 species in 2014 and 2015 to 5 in 2016. This shift in species composition is illustrated in Figure 4 (right), which breaks out *Typha* species from other glycophytic and brackish species observed within the 2016 plots. The graph illustrates that diversity in this area has been lost, and the vast majority of remaining plants are cattails.

As noted in Section 3.4, and described further in Section 3.10 (and illustrated in the 2015 longitudinal profile in Fig. 21), over the course of several monitoring visits, CBEP observed that surface water was pooling in the excavated channel outlet of crossing 9078 due to a lack of channel development/scour. Water flowing into the excavated area from upstream (north side of culvert) is impounded at the edge of the area excavated during installation, and backs up through the pipe into the excavated area upstream of the inlet, creating a standing pool of water that discharges in a braided network of channels before it reaches the downstream channel. Closer examination revealed that a sediment slug from a historic culvert failure is controlling the grade just downstream of the 9078 outlet. This may be maintaining water levels that allow for persistence of glycophytic species and slow the process of conversion to brackish and halophytic communities at Station 10. The issue is most obvious during low flow conditions that co-occur with a neap tide phase when the flow out of this pool becomes a trickle (Fig. 25). Shallow exploratory probing of the channel suggests that coarse-grained sediments are present on the marsh surface along the edge of the excavated area, and are not mobilizing, presumably due to a lack of velocity/volume combined with volume of sediments present. As previously mentioned, anecdotes from abutters confirm that several years ago (preceding the project), the culvert blew out at this location, washing road fill onto the downstream marsh. The pool, and the sediment slug, may be contributing to the presence of cattails immediately downstream (Fig. 25).

2. Remove sediments from the channel. Use hand tools (shovel, hoe) to carefully hand dig coarse-grained sand out of the narrow channel without damaging adjacent vegetation, and transport sediments offsite using a few five gallon buckets. Prior to implementation, additional sediment probes in the channel could be used to determine the extent and depth of coarse grained road fill in the channel. A simple plan could be drawn up in advance to determine channel elevations and width, based on the 2015 longitudinal profile, and survey equipment would be used to check elevations during field implementation. Implementation could be conducted in the summer of 2016. No cost is anticipated with this approach, which could be completed by two people in a couple hours. This is the preferred approach and is recommended out of the three options presented, provided that no additional permitting and approvals is required.

3. Remove sediments from the marsh and channel. Another approach would be to bring heavy equipment back to the site to excavate sediments from both the marsh surface and the channel. The purpose would be to not only improve flow out of the excavated area, and relieve the impoundment, but also to lower marsh surface elevations. A detailed topographic survey downstream of the 9078 outlet may be warranted, as well as a more expansive survey of sediments, to determine the extent and depth of coarse grain sediments downstream of 9078. Simple drawings may be warranted to guide excavation of sediments working with large equipment (presumably, a back hoe or excavator and a dump truck). This option is least preferred. Although this approach could realize additional benefits by removing fill from the marsh surface, use of an heavy equipment brings an inherent risk of doing more harm than good (damage to vegetation, digging out a larger or deeper channel than is suitable, etc.). For this reason, the approach is not recommended. Work could be conducted in late summer/early fall 2016 if funding was obtained, and permits were secured if necessary, but these are unknown considerations at this time.
