# Mill Brook Stream Bank Stabilization and Habitat Enhancement Project September 2007

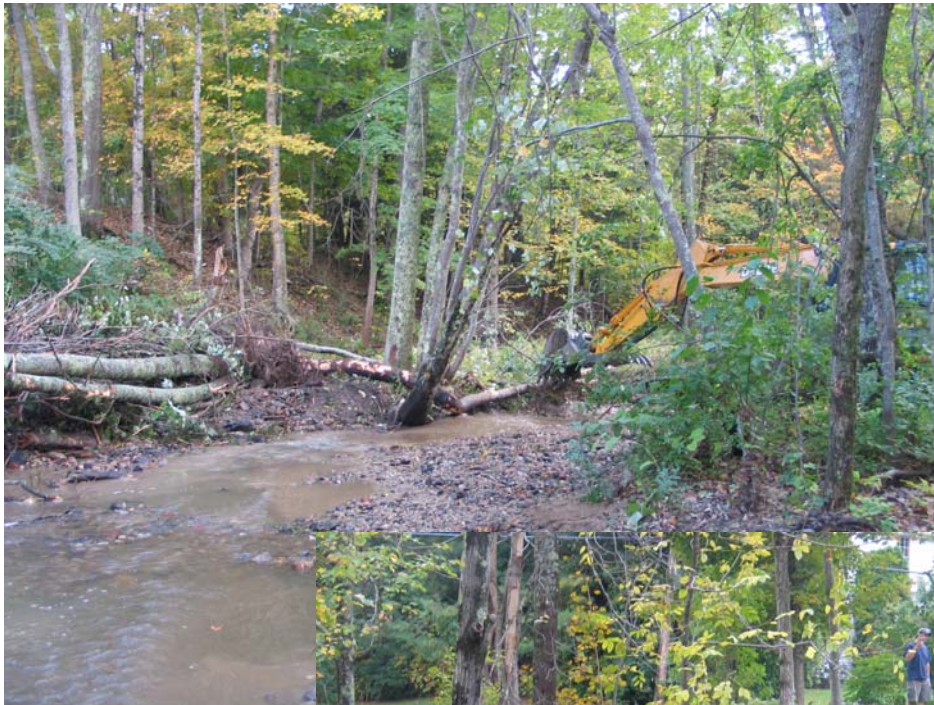
**Left - Root wad and native tree stacking.**

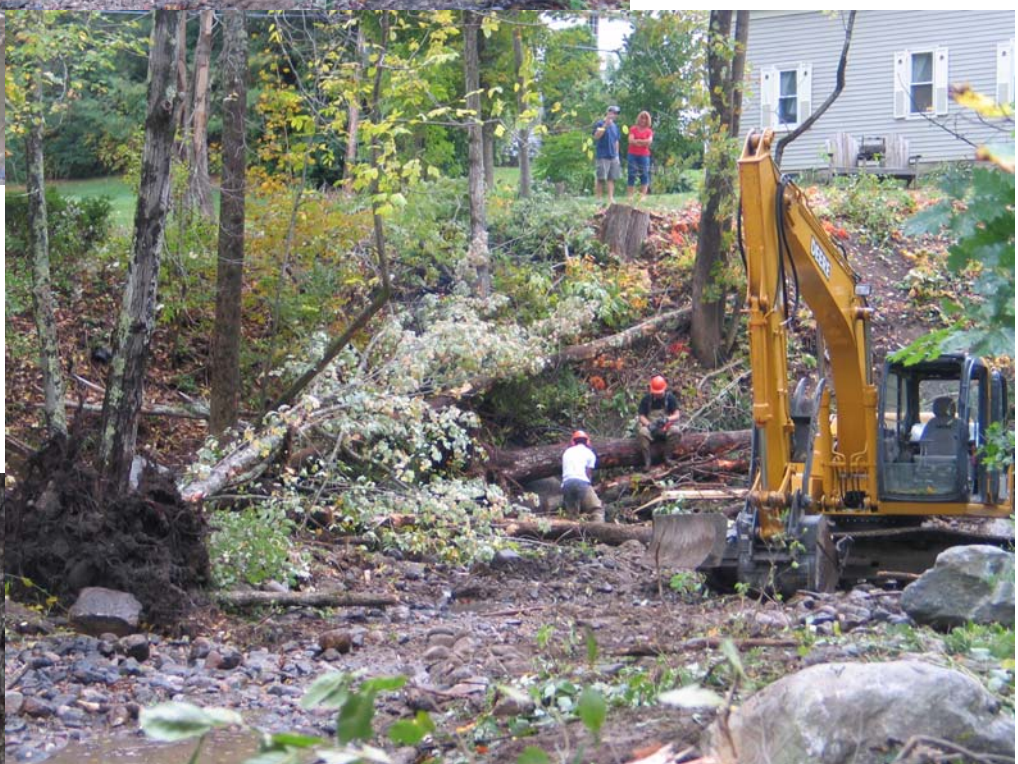
**Below - Anchoring of root wads to boulders and or live native trees**

**Cable anchoring root wad to live native tree**

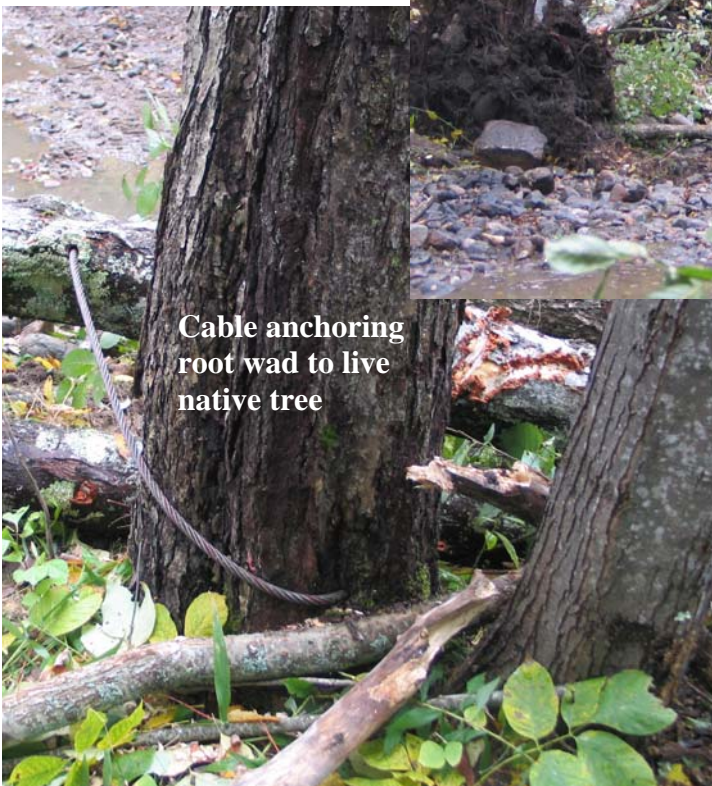
**Eye bolt and cable for anchoring**

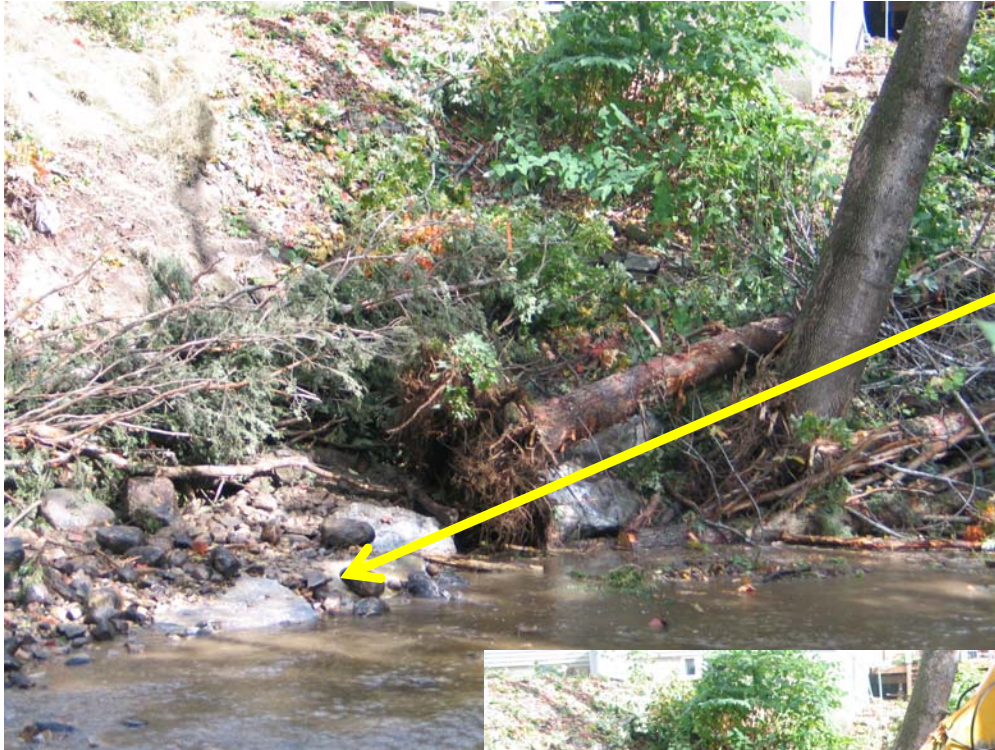
Rock vein with  
root wads  
packed around  
and behind.

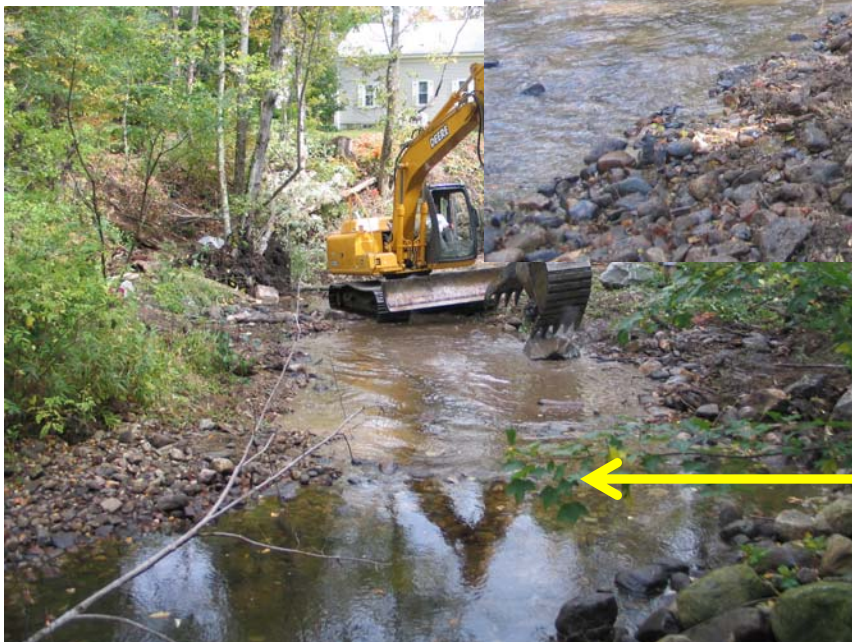
Temporary dam re-  
moved and feathering of  
stream bed

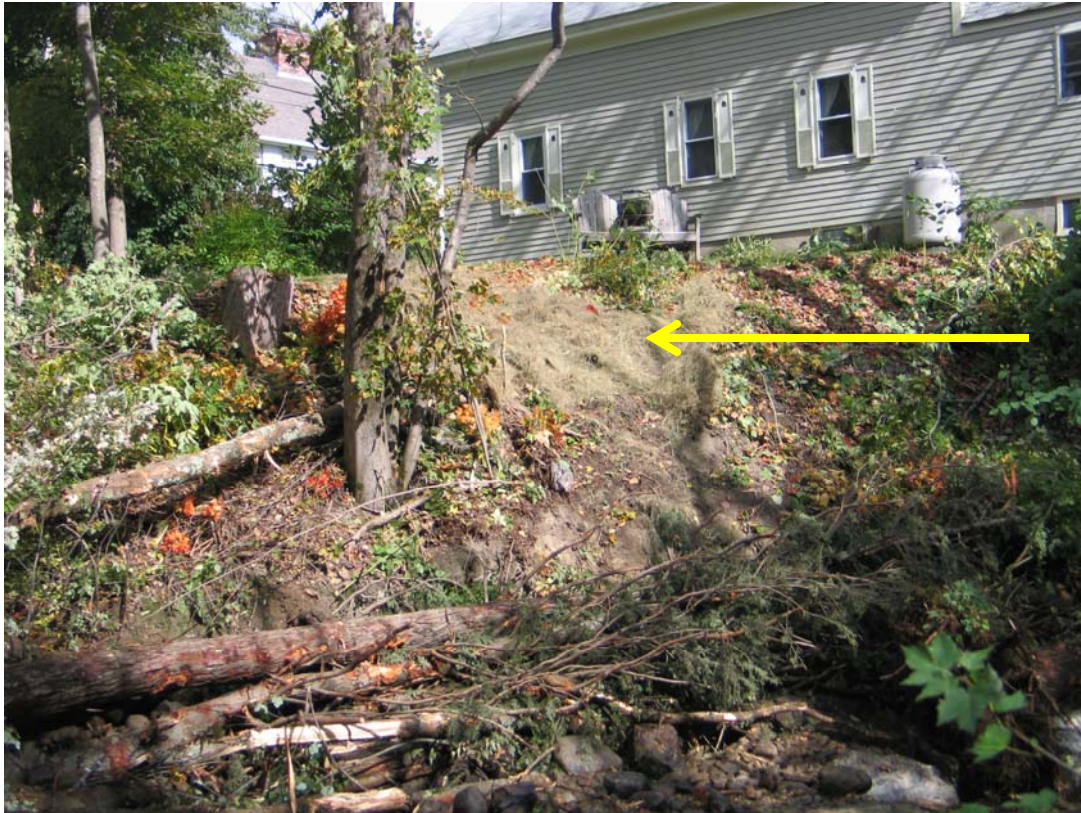
**Seeding and Hay bare areas with winter rye**

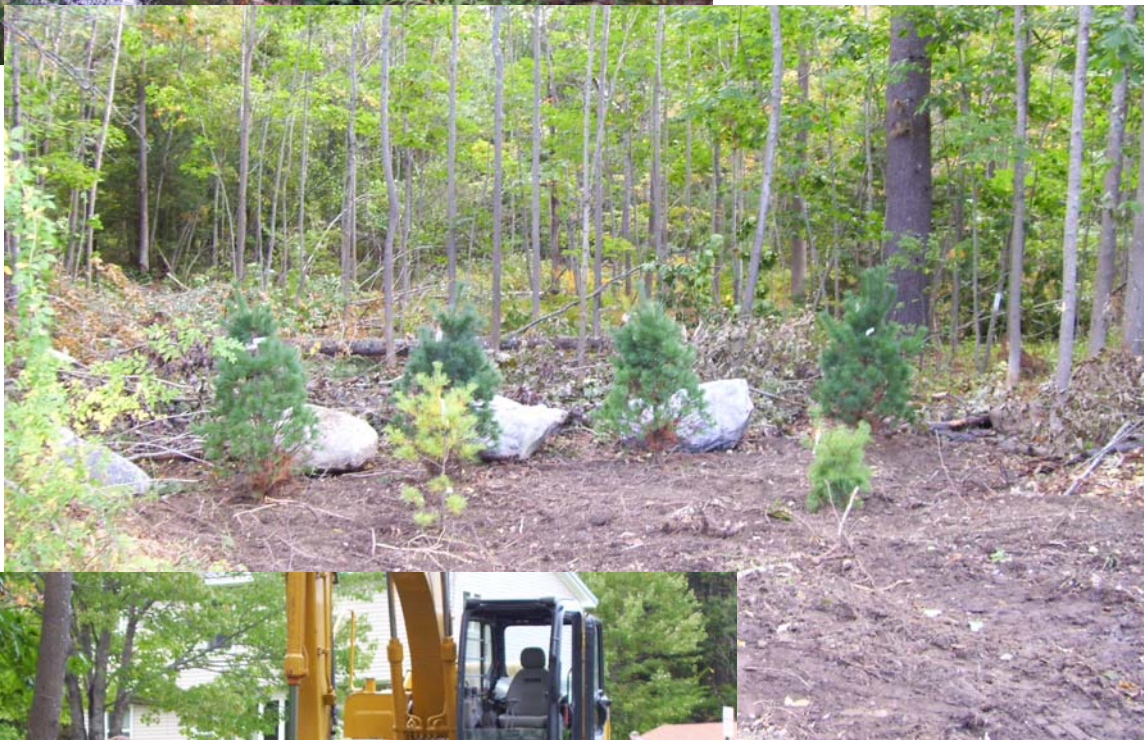
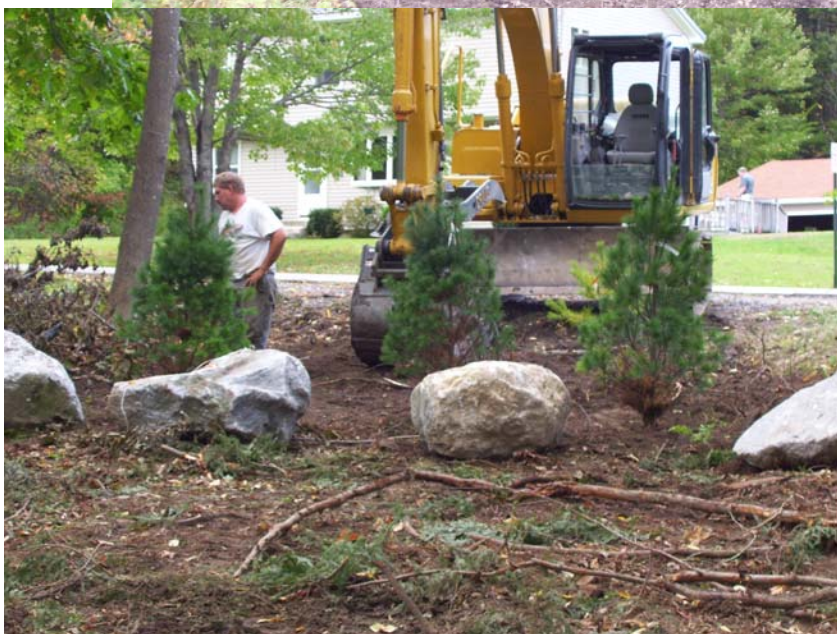
**Access/entrance area blocked by boulders and six white pines.**

**Access road also stabilized with brush, winter rye and hay.**
