# CROOKED RIVER

## WATERSHED SURVEY

Cumberland County Soil & Water Conservation District

March 2012

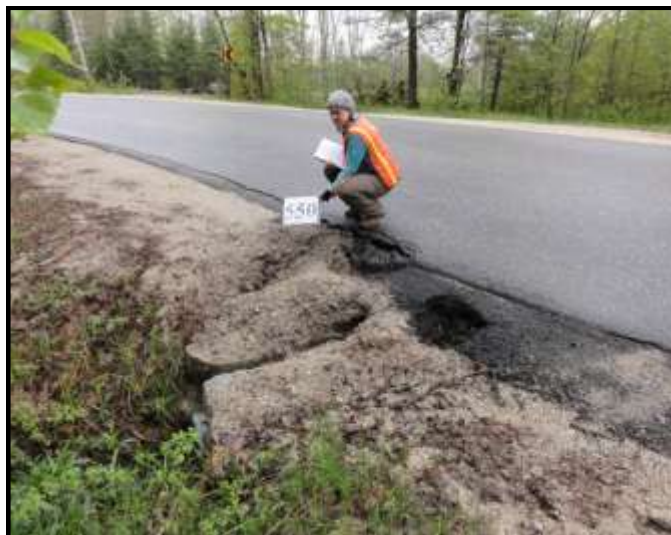
Runoff from the paved road concentrates around this culvert to contribute significant sediment to a Crooked River tributary.

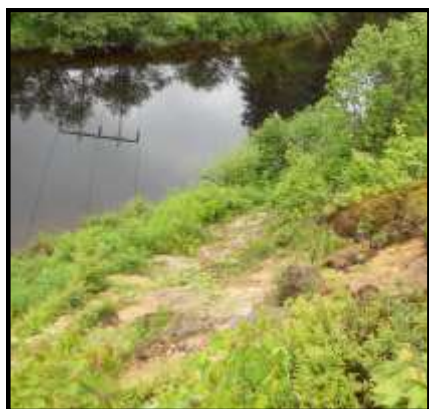
**CMP Power Lines bank erosion**

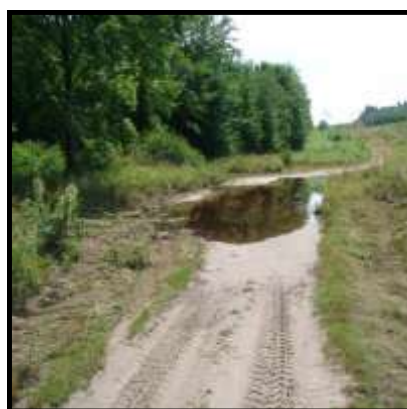
**Runoff from ATV Trail**

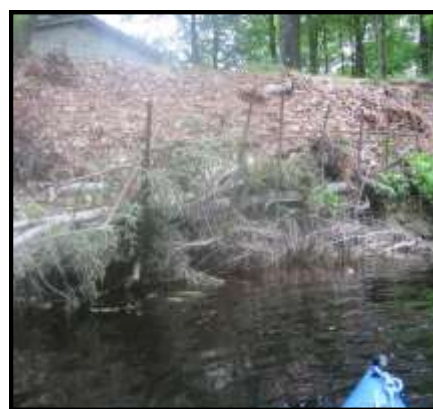
**Yard waste dumping**

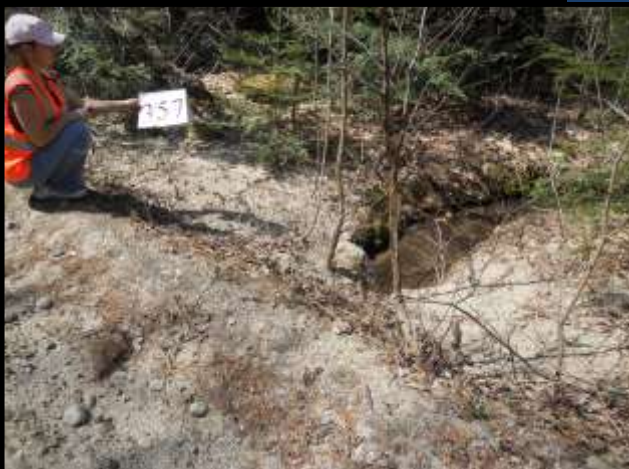
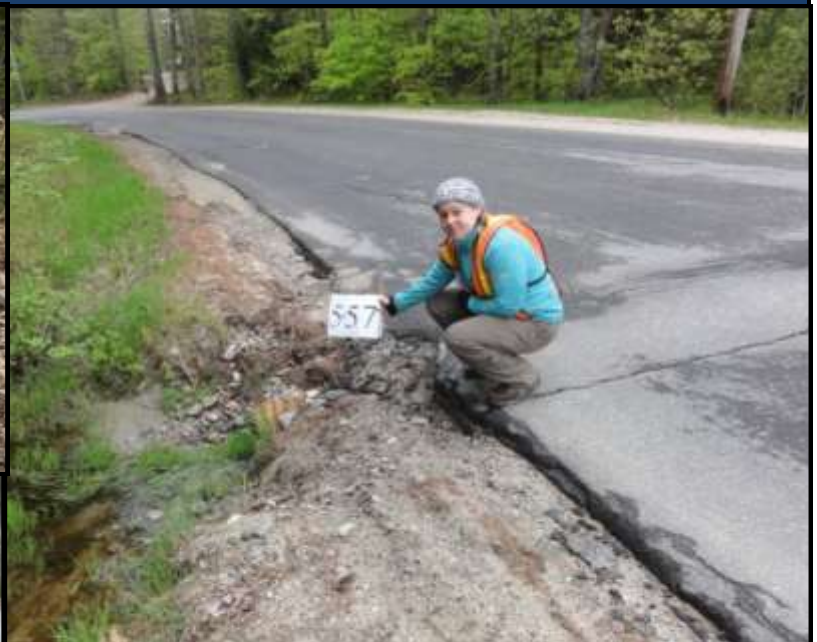
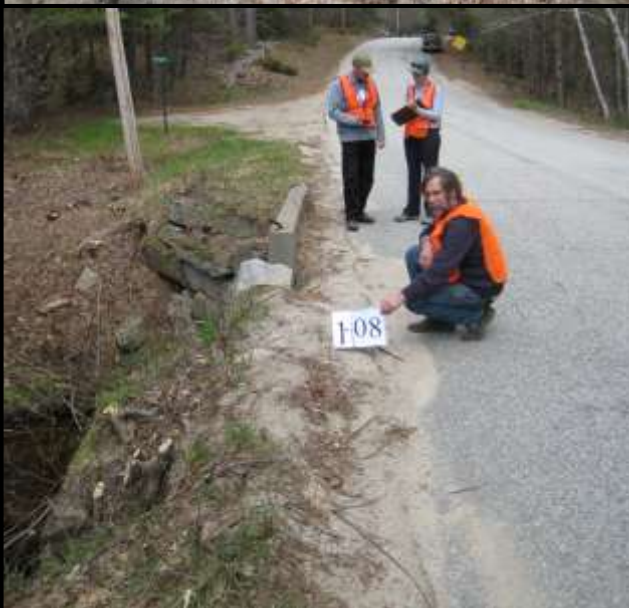
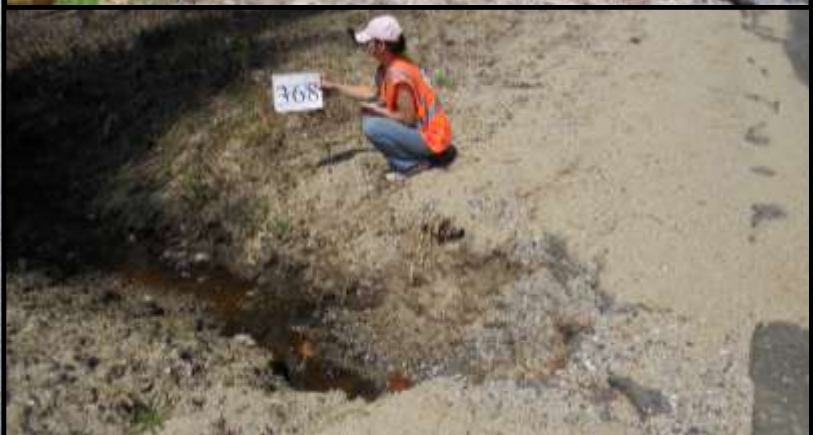
- ◇ Unstable culvert inlets/outlets
- ◇ Road shoulder erosion
- ◇ Unstable ditching/erosion
- ◇ Clogged or rusted culverts
- ◇ Road surface erosion
- ◇ Buildup of winter sand
- ◇ Undersized culverts

- ◇ Clean out culverts and armor inlets/outlets with rip rap
- ◇ Re-grade, vegetate to stabilize shoulders
- ◇ Clean, re-shape and stabilize ditches
- ◇ Clean out and/or replace
- ◇ Grade, shape and stabilize surface with quality material
- ◇ Remove winter sand build up
- ◇ Replace with larger size culvert and stabilize

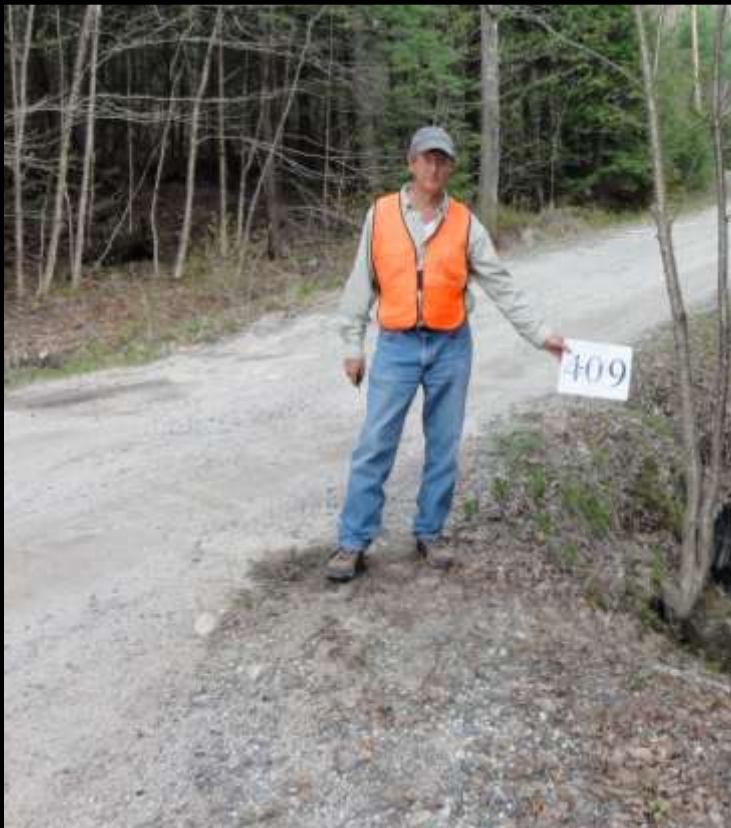
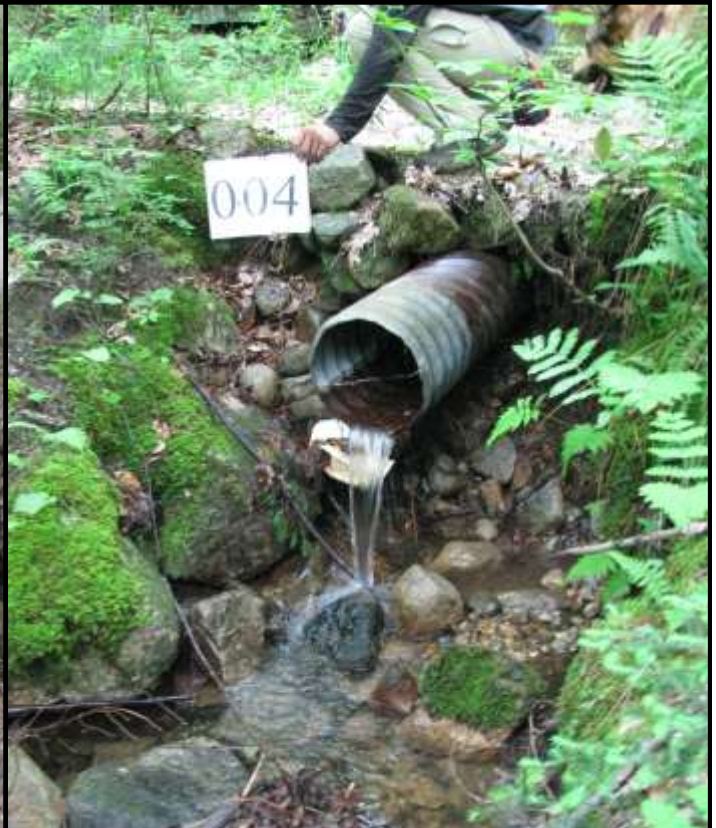
- ◇ Unstable culvert inlets/outlets
- ◇ Road shoulder/ditch erosion
- ◇ Clogged or rusted culverts
- ◇ Road surface erosion
- ◇ Buildup of winter sand/grader berms
- ◇ Undersized culverts

- ◇ Clean out culverts and armor inlets/outlets with rip rap
- ◇ Re-grade, vegetate and re-shape ditches/stabilize shoulders
- ◇ Clean out and/or replace
- ◇ Grade, shape and stabilize surface with quality material
- ◇ Remove winter sand and grader berm build up
- ◇ Replace with larger culvert and stabilize

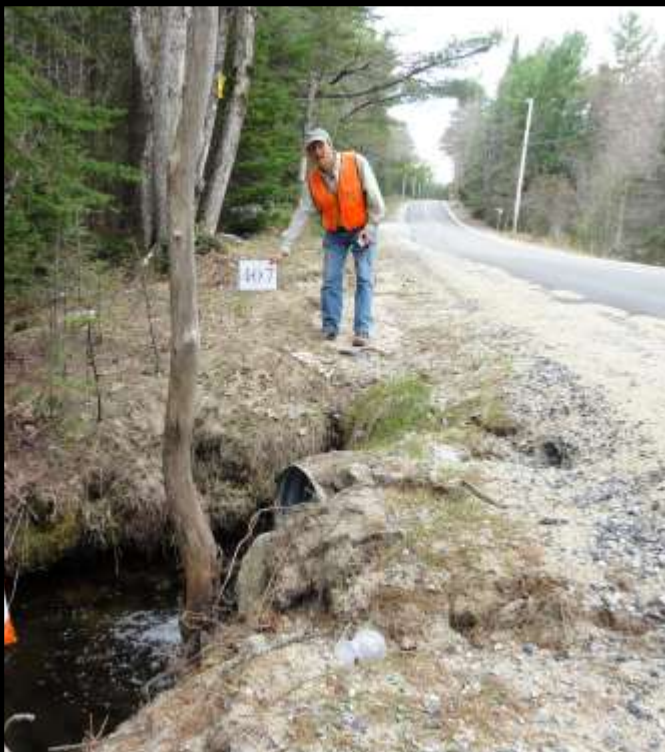
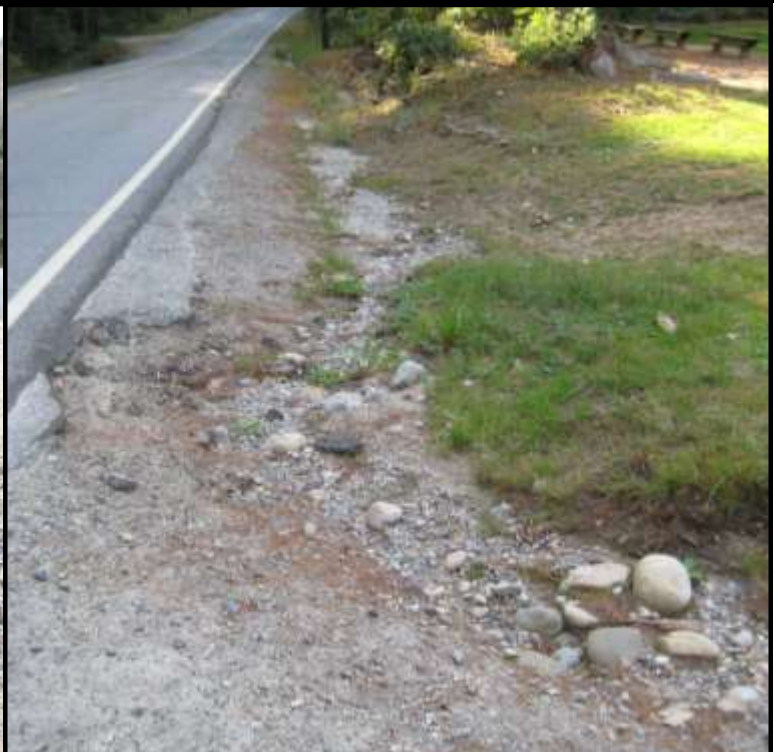
- ◇ Slight or moderate surface erosion
- ◇ Unstable or eroding shoulders and ditches
- ◇ Unstable culverts
- ◇ Direct flow to the river
- ◇ Inadequate vegetated buffers

- ◇ Seed and mulch bare soil
- ◇ Reshape and stabilize with stone or curlex
- ◇ Stabilize and or replace if necessary
- ◇ Plant vegetated buffers
- ◇ Divert flow away from river and or treat or detain stormwater
