Cape Elizabeth Culvert and Habitat Assessment Study

March 22, 2019

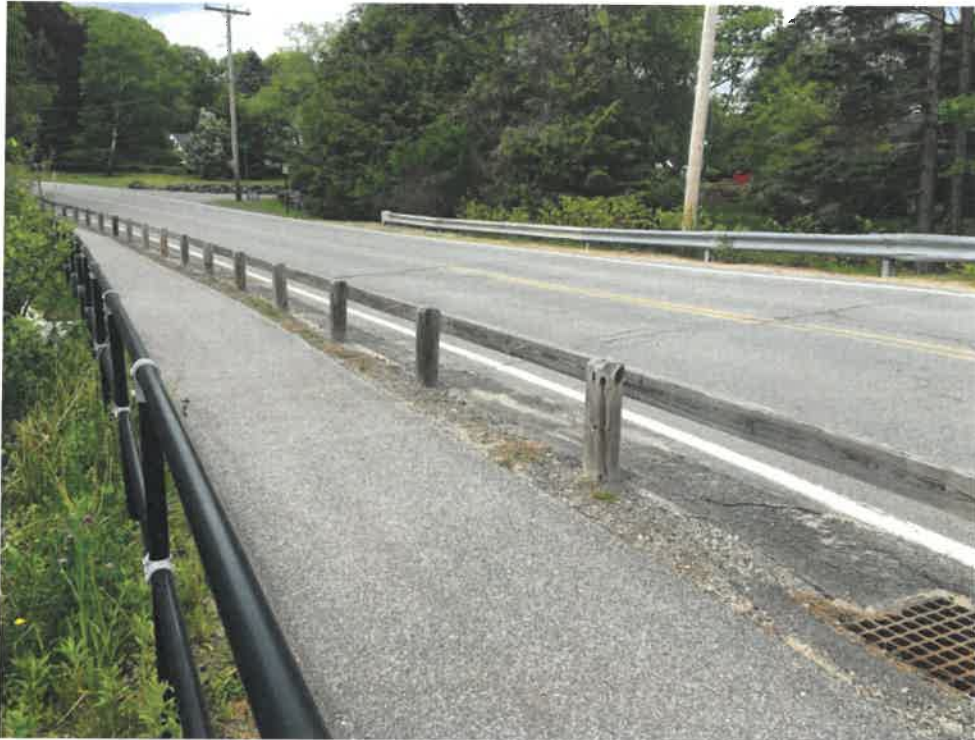
Photo 1 (06-06-18): Facing northeast at Shore Road crossing of the Dyer Pond outflow. Culvert crossing coincides with the pavement crack across the surface of Shore Road.

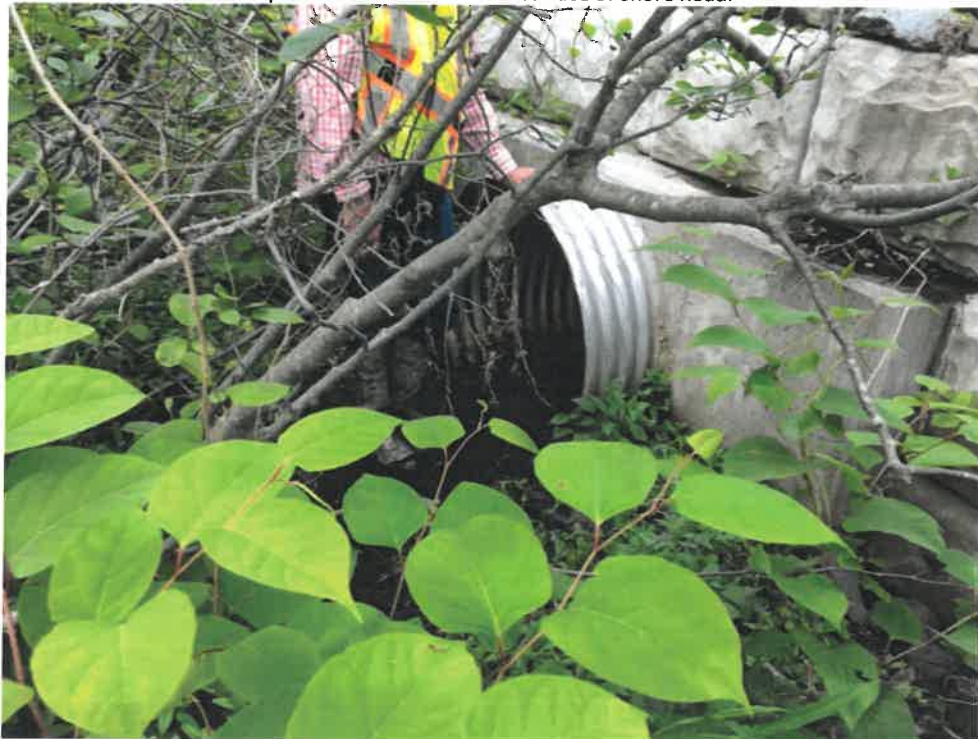
Photo 2 (06-06-18): Inlet of 36-inch corrugated aluminum cross pipe with a cast-in-place concrete collar and base set within a large concrete block "Stonestrong" retaining wall. Inlet is on the west side of Shore Road.

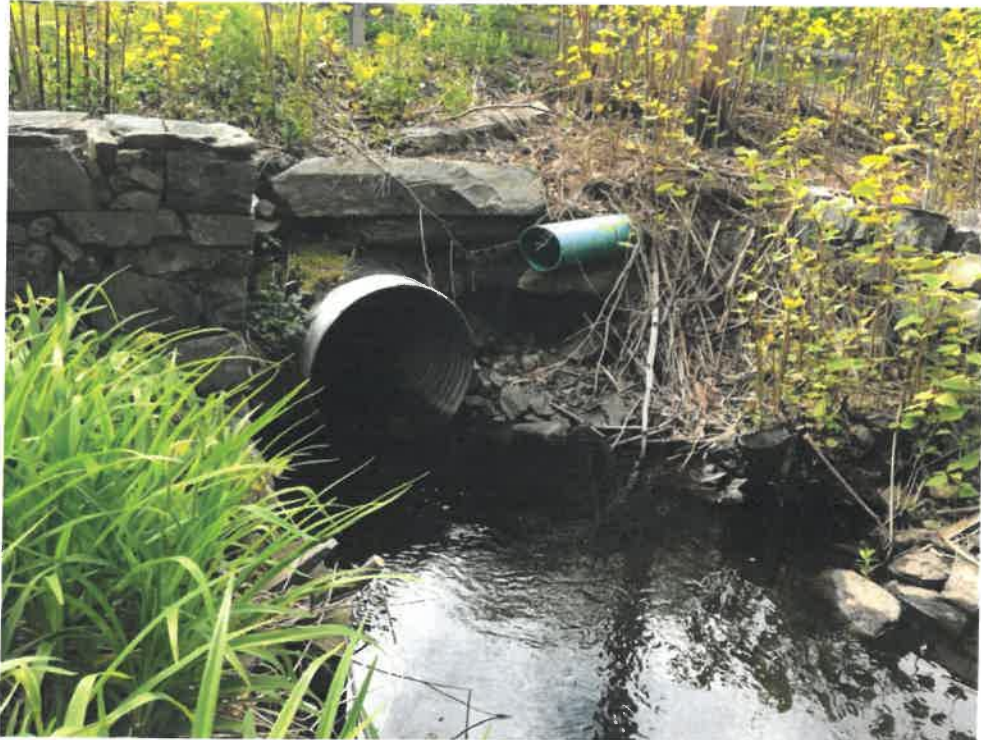
Photo 7 (06-06-18): Submerged outlet of culvert on the east side of Shore Road. Loose stones on headwall of outlet with smaller diameter green polyvinylchloride (pvc) pipe discharging well above the outlet invert elevation of the cross culvert.

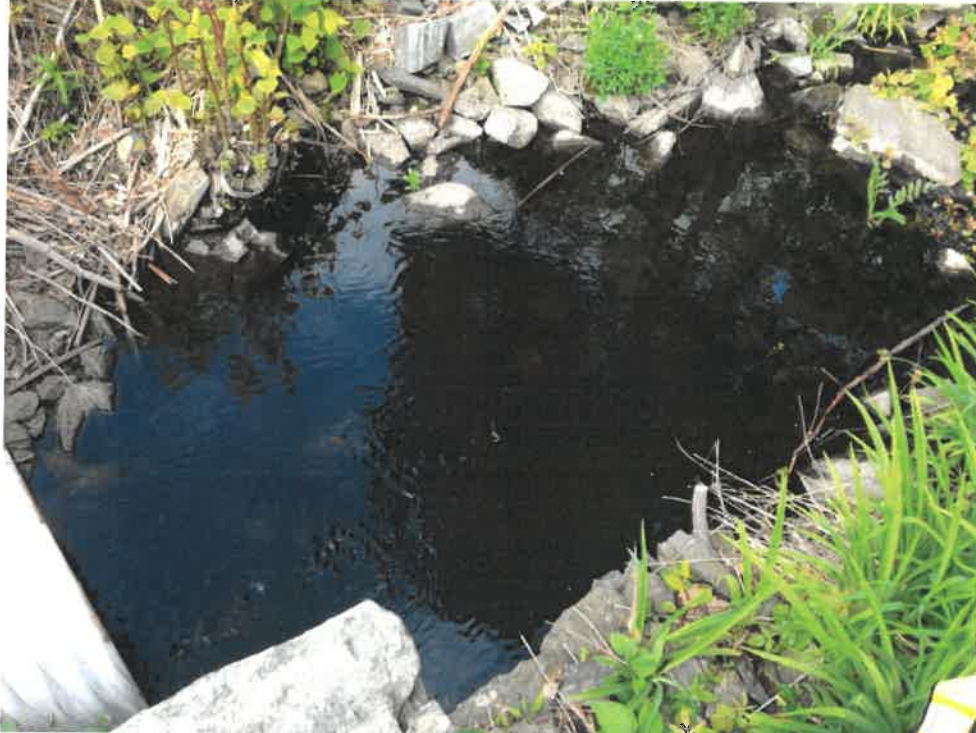
Photo 8 (06-06-18): Overhead view of culvert outlet with rip rap plunge pool apron area. Stone lined plunge pool dissipates energy of the outfall and reduces the velocity of the outflow to the receiving channel.

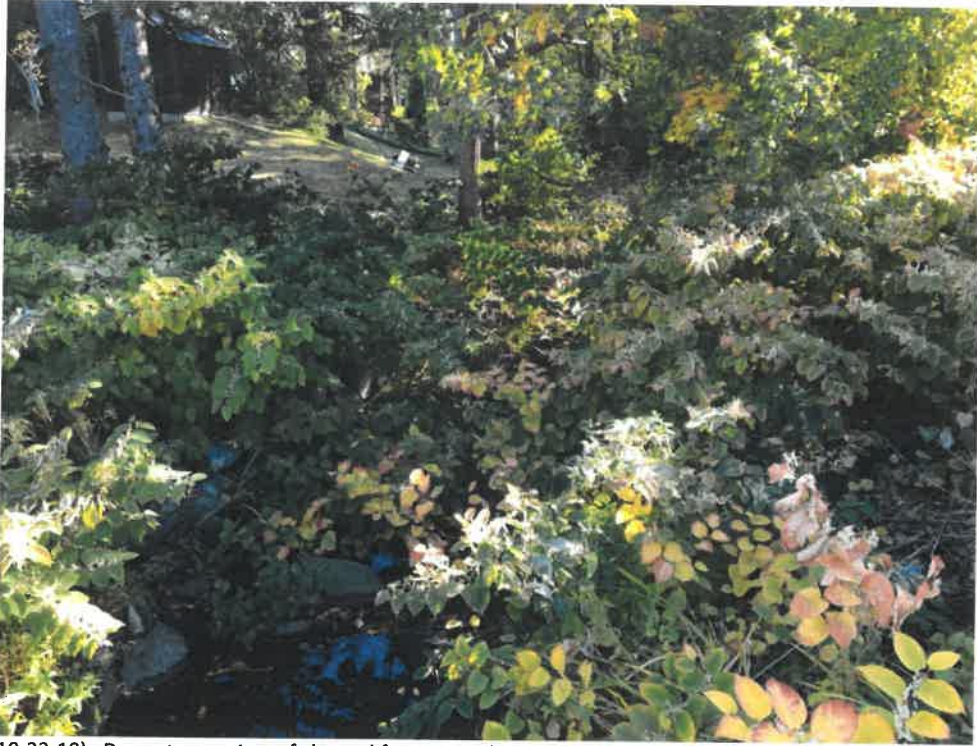
Photo 9 (10-22-18): Downstream view of channel from the culvert outlet rip rap plunge pool apron area on the east side of Shore Road. This flow travels to Casco Bay through the Delano Park neighborhood which is susceptible to high flow conditions.

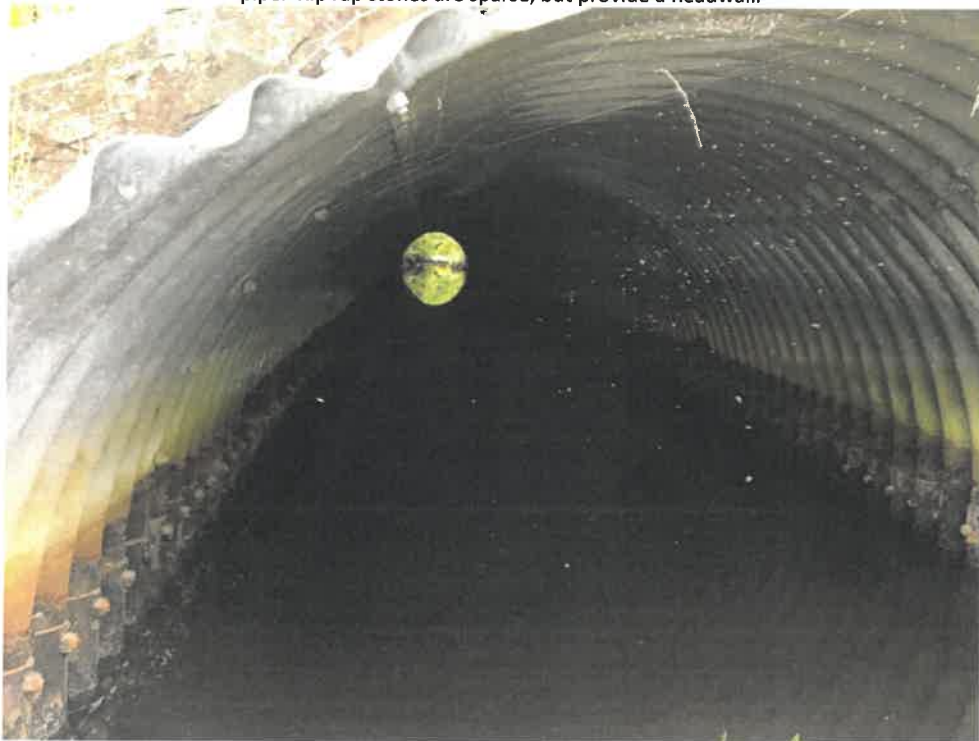
Photo 7 (06-06-18): Interior view of culvert from the outlet end on the west side of Route 77 toward the east side of Route 77 inlet. Corrosion evident along sidelines and invert of the pipe, however, the pipe alignment and integrity appear to visually be in good condition.

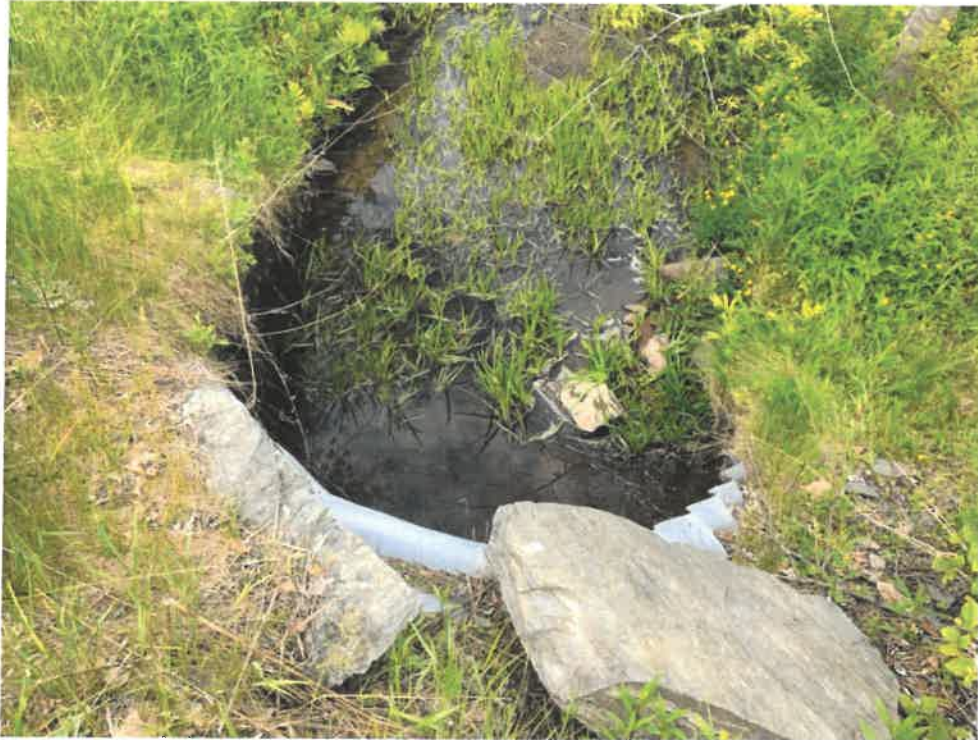
Photo 8 (06-06-18): Overhead view of culvert outlet with stones and vegetation in the outlet channel.

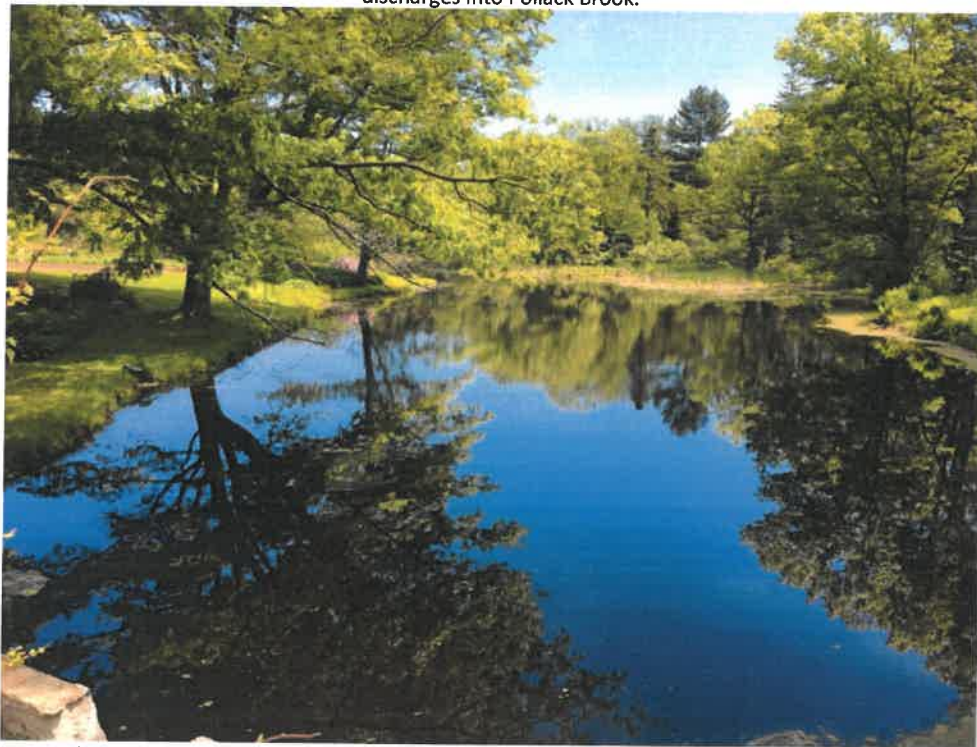
Photo 2 (06-06-18): Manmade pond impoundment on the south side of Spurwink Avenue.

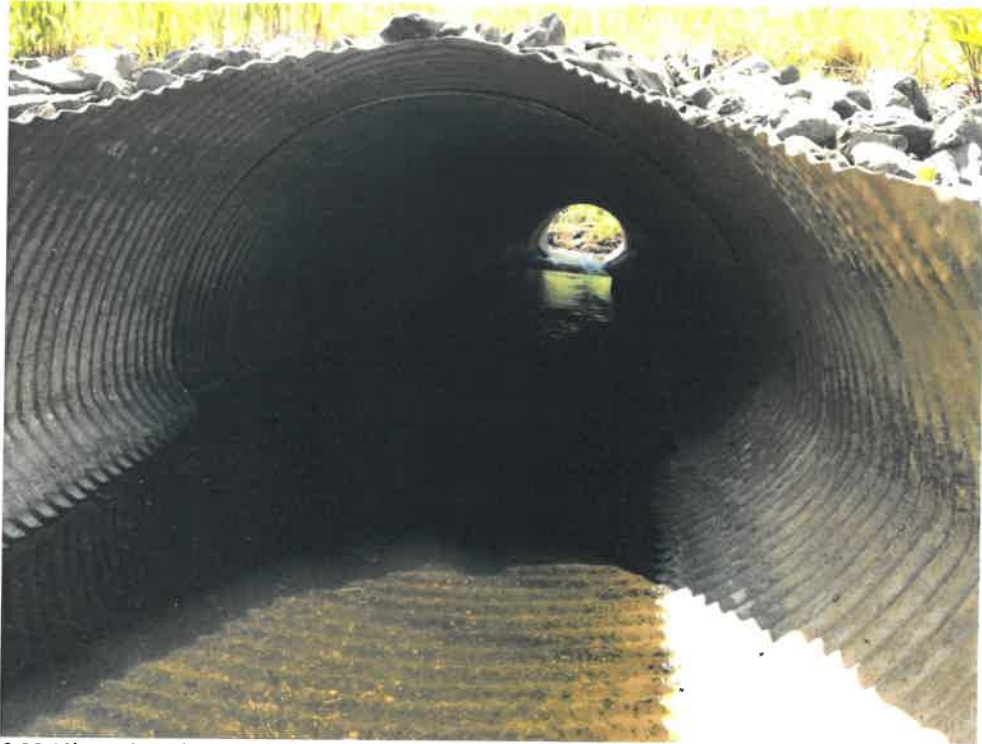
Photos 3 (06-06-18): Looking through the culvert from the inlet side, interior of the elliptical pipe appears visually to be in good condition, however, the flared end section appears to be pulling away from the last section of pipe.

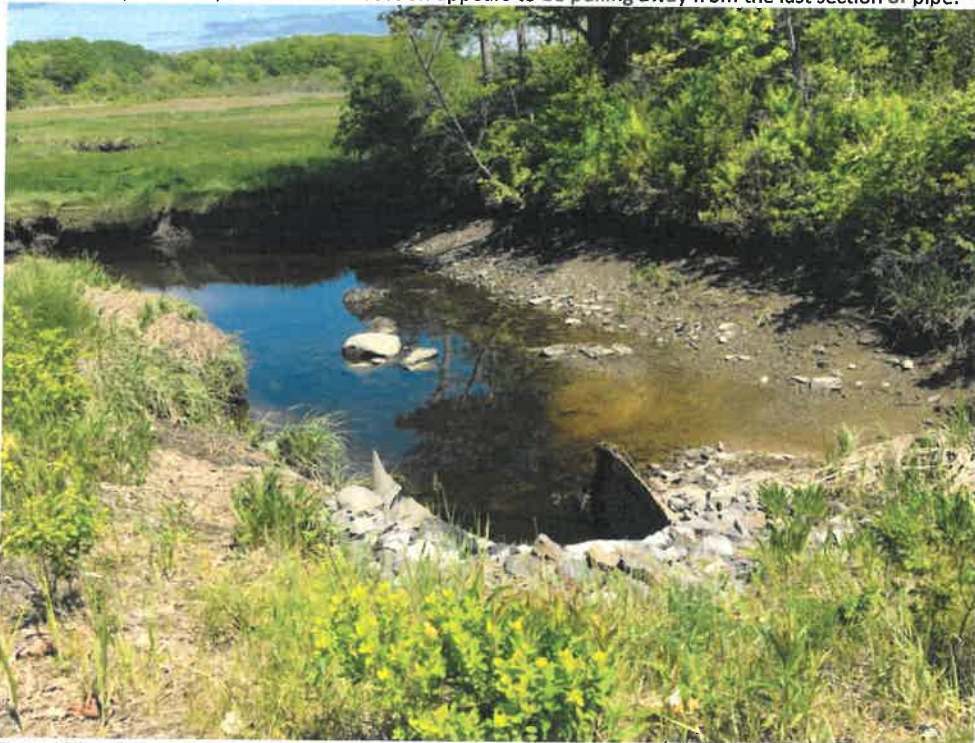
Photo 4 (06-06-18): Inlet to culvert with channel of the Spurwink River upstream of the culvert. North bank of the channel is eroded due to the sharp bend in channel just upstream of the culvert location and may need to be bolstered with rip rap armor at some point in the future.

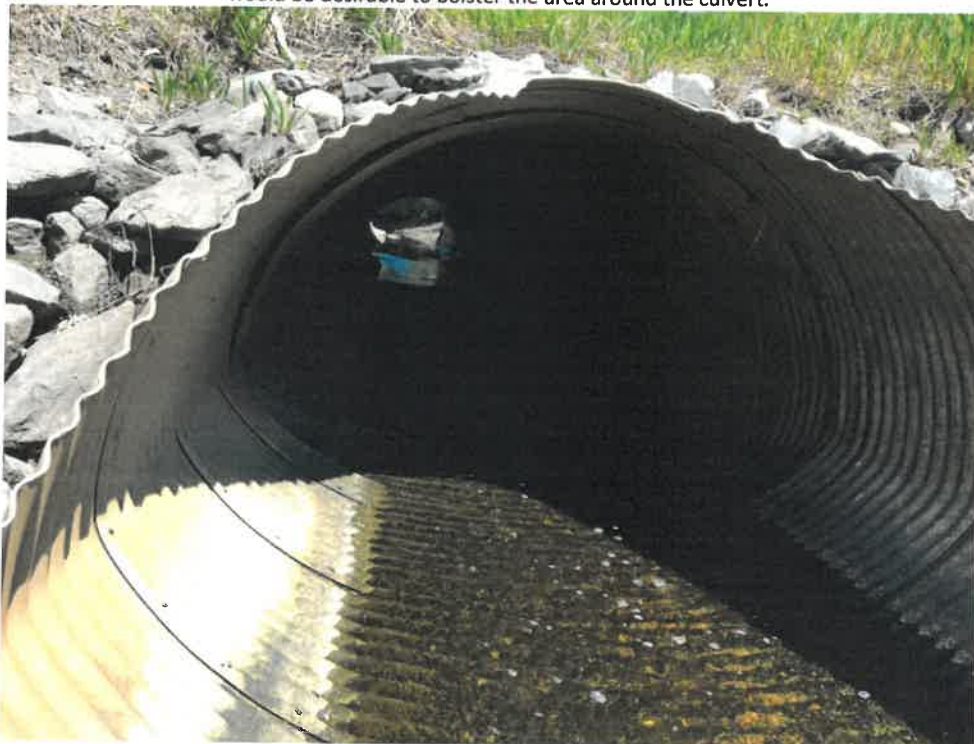
Photo 6 (06-06-18): Looking through the culvert from the outlet side, interior of the elliptical pipe appears visually to be in good condition, however, the flared end section appears to be pulling away from the last section of pipe.

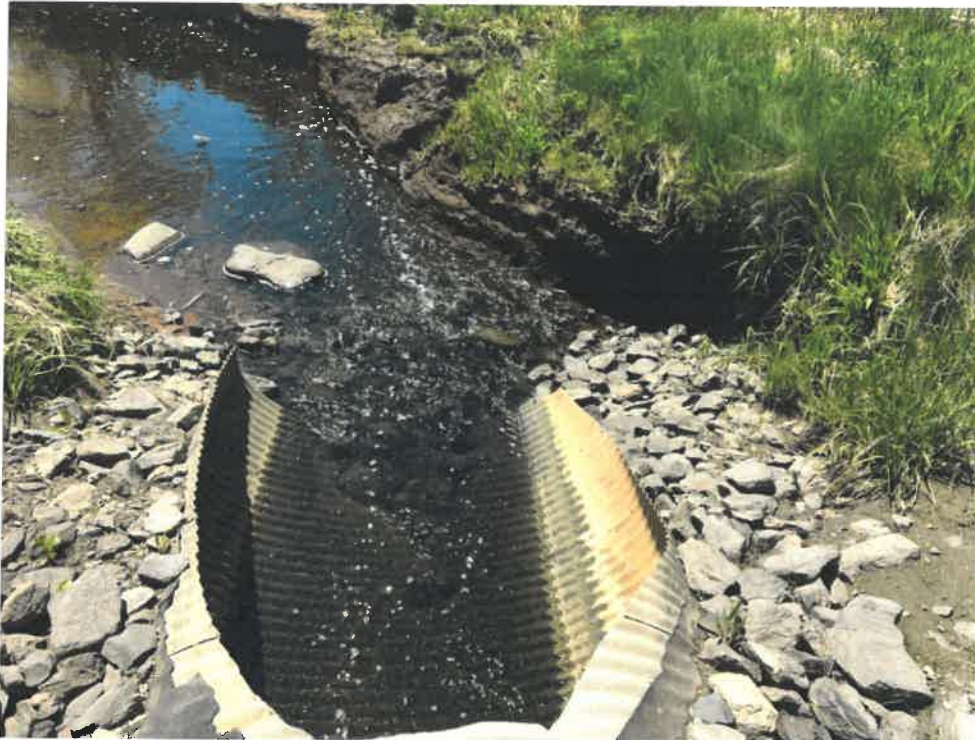
Photo 7 (06-06-18): Overhead view of culvert outlet with stones in and beyond the flared apron area. Headwall stones around the culvert appear to be depleted of rip rap layers and should be replenished.

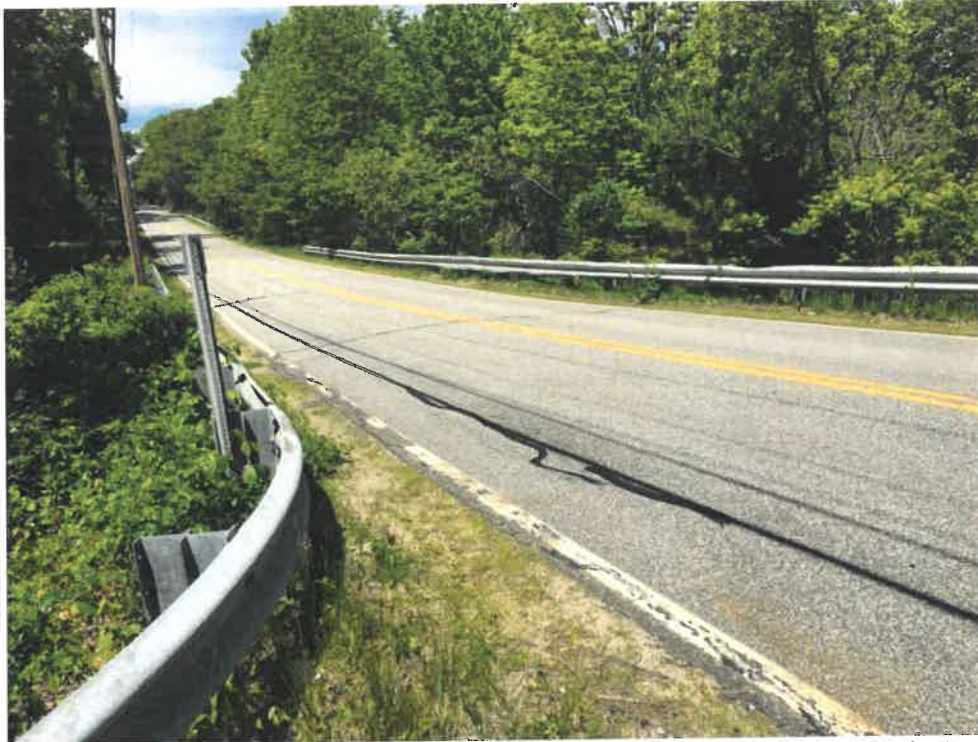
Photo 1 (06-06-18): Facing north at pavement surface of the Spurwink Avenue culvert crossing for the Jordan Pond outflow. Culvert crossing coincides with the pavement crack across the surface of Spurwink Avenue in the center of photo.

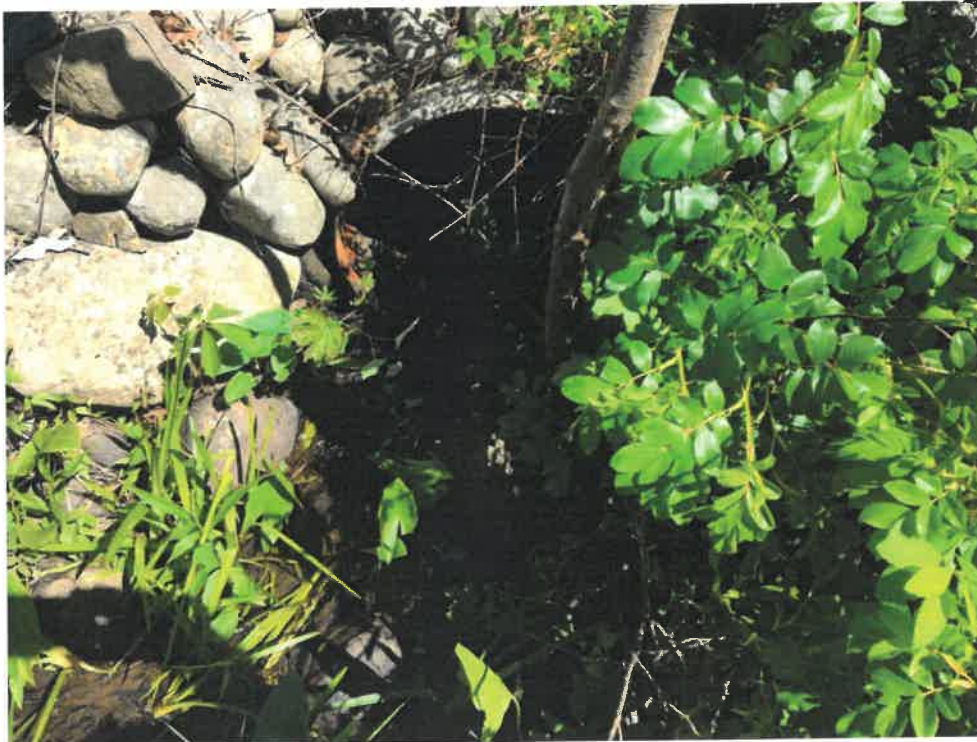
Photo 2 (06-06-18): Inlet of 24-inch corrugated aluminum cross pipe with a rip rap creating a headwall and apron. Inlet is on the west side of Spurwink Avenue and very thick vegetation made locating the culvert difficult.

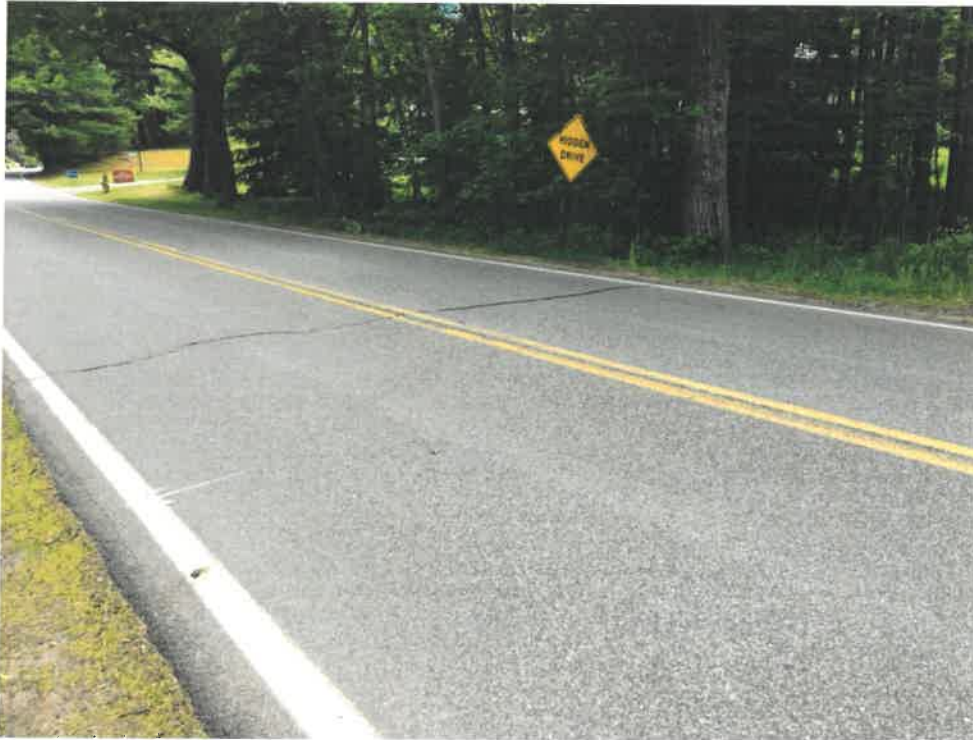
Photo 1 (06-06-18): Facing south at pavement surface of the Spurwink Avenue culvert crossing for an unnamed tributary to Trout Brook. Culvert crossing coincides with the pavement crack across the surface of Spurwink Avenue in the center of photo.

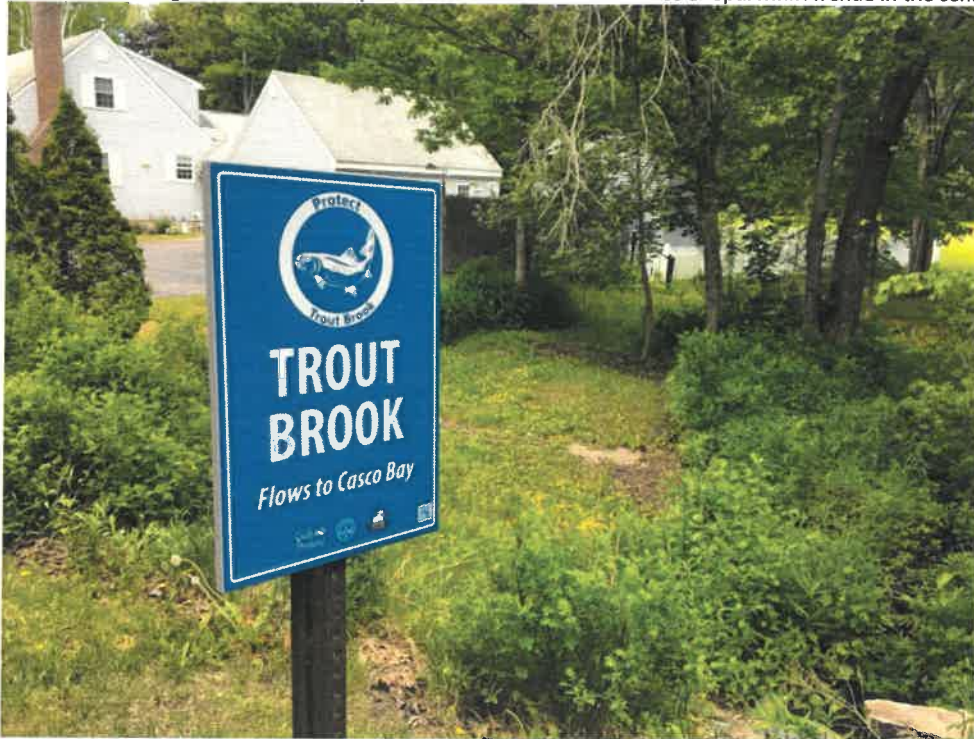
Photo 2 (06-06-18): Nearby sign indicating that the culvert is within the Trout Brook Watershed which is which is an Urban Impaired Stream.

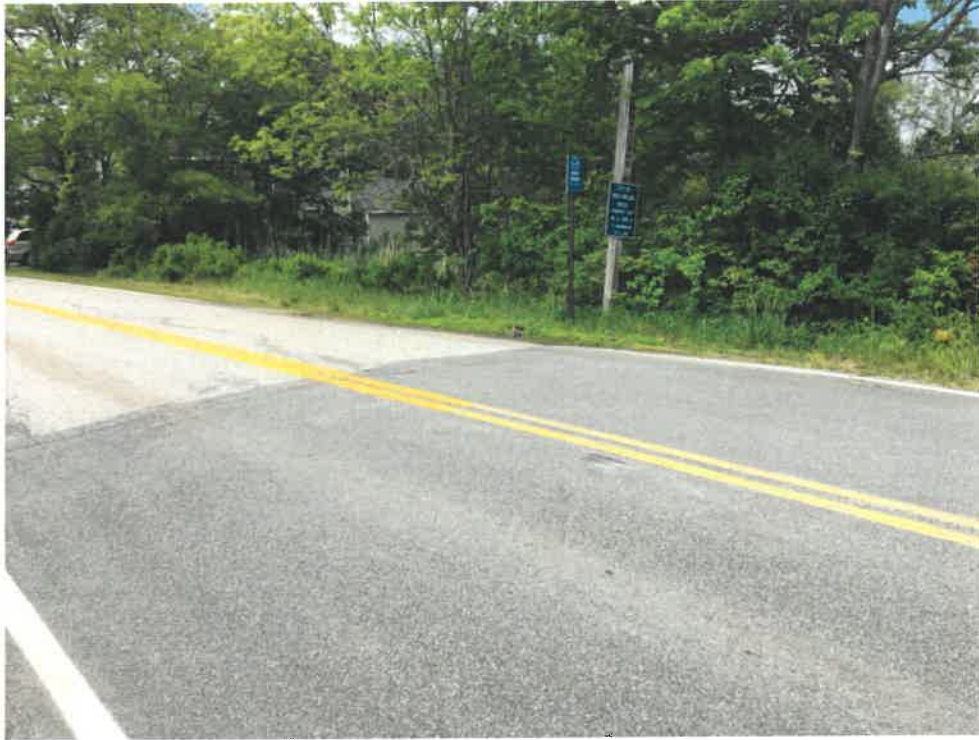
Photo 1 (06-06-18): Facing northeasterly at Spurwink Avenue crossing with Trout Brook which is an Urban Impaired Stream. Culvert crossing coincides with the pavement crack and change in pavement seam (which is also the South Portland municipal boundary) across the surface of Spurwink Avenue. Smaller blue sign indicates that the culvert is in the Trout Brook Watershed.

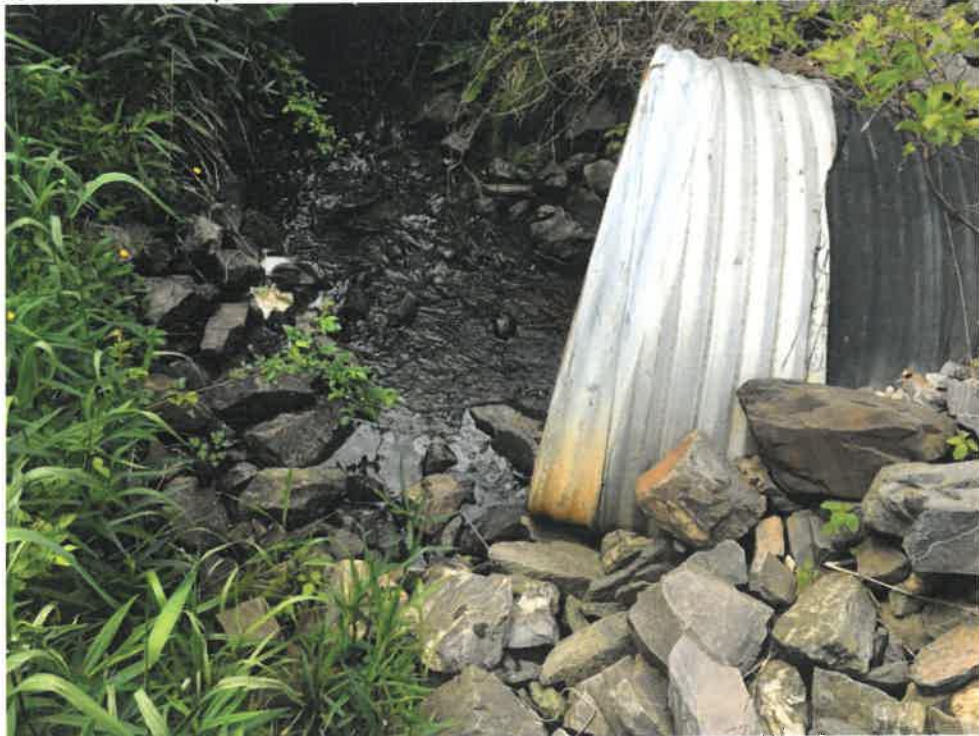
Photo 2 (06-06-18): Inlet of 60-inches wide by 44-inches tall corrugated aluminum elliptical cross pipe with rip rap apron and headwall. Flow curls into culvert abruptly after flowing southerly along and parallel to Spurwink Avenue.

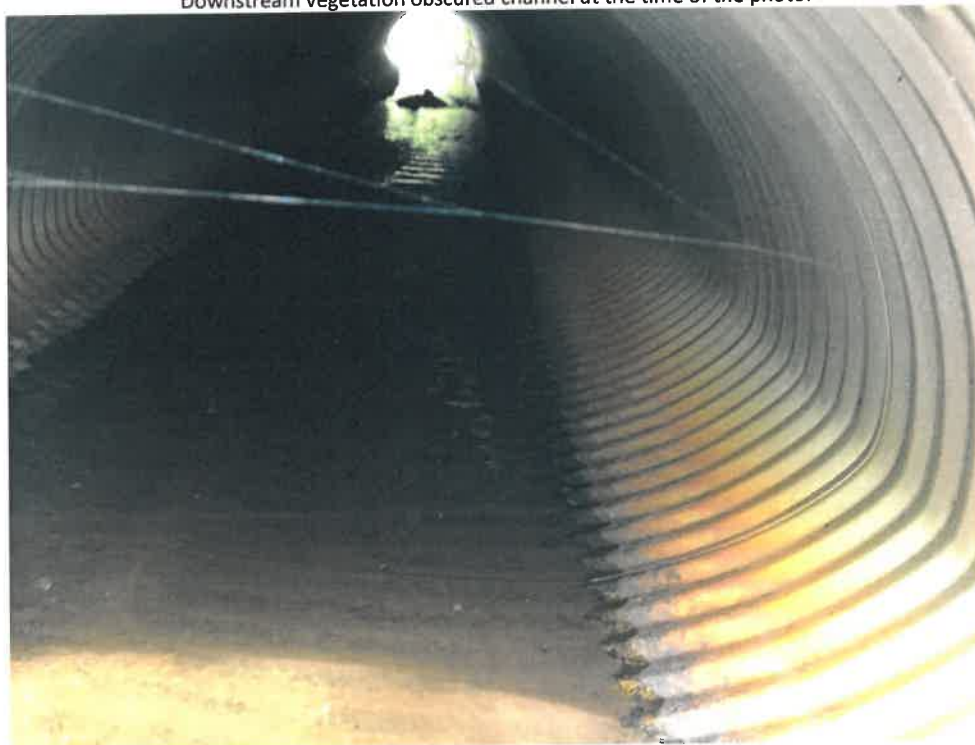
Photo 6 (06-06-18): Interior view of culvert taken from outlet to the inlet of culvert. Some corrosion visible along invert of pipe, however, the culvert appears visibly to be in good condition.

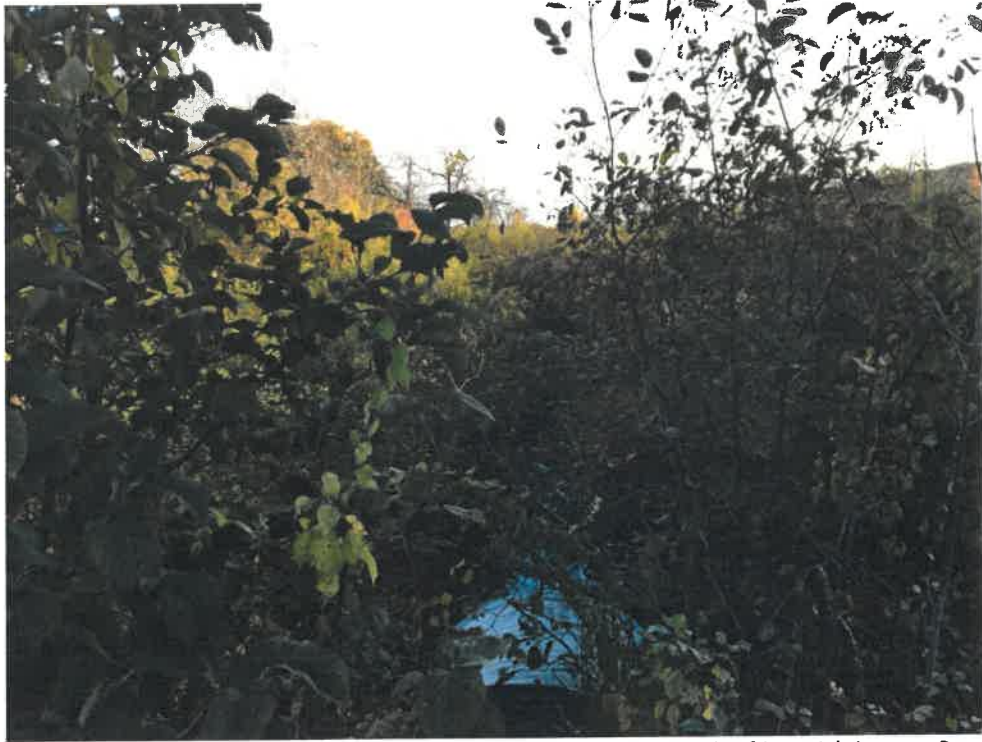
Photo 7 (06-06-18): Looking northeast at the flow from the culvert outlet on east side of Spurwink Avenue. Downstream vegetation obscured channel at the time of the photo.

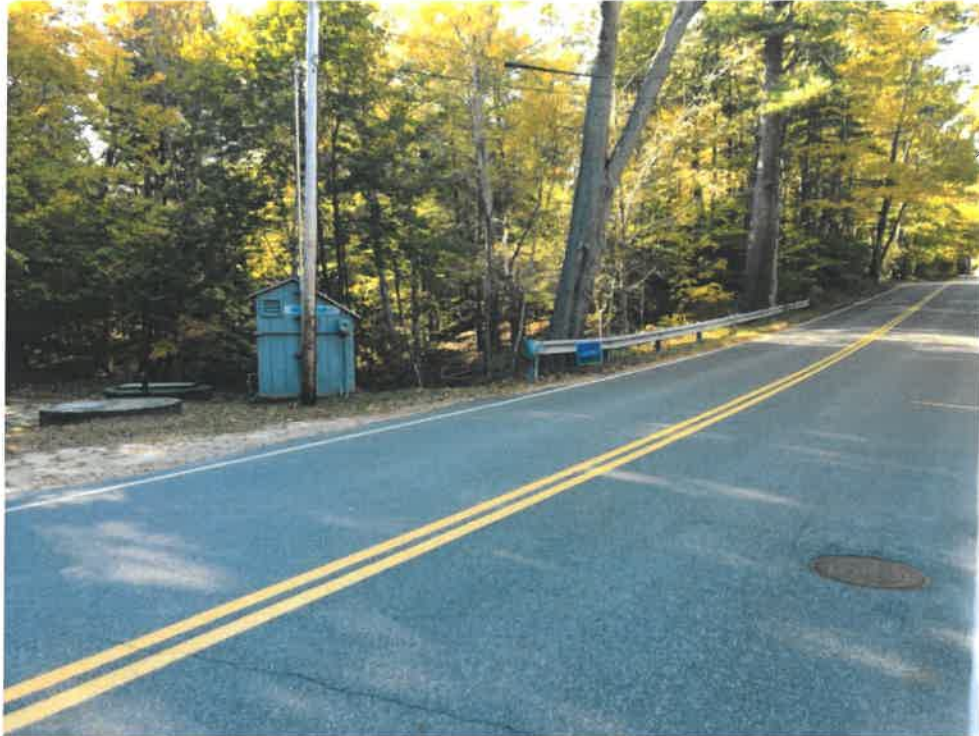
Photo 1 (10-22-18): Facing southeast at Mitchell Road crossing of Pond Cove Brook. Road is in good condition with a sanitary sewer pump station located near the brook (left hand side of photo).

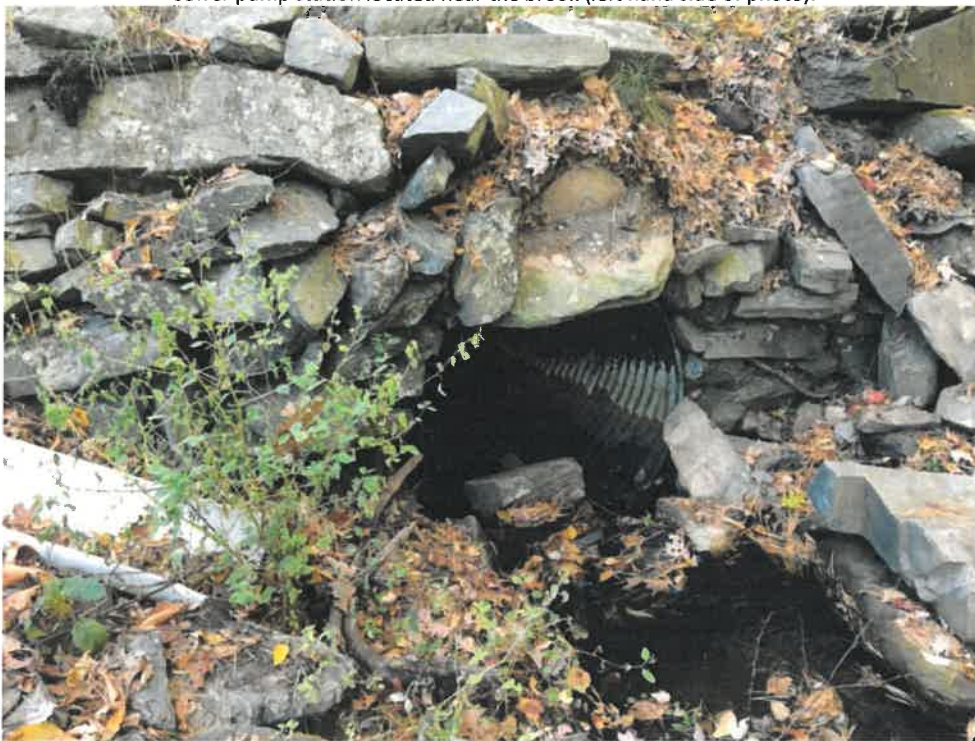
Photo 2 (10-22-18): Submerged inlet of 48-inch corrugated metal pipe with corroded invert and various stones blocking the inlet from reaching full flow capacity. The stone headwall needs to be reset.

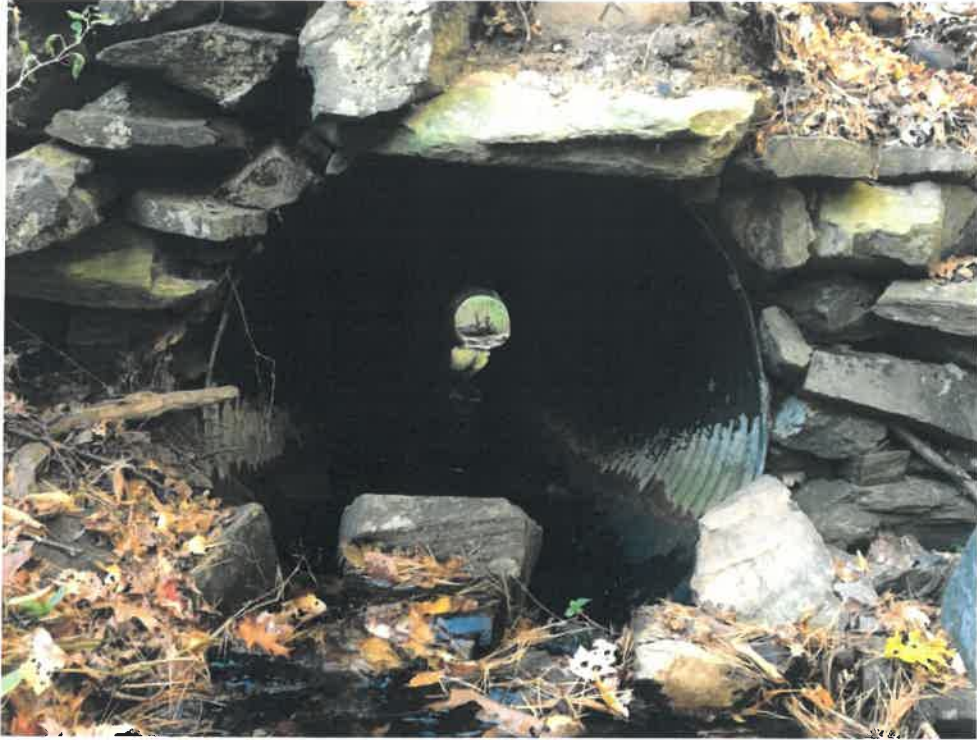
Photos 3 (10-22-18): Looking through the culvert from the inlet side, interior of the pipe appears visually to be in a degraded condition with the invert of the pipe clearly corroded.

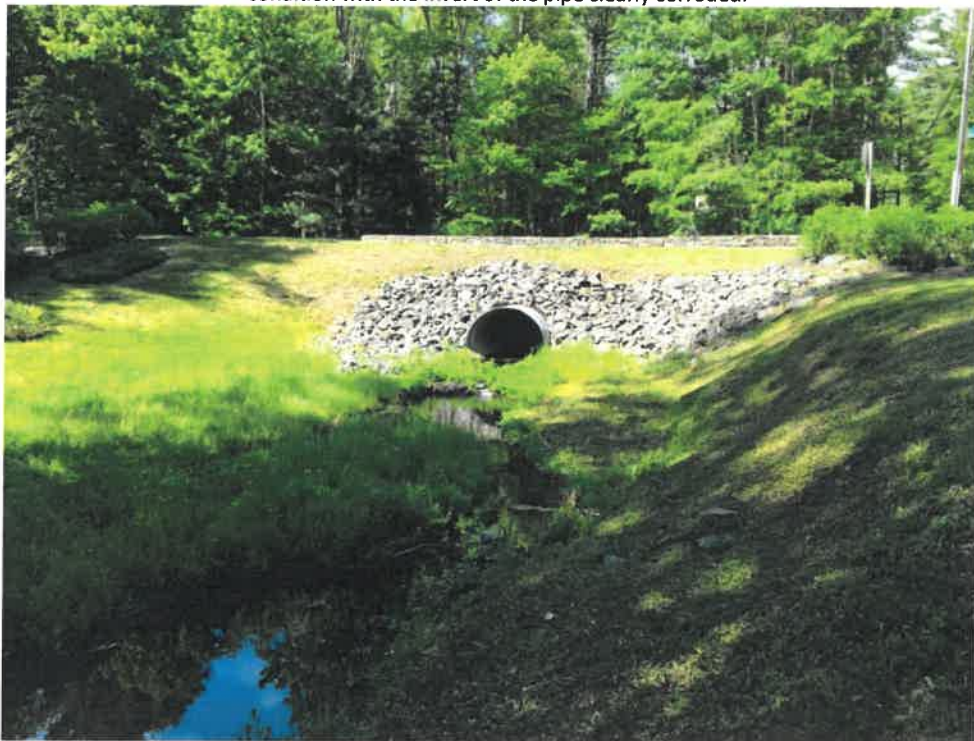
Photo 4 (06-06-18): Facing northwest from the Mitchell Road culvert toward the 3-feet tall by 4-feet wide elliptical culvert under nearby Hobstone Road with channel of the Pond Cove Brook upstream of the Mitchell Road culvert inlet.

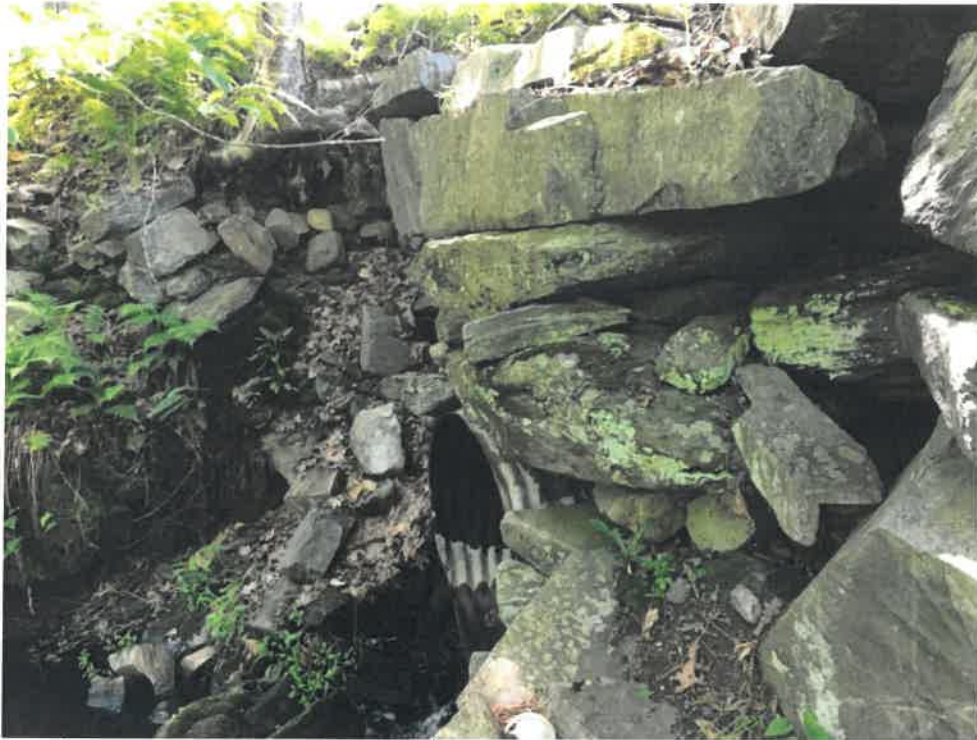
Photo 7 (06-06-18): Stone headwall at the outlet has deteriorated and has many loose and dislodged stones.

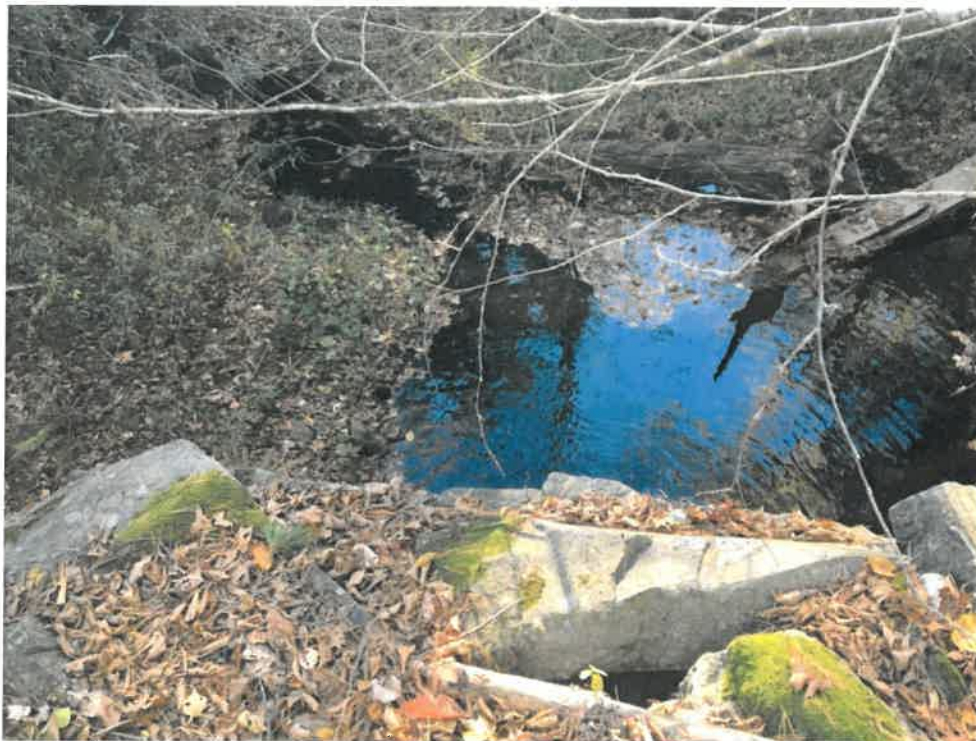
Photo 8 (10-22-18): Overhead view of culvert outlet with loose stones in the stone headwall.

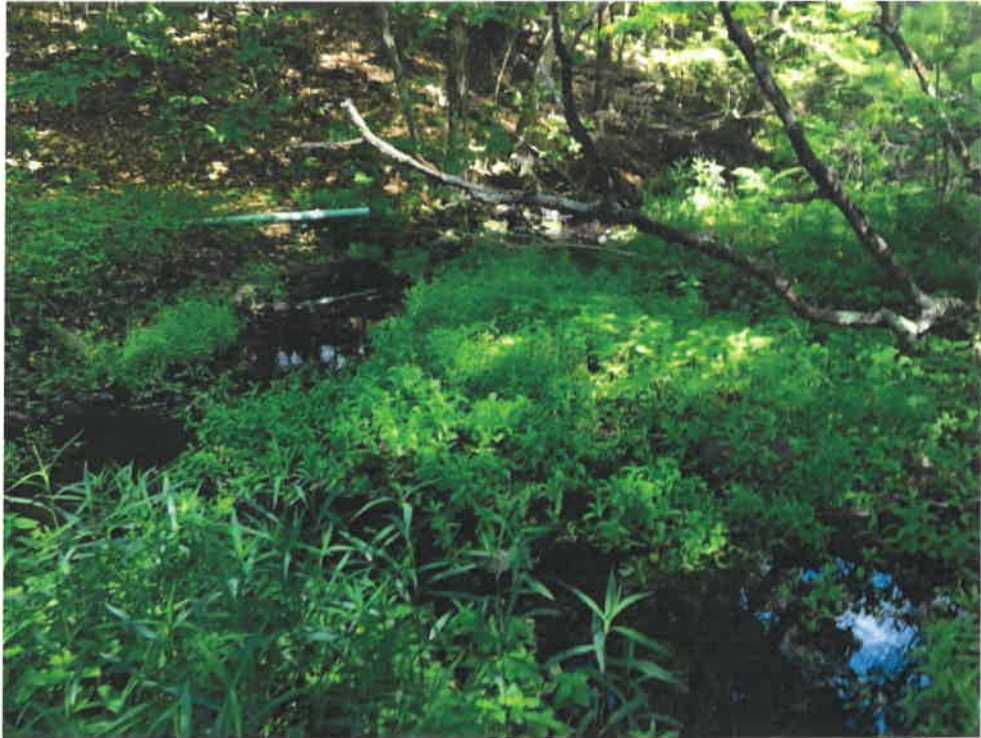
Photo 9 (06-06-18): Downstream flow of Pond Cove Brook from the Mitchell culvert outlet flows through the ponded area upstream of the multiple Shore Road culverts which convey flow to Pond Cove and Atlantic Ocean.

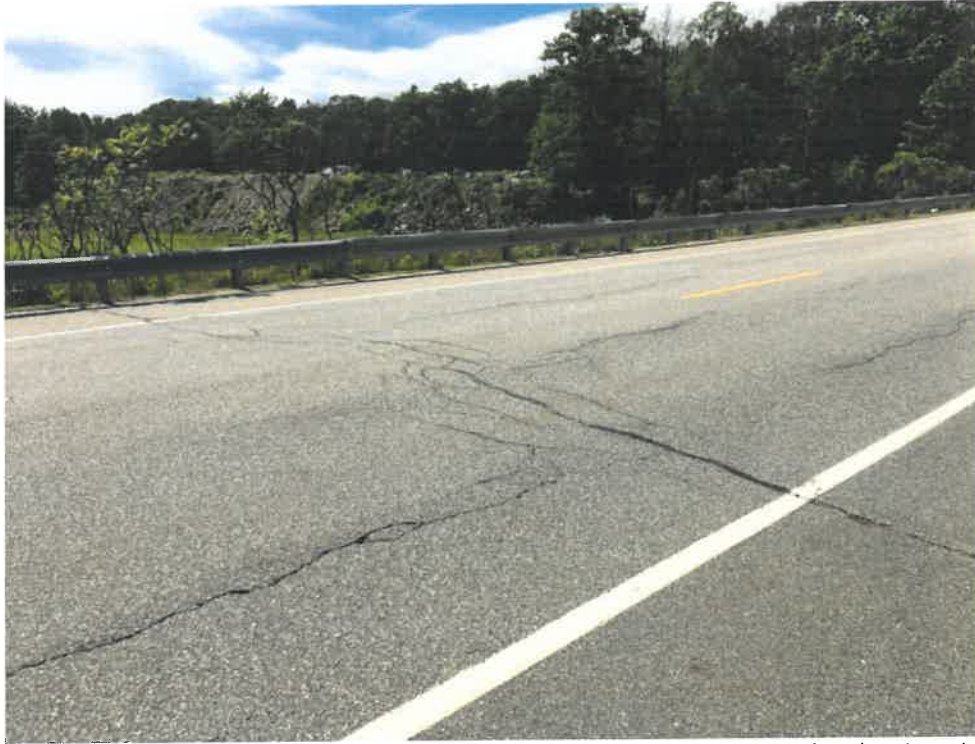
Photo 1 (06-20-18): Facing west at Ocean House Road (Route 77) crossing of Alewife Brook. Culvert location coincides with the crack across the pavement surface. Culvert is located relatively deep in relation to the road surface elevation with a steep roadway embankment.

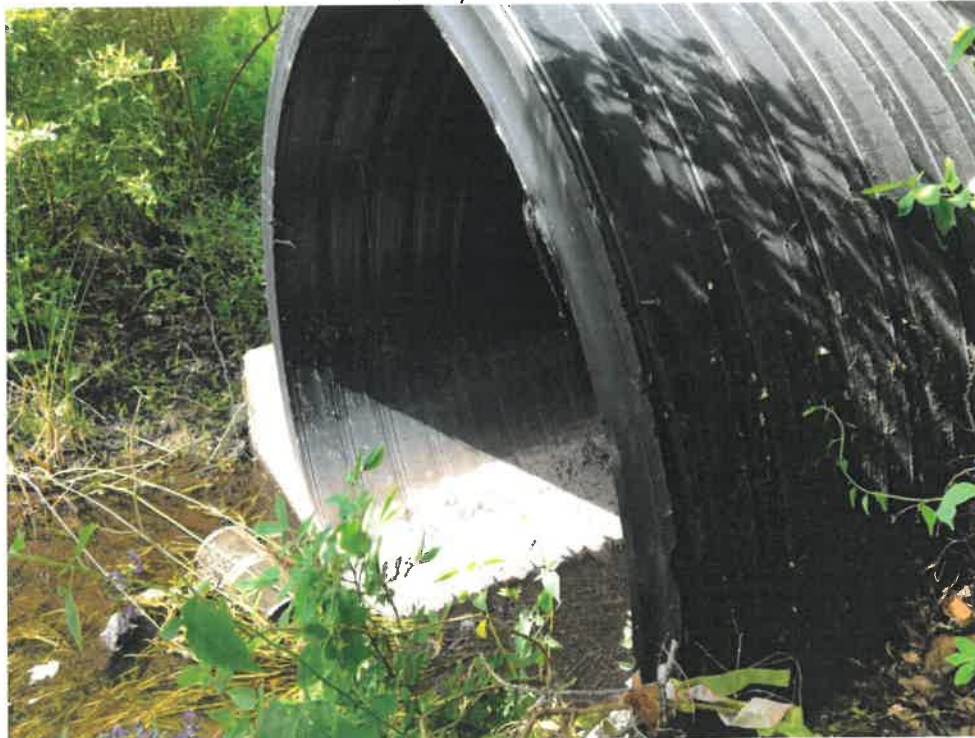
Photo 2 (06-20-18): Submerged inlet of the 70-inch high density polyethylene liner pipe within the original corrugated aluminum cross pipe. Pipe is supported on a concrete saddle.
