Cape Elizabeth Culvert and Habitat Assessment Study

March 22, 2019

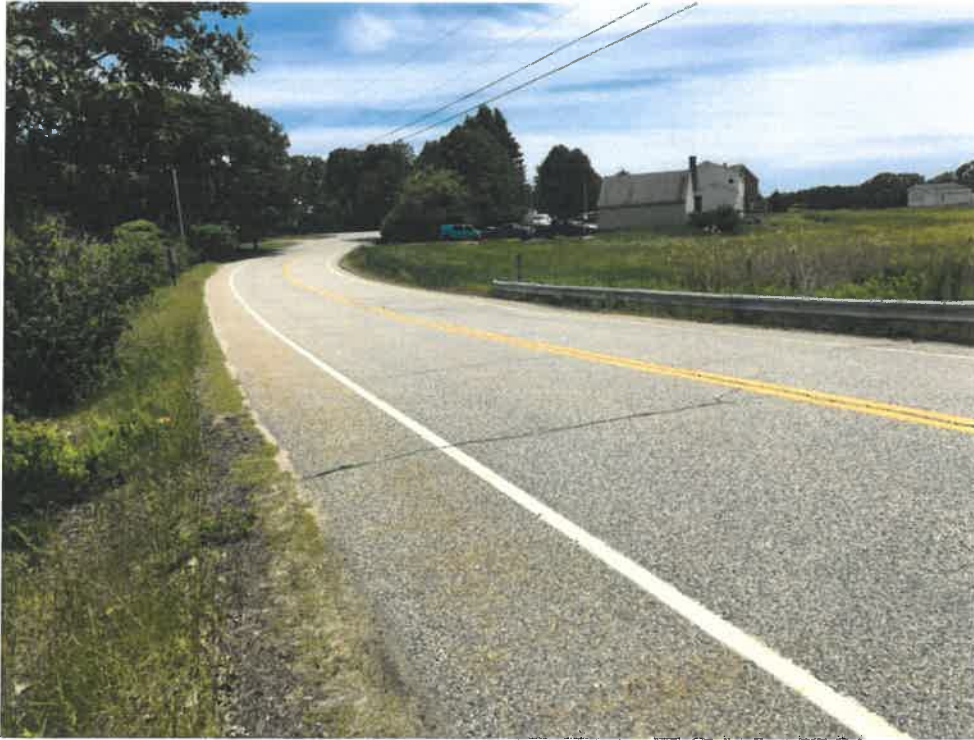
Photo 1 (06-20-18): Facing south Sawyer Road crossing of the culvert. Crack on surface of the road may be due to the presence of culvert.

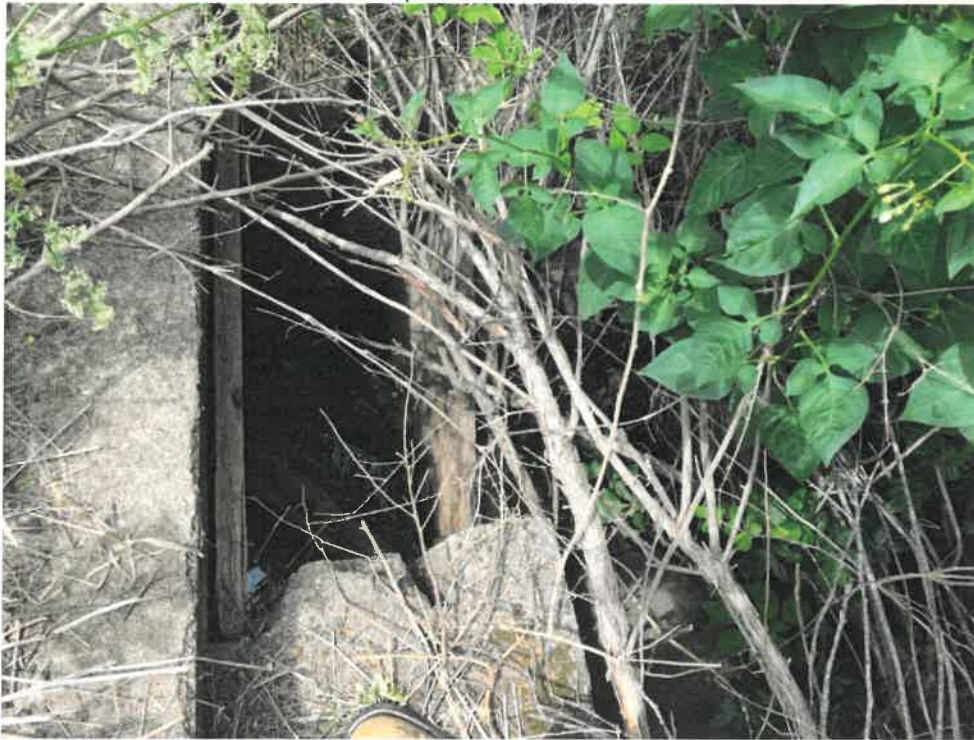
Photo 2 (06-20-18): Inlet of 36-inch High Density Polyethylene (HDPE) pipe headwall on northeast side of Sawyer Road. Concrete headwall conceals the HDPE pipe and pieces of concrete support wooden boards that creates an inlet weir to create an impoundment upstream of the pipe.

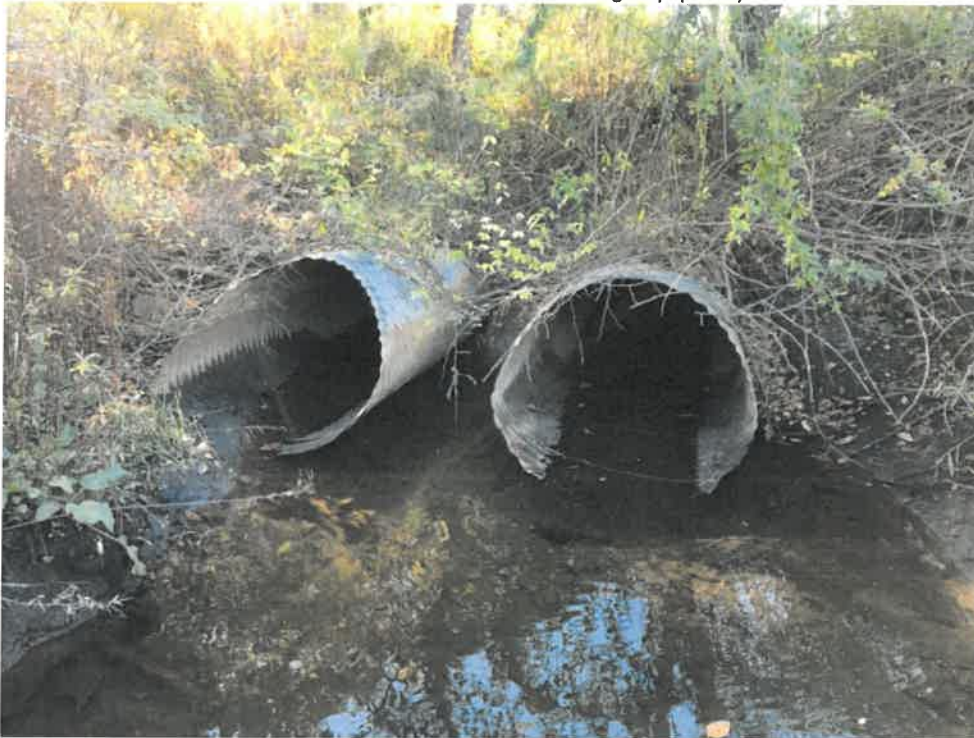
Photo 2 (10-22-18): Inlets of the two, 48-inch wide by 36-inch tall corrugated aluminum pipes located northerly of the sanitary sewer crossing embankment. Inverts to both pipes are corroded and in decay.

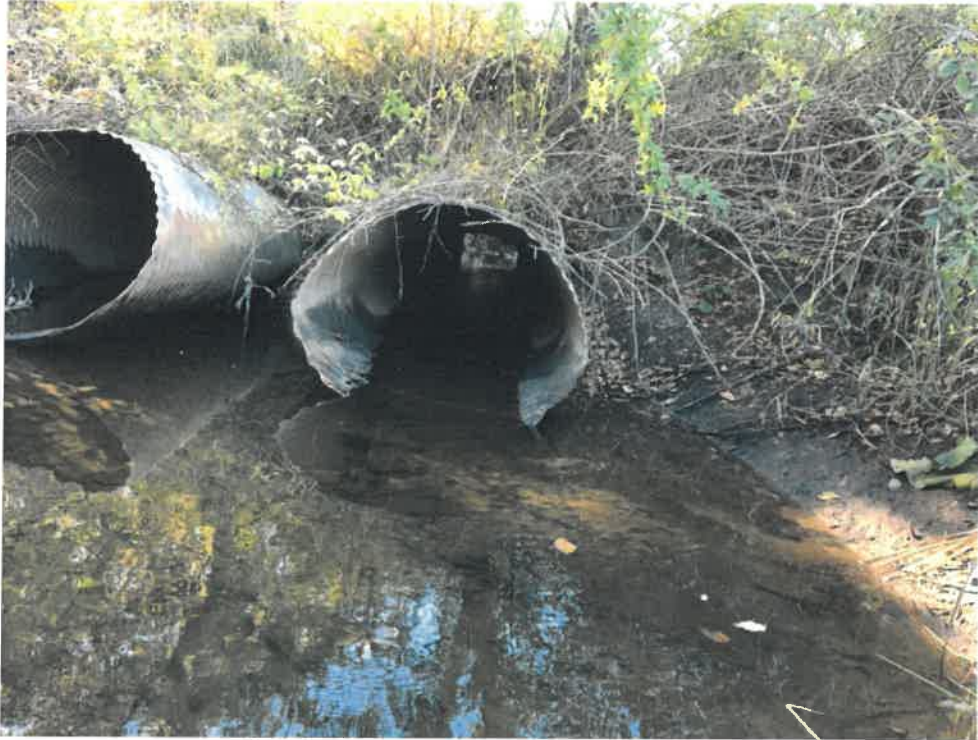
Photos 3 (10-22-18): Looking down the barrel of the westerly inlet of the two Inlet culverts. Culverts' inlet invert has rusted away and the pipes are in poor condition.

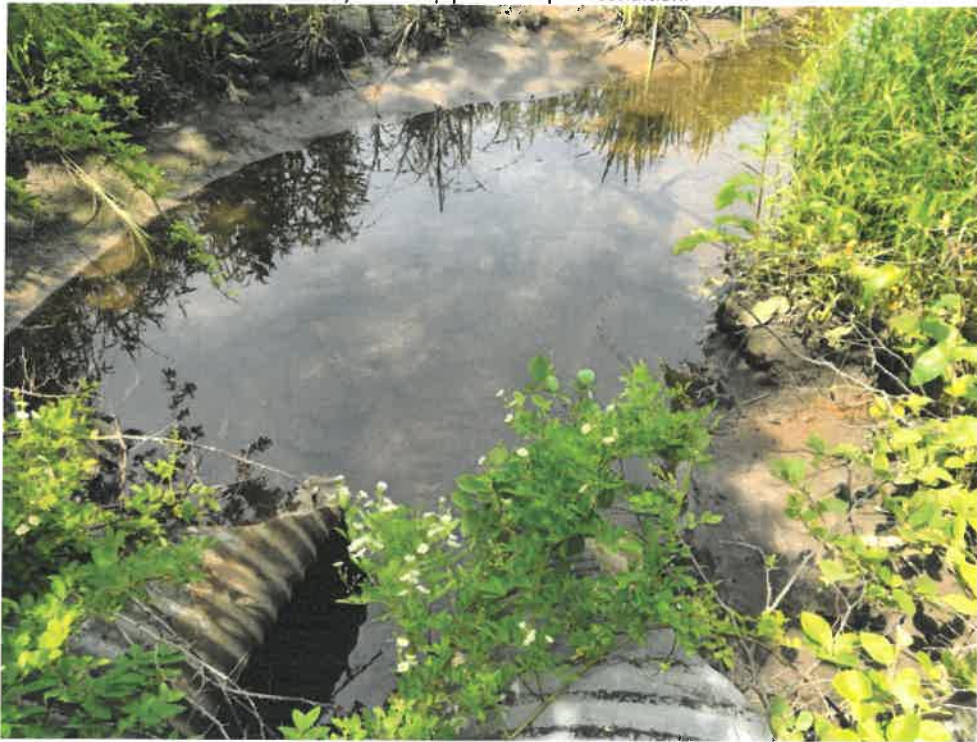
Photos 4 (06-20-18): Looking down from onto one the two culverts' inlets. Culverts' inlet area is wide just upstream from the pipes with a narrower channel further upstream flowing toward the culverts.
