**HABITAT RESTORATION INVENTORY
SUMMARY REPORT
FOR THE
ROYAL RIVER, SPRUCE CREEK, AND LOWER KENNEBEC
RIVER ESTUARY
VOLUME I**

DECEMBER 2005

**Prepared by: Northern Ecological Associates, Inc.
451 Presumpscot Street
Portland, Maine 04103**

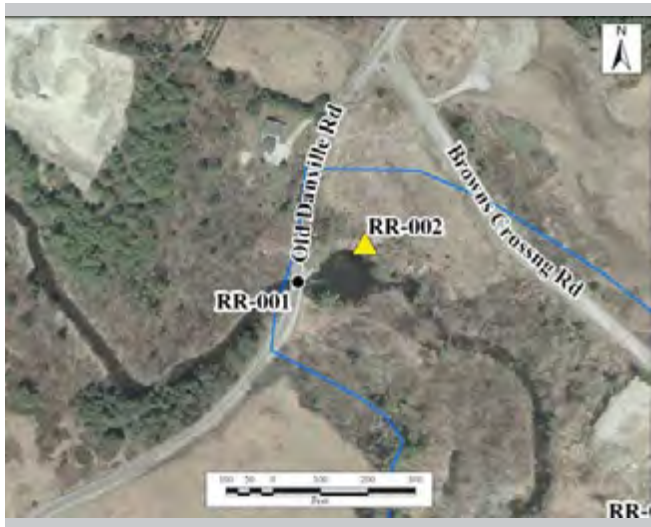
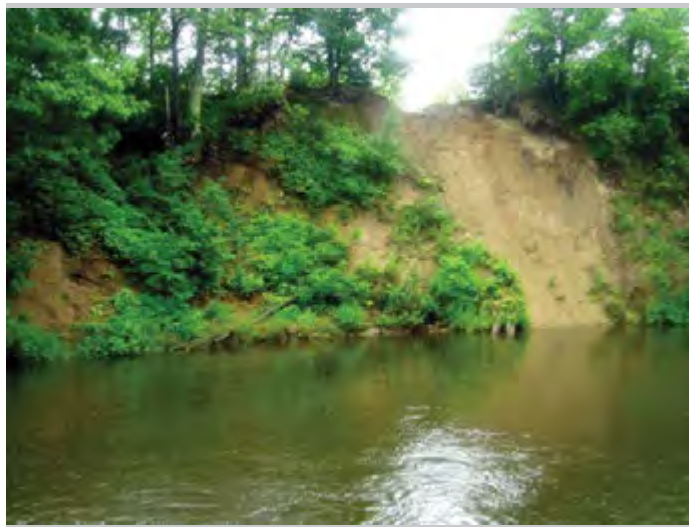
Very steep, actively eroding bank on opposite shore from RR-001. Site is ~30-feet tall and 50 to 75-feet wide, and consists of silt and sand, with exceptionally loose material across the lower 20-foot swath. Trees on the adjacent bank are severely undercut. Bank damage does not appear to be due to river flood stage. Observe substantial downstream deposition of sand

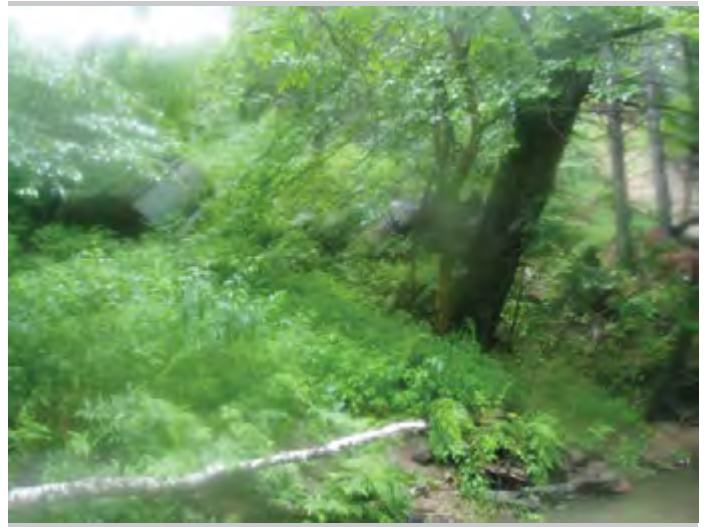
Trash/debris/old cars dumped on one side of the bank. Japanese knotweed along 75 foot section, and bank erosion along 25 foot section of other bank.

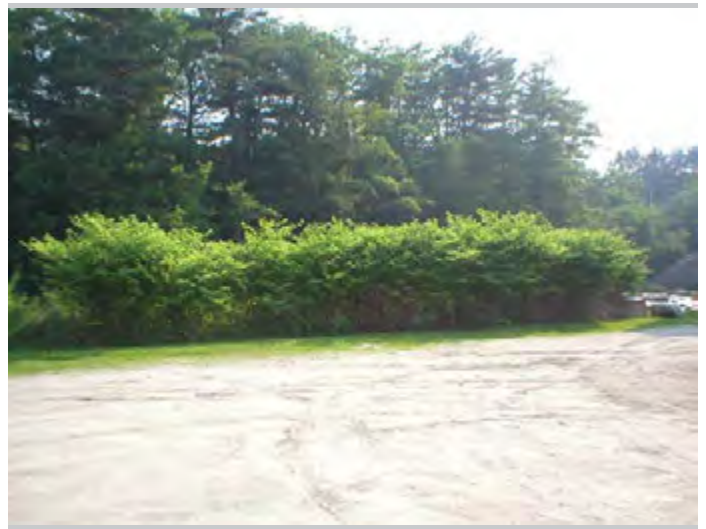
Japanese knotweed stand, approximately 6 x 60 feet. Lack of adequate buffer between dirt parking lot and river.

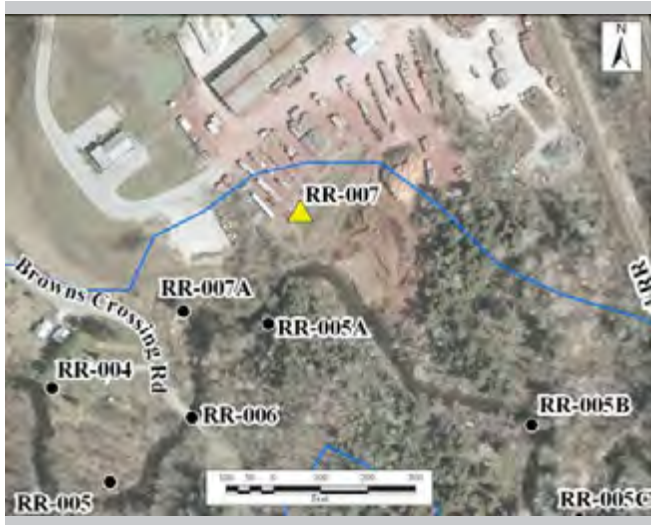
Morin Brick Company property consists of a mix of stable and eroded bank areas. Stable banks consist of placed stone and/or discarded brick. Unstable areas generally have denuded vegetation, loose soil and erosion, undercut banks, sediment loading in water, and turbid water inputs. Native vegetation impaired in most areas.

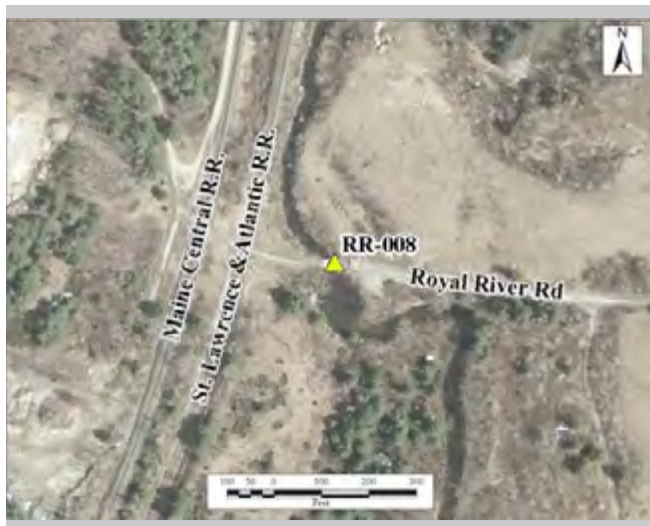
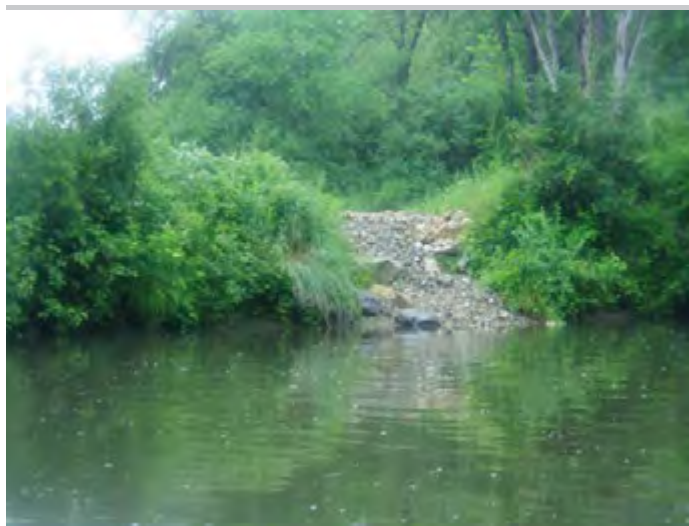
Bridge road crossing with associated rock support structure. Orientation of bridge has redirected the stream flow into an unnatural direction, thus causing a localized constriction and downstream erosion bank area. The bridge itself is unused and in poor condition.

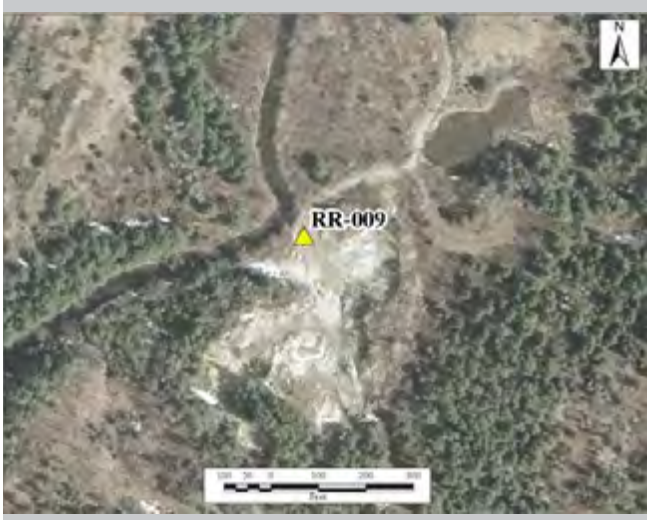
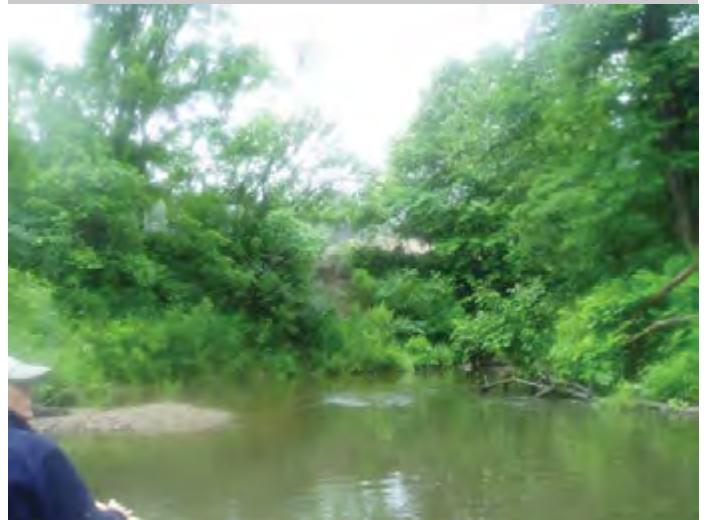
Active gravel pit adjacent to river. Narrow buffer vegetated to top of slope, then gravel pit operations. Steep slope (approx. 45-degree), and 25-feet high. Some minor erosion noted on outside bend in channel, which may be partially due to natural causes.

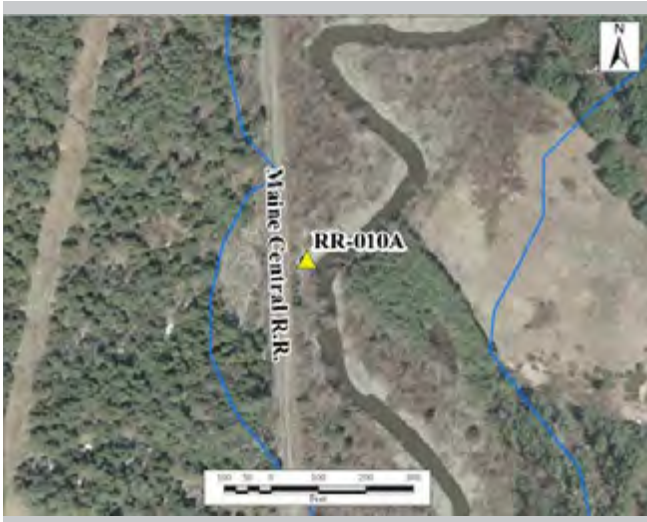
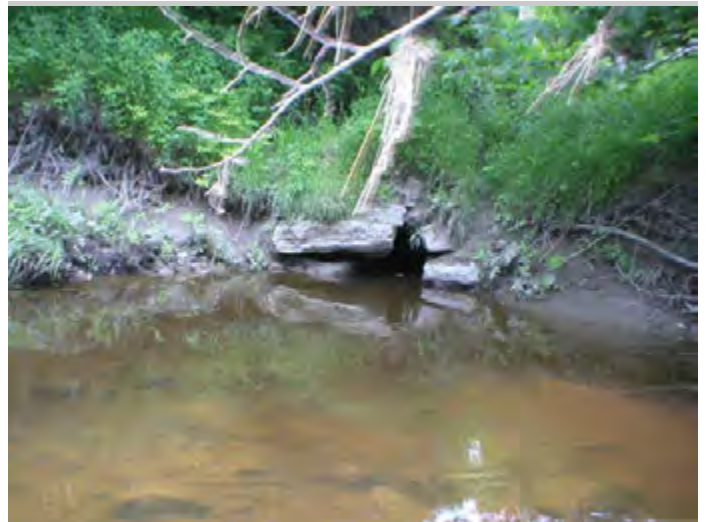
Rock culvert at railroad tracks has minor erosion noted around top and sides of culvert. Railroad bed may eventually need stabilization. Buffer is high quality but narrow (60 feet); maintained within 20 feet of railroad line.

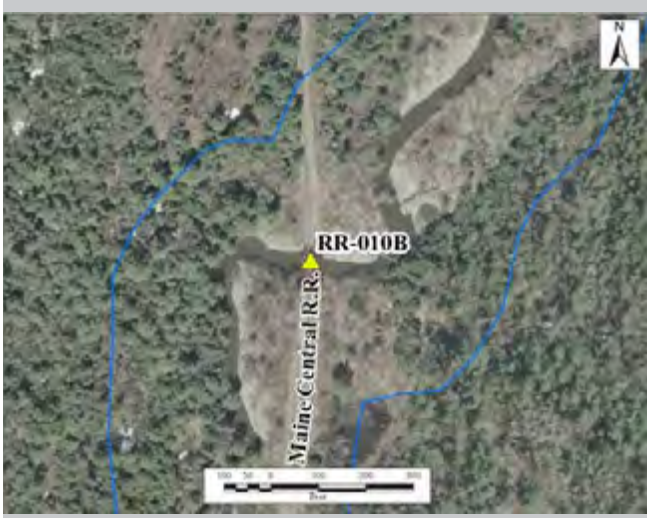
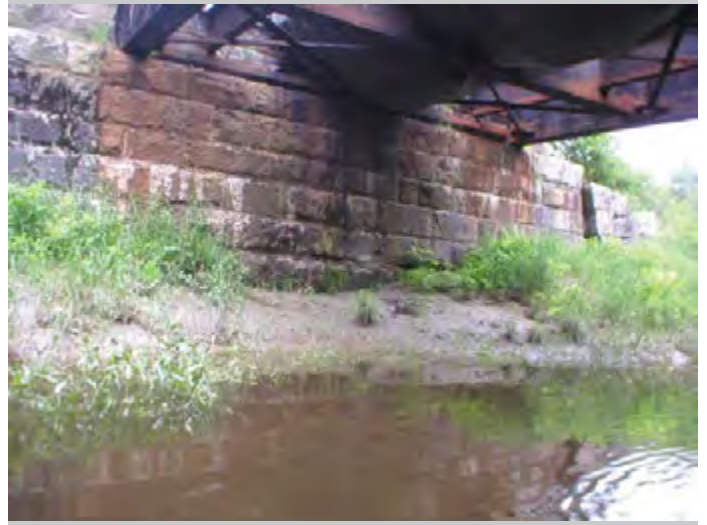
Railroad bridge crossing. Fabric liner under railroad tracks catch debris from railroad. Minor erosion, lack of vegetation under bridge. Bridge foundations have some minor effect on flow. Maintained buffer along railroad ROW.

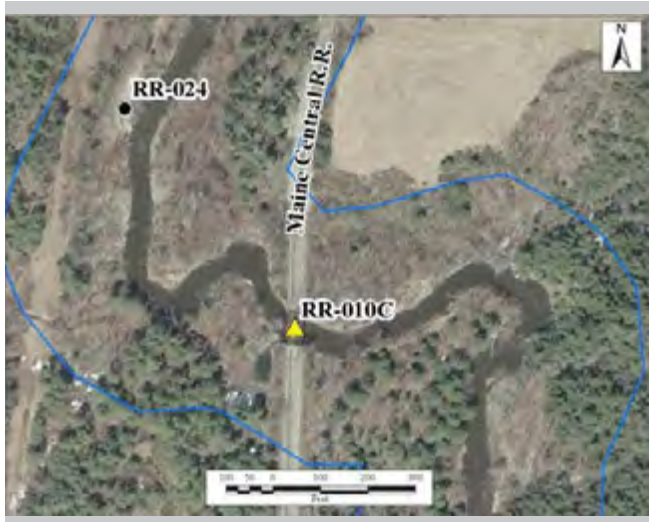
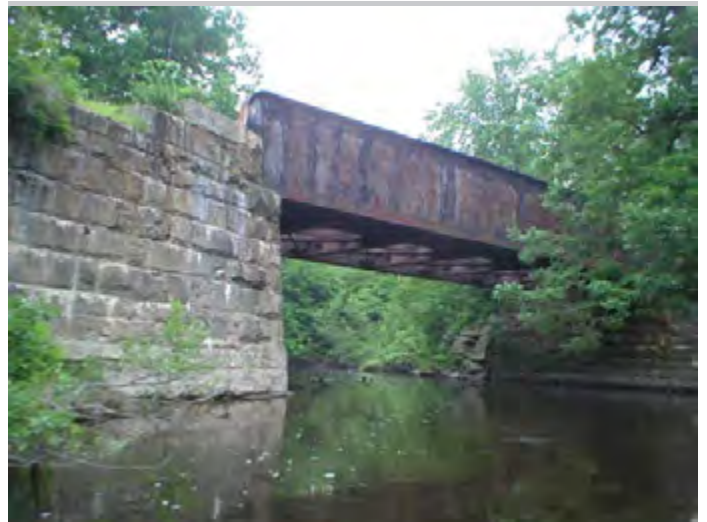
Railroad bridge crossing. Some sediment accumulating under bridge; foundation is constricting flow slightly. Banks held in place with stone wall. Otherwise, banks well vegetated and stable.

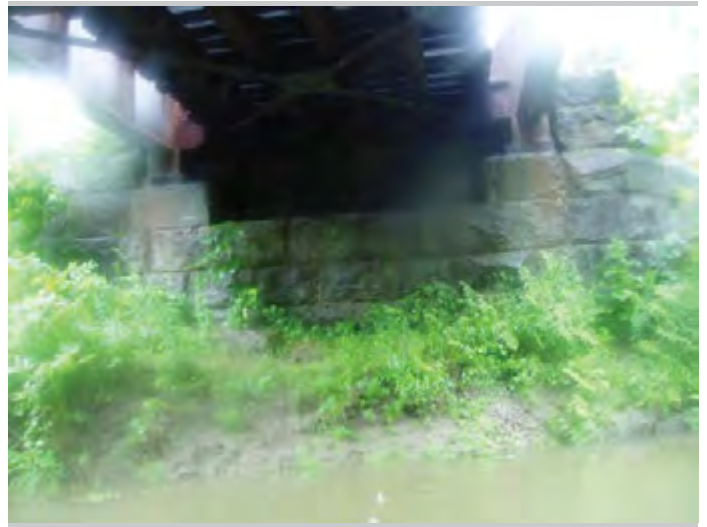
Railroad bridge crossing. ROW maintained through cutting back of vegetation. Banks stable, not eroding. Sediment deposition under bridge, with herbs revegetating in places. Banks stabilized with placed, cut rock.

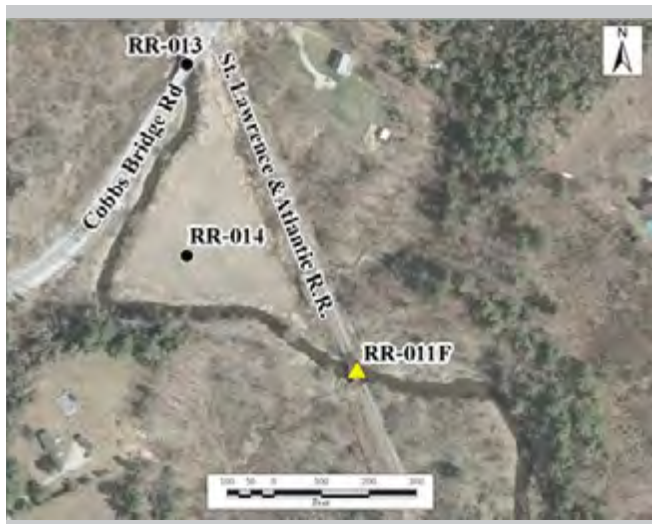
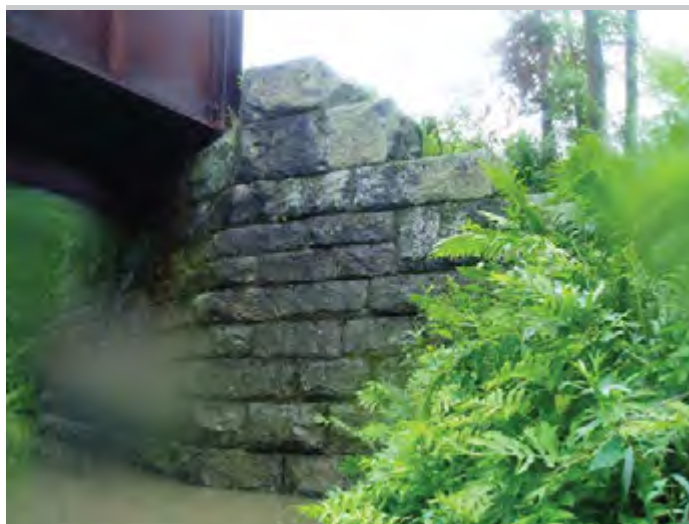
Railroad bridge crossing. ROW maintained through cutting back of vegetation. Sediment accumulation under bridge. Banks stable, placed, cut rock wall foundation.

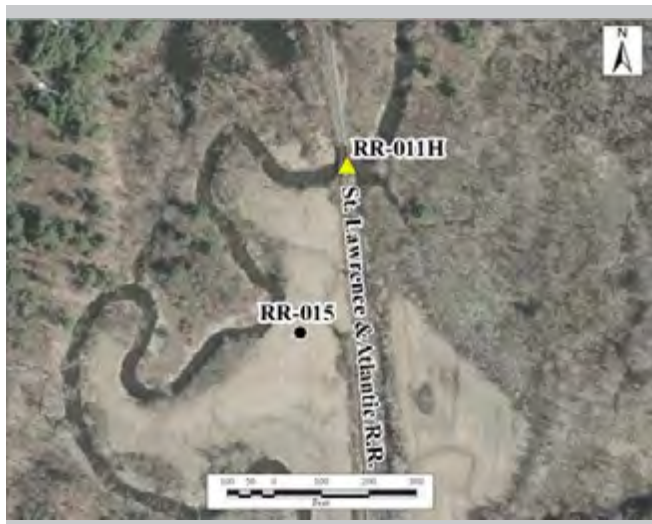
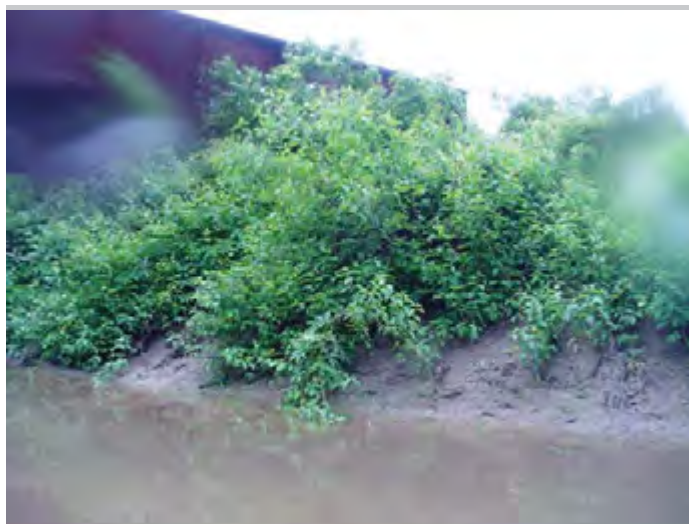
Railroad bridge crossing. ROW maintained through cutting back of vegetation. Banks stable, not eroding, with placed, cut rock foundation. Sediment deposition under bridge. Slight constriction of waterflow.

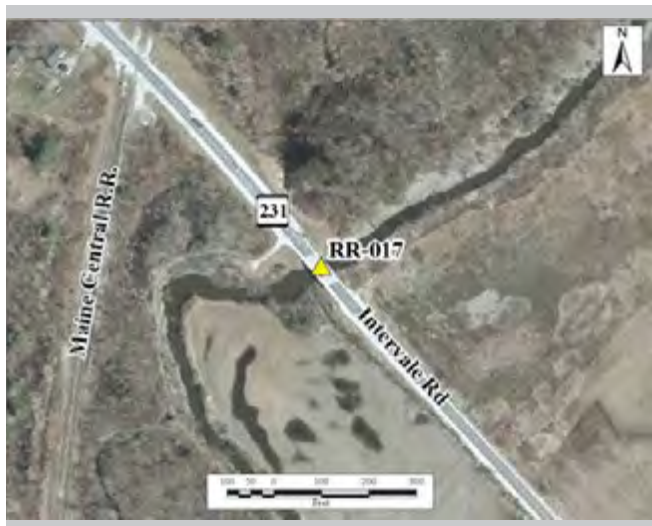
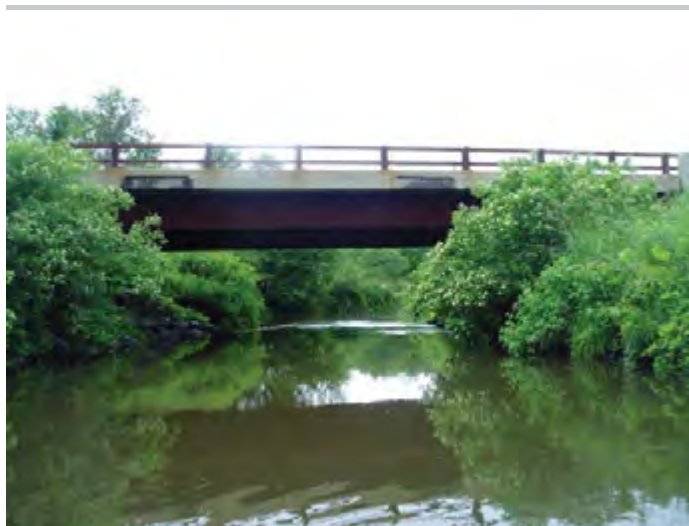
Highway 231/Intervale Rd crossing. Banks are generally stable and vegetated. Area under bridge is also stable with rip-rap on banks. Bridge causes a slight localized constriction and increased stream flow. Japanese-knotweed present at the top-of-bank adjacent to the road.

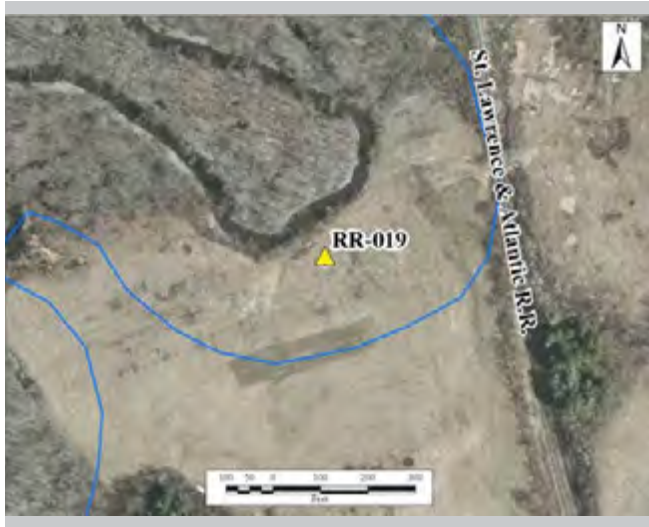
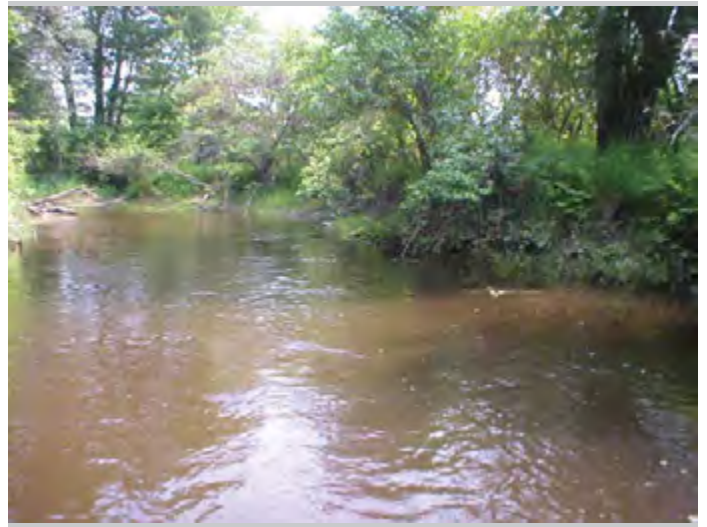
Inadequate buffer. Steep banks (approx. 50 to 75% slopes) have marginal vegetation with few trees, thus leaving exposed ground and slumping areas.

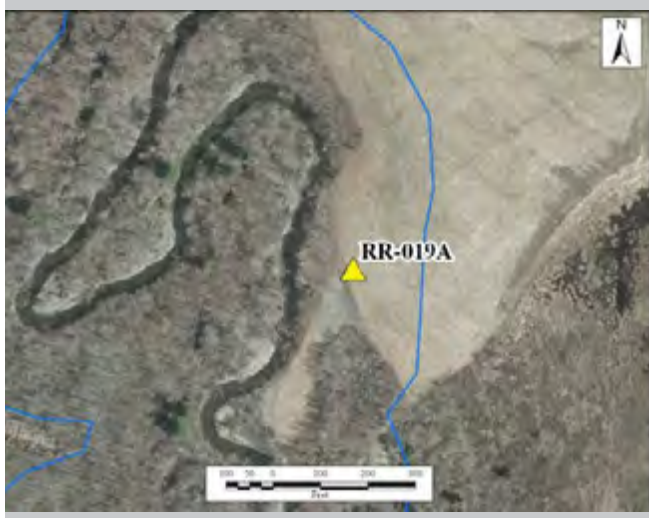
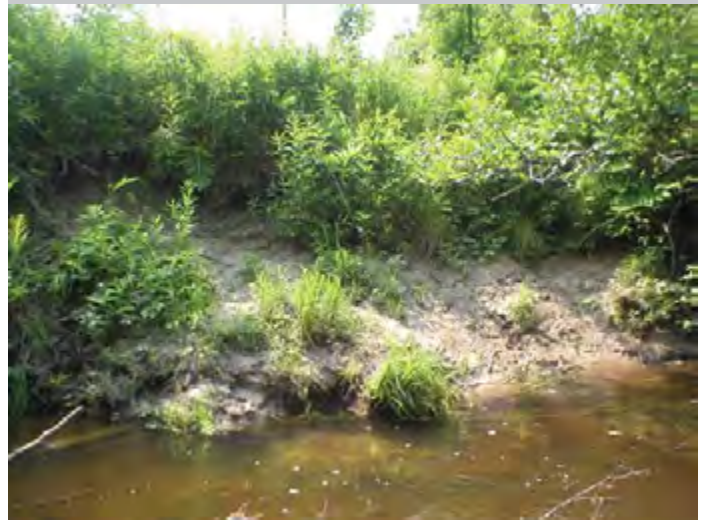
Minor erosion of shoreline. Some sediment loading has occurred as a result. Area has an inadequate buffer mostly of dense herbs.

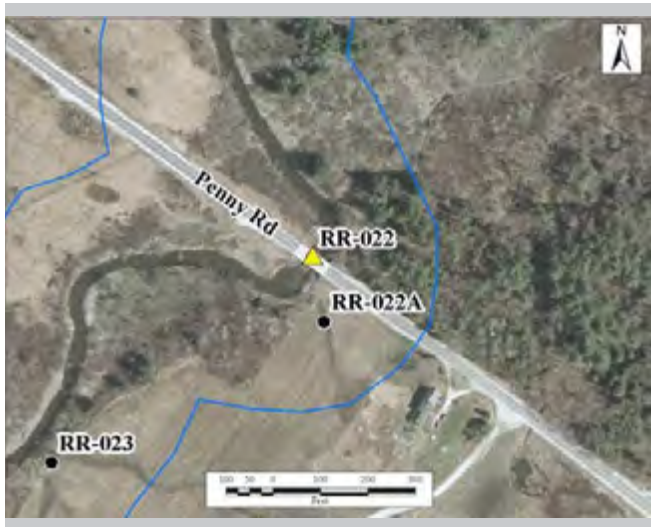
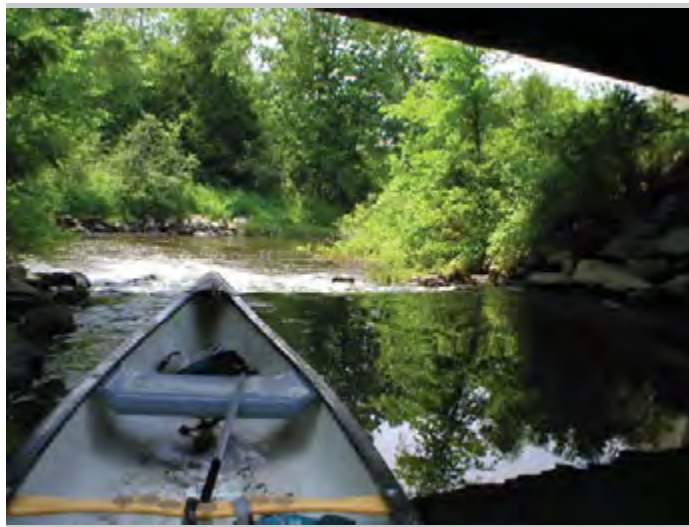
Penny Road crossing. Area under bridge stabilized with rip-rap, causing minor constriction of flow. Banks stable, not eroding, well vegetated with herbs, shrubs. Some loose dirt beneath bridge.

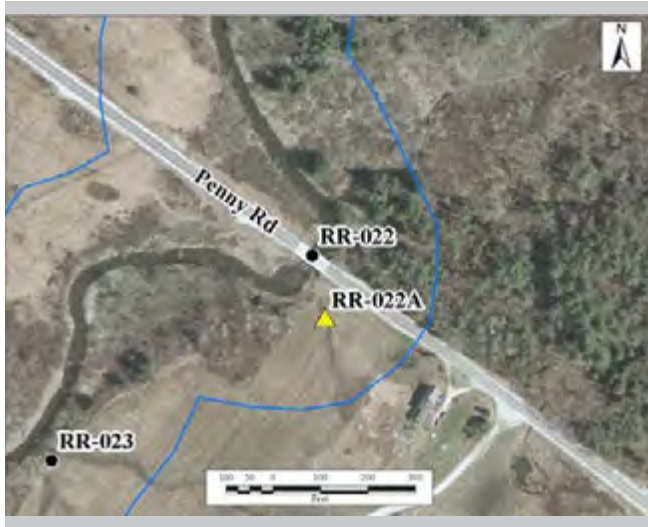
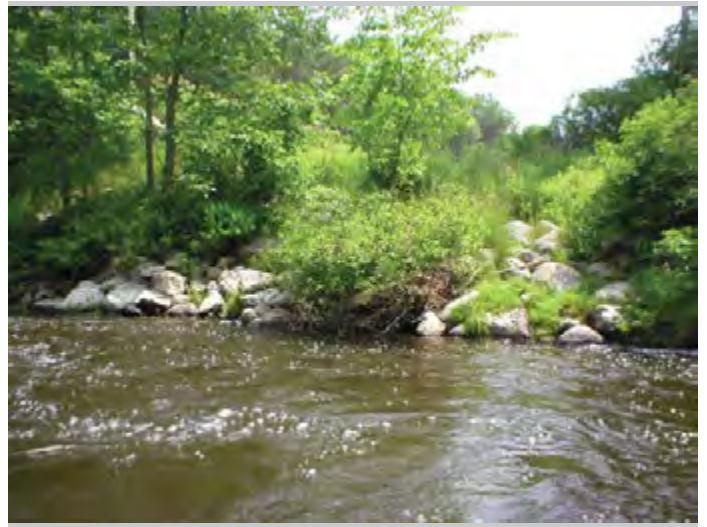
Inadequate buffer. Stable bank but mostly herb and shrubs. Rip-rap on shoreline impeding some vegetation growth.

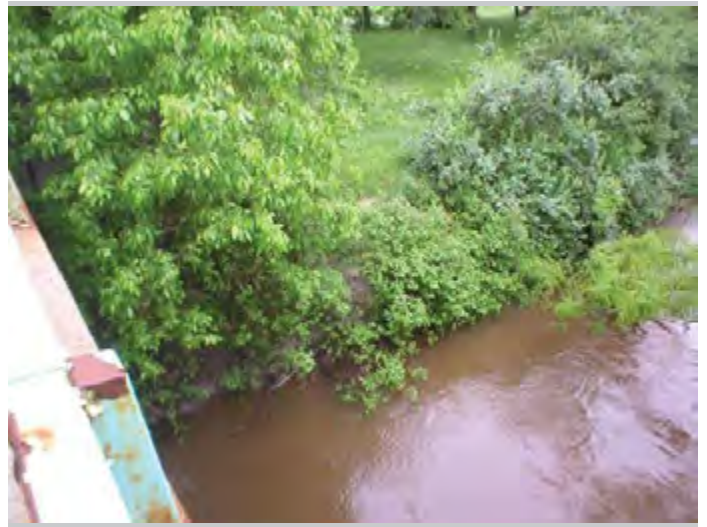
Mill Road bridge crossing. Most of buffer intact, comprised of herbs, shrubs, and trees. Some signs of erosion associated with mowed lawn to the south side of river / west of bridge.

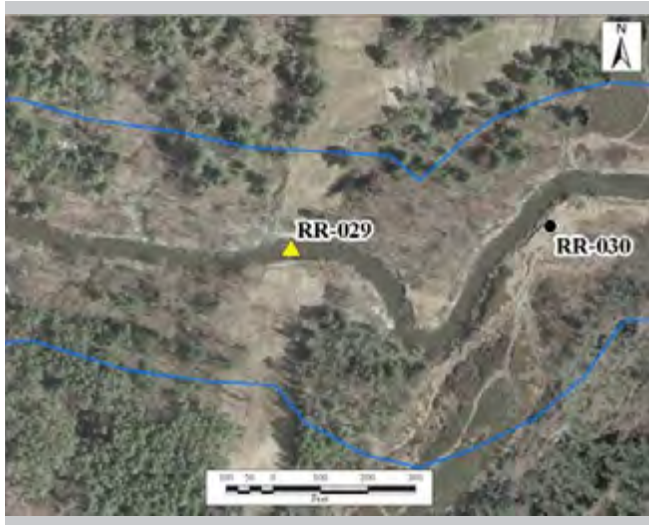
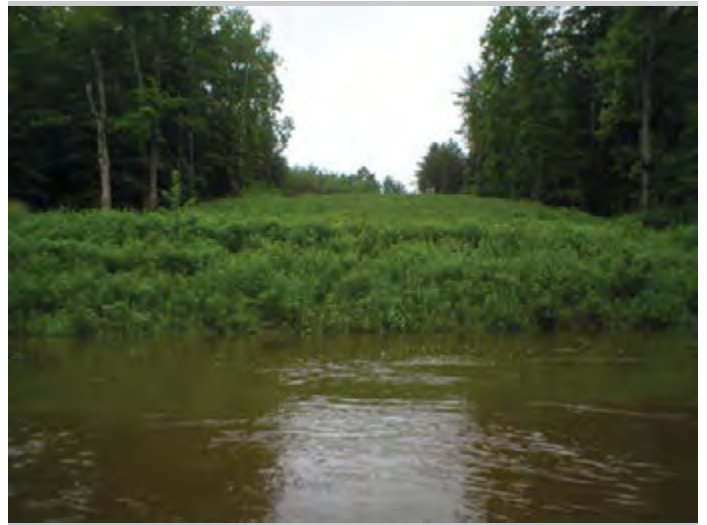
Pipeline right-of-way, approximately 100-feet wide and maintained. Only herbaceous vegetation, no shrubs or trees. Some minor bank erosion noted.

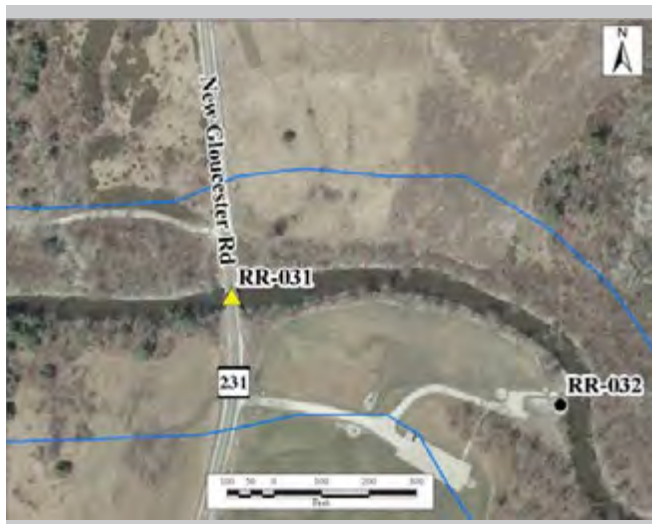
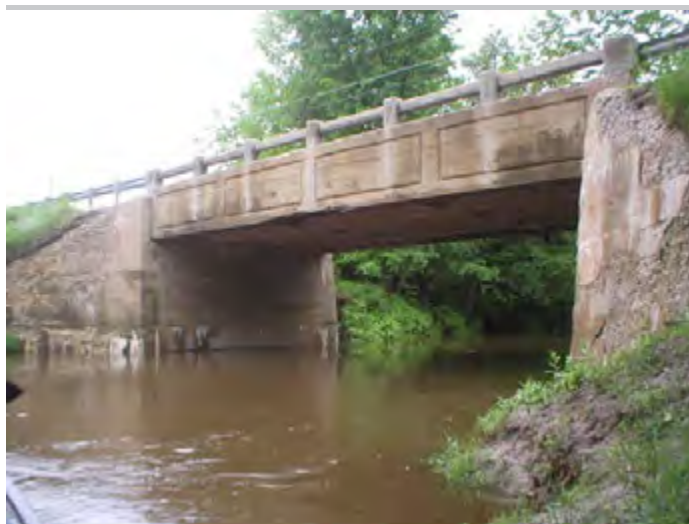
Hardened road crossing/bridge at New Gloucester Road and Route 231. Concrete foundations have replaced/hardened shoreline. Inadequate buffer on north side, mostly herbs and evidence of erosion in bare areas.

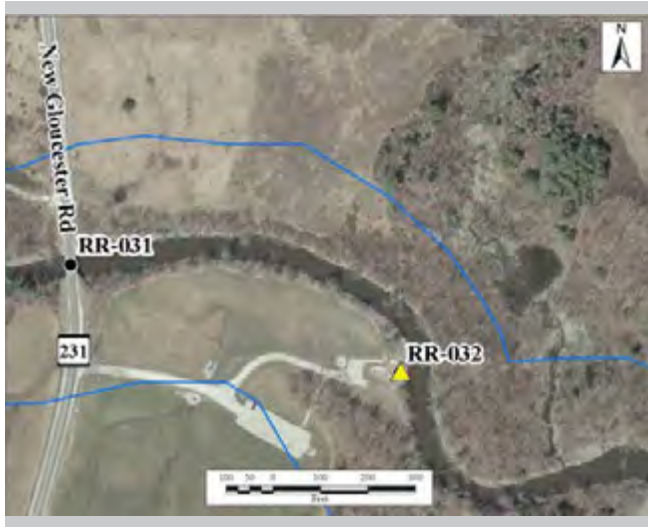
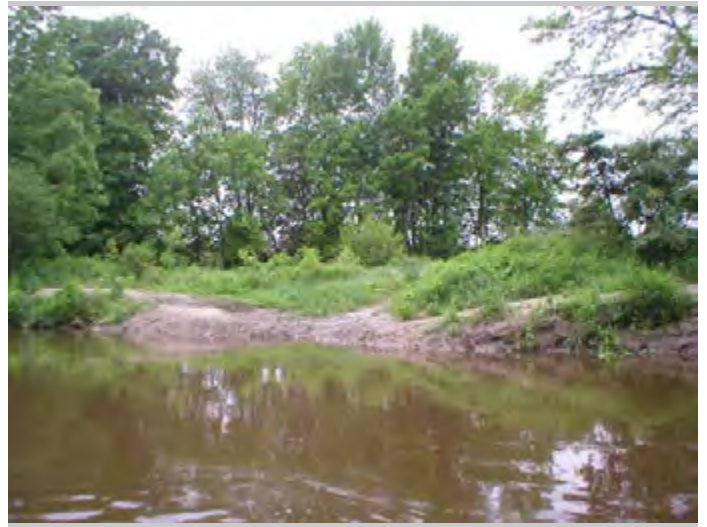
Public park, boat launch. Inadequate buffer of mostly herbaceous with bare areas used as a boat launch within 25 ft of water. Narrow tree line and open mowed areas beyond 25 feet. Storm water wetland detention areas nearby have rip-rap and culverts. Sediment loading in basin and throughout area (likely from an upstream source).

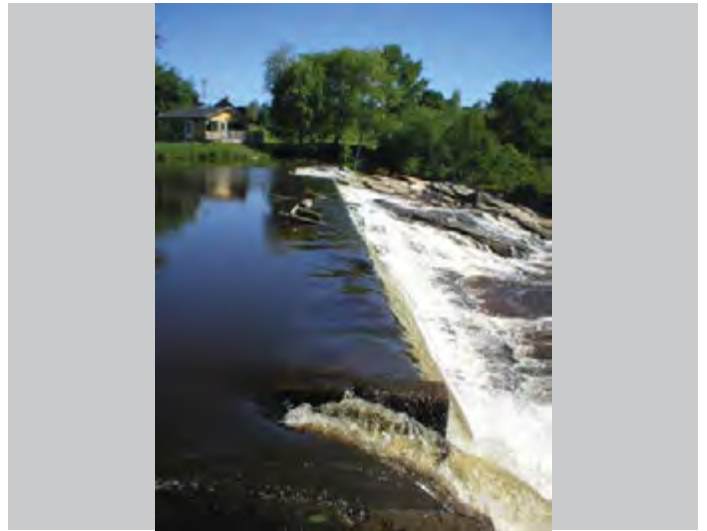
Dam near East Elm St, adjacent to Yarmouth Town Park. Buffer of herbs, shrubs, trees. Fish ladder intact, but tree limbs may be blocking lower entrance and debris is accumulated at top of fish ladder, and may impede fish passage.

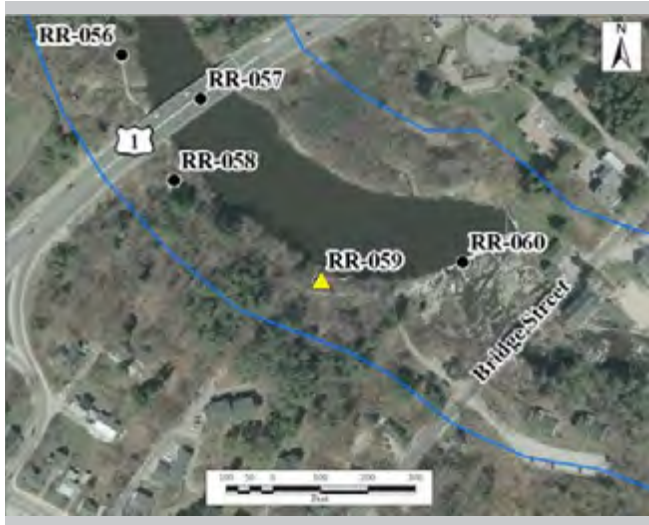
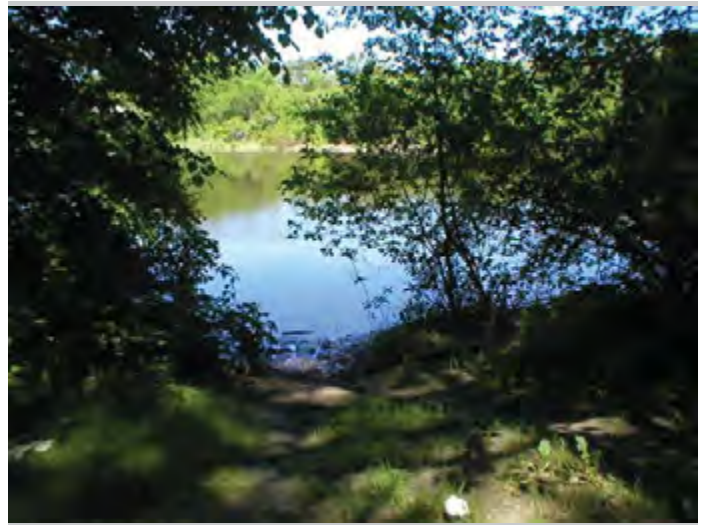
Access point to river (15 x 6 feet wide). Eroding banks with bare ground. Loose silty soil. Sparse herb cover on path.

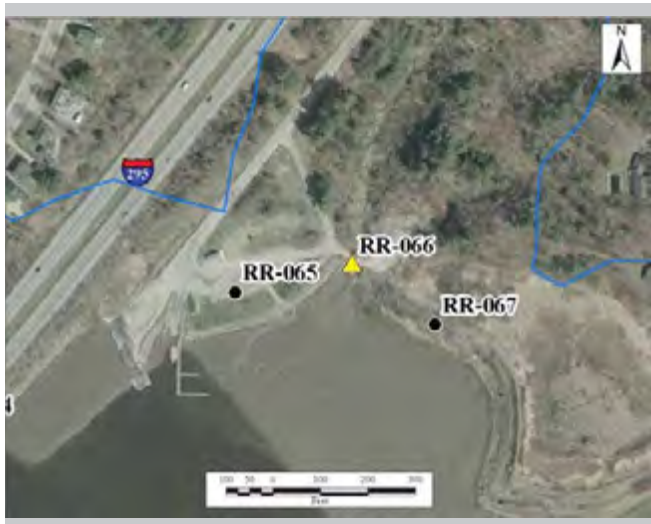
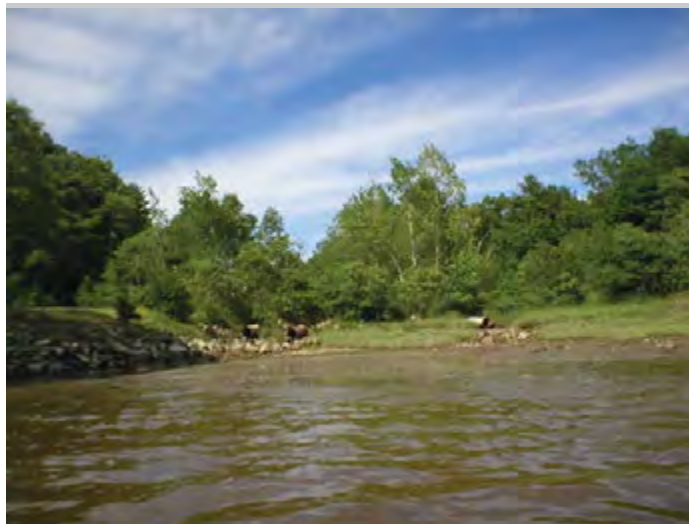
Three culverts that drain under gravel access road. Culverts of corugated metal all have rusted at the bottom. Slight erosion issue. Salt marsh in front of culverts is gone. Drain over cobble/gravel to water.

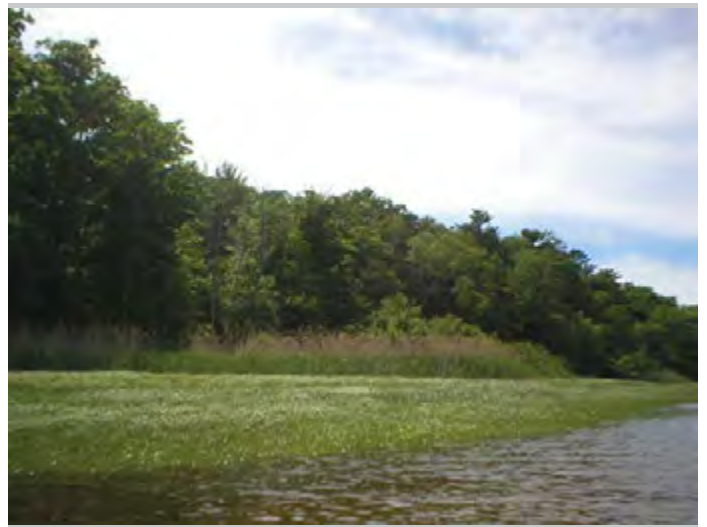
Two Phragmites stands in close proximity, approximately 150 x 30 feet and 60 x 12 feet.

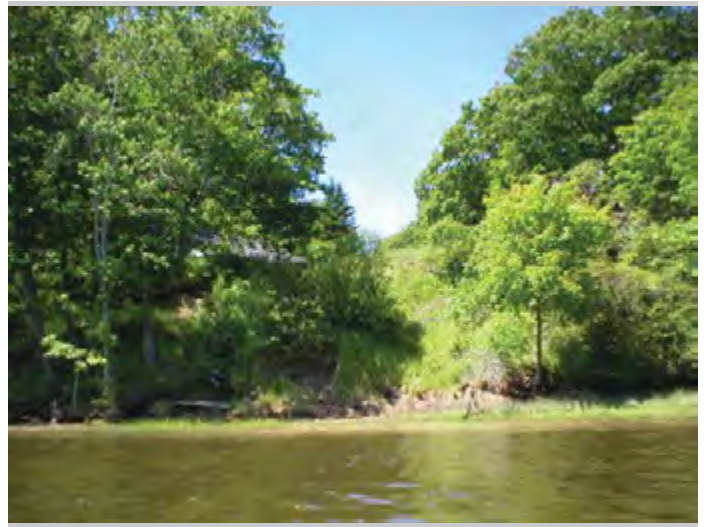
Slumping shoreline. Vegetated with forested buffer to top of slope, then mowed lawn. Large chunks of bank eroding away.

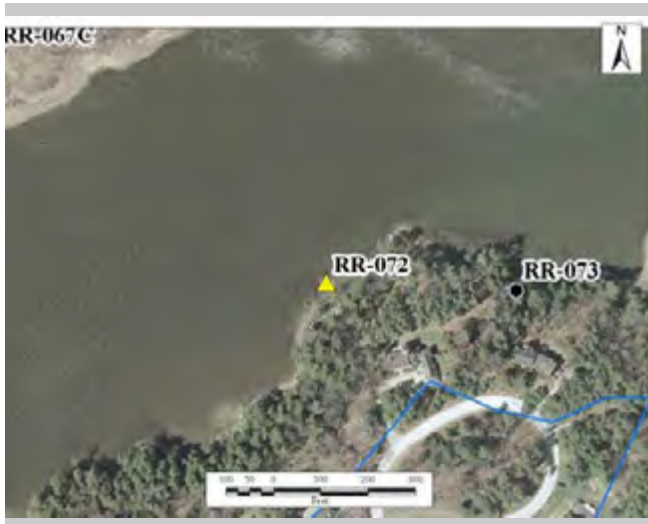
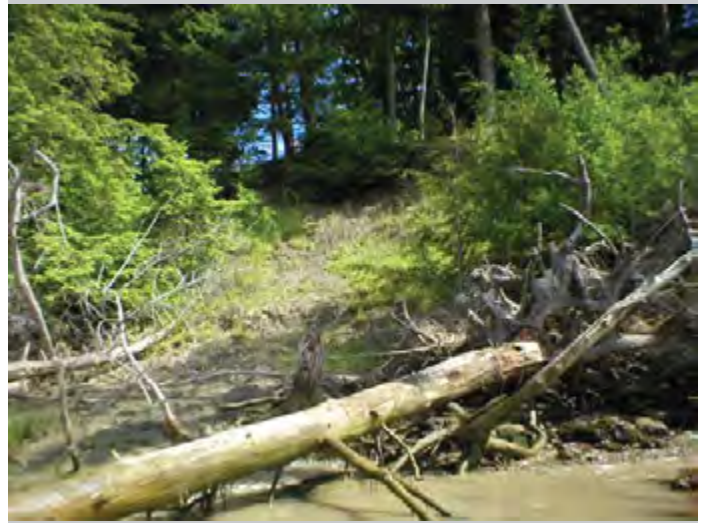
Bank erosion. Turbid water due to erosion of loose sediment.

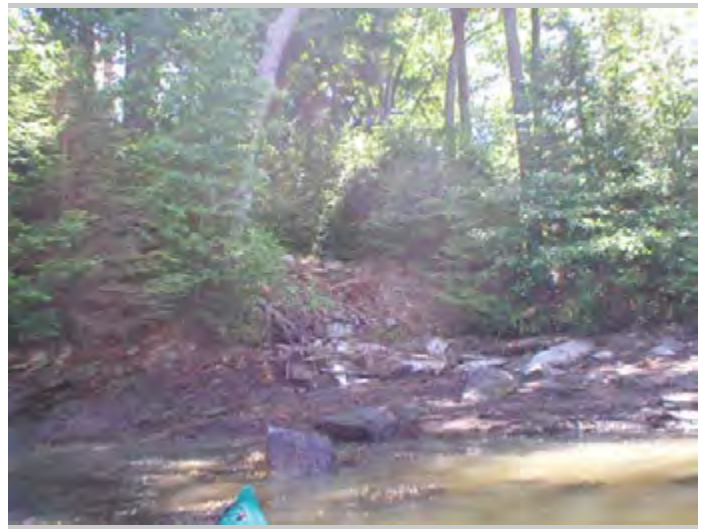
Path to access beach area has washed out. Appears that steps have been buried by debris.
