Kennebec Barrier Survey 2010

Grantee: Kennebec Valley Soil & Water Conservation District

Revised May 7, 2011

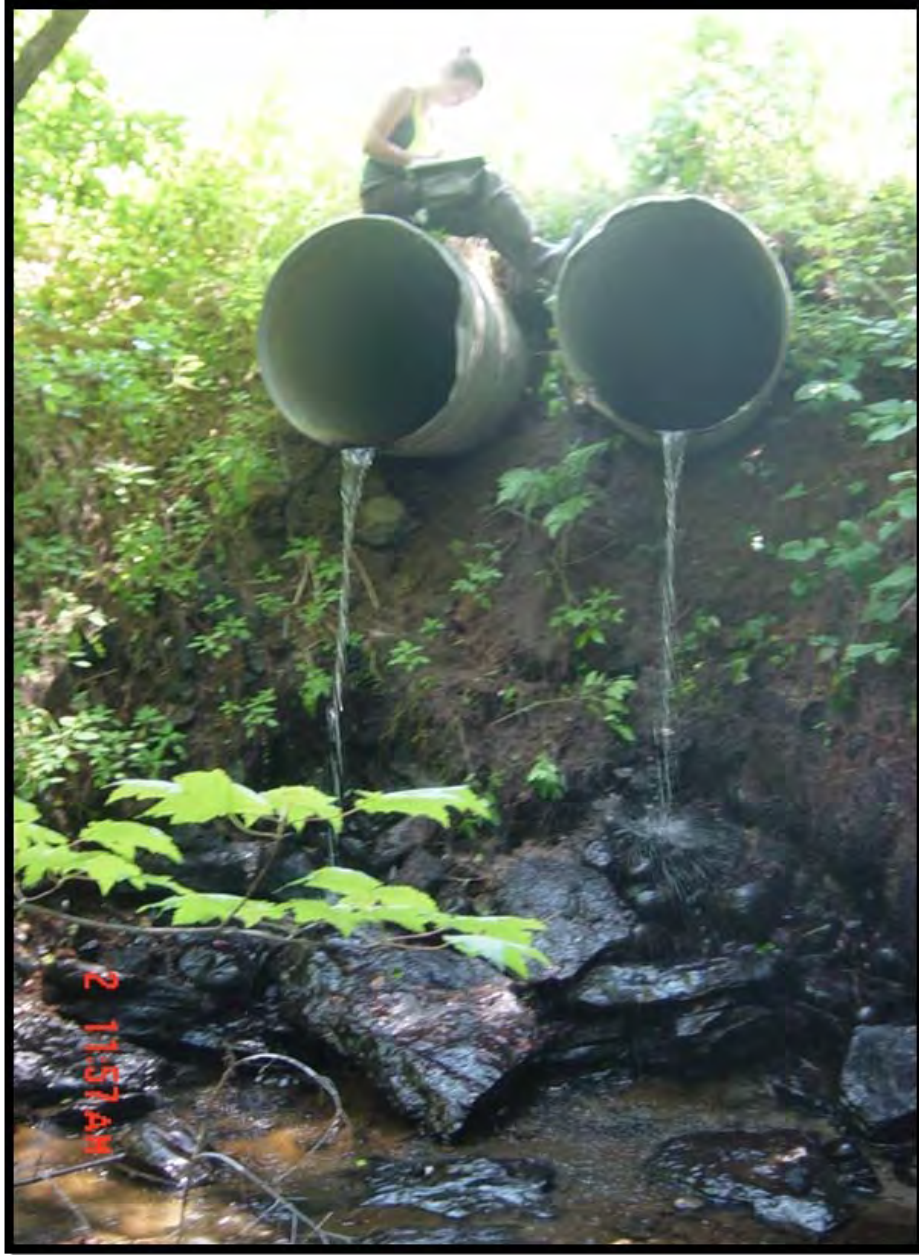
Cover Photo: The photo shows a “perched” culvert, defined as a culvert whose inlet or outlet is elevated above stream grade. In the lower Kennebec River watershed, perched culverts are the primary reason road-stream crossings block or impair fish passage. Courtesy Charlie Baeder, 2010.

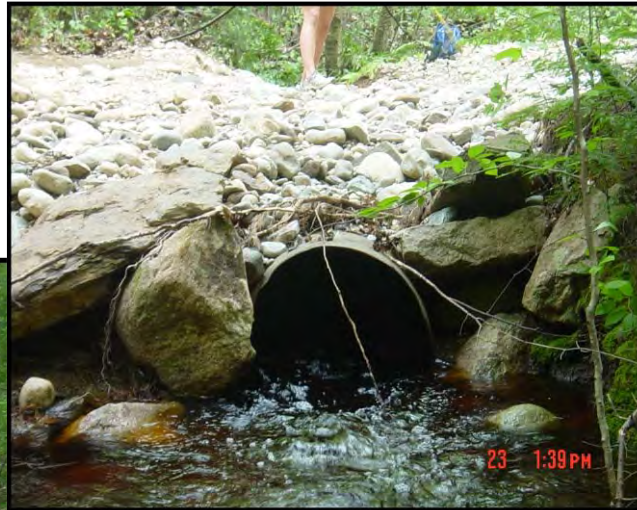
One of our survey crews observed this firsthand in the lower Kennebec watershed on Meadowbrook Road in Phippsburg following a storm in July 2010 that washed out the road. These photographs show the road after initial repairs were started and what appears to be the re-installation of an undersized culvert. Road failures were observed on a larger scale in Downeast Maine following a December 2010 storm that blew out several roads in that region. Culverts in that same area that had been replaced in the last few years by

Project SHARE with culverts sized at 1.2x bankfull width in order to restore fish passage weathered the storm without incident. In addition to impairing fish passage, undersized culverts are clearly a road infrastructure, public safety, and FEMA cost issue.
