PROPERTY OF THE FRIENDS OF THE ROYAL RIVER

## LIBBY BROOK WATERSHED SURVEY FINAL REPORT

Prepared by:  
**John MacKinnon, P.E.**  
Friends of the Royal River  
January 2002

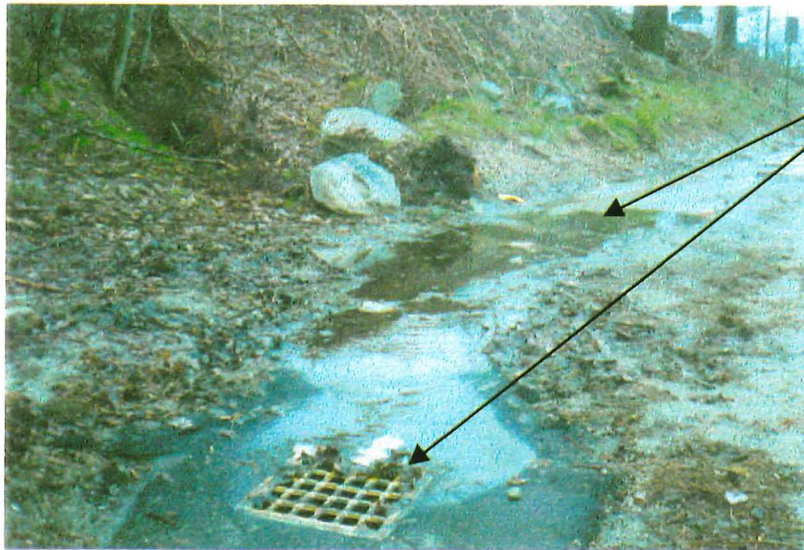
**Problem:**

- Winter sand and eroded road shoulder material is washed into storm drain inlet located directly over a stream
- Polluted runoff from an upstream parking lot also flows into the storm drain inlet

**Possible Solutions:**

- Excavate a ditch at toe of embankment and construct a sediment trap upstream of the storm drain inlet
- Stack rock-filled mesh bags around the storm drain inlet

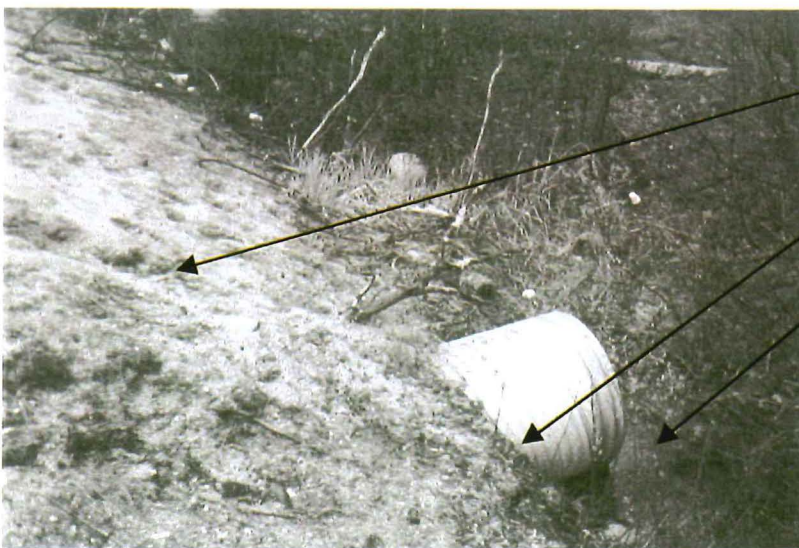
**Problem:**

- Bare soil on road embankment eroding into stream
- Unstable soil around culvert outlet
- Stream channel filling with sediment reduces channel capacity and harms aquatic habitat

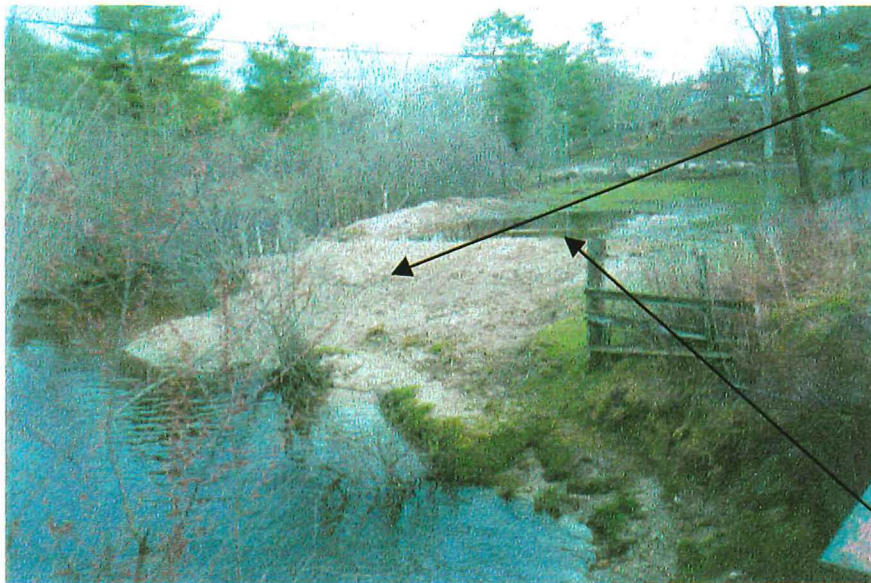
**Problem:**

- Livestock have trampled and stripped the streambank of vegetation
- Bare soil is eroding into the stream
- Manure washed into the stream could lead to elevated bacteria levels in the water

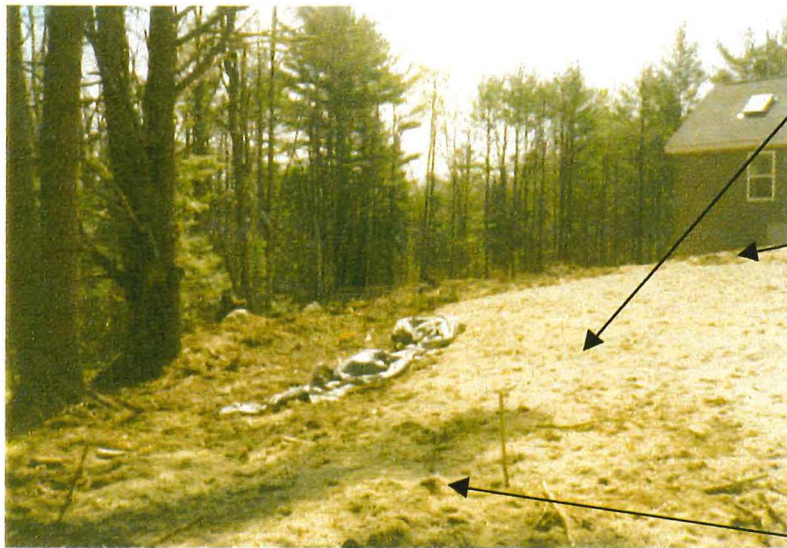
**Problem:**

- Soil is bare and prone to erosion
- No established erosion and sediment controls other than debris berms
- Roof runoff discharges onto bare soil

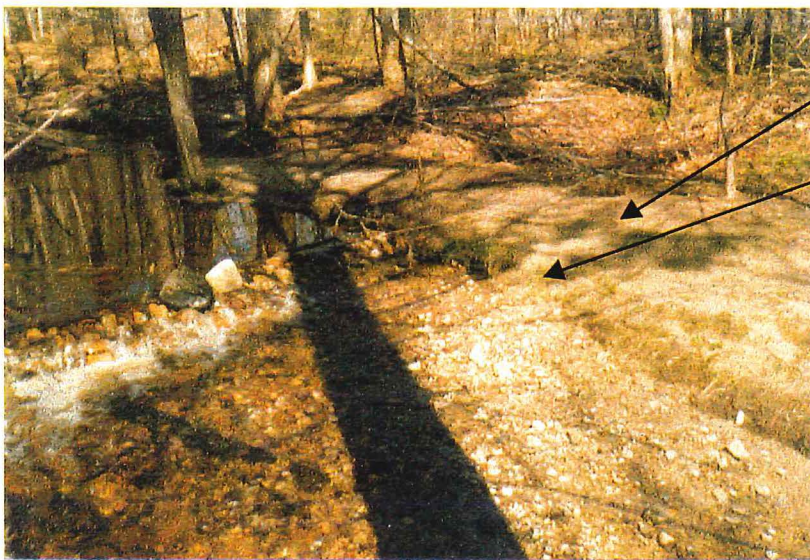
**Problem:**

- Foot traffic has trampled vegetation on the streambank, leaving the soil bare
- Bare soil is eroding into the stream
- Streambank erosion will accelerate during high flows because there is no vegetation holding the soil in place

Resolving streambank erosion problems caused by foot traffic would obviously require cooperation from the people that use the stream. They would have to agree to using a foot path set back from the streambank and only approach the stream where the banks are reinforced by existing rock or imported rock. Once it is determined that the eroding streambank is no longer subjected to foot traffic, the revegetation process can be accelerated using cuttings of dormant water-loving plants. The cuttings would take root and the resultant trees would rapidly spread along the streambank. Care should be taken to ensure that the cuttings are from trees that are able to thrive in that particular environment.

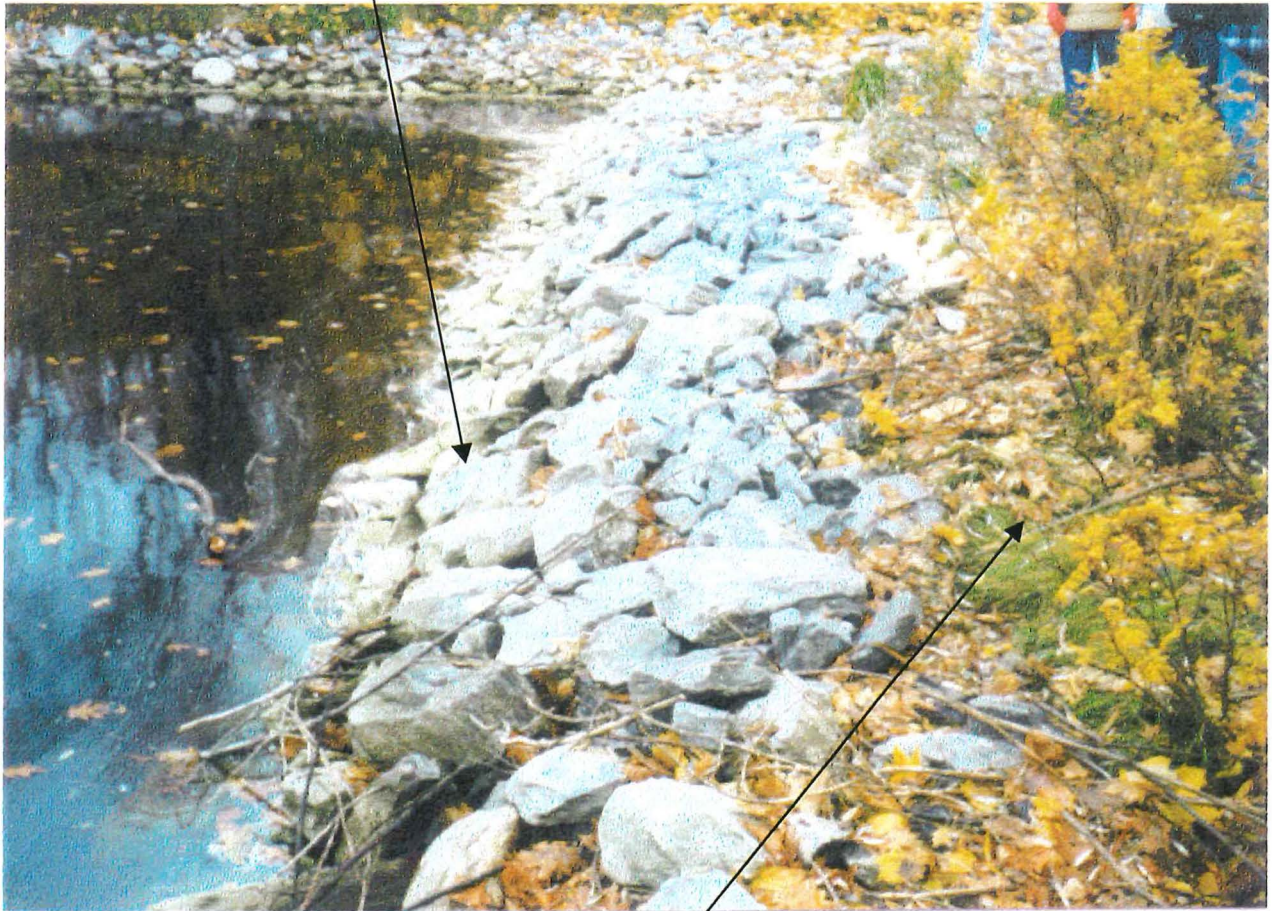
**FIGURE 12**  
**STREAMBANK STABILIZATION**

Three streambank sites were identified during the survey. Erosion at one of these sites was caused by a road culvert that aimed stream flow directly against the streambank, resulting in periodic undermining of the bottom of the bank and the sloughing of bank soil into the stream. Erosion at the other two sites was caused by foot traffic that had trampled streambank vegetation, leaving the banks vulnerable to erosion when the stream is flowing full.

The solution to streambank erosion caused by the road culvert would include protecting the bottom of the streambank from the force of the water by using large rip rap. The rip rap would be large enough to absorb the force of the water without moving. With the bottom of the streambank stabilized by the rip rap, the remainder of the streambank could be stabilized using vegetation. An example of this type of streambank stabilization is shown in Figure 12.

Rip rap absorbs the force of waves and currents that might otherwise undermine the base of the streambank.

Vegetation stabilizes the top of the streambank against erosion during floods.
