Little Sebago Lake Watershed Survey Report

Part I—North of Lyons Point

**Cumberland County Soil and Water Conservation District
Little Sebago Lake Association
Maine Department of Environmental Protection**

May 2003

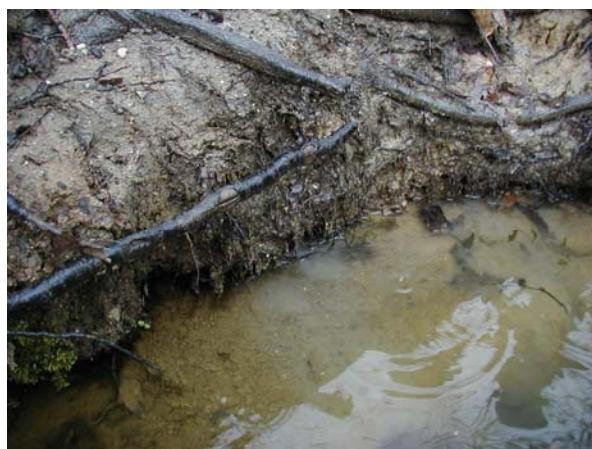
When combined with many other similar sites from throughout a watershed, even erosion from small sources such as this can have a significant impact on lake water quality.

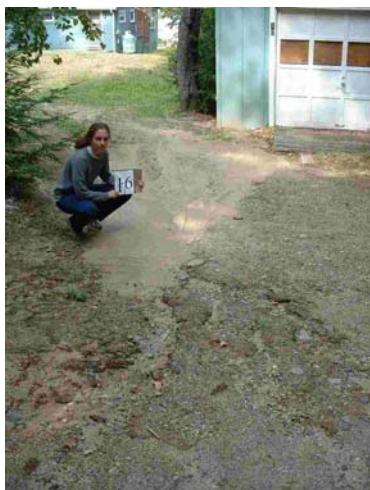
Runoff from the driveway and rooftops on this property combine to transport significant sediment into Little Sebago Lake.

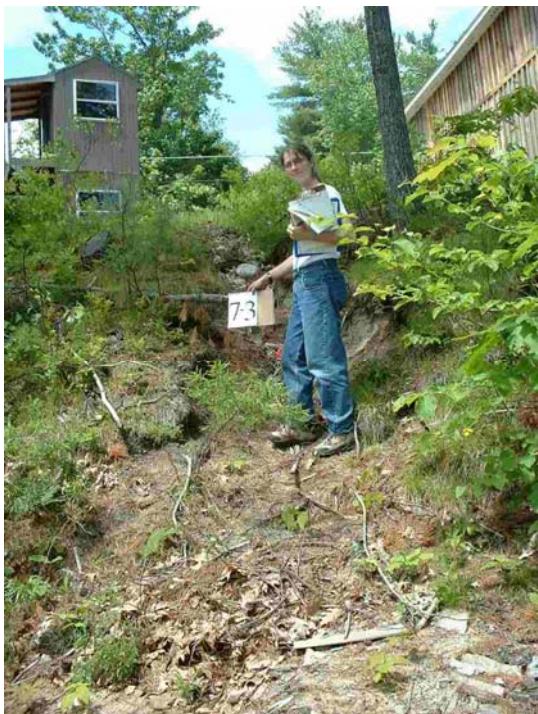
Problems:

- Moderate bank erosion from runoff.
- Unstable foot access to lake.
- Direct flow of sediment to lake.

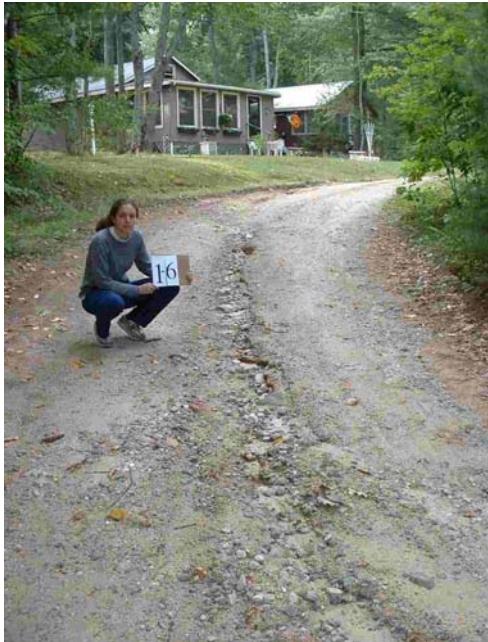
Problems

- Moderate surface erosion.
- Poor driveway shaping and ruts cause water to concentrate and erode the surface.
- No ditches on the sides of driveway.

Preserve water quality and save time, money, and wear and tear on your vehicle by having a well crowned driveway. Use adequate surface material and add diversions to direct runoff into buffers.

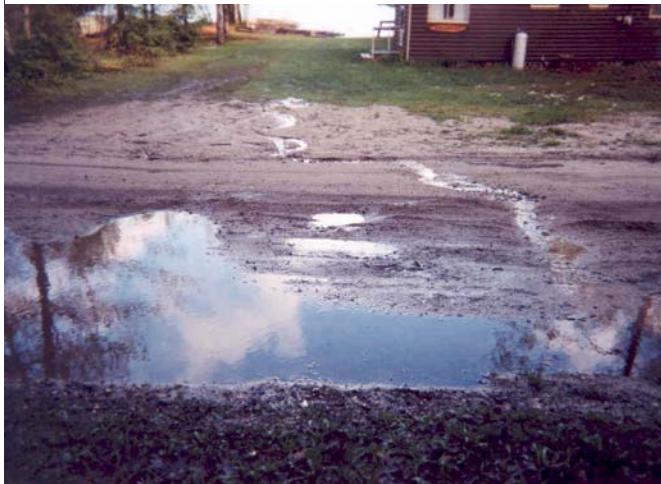
Problems:

- Poor road surface material (too sandy).
- No ditch or culvert; no stable escape for water on road.
- Direct flow of road material to lake.

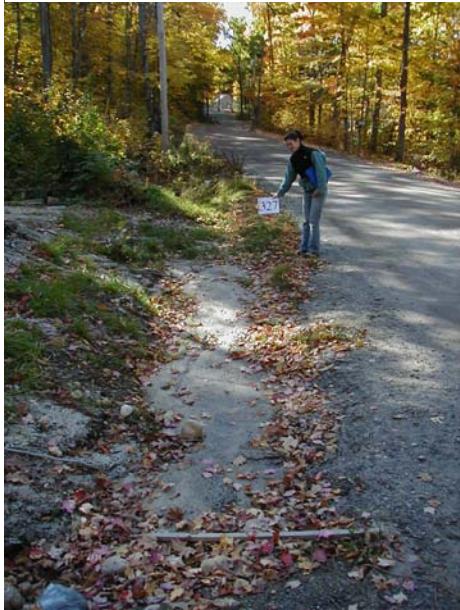
Problems:

- Moderate to severe ditch and road shoulder erosion above leads to sediment deposition here.
- Direct flow of sediment and winter sand into stream.
