Moose Pond

WATERSHED SURVEY REPORT

A study of the entire Moose Pond Watershed was conducted over the summer of 2010 to identify sites contributing polluted runoff, particularly soil erosion, into the Pond. Volunteers and technical staff identified 208 erosion sites currently impacting or having the potential to impact the Pond's water quality. Of these 208 sites, 23 were rated as having a high impact to water quality, 75 as medium impact, and 110 as low impact (see Table 1 p. 5). Impacts predominantly consisted of the following land uses: residential (73 sites), town roads (34 sites), commercial (30 sites),

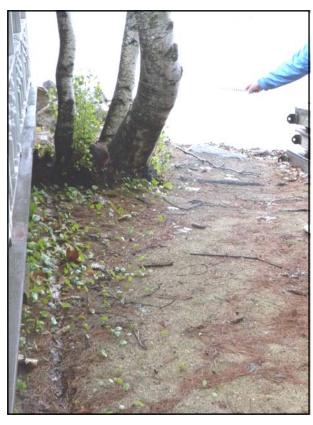
The erosion problems associated with the property pictured at left were common on many other properties within the watershed.

- Plant native plants.
- Mulch bare areas.
- Infiltrate or redirect runoff above shoreline.
- Stop raking.
- Create defined foot paths.

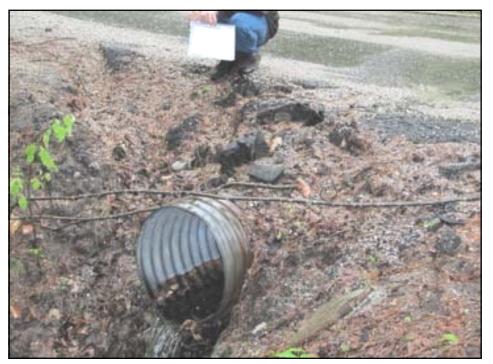
The erosion problems associated with the town road pictured below were common on many other roads throughout the watershed.

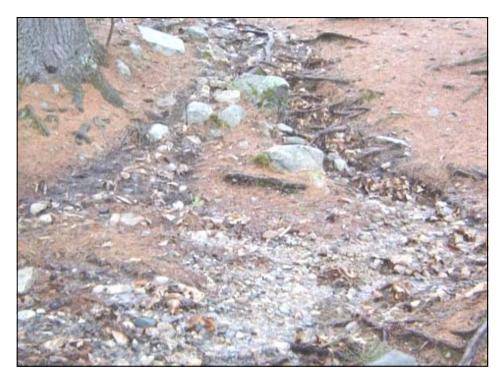
The erosion problems associated with the commercial site pictured below were common on many other sites throughout the watershed.

- Erosion from high concentrated water flows.
- Bare soil, exposed roots.

- Divert and infiltrate stormwater uphill of erosion site using water diverters and native shrubs.
- Create defined walkways.
- Cover areas of bare soil with erosion control mulch.
- Use strategic plantings to divert water flow and define walking paths.

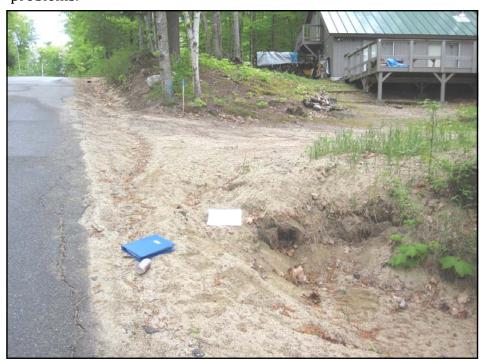
The erosion problems associated with the driveway pictured below were common on many other driveways within the watershed. Runoff from this driveway is also contributing to road shoulder problems.

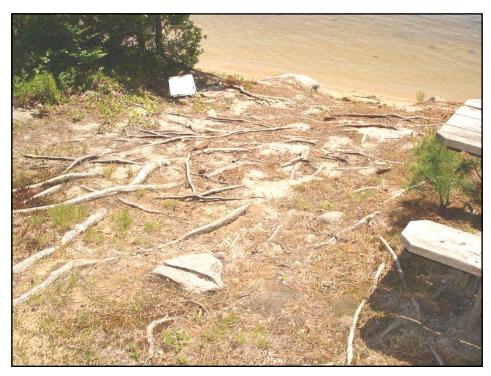
The erosion problems associated with the beach access site pictured below were common on many other shorelines within the watershed.

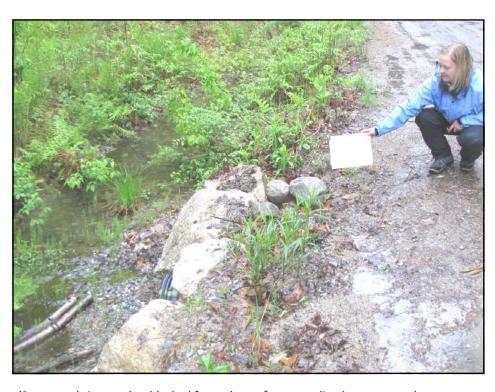
The erosion problems associated with the private road pictured below were common on many other roads within the watershed.

- Add new / proper road surface material.
- Reshape and crown road.
- Install runoff diverters or turnouts to direct water to areas where it will infiltrate.
- Stabilize road shoulder with riprap.

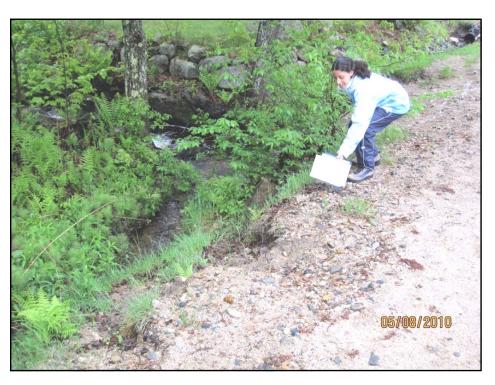
The erosion problems associated with the state road pictured below were common on many other roads within the watershed.

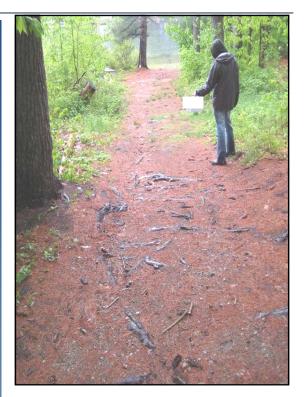
The photo above shows a wide path leading to Moose Pond. Exposed roots are signs of erosion that has likely occurred over time.

Eroding trails or paths can be improved by reducing path width, using native plants, creating a meandering path, and covering the path with erosion control mulch. Steeper paths may need timber tiers and crushed stone to hold soil in place.
