# Pleasant River Watershed Survey Report

## Presumpscot River Watch

Cumberland County Soil and Water Conservation District  
& Maine Department of Environmental Protection

*September 2009*

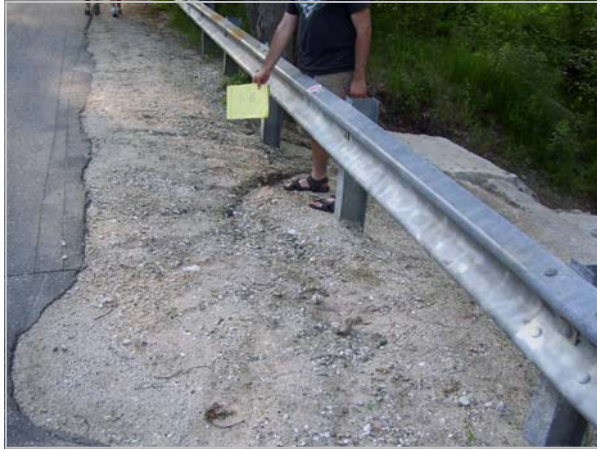
*Example of erosion on a road shoulder.*

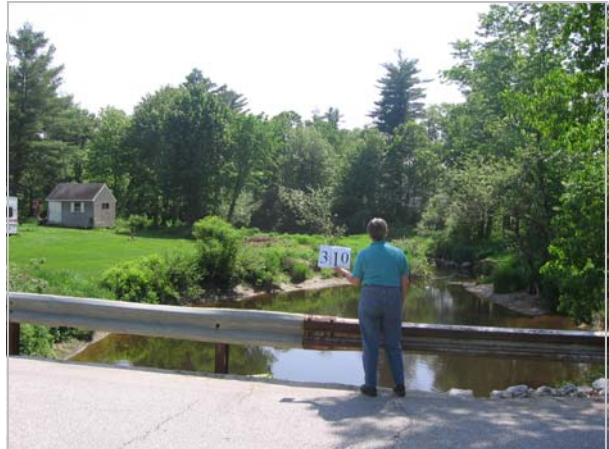
*Example of an inadequate vegetated buffer along the stream bank.*

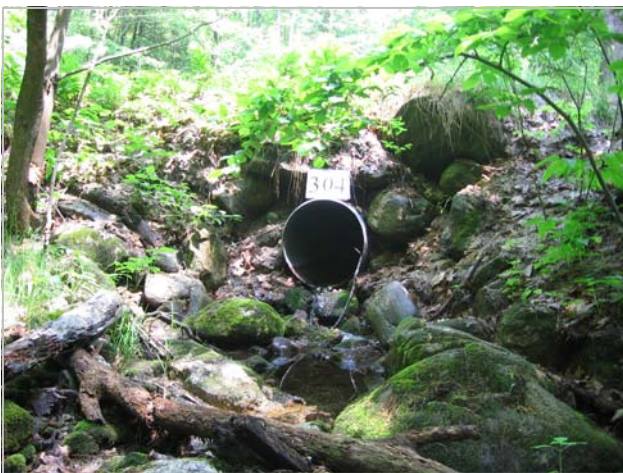
*Example of a hanging culvert.*

- Clean out culvert regularly to minimize blockage and backflow
- Enlarge, replace, or lengthen culvert to account for type of flow
- Install plunge pool to reduce downstream erosion
- Stabilize inlet/outlet with rock and vegetation to reduce erosion

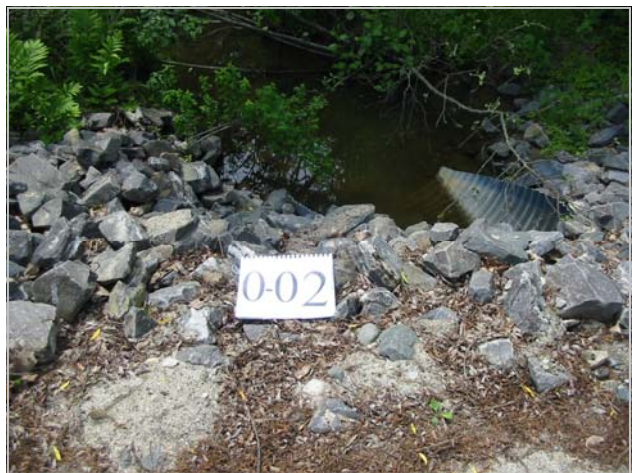
*Example of winter sand buildup.*

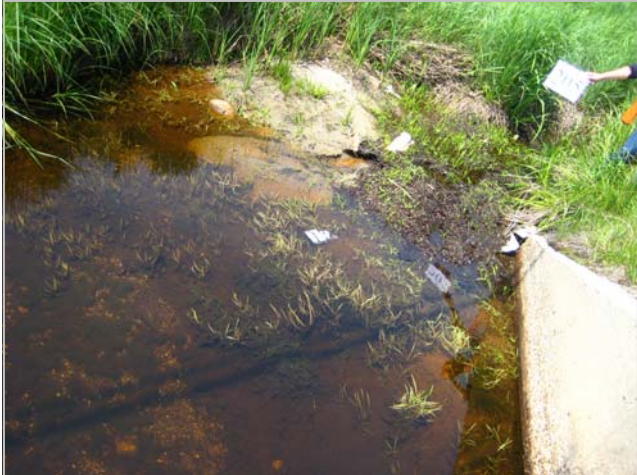
*Example of trash in stream.*

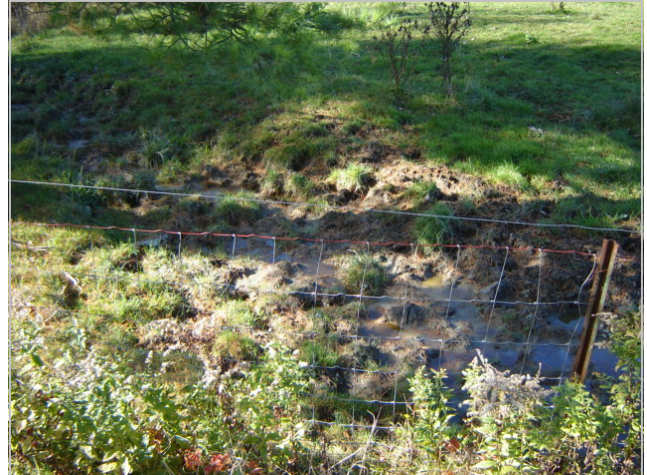
*Example of livestock access to stream.*

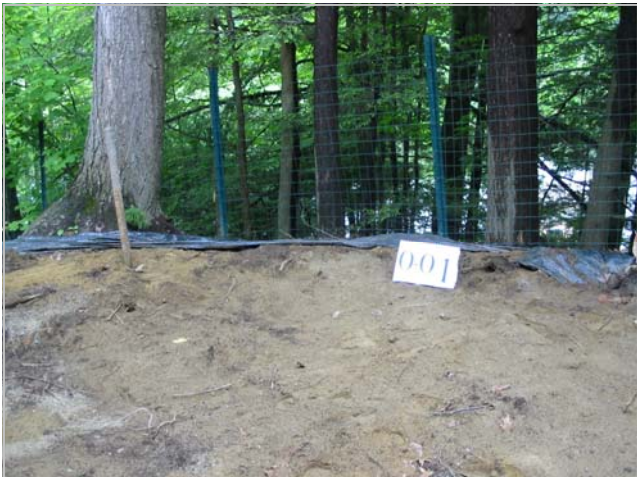
*Example of bare soil at a construction site.*

- Put up fences and signs to contain damage caused by heavy equipment
- Use Grading plans to minimize erosion
- Use filter strips and buffers to prevent runoff, and stabilize erosion prone slopes.
- Place soil piles where they will not erode into watercourse
- Seed and install effective erosion barriers (temporary BMPs) around spoil piles
- Stage projects to minimize area of exposed soil at any one time
- Select and protect trees to the maximum extent possible, prior to construction.
- Dewater with well points/ cofferdams and pumps to remove ground and surface water from a construction site to reduce scarring and erosion
- Install Filters of crushed stone, straw or geotextile to remove sediment from stormwater before it exits a construction site

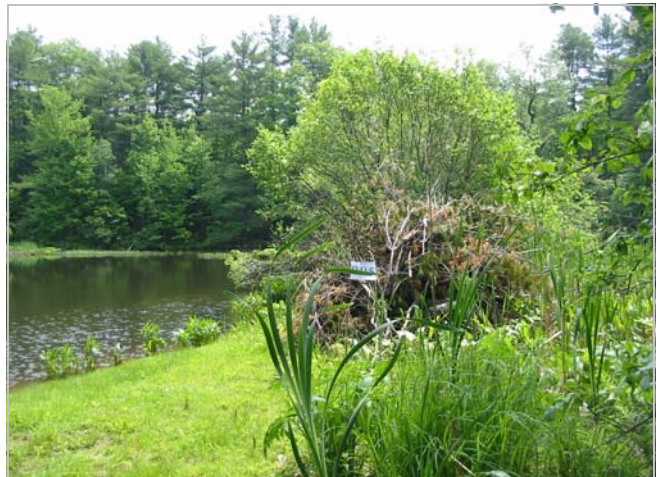
*Example of yard waste piled adjacent to shoreline.*

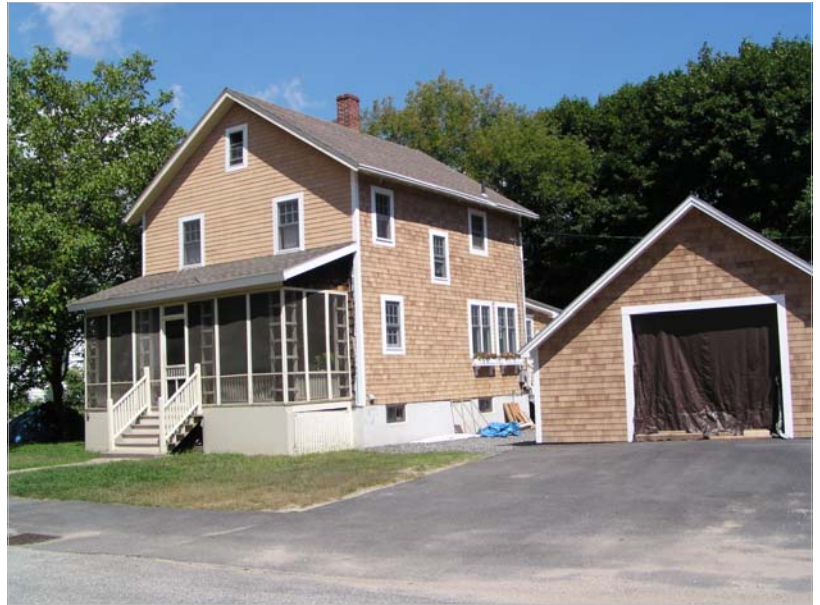
*An example of a parcel with little to no landscaping and high impervious cover.*

In all of the neighborhoods surveyed, there is a lack of adequate landscaped vegetation and a high percentage of impervious and semi-pervious areas of lawn. If landscaping and tree canopy increased, more rainfall and runoff would be intercepted and infiltrated. BMPs such as drywells and rain gardens catch and infiltrate stormwater and reduce the overall amount ending up in the sewer system and river. Another alternative is to encourage homeowners to declare part of their lawn a “no-mow zone” allowing their grass to grow several inches taller , which would increase infiltration and slow down the flow of water. With proper public education, homeowners can reduce their impact to the water quality of Pleasant River by practicing low impact landscaping techniques.

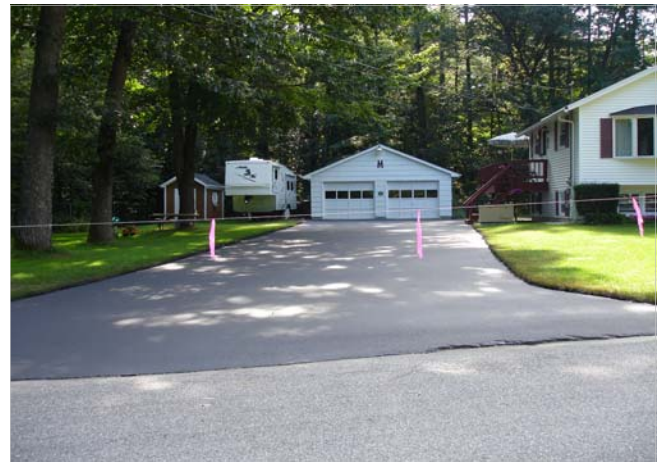
*Typical large, seal coated driveway.*

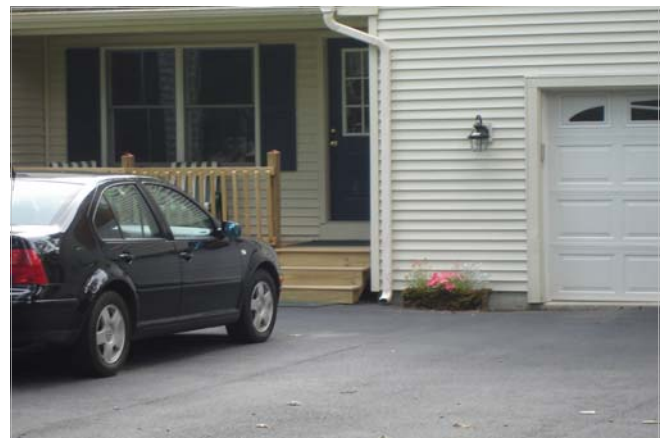
**4. Roof Runoff** - In general, roof runoff was not primarily managed by downspouts in any of the three neighborhoods- only 30% of the homes had this feature. Between 35-45% of homes had situations in which the runoff led directly to a paved surface. In the Falmouth Rd. area, 90% of homes also had the situation in which runoff would lead to a pervious area; in the Rte. 302 and downtown Gray area it was between 60-70%. This shows that although there is a considerable amount of runoff being deposited onto pervious surfaces, most homes also have portions of the roof draining onto vegetated areas. Approximately 40% of homes surveyed had an ideal situation for rain garden installation to help infiltrate roof/downspout runoff.

*Example of downspouts leading directly to impervious surface of driveway.*

- Install a stone-filled dripline trench to capture and infiltrate rainwater
- Install a drywell at gutter down spout to capture water and prevent overland flow

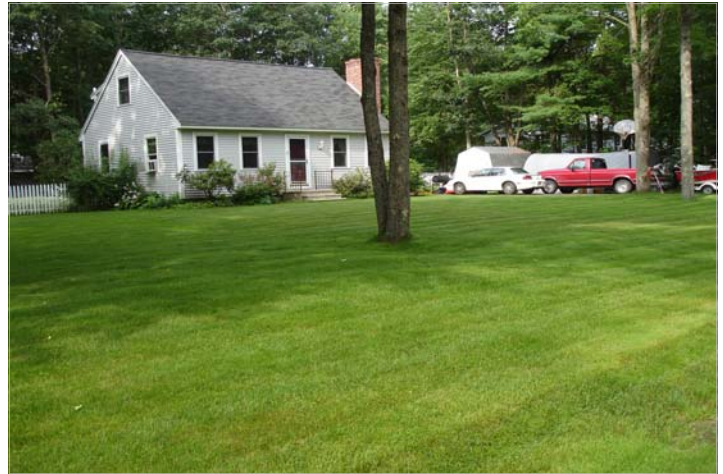
*An example of a home practicing a high level of turf management.*

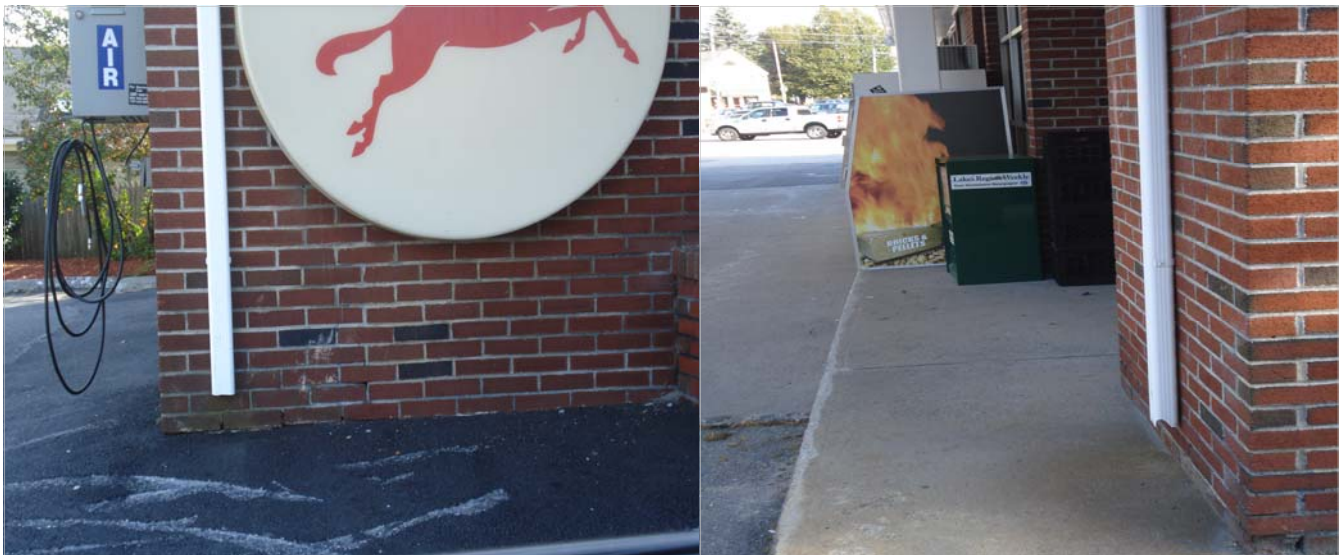
*Downspouts such as these that drain to an impervious surface contributed to the designation of these properties as “potential” hotspots.*

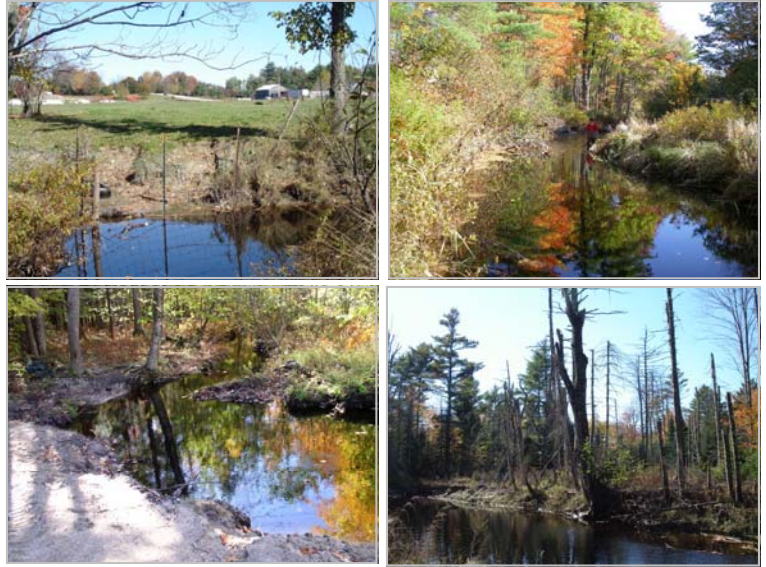
*Example of the range of conditions found during the Thayer River and Thayer Brook surveys.*

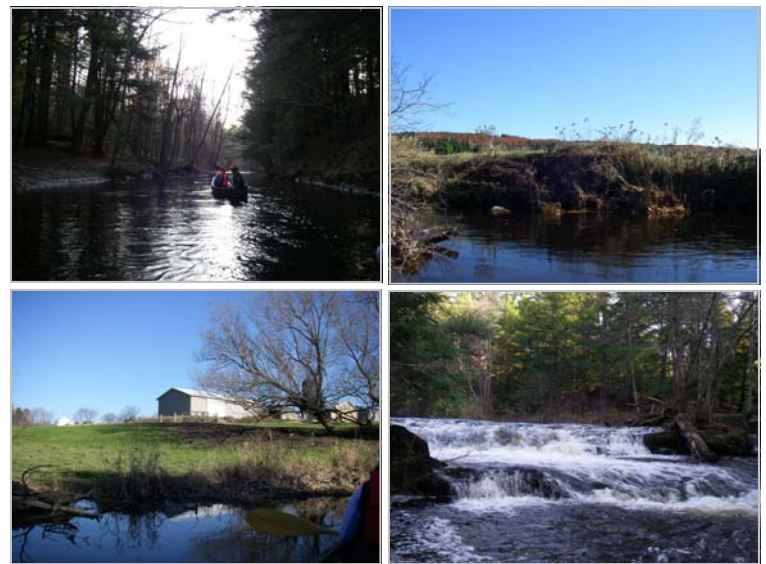
*Example of the range of conditions found during the Pleasant River survey.*
