Preparing for Coastal Flooding in Harpswell: A Plan for Basin Point Road and Its Wetlands

December 2018

Date: November 20, 2018

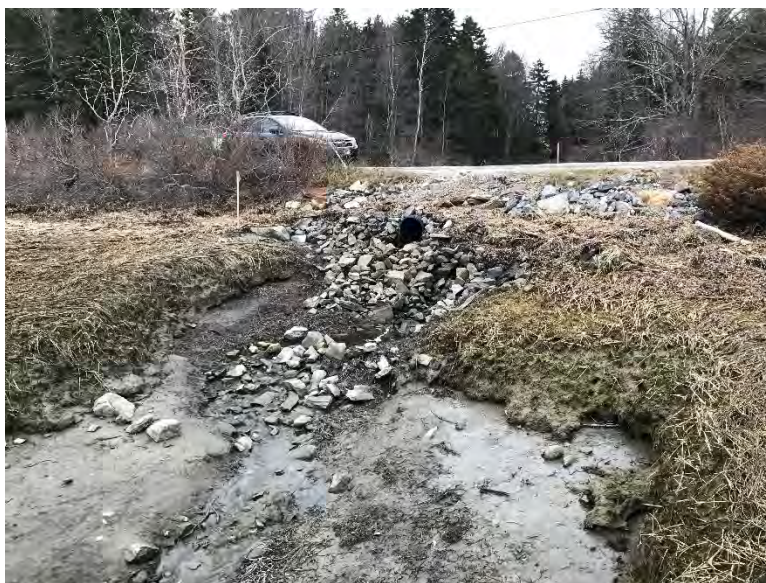
Figure 3 Downstream End of Culvert & Tidal Channel

Cove side) is elevated above the bottom of the tidal channel invert by approximately 3.7-feet. Under normal high tide conditions (2018), the tide does not flow through the culvert into the pond. The low point of Basin Point Road centerline at the culvert is approximately 9-feet, which is about 2.5-feet above the current highest annual tide (HAT) of 6.5-feet. There is no anecdotal evidence that historic high tides have overtopped the road, however, the tides have flowed backward through the culvert and into the pond on the northerly side of the road.

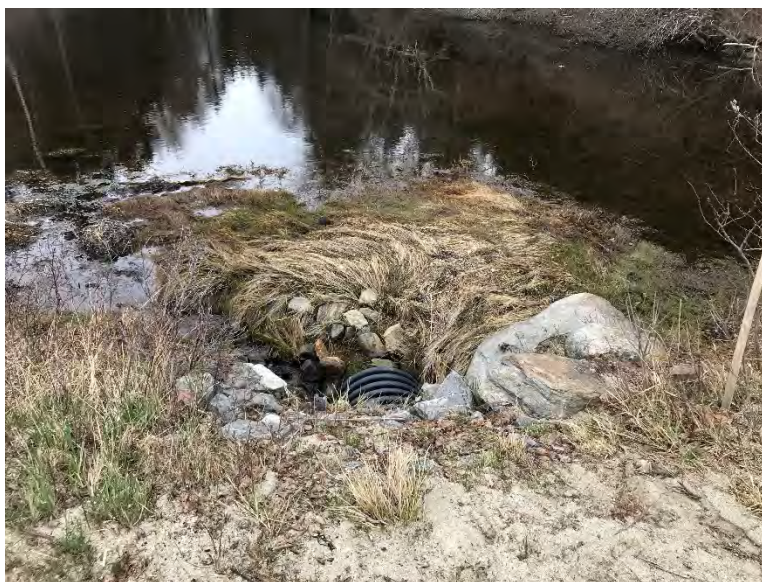
Figure 4 Upstream End of Culvert & Berm

On December 4, 2017, there was an extreme high tide event where tidal water levels on the cove side of the road were measured at approximately elevation 6.5-feet (current HAT) at the time of peak high tide. The winds during this event were minimal, therefore, there were no observed impacts to the road.

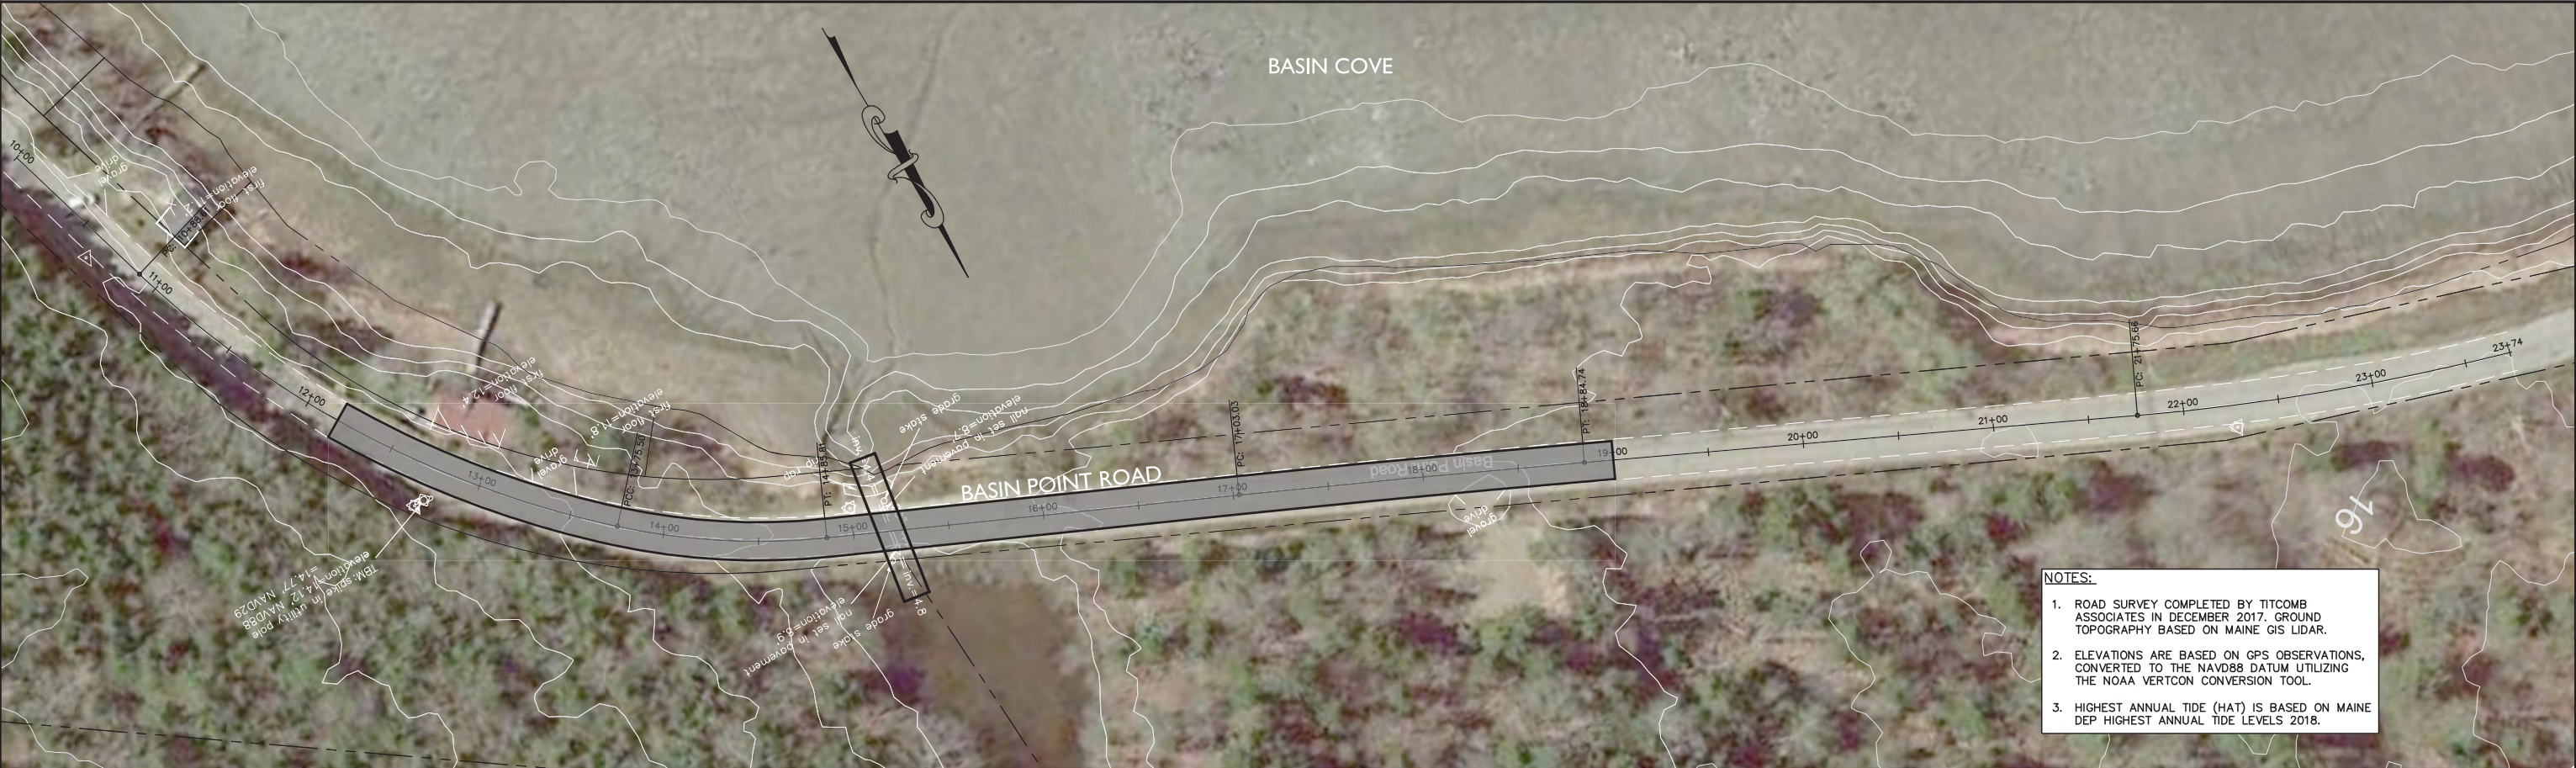
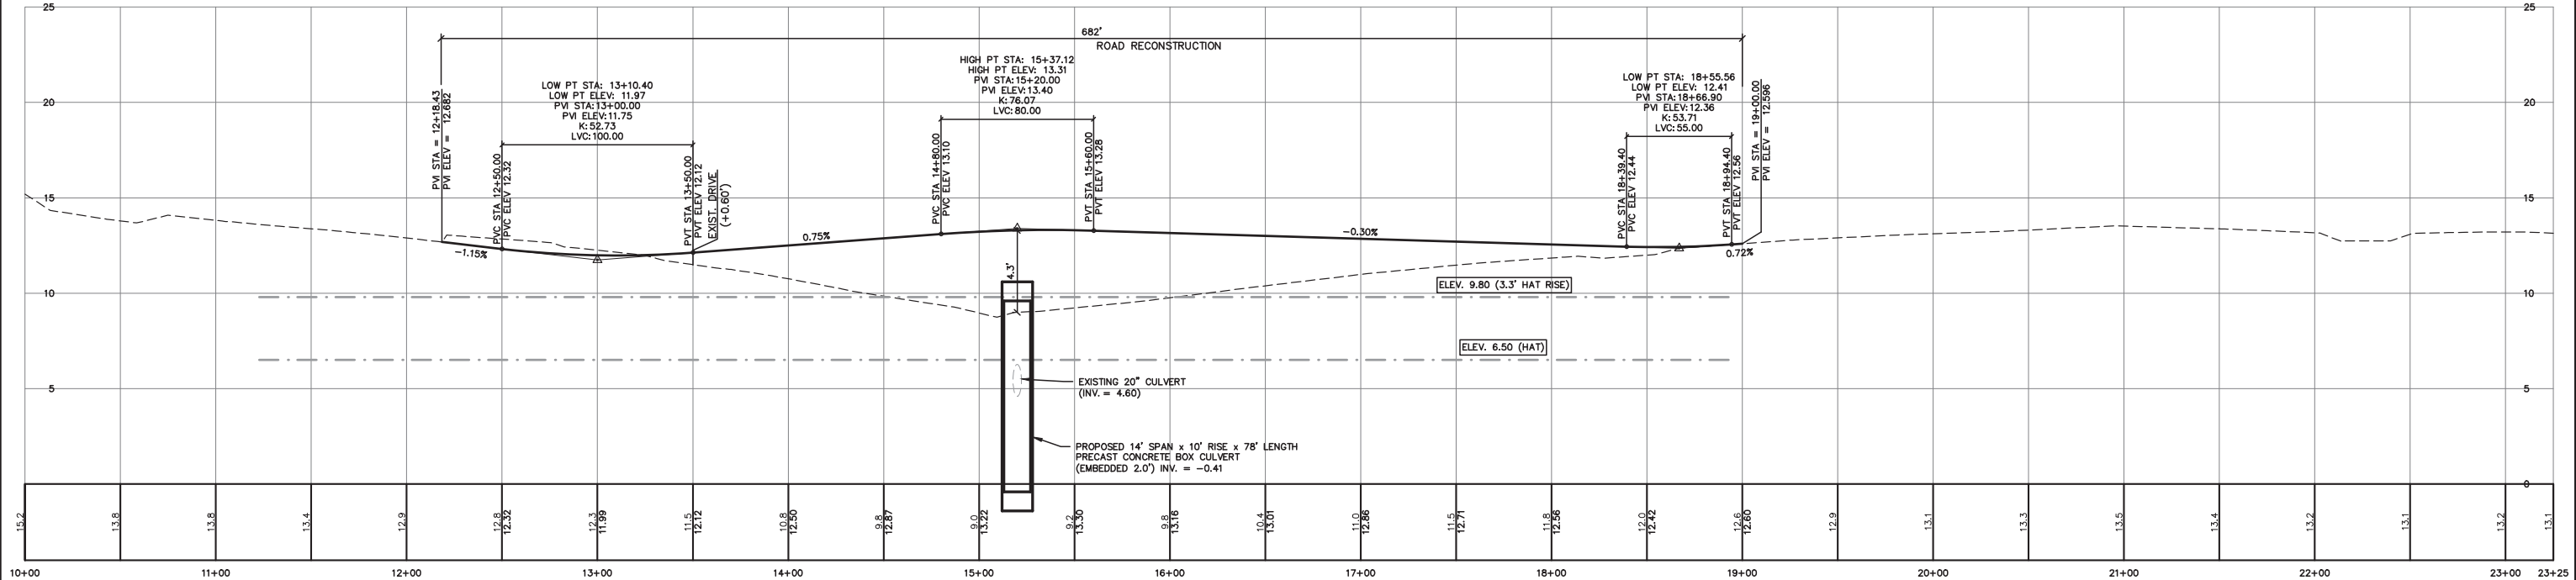
Drawing Name:	3.3' RISE PLAN AND PROFILE
Project:	Basin Point Road Improvements Harpswell, Maine
Client:	Town of Harpswell Mountain Road, Harpswell, Maine

As shown in Table 2, by raising the road profile by approximately 4.3-feet, the impacts caused by the 3.3-foot SLR scenario are mitigated as the MHW and HAT elevations are located below the road surface and subgrade elevations of the proposed road.

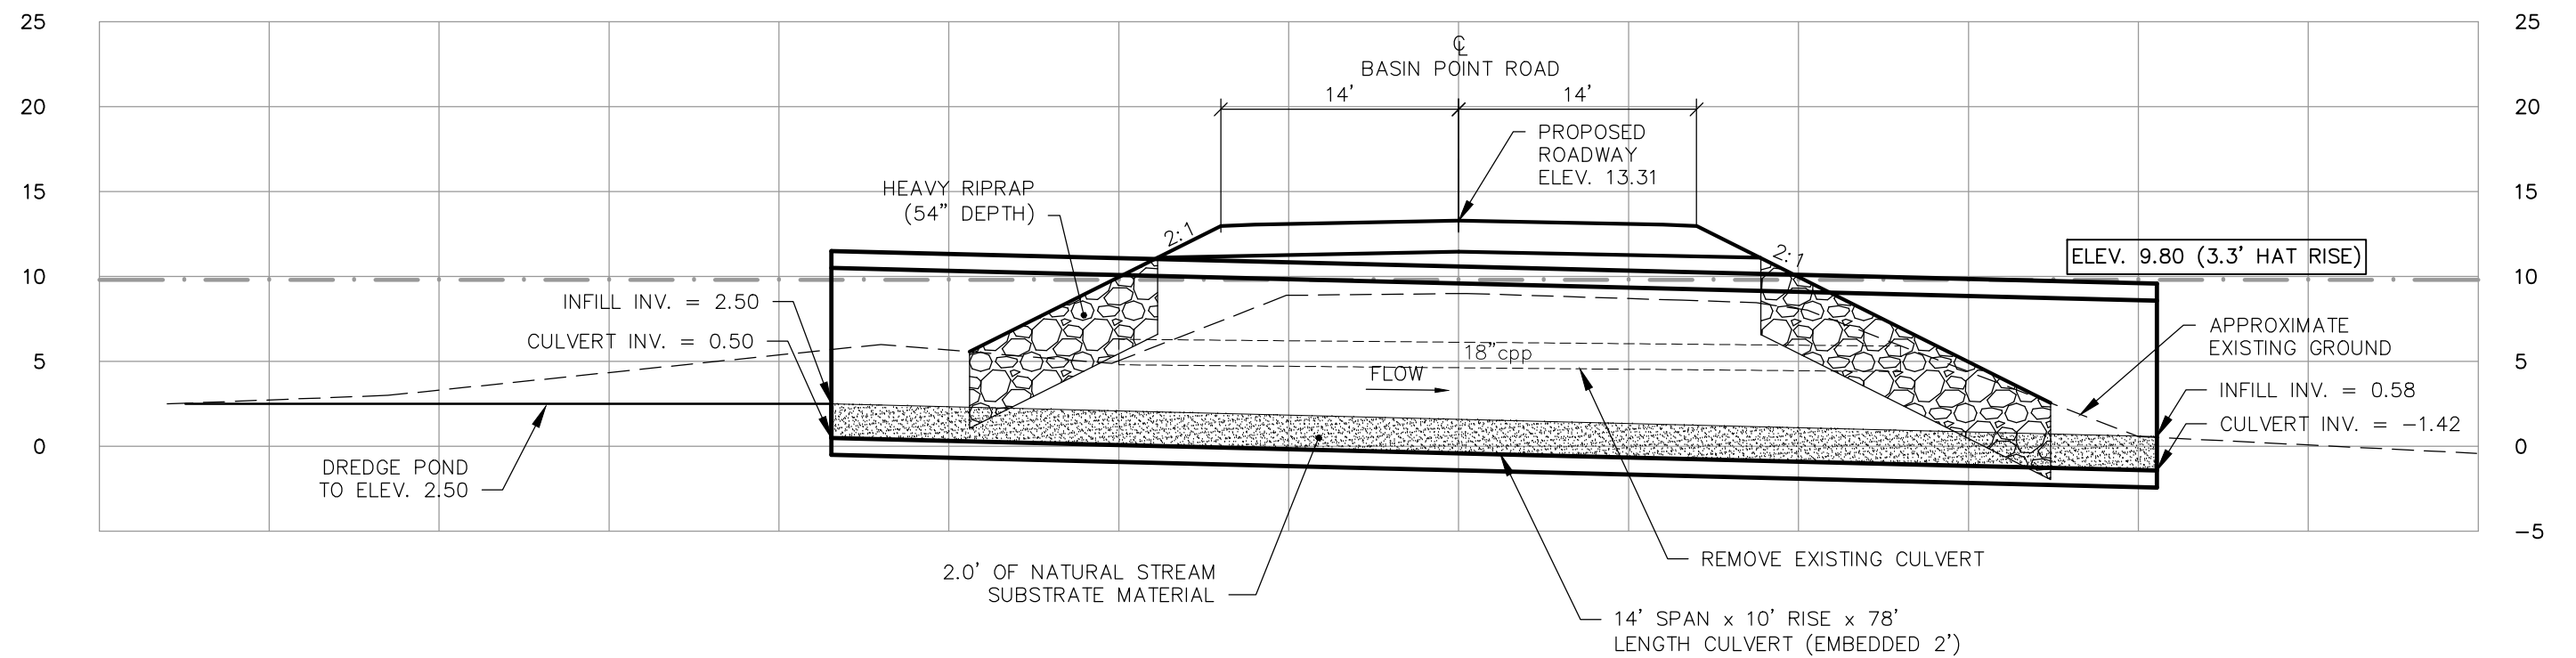
BASIN POINT ROAD CULVERT CROSS SECTION
(3.3' HAT RISE)
SCALE: 1"=10'

There are several possible options for this culvert design. The regulatory agencies generally prefer culverts with natural channel bottoms, such as a three-sided box culvert or arch set on footings. In our experience, structures on footings are often more expensive and require additional geotechnical investigations for the footing design. Since our current scope did not include a subsurface investigation, we have recommended the four-sided box culvert with natural channel bed infill. This type of structure still provides many of the same benefits of a natural channel bottom, while also providing a solid foundation of support from the bottom slab of the box culvert. If the Town decides to proceed with further design and permitting, other culvert options can be considered. Generally, Stream Smart design principles call for culverts to be sized so the span is at least 1.2 times the bankfull width of the stream. At this site there is an existing pond located upstream of the road crossing, therefore there is no stream width immediately adjacent to the road culvert. The channel cross section at the northerly end of the pond is about 1 to 2-feet wide. The *Basin Point Road Assessment* (CBEP 2018) report and field work identified the natural channel thalweg elevation upstream of the existing culvert (in the pond), as well as the downstream channel inverts and cross sections. The down stream channel, from the existing culvert outlet to the mudflat appears to range from 15- to 22-feet wide, getting wider towards the mudflat. The culvert size we selected (14-foot span by 10-foot rise) must be confirmed by further modeling; however, the proposed size significantly exceeds the size needed to convey freshwater flows. The Stream Smart culvert span design criteria is not applicable to tidal culverts; therefore, we selected a culvert span that generally matched the downstream channel width near the existing culvert, set at an elevation that matches the upstream and downstream channel thalweg elevations measured by CBEP in their study. We selected the 10-foot culvert rise to allow for 2-feet of channel embedment. This culvert will provide 112-square feet of cross-sectional area. The propose culvert would:

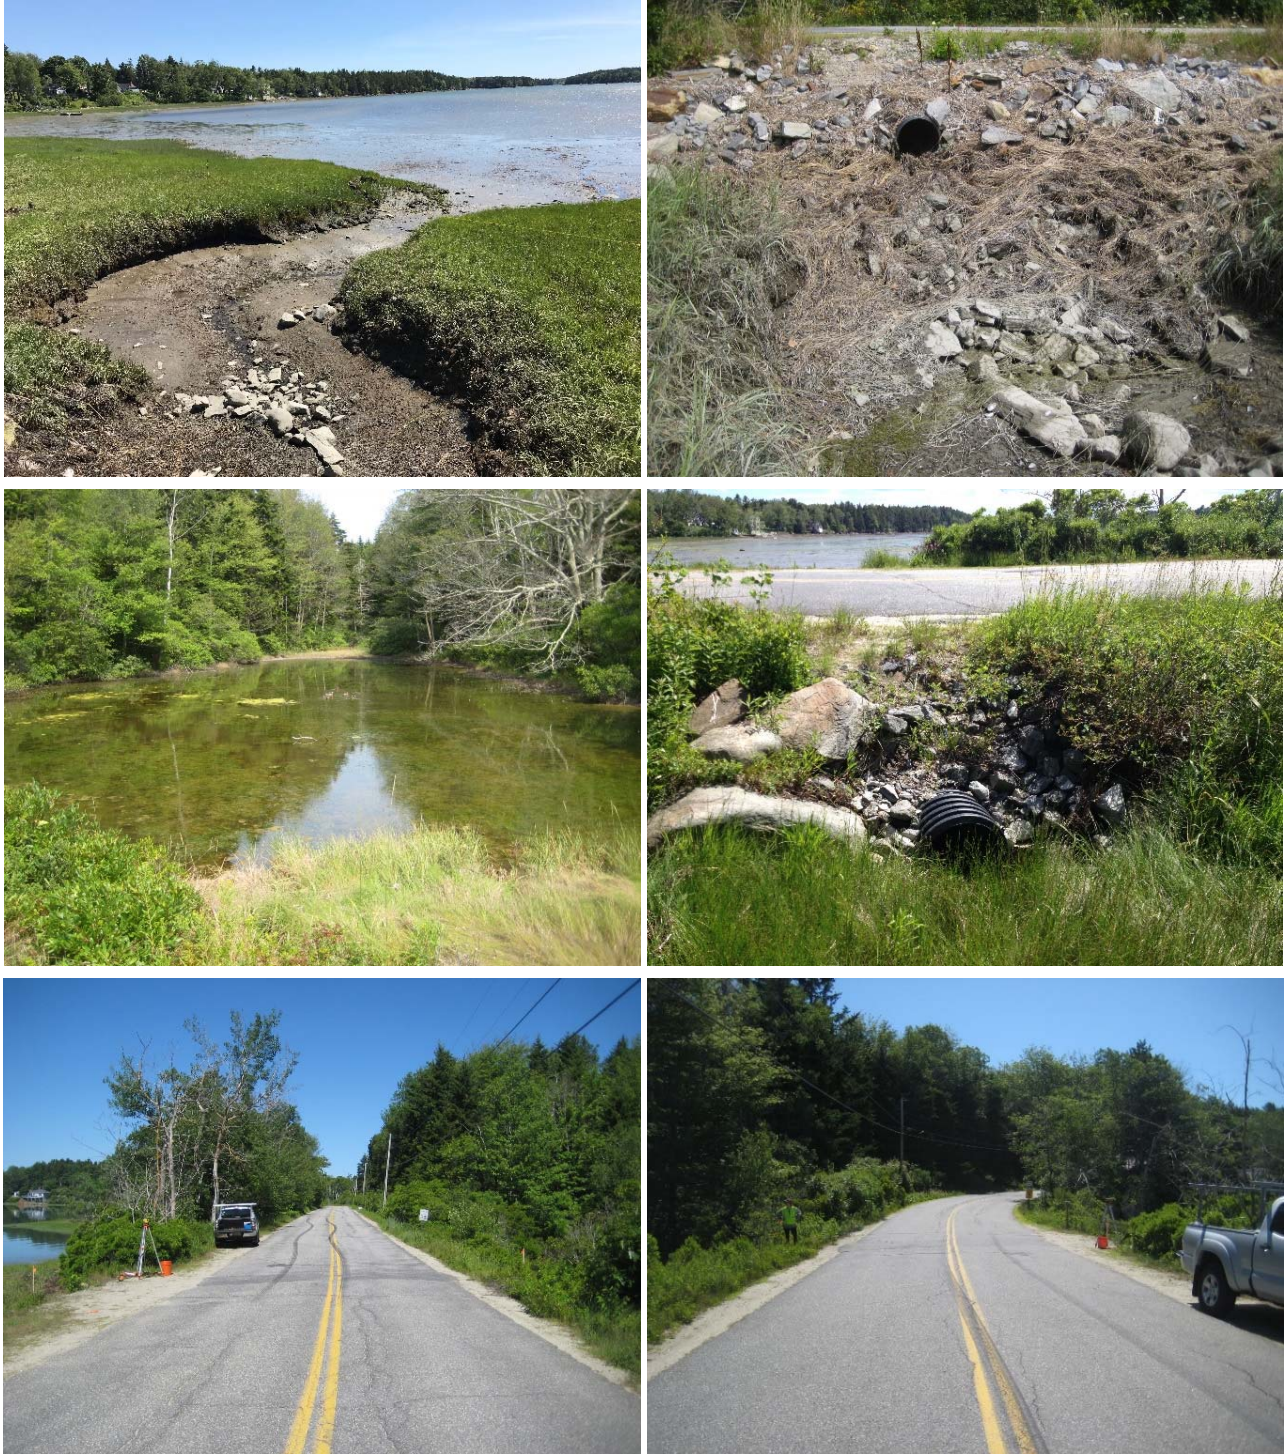
Standard photo stations for stream/road crossing surveys (Fig. 6a-6f) include views: downstream, culvert outlet, upstream, culvert inlet, and road approach from each direction. The site was not surveyed in 2009/10 because of the lack of a perennial stream feeding into the pond, causing the site to be dropped during desktop screening.

Figure 6. Fig.6a-6f, from left to right. Top row: downstream channel; culvert outlet to channel (north). Middle row: upstream pond with berm/dam in foreground; culvert inlet with berm/dam in foreground. Bottom row: road approach (west); road approach (east).

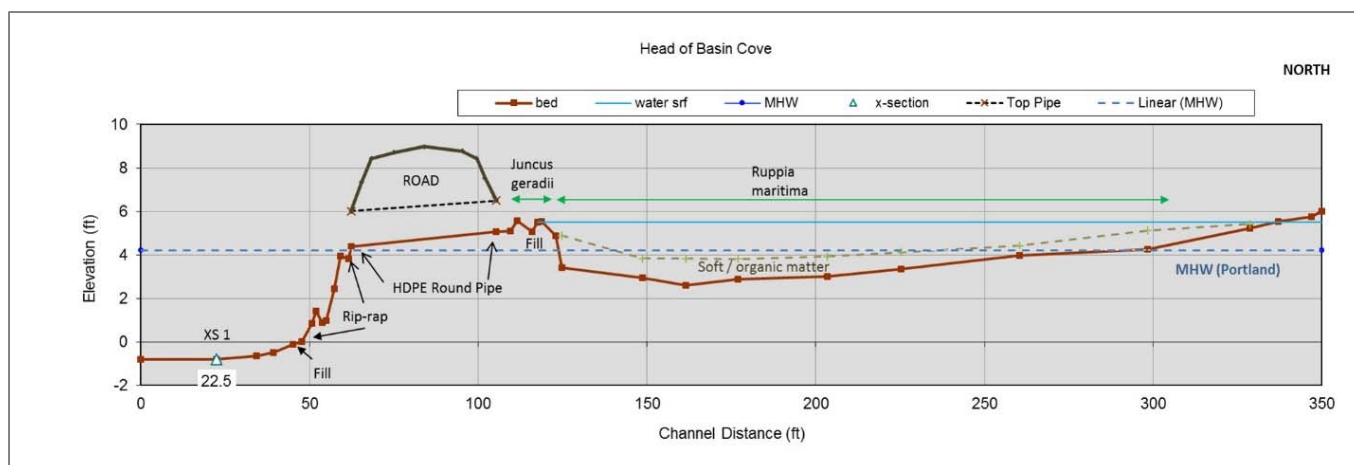
Figure 8 (below) plots the longitudinal profile. Mean High Water (MHW) of 4.21' from the Portland Tide Gauge is shown for reference². The start of the transect at zero lies at an elevation of approximately -1.0'. Cross section 1 is shown at 22.5' along the transect, and is considered most representative of 'natural' creek channel conditions. Between XS1 and the culvert outlet, road fill and riprap defines the channel bottom and elevations are presumed to be artificially high. The culvert is sloped, which is atypical for tidal culverts, with the inlet higher than the outlet. Both the outlet invert (bottom elevation) and the inlet invert are set high in the tidal range, well above the natural channel bottom at XS1, and above the MHW line. This "perched" condition contributes to the tidal restriction shown in the hydrology data and presents a barrier to aquatic organism movement under the road. Immediately upstream of the culvert inlet, an artificial earthen dam (fill) further restricts the movement of salt water into the pond, and impounds water preventing it from draining out of the pond. The dam controls water levels in the pond. Within the pond, a layer of loose, mobile organic matter has accumulated over the true bottom. The bottom elevation was obtained by pushing the stadia rod down to refusal after measuring the surface of the organic matter. The bottom is presumed to be remnant salt marsh peat.

Figure 8. Longitudinal profile of the channel thalweg at Basin Point Rd., with 0' at downstream mudflats. Elevations in NAVD88.

Bottom elevations gradually increase moving north toward the head of the pond. All bottom elevations lie within the upper end of the tidal range (0' to 6'). A narrow band of high marsh (mostly blackgrass, *Juncus gerardii*) is growing atop the earthen dam, and widgeon grass (*Ruppia maritima*) is growing in lush beds rooted in the organic layer on the bottom of the pond. Widgeon grass is commonly found in salt marsh pools, and in restricted salt marsh creek channels. The elevation of the firm peat bottom indicates that prior to construction of the road and the dam, the pond was at one time a tidal marsh. Most of the organic matter is loose and would presumably wash away if the dam was removed and the culvert enlarged. Bottom elevations are suitable for a combination of low and high marsh communities to colonize the current pond if the existing impoundment were to be removed through culvert replacement.

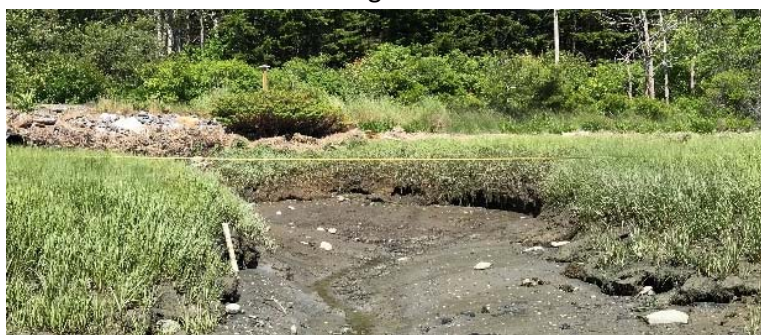
Station 1 served as a reference site³ for comparison with upstream conditions and monitoring ecological response to future culvert replacement. The cross section transect started and ended on the marsh surface, perpendicular to the channel (Fig. 9). The channel bottom is soft mud with no indication that riprap or road fill are present.

Figure 9. Photo of St. 1 cross section. Yellow tape shows location of transect.

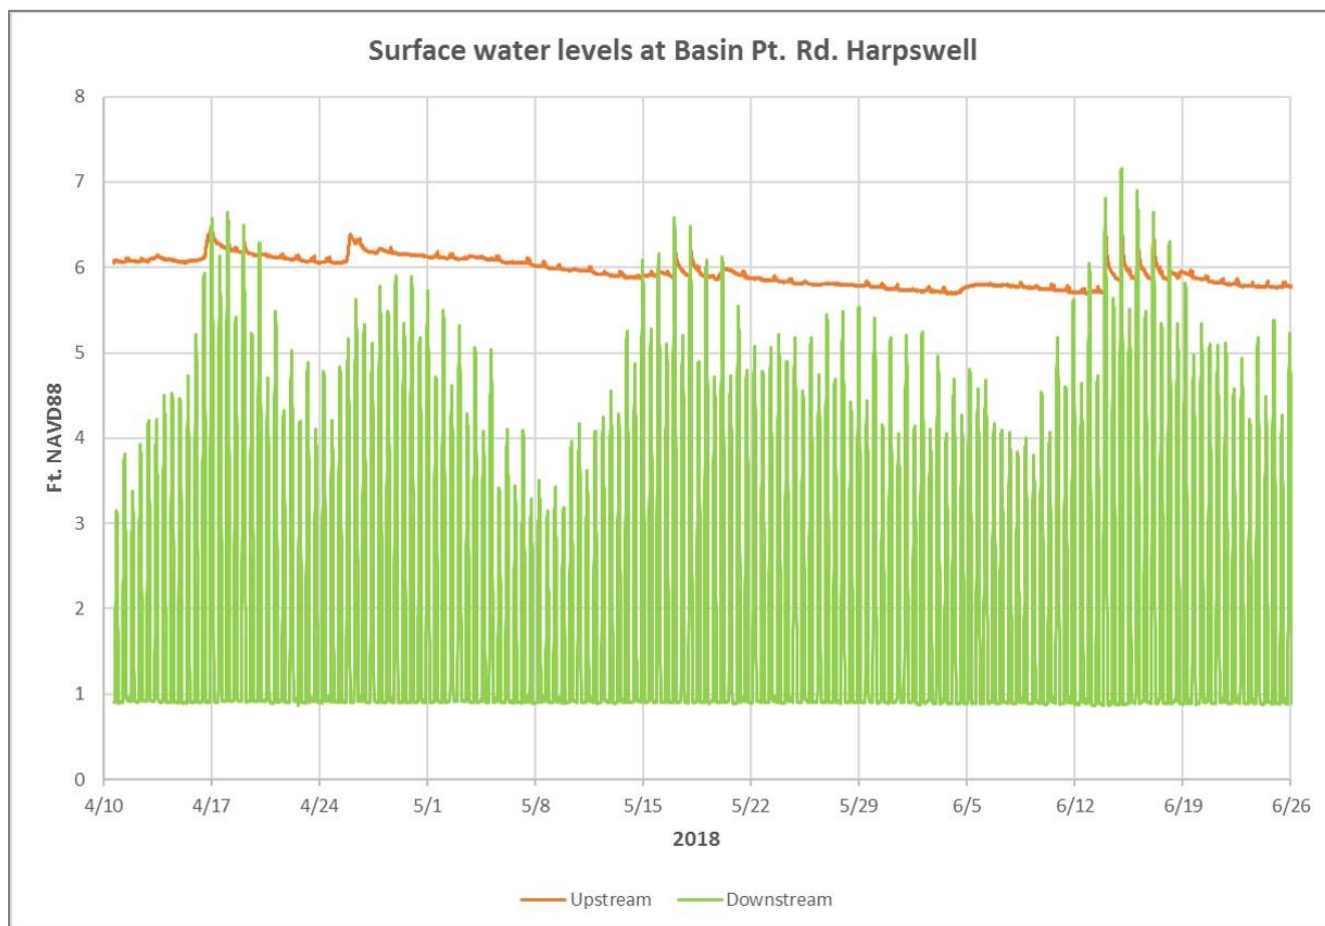
Figure 16. Plotted surface water elevations adjacent to Basin Point Road, April 10 - June 26, 2018.

The data set captured three astronomical high tide phases, in mid-April, mid-May, and mid-June, with neap tide phases in between (Fig. 16). The highest observed water levels for the deployment were recorded in the early

The maximum difference between highest and lowest water levels throughout the data set was 6.24' downstream, and 1.3' upstream. A 1.3" rain event (Portland Jetport, Weather Underground) occurred on 4/25 and is evident in a spike in upstream water levels during the neap tide phase. Tidewater enters the pond only during astronomic high tides. An artificial berm/dam upstream of the culvert inlet sits high in the tidal range and controls water levels in the pond at a minimum of about 5.7', resulting in a total lack of salt-water infiltration to the pond for a month at a time. During neap tides, and concurrent with the transition from spring runoff to drier summer conditions, water levels slowly dropped in the pond over the course of the deployment.

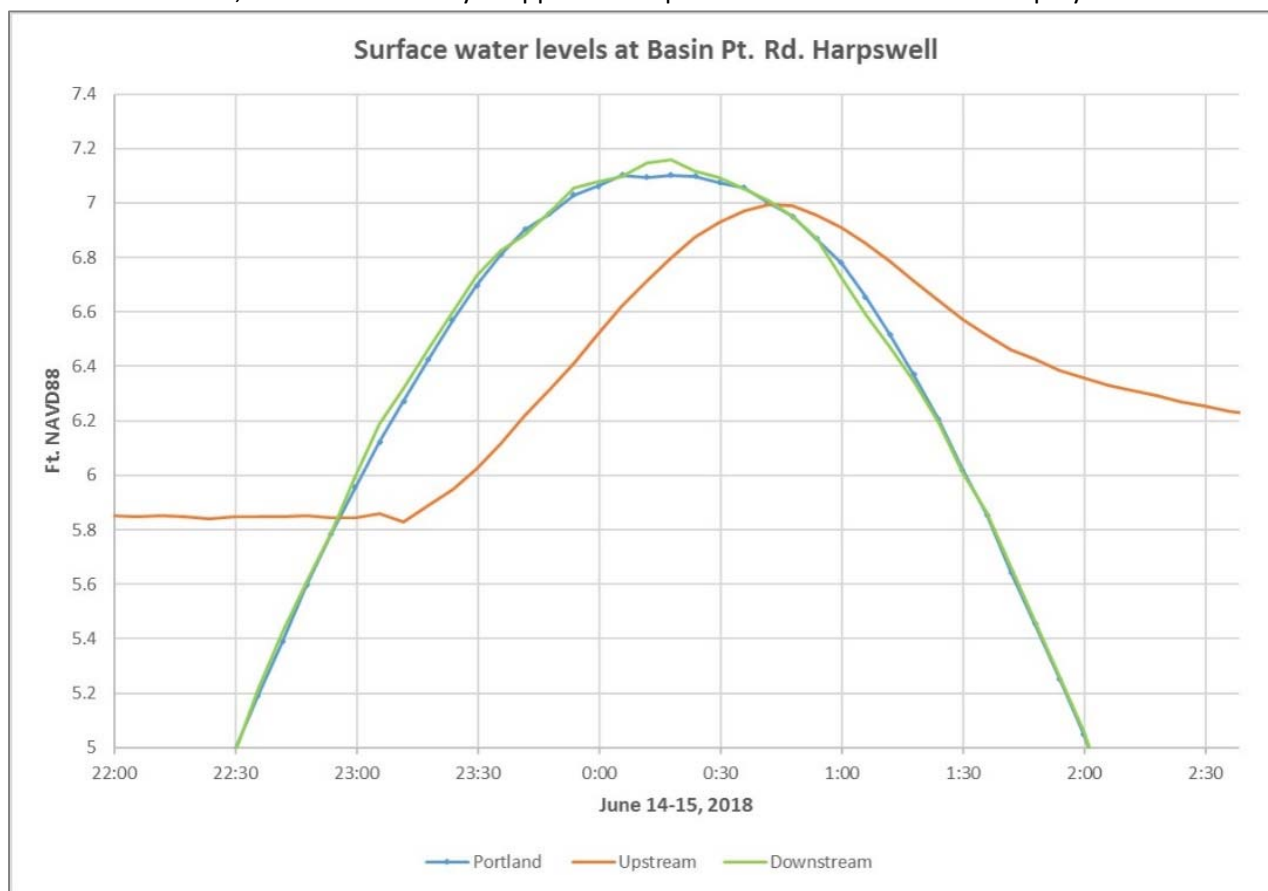
Figure 17. Detail of June 14-15 high tide water levels.

The effect of the culvert and road on tidal exchange is also evident over the course of an individual tide cycle. During upper phase of the June 14-15 high tide event, water levels were nearly identical at the downstream logger and Portland (Fig. 17). Meanwhile, a time lag upstream was evident, with salt water moving through the pipe but delayed in entering the pond due to the earthen dam. The restriction created by the undersized pipe and dam results in a lag of 30 minutes once tide levels reach about 6' NAVD88. The lag continues until the tide turns, and high tide upstream occurs about ½ hour after high tide downstream, while never getting as high. The
