Fishway Assessment and Cost Analysis Report

ROYAL RIVER, YARMOUTH ME

**PREPARED FOR THE NATURE CONSERVANCY
FINAL – JULY 2017, REVISED JANUARY 2018**

**INTER-FLUVE
P.O. BOX 236
DAMARISCOTTA, ME 04543**

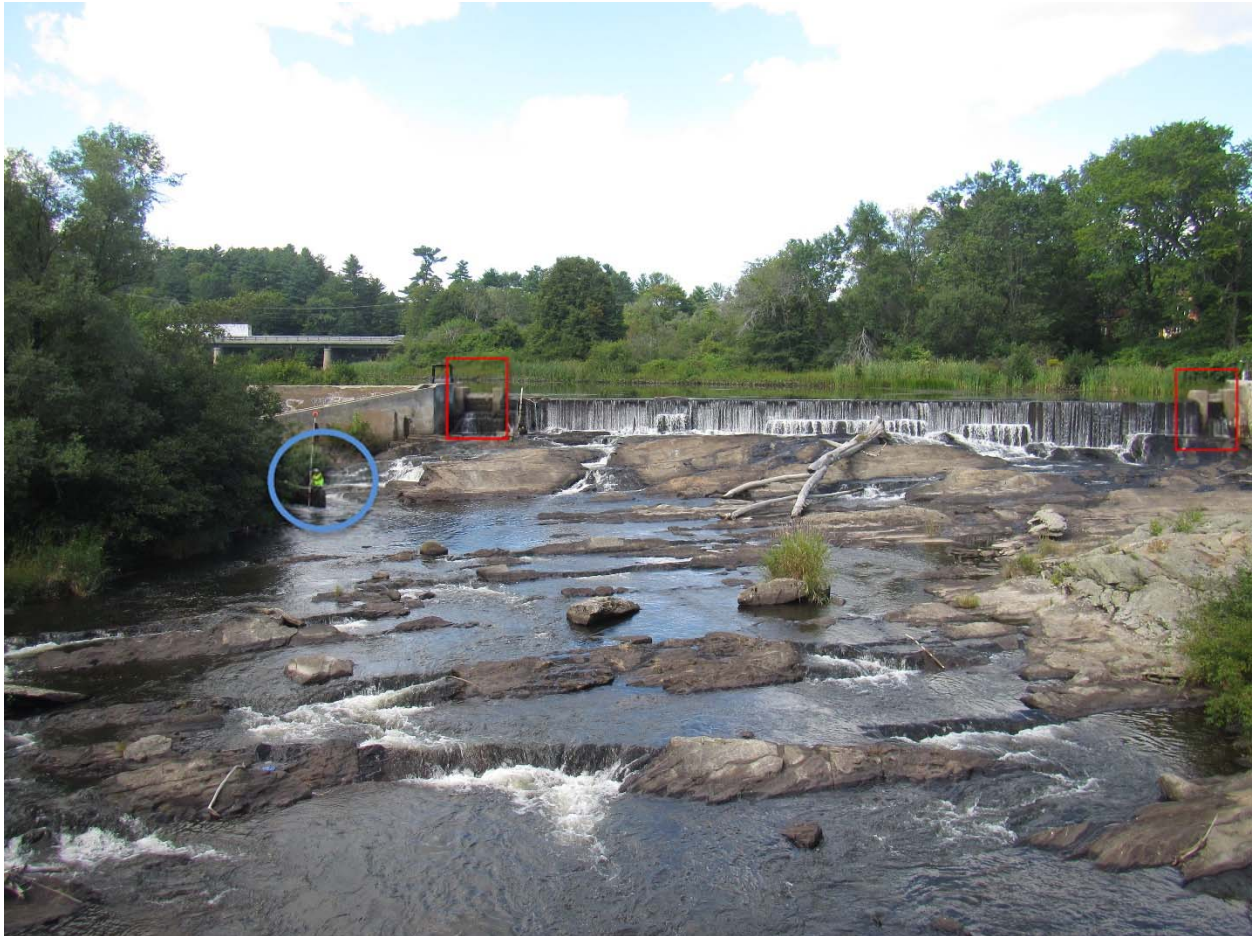
The Bridge Street Dam is a masonry and reinforced concrete gravity-type run-of-river structure that spans the full width of the river at approximately 275 feet, with a 75-foot spillway at its center (Figure 4). It is constructed upon a metamorphic bedrock exposure known as the Second Falls, and lies 250 feet upstream from Bridge Street. Low-flow stop log weirs are built into the 10-foot tall

structure on either side of the spillway. To provide upstream fish passage, a concrete Denil-type fishpass was built in 1974 at the southwest end of the spillway, discussed in more detail later in the report. At the time of the assessment, the majority of flow was running through the partially deployed stop log structure and the Denil fishway, with approximately 0.1 feet of flow over the spillway.

Figure 4: View looking upstream at Bridge Street Dam. Stop log weirs are indicated within the red squares and fishway entrance is indicated with a blue circle. Note surveyor for size. Flow direction is toward viewer.

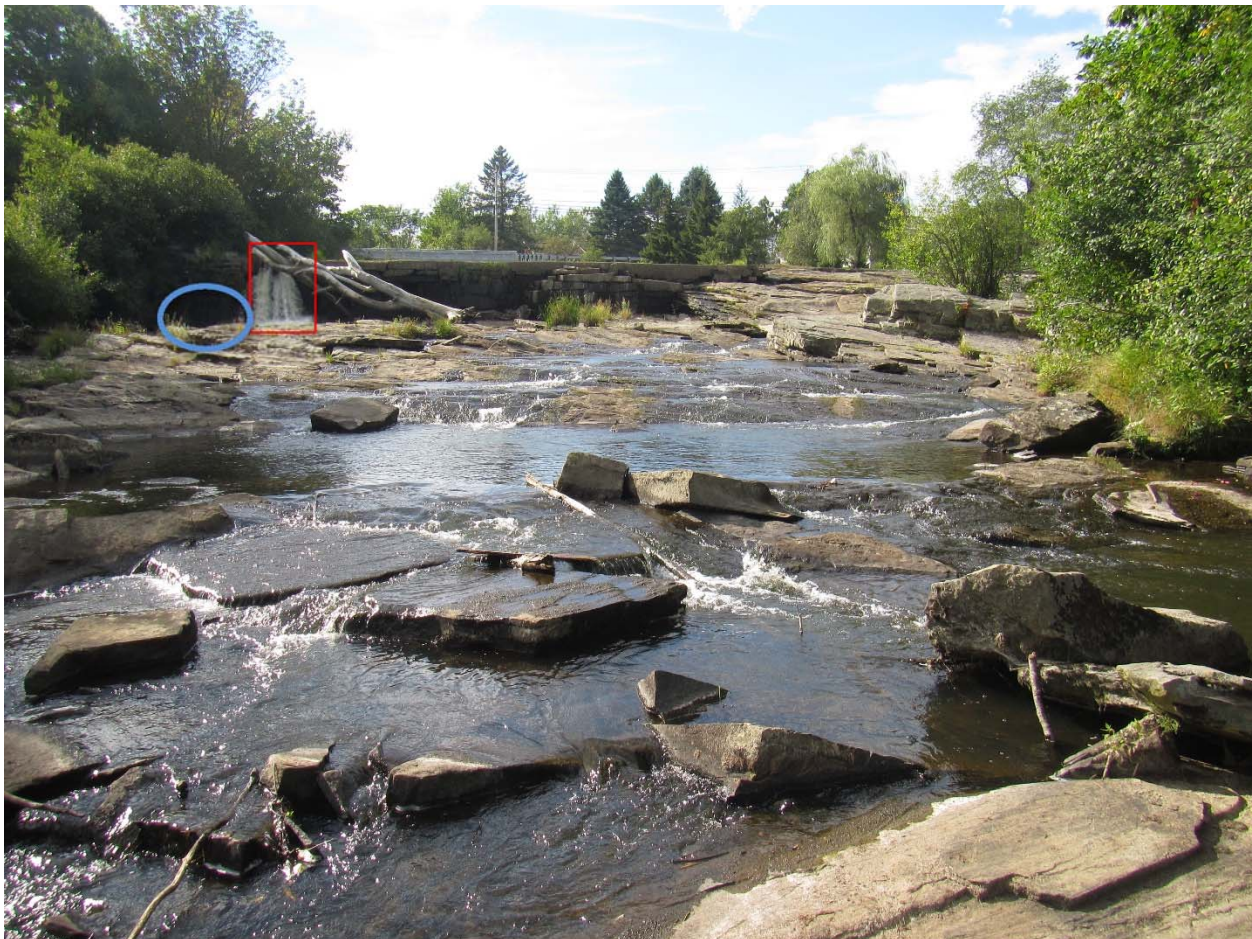
East Elm Street Dam consists of a 250-foot long stone masonry run-of-river gravity type structure approximately 12 feet in height (Figure 5). The full span of the dam functions as a spillway, allowing water to flow downstream onto a metamorphic bedrock exposure. A low-flow stop log weir is built into the structure at the right end of the spillway. To provide fish passage, a concrete Denil-type fishway was built in 1979 at the south end of the dam, discussed further in Section 3. At the time of field assessment, the stop logs were missing and the weir was partially blocked with large woody debris. The spillway was dry, with the majority of flow running through the partially blocked weir.

Figure 5: View looking upstream at East Elm Street Dam. Stop log weir is indicated within the red square and the fishway entrance is indicated with a blue circle. Flow direction is towards viewer.

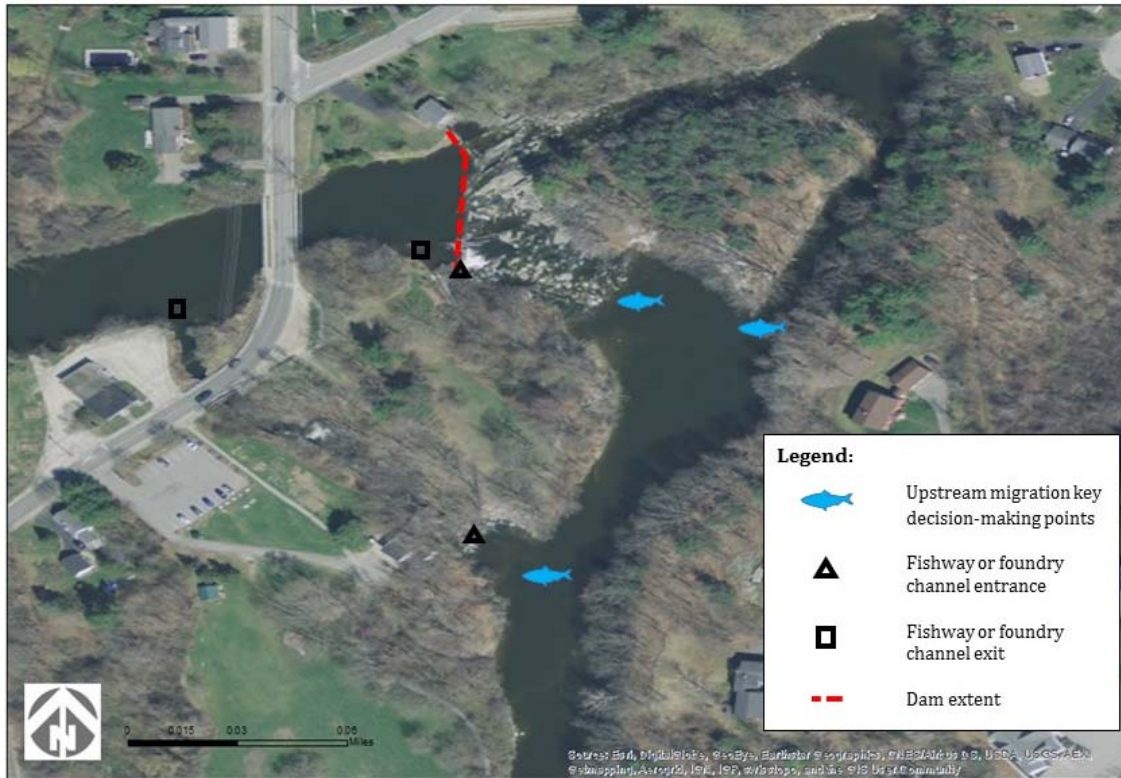
As upstream migrating fish approach the zone of passage, they first encounter the outlet of the foundry channel (Figure 9). Based on review of the aerial photography, the flow out of the foundry channel does not appear to create a substantial attraction cue (Figure 10), although the flow analysis reported in the next section suggests that the channel could convey a substantial proportion of the total flow particularly in the lower half of the fish passage flow range. The foundry channel does not appear to offer a passage pathway at present as the downstream confluence is over a relatively steep confluence fan with minimal depths of flow. In addition, there is a substantial vertical drop greater than 3 feet in height located in the upper 1/3 of the foundry channel where it flows over a former mill foundation or control structure.

Figure 9: Site map of the East Elm Street site indicating key decision points for upstream migrating fish. Date of imagery is March 31, 2012. Flow direction is left to right at top of figure.
