# STROUDWATER RIVER WATERSHED

## SURVEY REPORT

Cumberland County Soil & Water Conservation District

June 2014

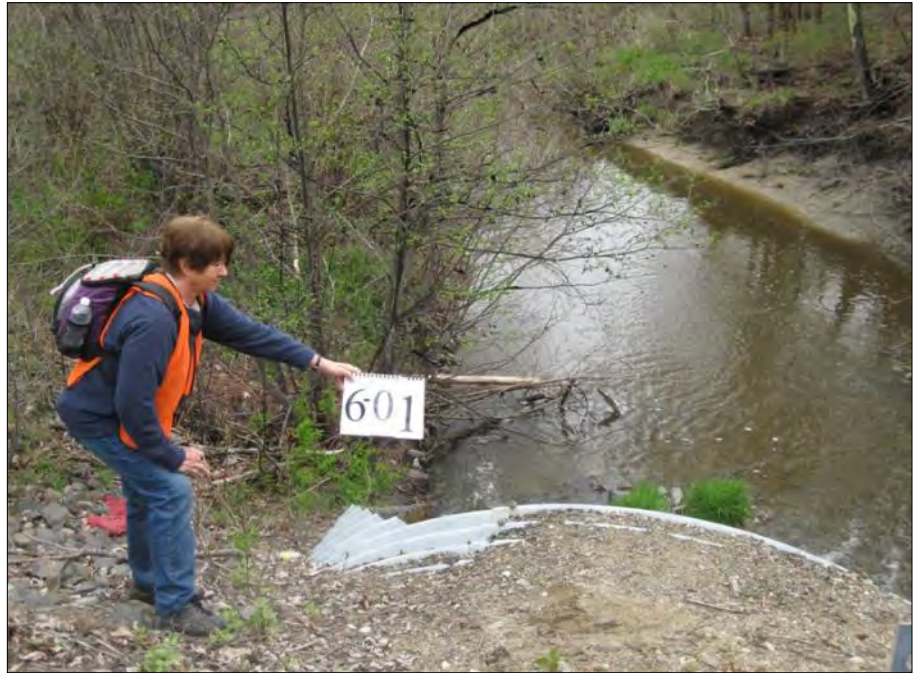
Volunteer documenting erosion around a culvert at a stream crossing.

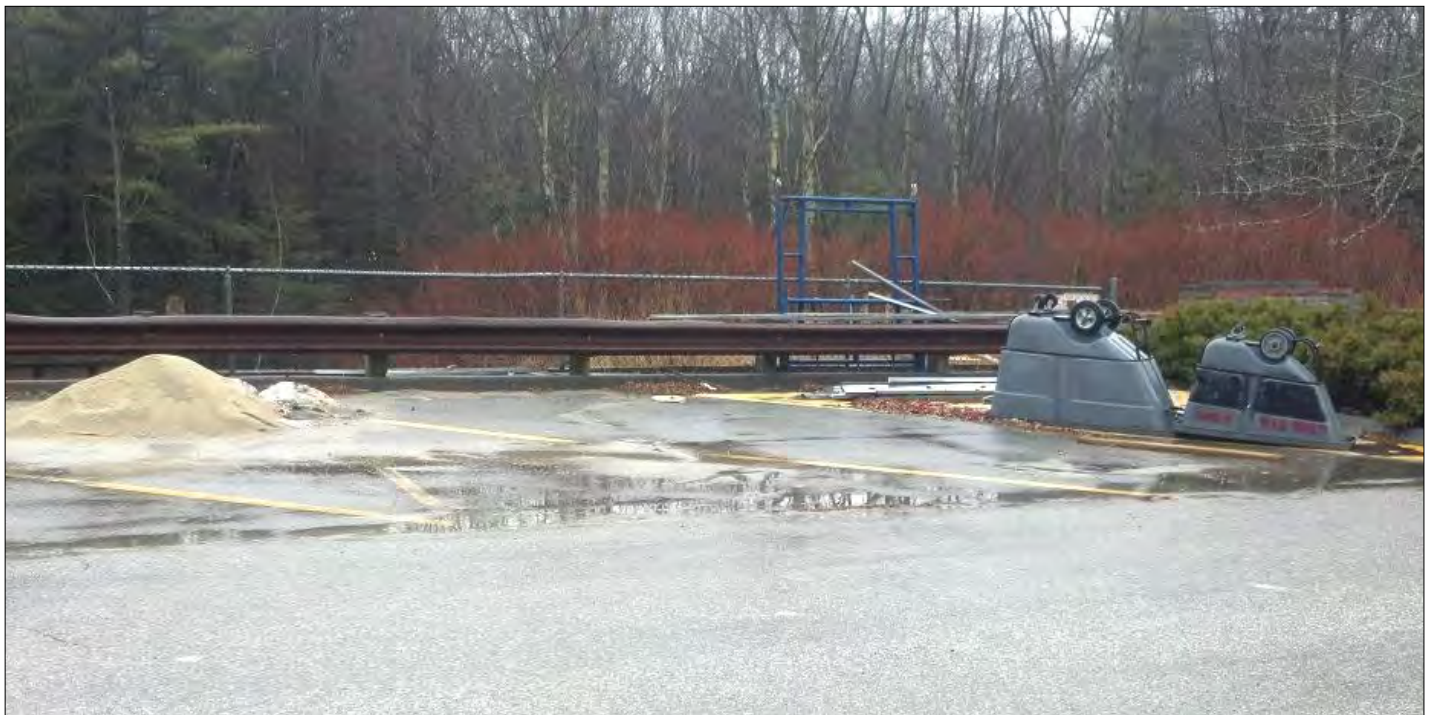
*A sand pile washing into a catch basin in the Stroudwater River watershed may contribute pollutants to the River.*

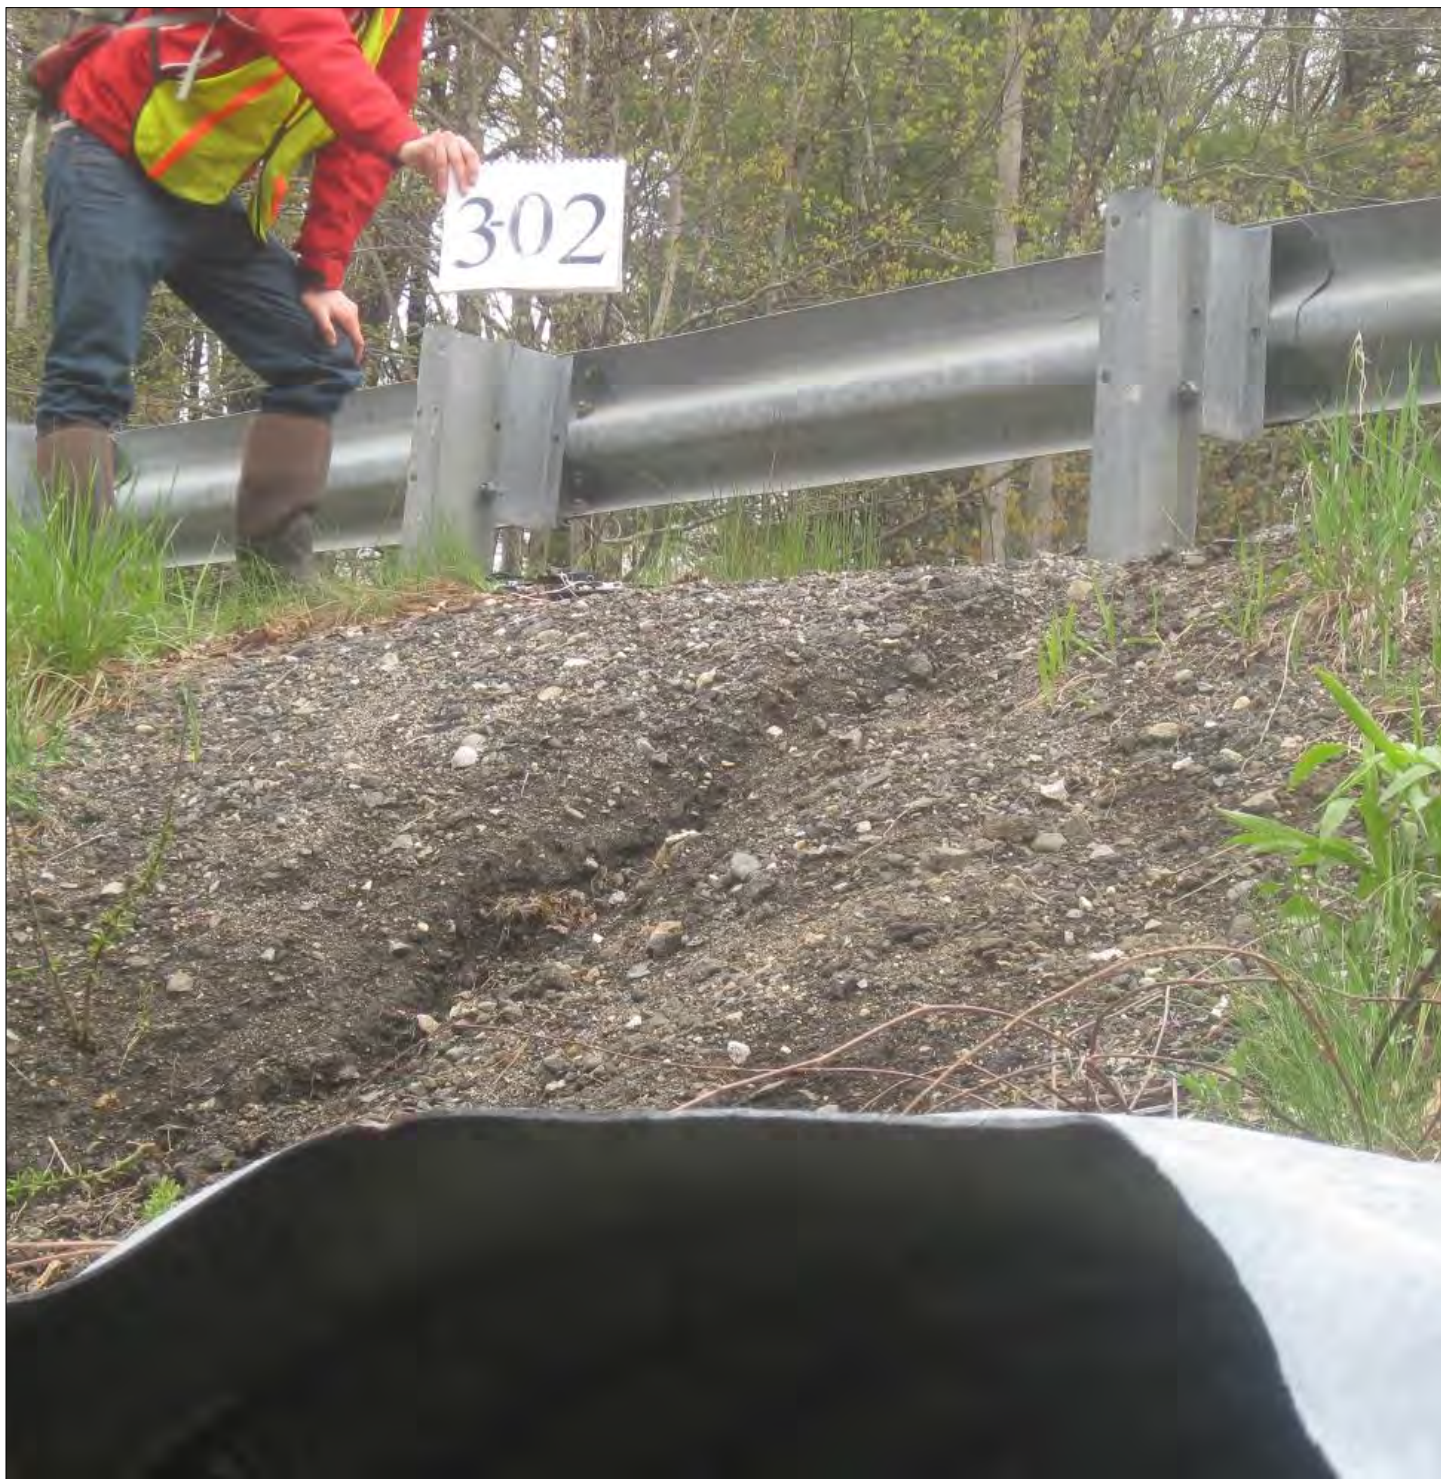
*Road shoulder erosion was commonly identified at sites visited during the shoreland survey.*

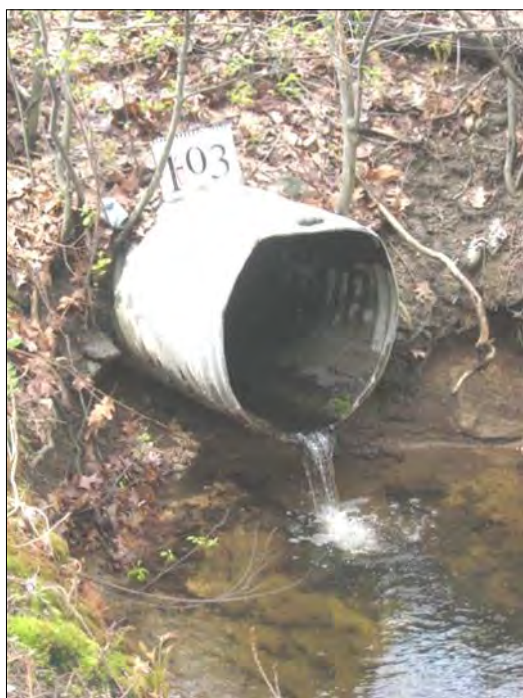
Hanging culvert flowing to Stroudwater River

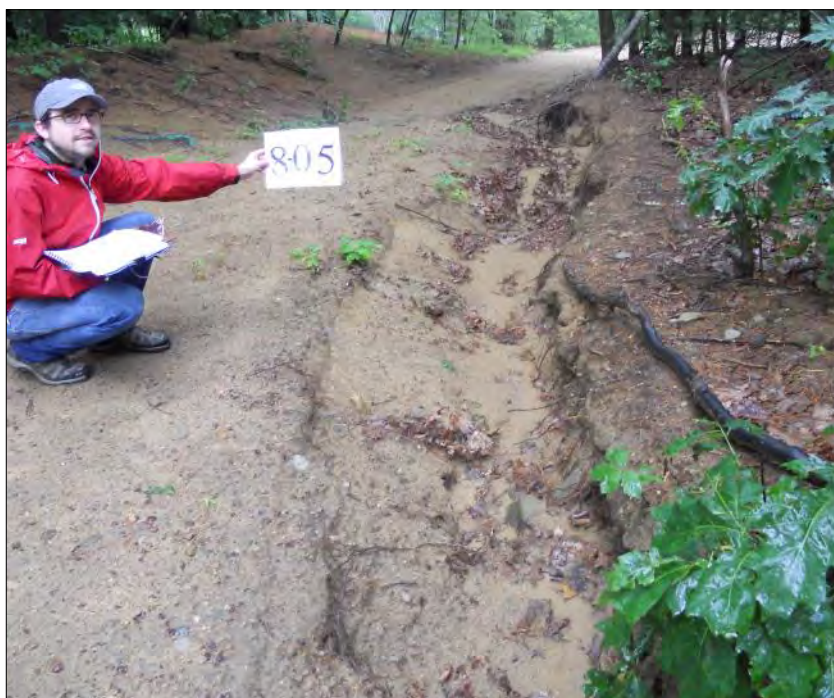
Survey volunteer documents an eroding gully along a gravel pathway

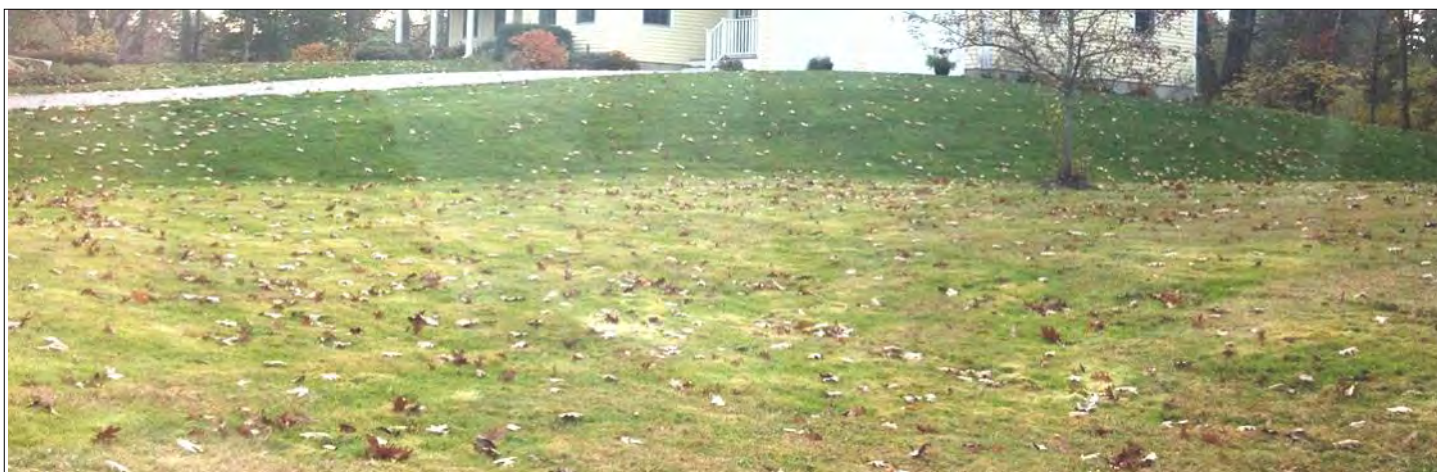
*The very green lawn (background) is likely maintained using fertilizer. Overuse of fertilizer can pollute the River. To prevent overuse, lawns should be fertilized in the fall and only after a soil test has been done.*

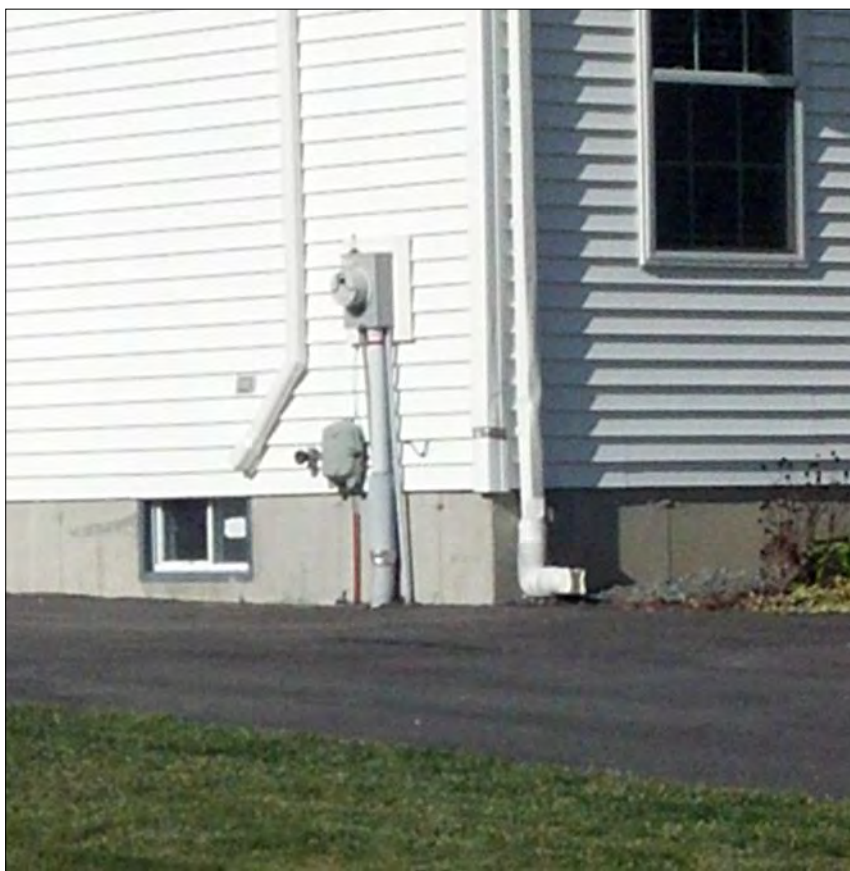
*A gutter downspout empties onto a paved driveway. Downspouts should be directed to vegetated areas so the water can soak into the ground.*
