# **Thompson Lake Watershed Survey - Southern and Northern Sections (Casco, Poland, Oxford, Northern Otisfield, and Norway)**

**Thompson Lake Environmental Association  
Fiddlehead Environmental Consulting  
Maine Department of Environmental  
Protection**

**March 2011**

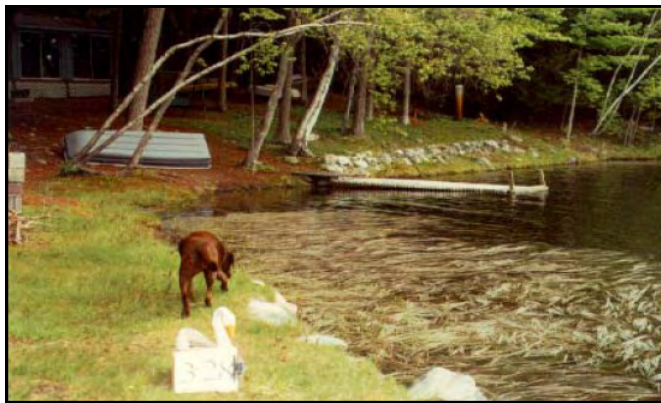
*Several lakeshore properties were observed to have little or no **vegetated buffer** at the water's edge. It is important to note that buffers of shrubs and trees do a much more effective job than bare ground or grass at keeping NPS pollution from entering lakes. Deep shrub and tree roots also help hold the shoreline.*

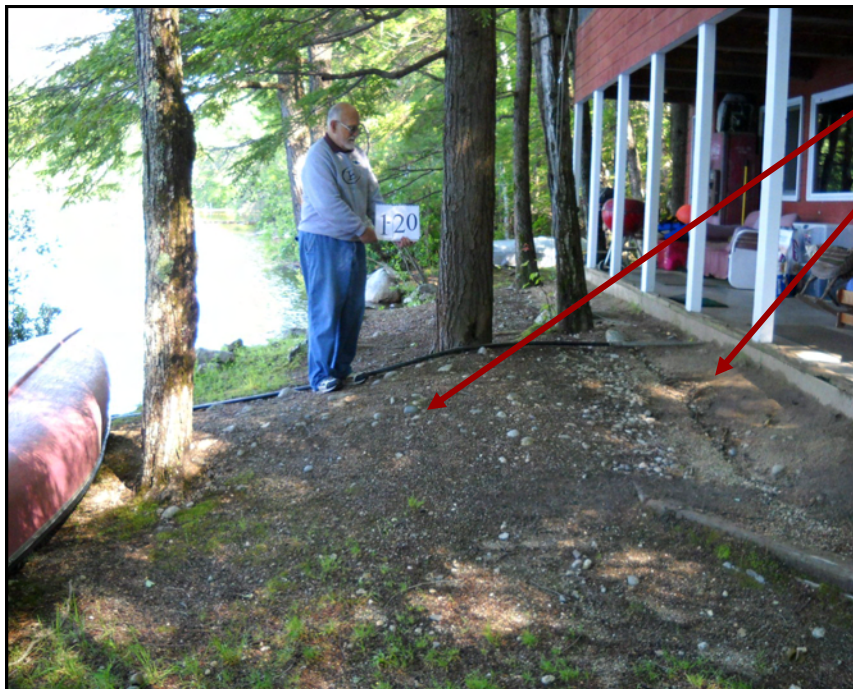
## Problems:

- Bare soil down to lakeshore.
- Roof runoff hits bare soil and carries it to the lake.
- Inadequate vegetation along shoreline.

- Cover bare soil by seeding and haying or apply erosion control mulch.
- Install infiltration trench to catch roof runoff.
- Enhance buffer along shoreline.

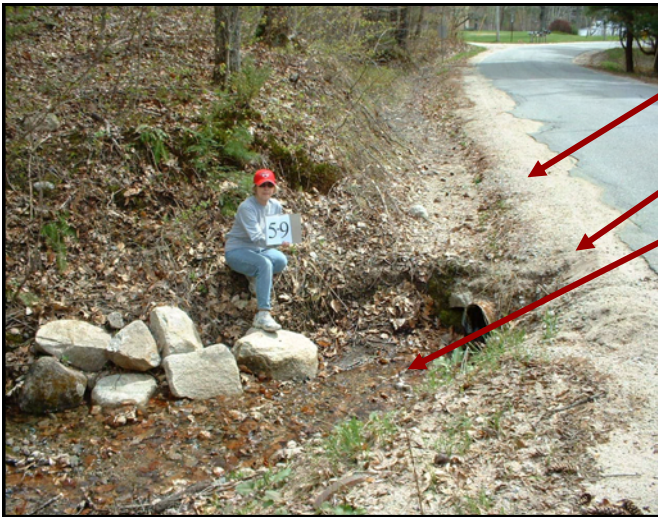
## Problems:

- Winter sand runoff.
- Bare soil in and along ditches.
- Road shoulder erosion.
- Evidence of soil & sediment entering ditch, which flows to Thompson Lake.

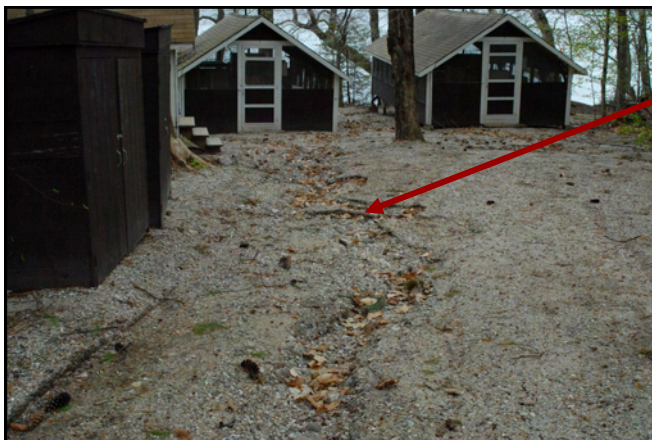
## Problem:

- Heavy foot traffic causes erosion on path that washes soil into Thompson Lake.

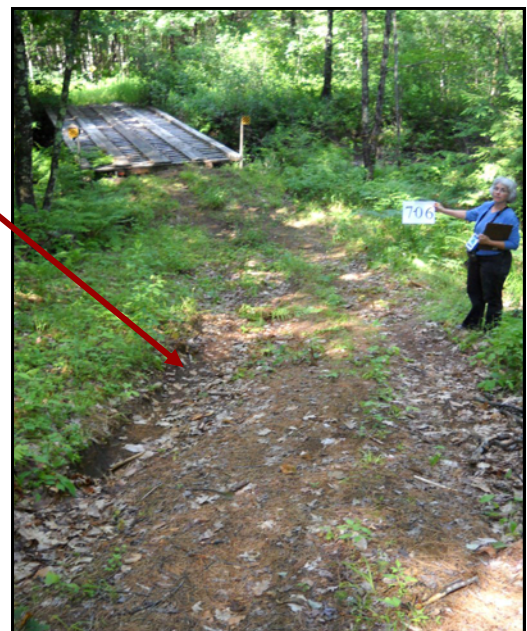
- Poor shaping of snowmobile trail traps runoff in the road which causes erosion.
- Roadside berm prevents runoff from entering buffer.

## Solutions:

- Properly shape (crown) the trail.
- Install a water bar across the trail to divert runoff into the woods.

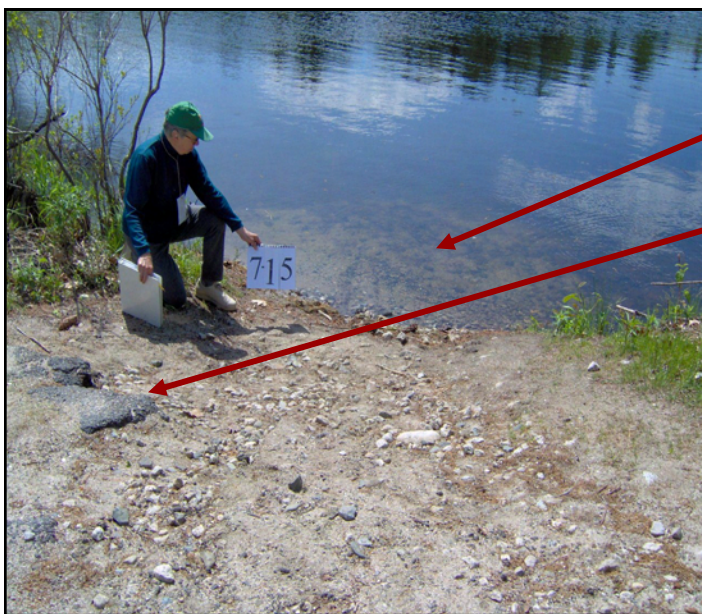
## Problems:

- Direct flow of sediment into the Heath.
- Severe surface erosion.
- Asphalt road shoulder is chipping.

- Install infiltration steps for hand-carry boat launch.
- Stabilize road shoulder.
- Enhance buffer at sides of boat launch.
