# Tidal Restriction Restoration at Wallace Shore Road

## 2015 Monitoring Report: Year 1 of 5, Post-Construction

Submitted: March 1, 2016

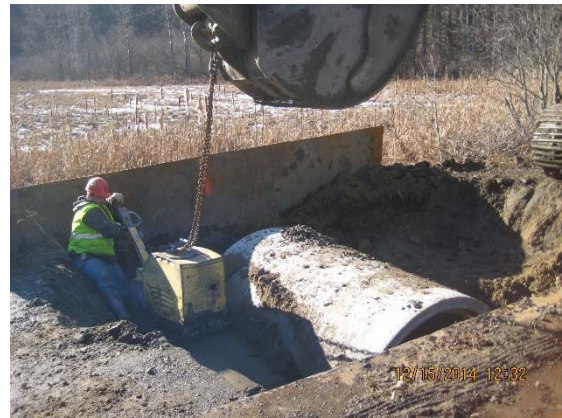
*Figure 1. Installation of open bottom concrete box culvert at the lower site (9079, left) and embedded concrete round pipe at the upper site (9078, right).*

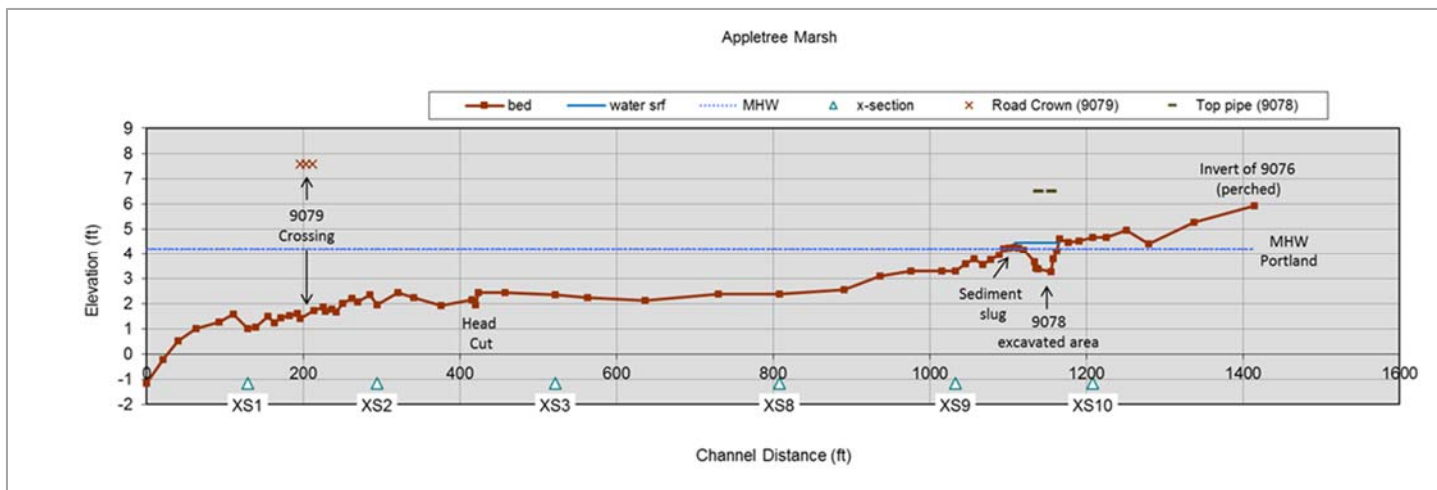
Figure 18. Post-project longitudinal profile of the tidal creek (2015). Mecklenburg 2006.

The channel bottom at 9079 is consistent with the channel grade upstream and downstream, and the accumulated sediment upstream is no longer evident. A series of shallow pools remains immediately downstream of 9079, and has formed immediately upstream in response to gradual movement of sediment. A small head cut was observed a little more than 400' upstream from the bay, with the channel bottom relatively flat until getting shallower between Station 8 and 9. The channel bottom at 800' (Fig. 18) has dropped by approximately 1' from the 2012 survey (50', Fig. 17). Further upstream, the channel becomes extremely shallow approaching 9078, where the slug of coarse-grained sediments (evident in both Fig. 17 and 18) sits on the marsh surface, resulting in a very shallow braided channel below the outlet of 9078. The sand is believed to have been deposited in this location during a culvert blow-out prior to any discussions about a restoration project. Local residents described a portion of the road bed washing onto the downstream marsh along with the culvert. Immediately upstream of the slug, and immediately downstream of the culvert outlet, is the area excavated during culvert installation. Here, water is pooled behind this grade control through the culvert into the excavated area upstream, above which a defined channel is no longer visible. This issue is discussed further in Section 4.2.

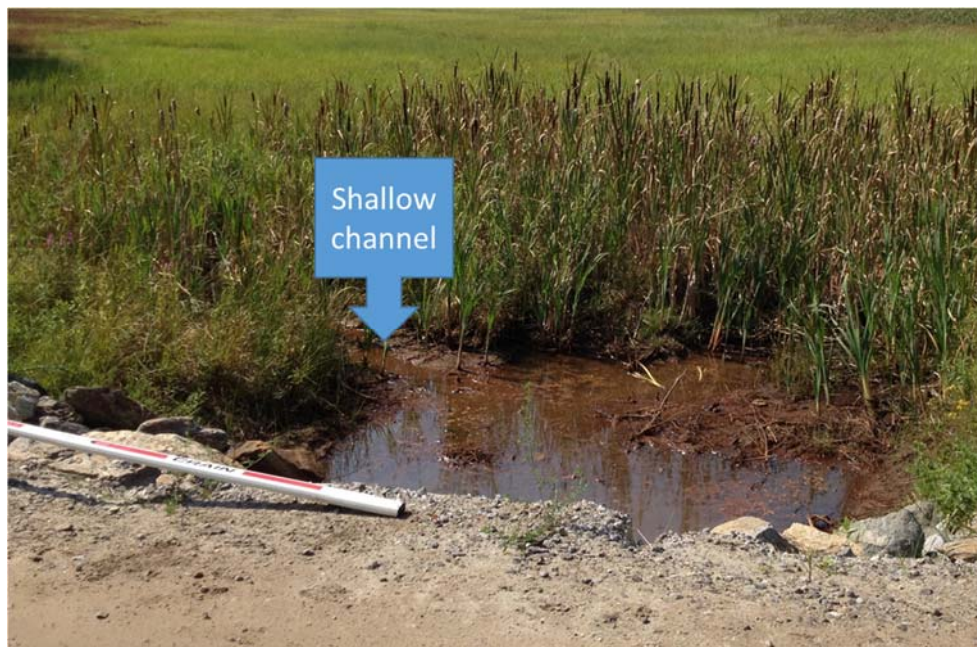
None.	Over the course of several visits, CBEP observed that water is now pooling in the excavated channel outlet of crossing 9078 due to a lack of channel development/scour. Probing suggests that coarse grained sediments are present on the marsh surface and are not mobilizing due to a lack of velocity/volume. Anecdotes from abutters confirms that several years ago the culvert blew out at this location, washing road fill onto the downstream marsh.	No action was taken during the monitoring period. See Section 4.2, Recommendations for Adaptive Management.

As noted in Section 3.4, and described further in Section 3.10 (and illustrated in the 2015 longitudinal profile in Fig. 18), over the course of several monitoring visits, CBEP observed that surface water is pooling in the excavated channel outlet of crossing 9078 due to a lack of channel development/scour. Water flowing into the excavated area from upstream (north side of culvert) is impounded at the edge of the area excavated during installation, and backs up through the pipe into the excavated area upstream of the inlet, creating a standing pool of water that discharges in a braided network of channels before it reaches the downstream channel. Closer examination revealed that a sediment slug from a historic culvert failure is controlling the grade just downstream of the 9078 outlet. This may be maintaining water levels that allow for persistence of glycophytic species and slow the process of conversion to brackish and halophytic communities at Station 10. The issue is most obvious during low flow conditions that co-occur with a neap tide phase when the flow out of this pool becomes a trickle (Fig. 22). Shallow exploratory probing of the channel suggests that coarse-grained sediments are present on the marsh surface along the edge of the excavated area, and are not mobilizing, presumably due to a lack of velocity/volume combined with volume of sediments present. As previously mentioned, anecdotes from abutters confirm that several years ago (preceding the project), the culvert blew out at this location, washing road fill onto the downstream marsh. The pool, and the sediment slug, may be contributing to the presence of cattails immediately downstream (Fig. 22).

*Figure 22. Pooled water at the outlet of crossing 9078 (2015).*

2. Remove sediments from the channel. Use hand tools (shovel, hoe) to carefully hand dig coarse-grained sand out of the narrow channel without damaging adjacent vegetation, and transport sediments offsite using a few five gallon buckets. Prior to implementation, additional sediment probes in the channel could be used to determine the extent and depth of coarse grained road fill in the channel. A simple plan could be drawn up in advance to determine channel elevations and width, based on the 2015 longitudinal profile, and survey equipment would be used to check elevations during field implementation. Implementation could be conducted in the summer of 2016. No cost is anticipated with this approach, which could be completed by two people in a couple hours. This is the preferred approach and is recommended out of the three options presented, provided that no additional permitting and approvals is required.

3. Remove sediments from the marsh and channel. Another approach would be to bring heavy equipment back to the site to excavate sediments from both the marsh surface and the channel. The purpose would be to not only improve flow out of the excavated area, and relieve the impoundment, but also to lower marsh surface elevations. A detailed topographic survey downstream of the 9078 outlet may be warranted, as well as a more expansive survey of sediments, to determine the extent and depth of coarse grain sediments downstream of 9078. Simple drawings may be warranted to guide excavation of sediments working with large equipment (presumably, a back hoe or excavator and a dump truck). This option is least preferred. Although this approach could realize additional benefits by removing fill from the marsh surface, use of an heavy equipment brings an inherent risk of doing more harm than good (damage to vegetation, digging out a larger or deeper channel than is suitable, etc.). For this reason, the approach is not recommended. Work could be conducted in late summer/early fall 2016 if funding was obtained, and permits were secured if necessary, but these are unknown considerations at this time.
