Mill Brook

Stream Habitat Walk

Cumberland County, Maine
May 31, 2003

Report Date: September 18, 2003
Prepared by the Maine Stream Team Program

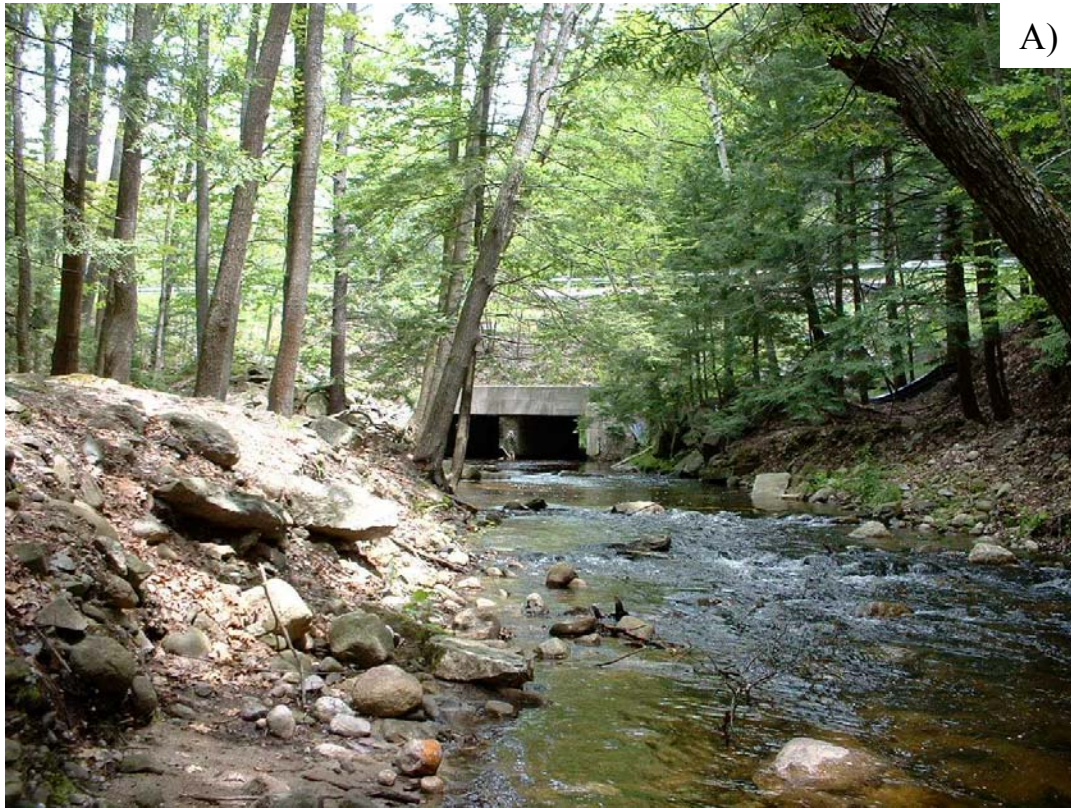
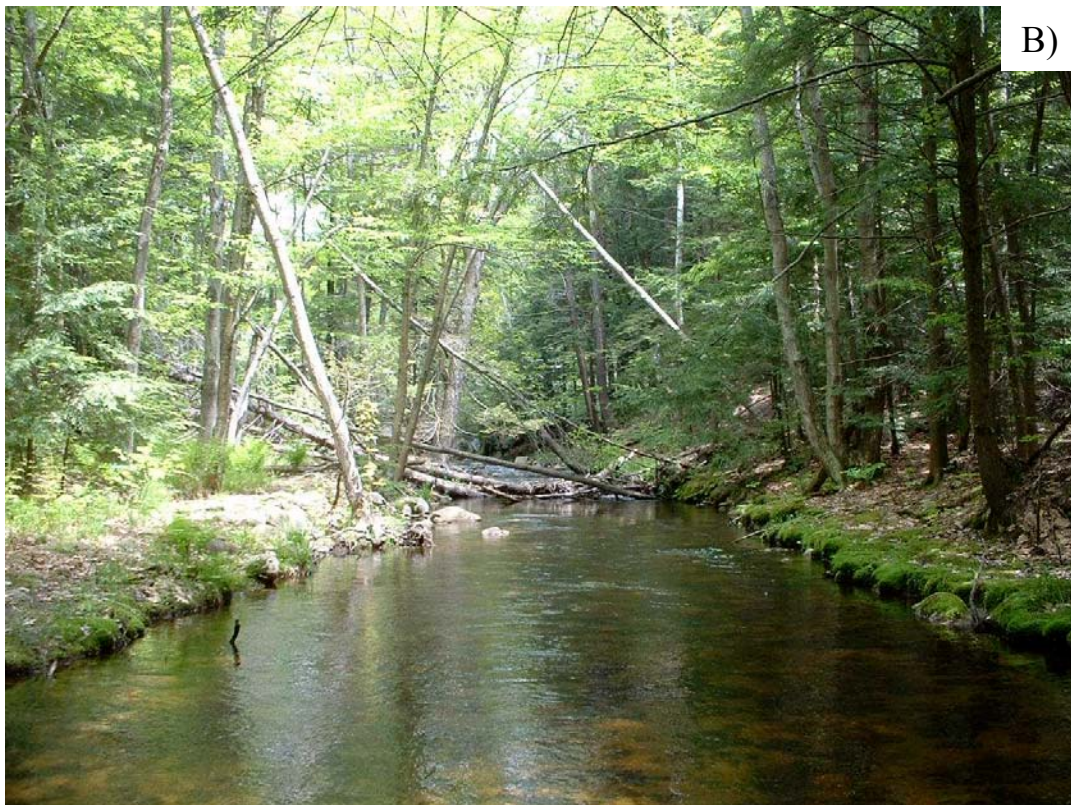
Site 1 photographs: A) the Route 302 bridge over Mill Brook and a riffle; and B) a run plus a woody debris dam.

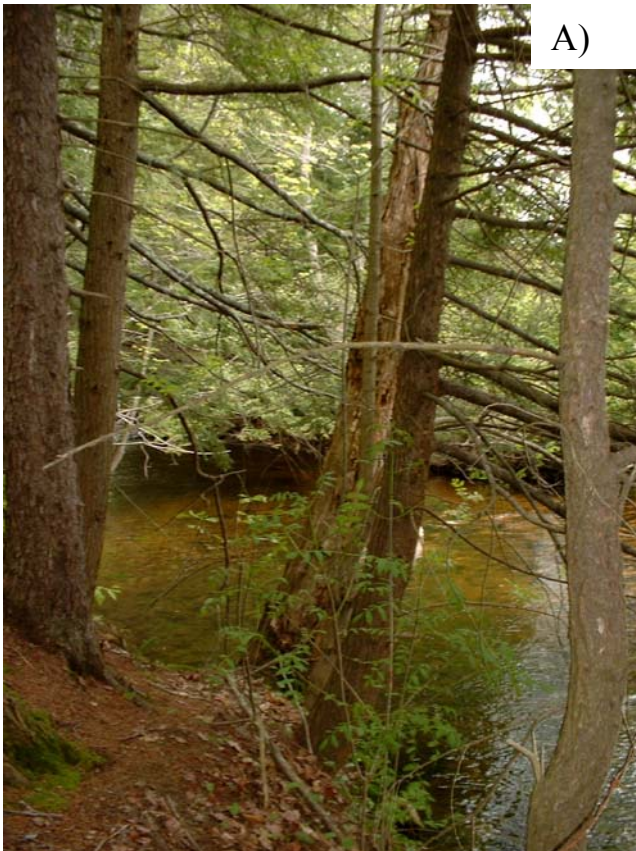
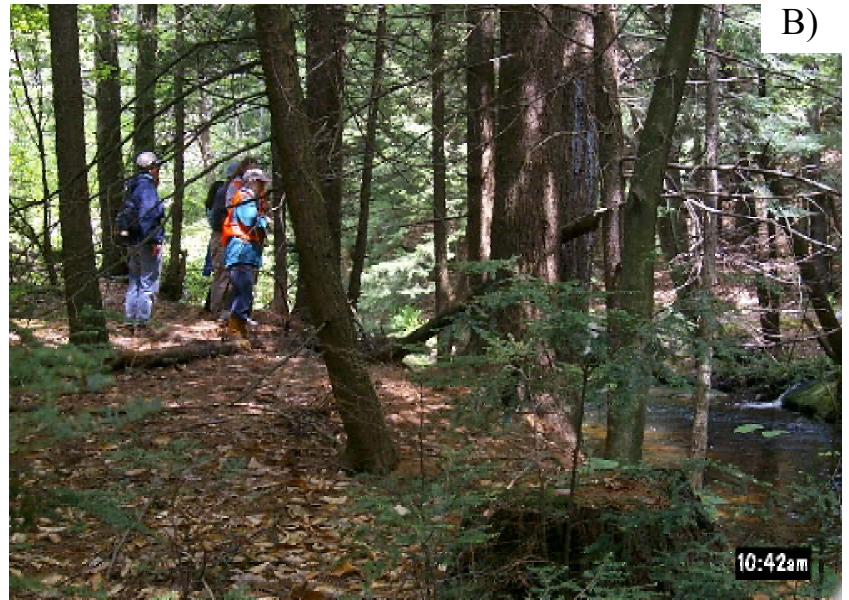
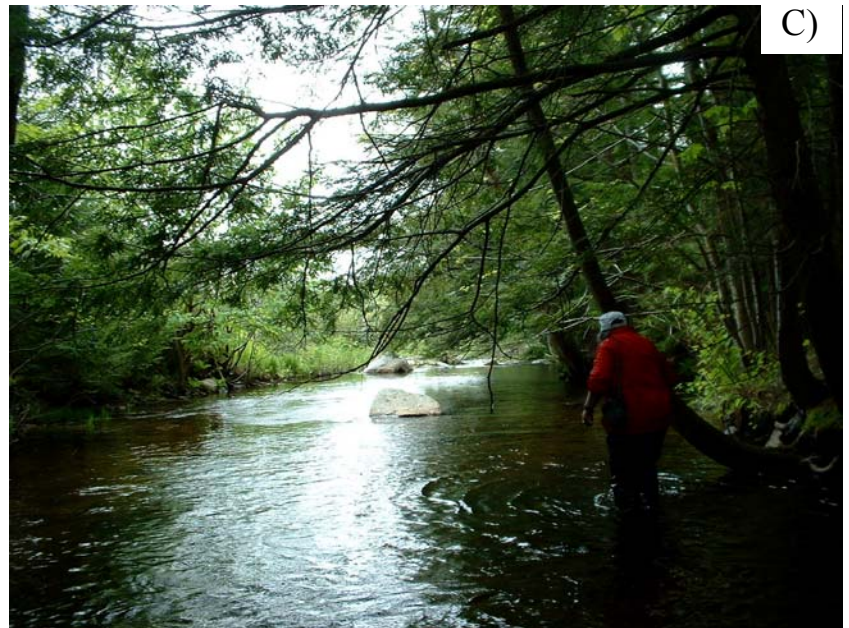
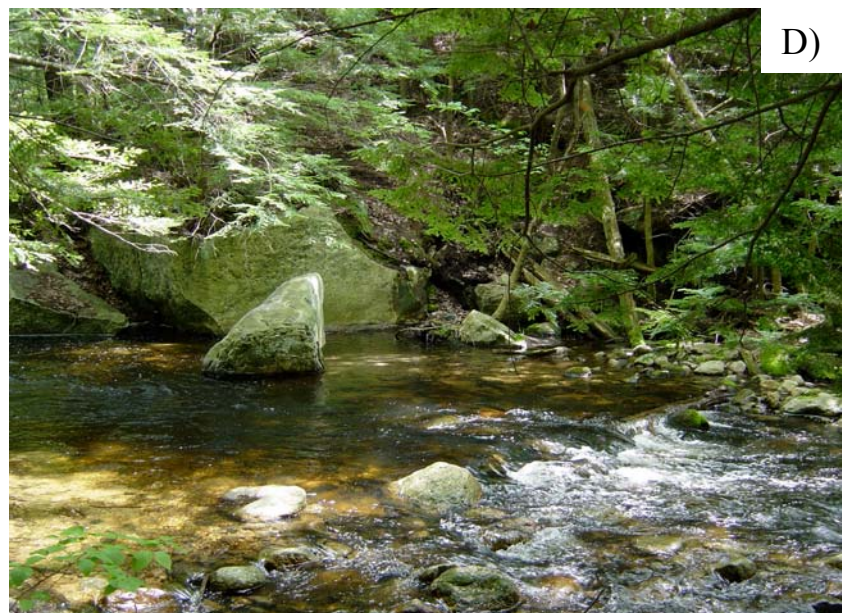
Site 3 photographs: A-B) view of stream through forested banks (note the J-shaped trees - they suggest that bank erosion rates may be relatively slow in the local area; C) a shaded pool.; and D) a riffle.

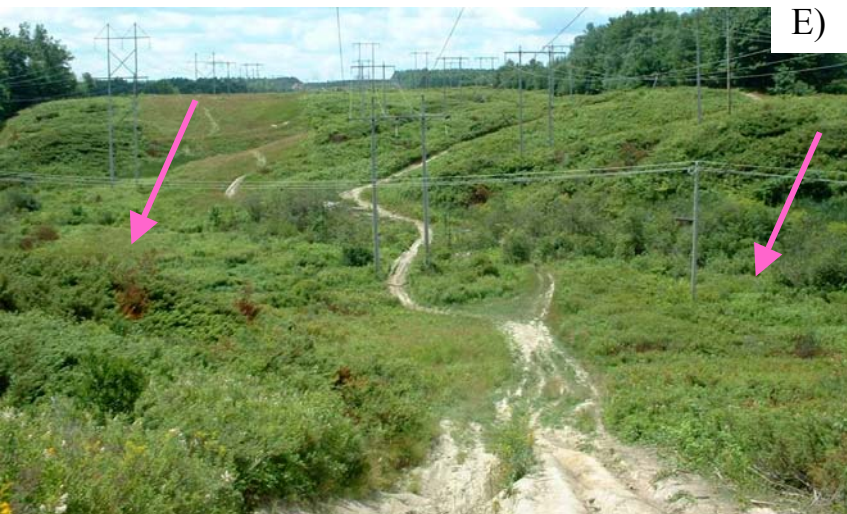
Site 4 photographs: A) recent riparian cutting along brook in powerline area; B) typical vegetation included bushes less than 10' in height such as young alders; C) *Elodea* sp. (American waterweed) found on July 14th (*Elodea* is an aquatic plant that is native to Maine, unlike Eurasian and variable water milfoil, both of which are exotic/invasive plants); D) Mill Brook in the powerline area, where shade is sparse; and E) looking downhill at the powerline area (the arrows point to where the brook is located; the stream is flowing right to left) (this photo was taken on 7/25/03).

Site 4) This area has been heavily disturbed by powerline-area clearing and associated ATV trail use. There is a high potential for erosion and sedimentation, as well as stream shading/temperature, problems here.

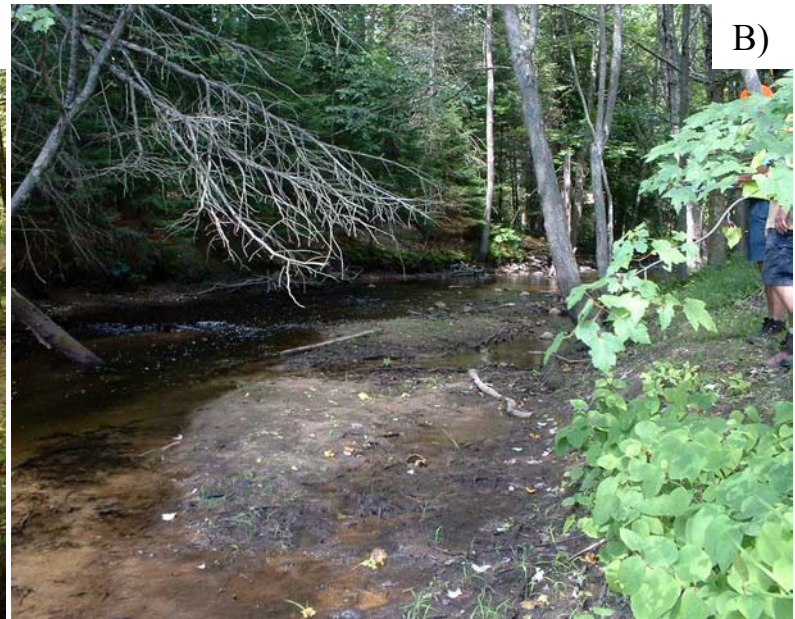
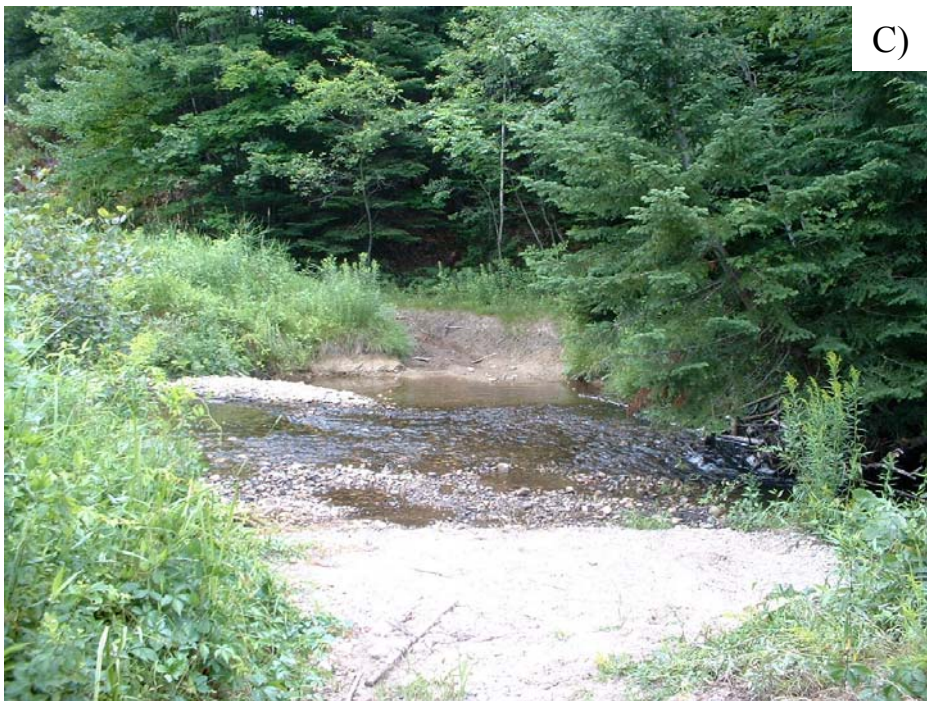
Site 4-B* photographs: A-B) signs of aggradation (that is, sediment accumulation or bar formation) in the middle of Mill Brook's channel and C-D) local ATV trail impacts. *These photos were taken on July 25, 2003, on a reconnaissance walk of this area.

Site 4-B) This site only was only subjected to a reconnaissance walk. However, this rapid survey discovered that sedimentation appears to be a problem, which is likely due to ATV trail use, upstream sources of erosion, as well as possibly a nearby gravel pit (although sediment settling basins are present here).

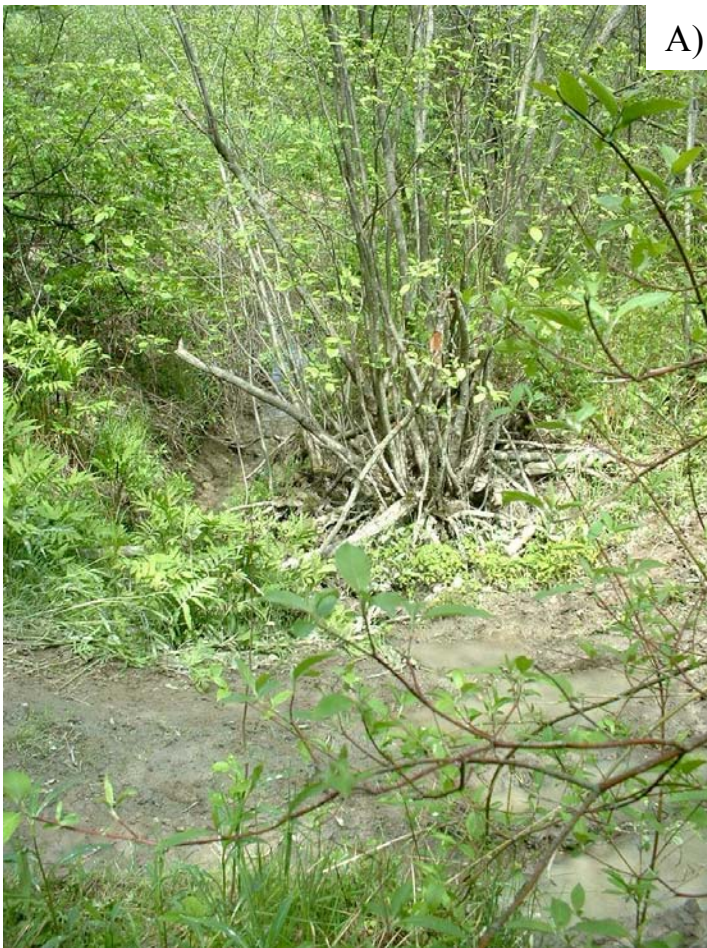
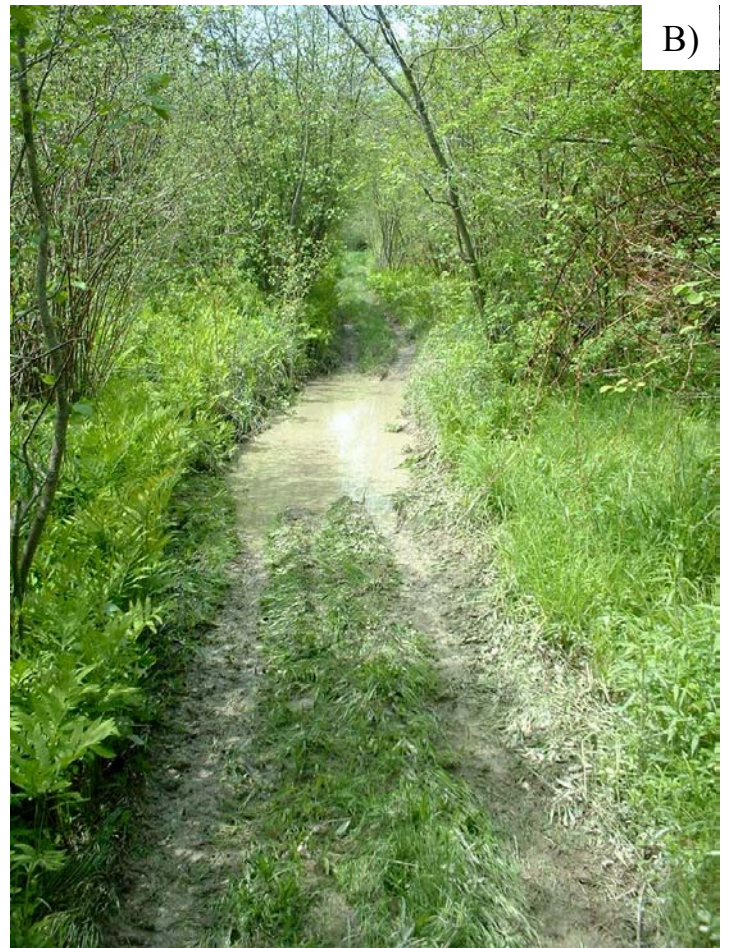
Photographs collected near and between Sites 5 & 6: A-C) muddy ATV trails located a few feet away from Mill Brook. The brook is fairly hidden behind some trees and shrubs in the upper-central location of photo A. Also note the drainage off of the ATV trail into the brook in this photo.

Sites 5 & 6) Major concerns: Sediment pollution from badly eroding ATV trails, thermal stress from a general lack of many mature, tall trees in the riparian zone, and potential sewer line leaks.

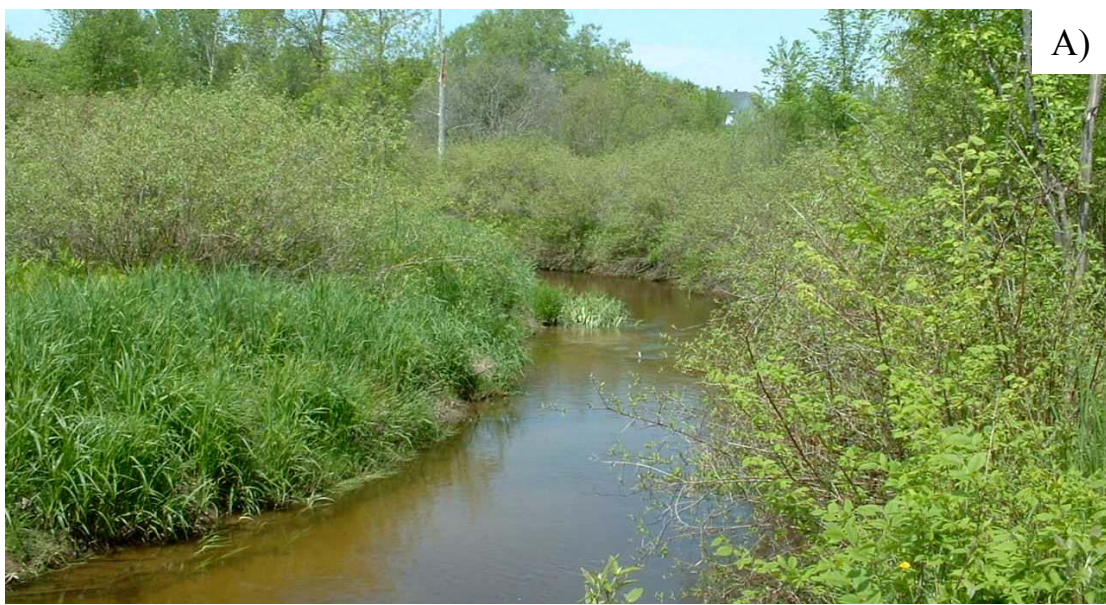
Site 6 photographs: A-C) meandering, low gradient, silty-sandy-bottomed stream; and D) a manhole above a sewer line and an ATV trail near Mill Brook. Photo C was taken on 5/20/03 and it is situated just upstream of Bridge Street.

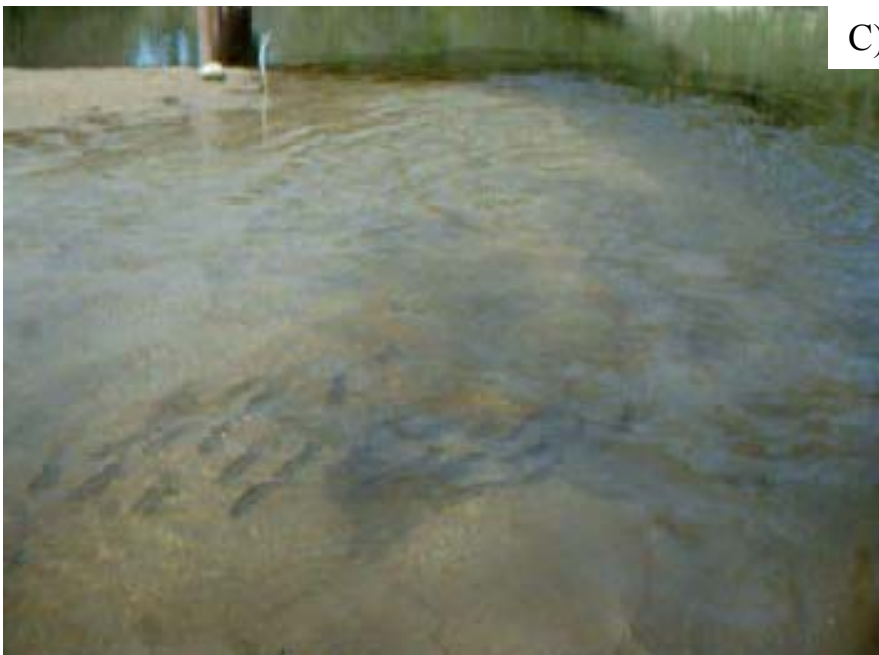
Photographs taken near where Mill Brook drains into the Presumpscot River: A) sandy banks; and B-C) alewives entering Mill Brook.
