# Casco Bay Stream Barrier Surveys

Alex Abbott  
U.S. Fish and Wildlife Service  
Gulf of Maine Coastal Program

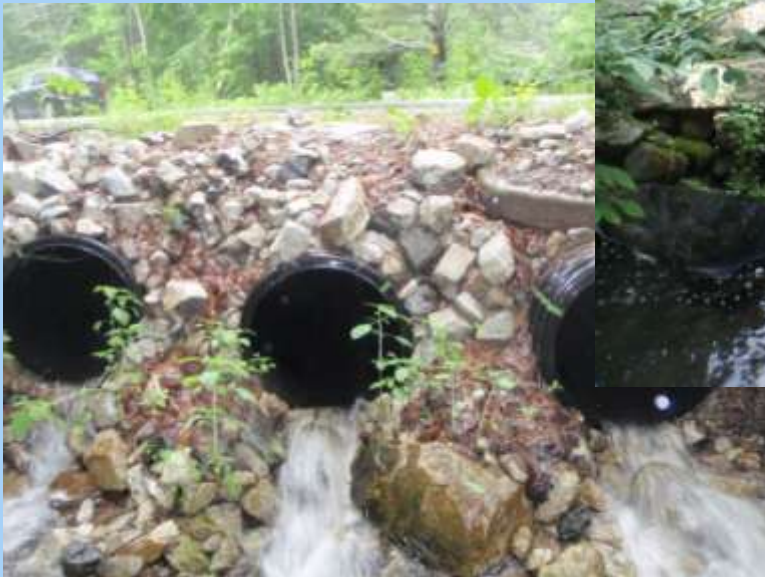
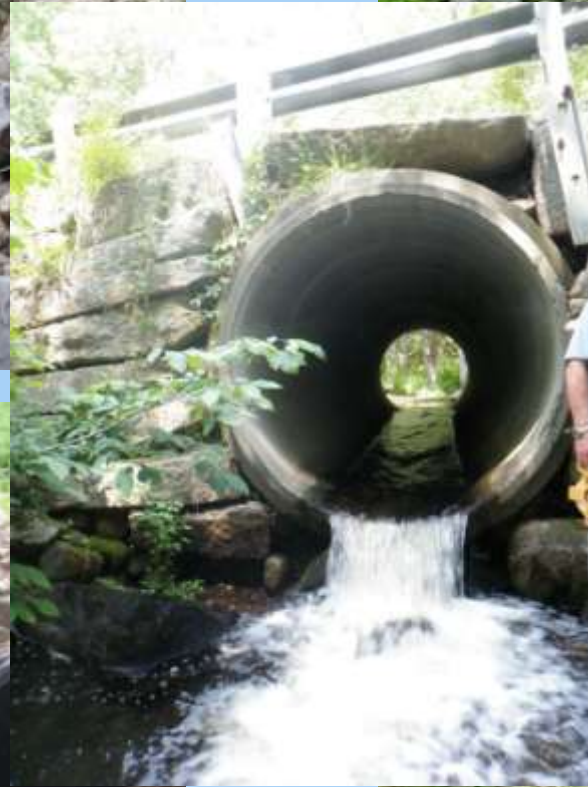
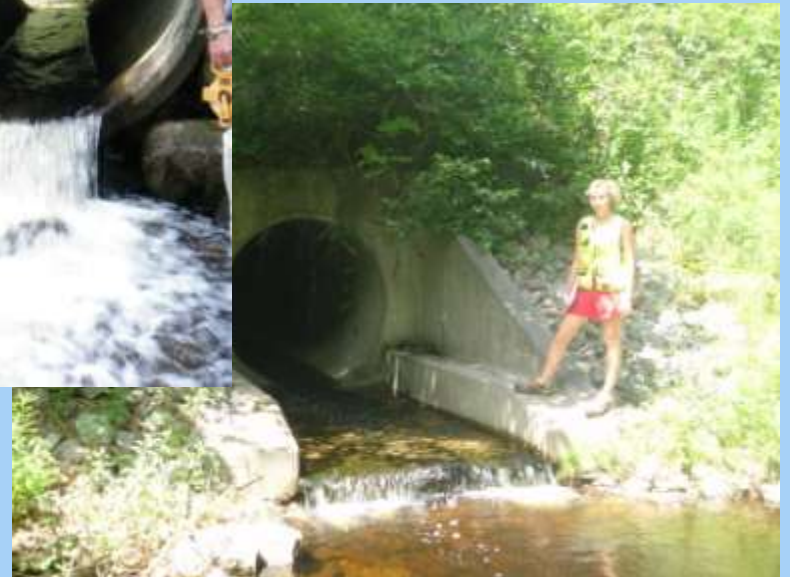
# 182 Perched Outlets

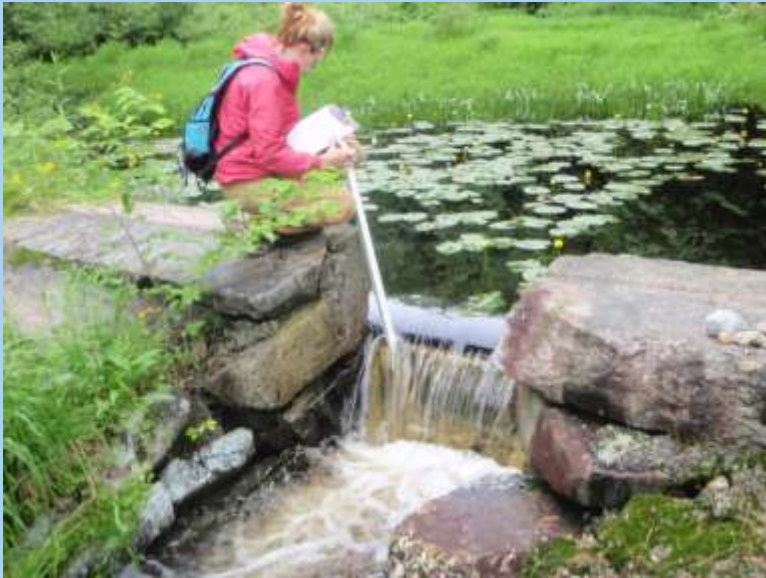
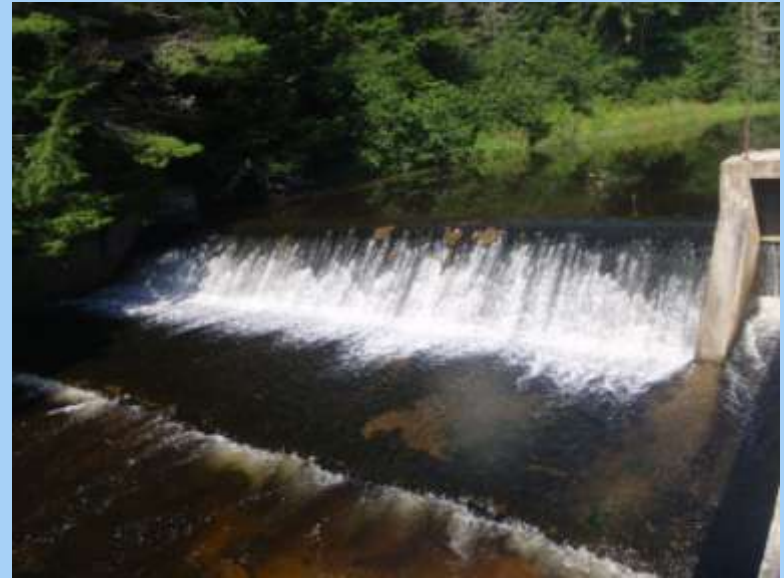
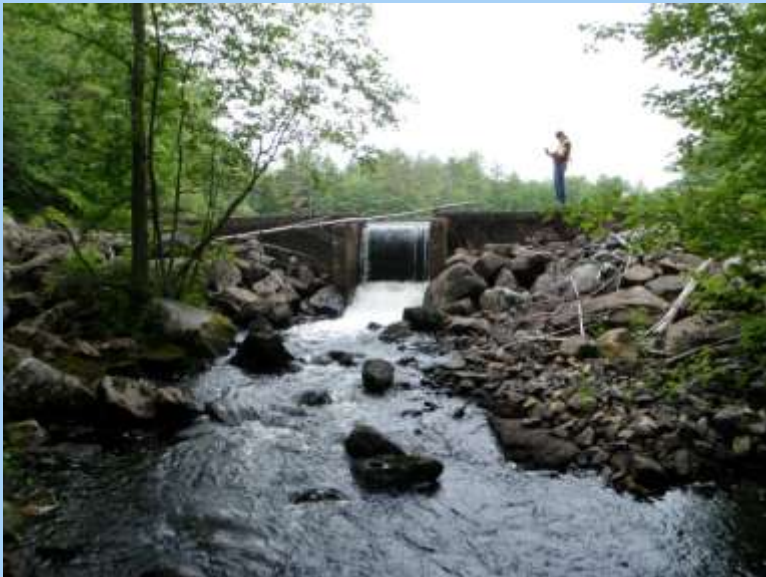
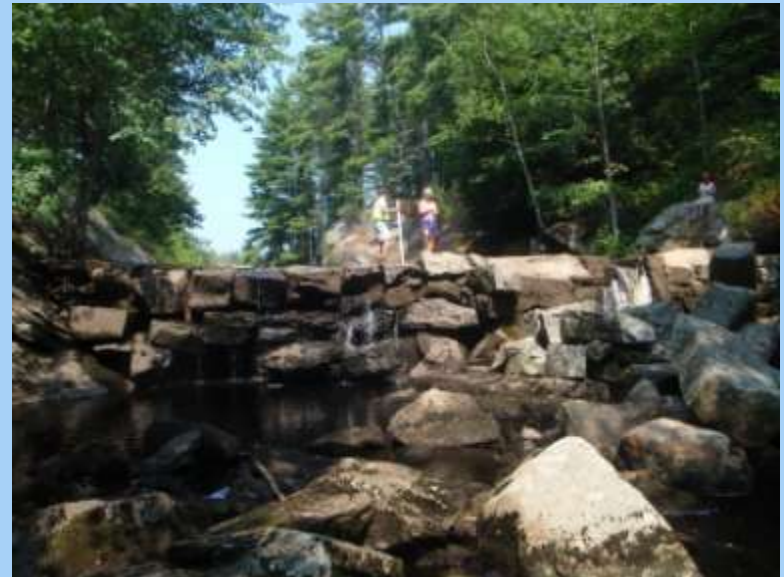
# 45 Severe Dam Barriers
