Casco Bay Watershed Fish Barrier Priorities Atlas

March 2012

Sebago

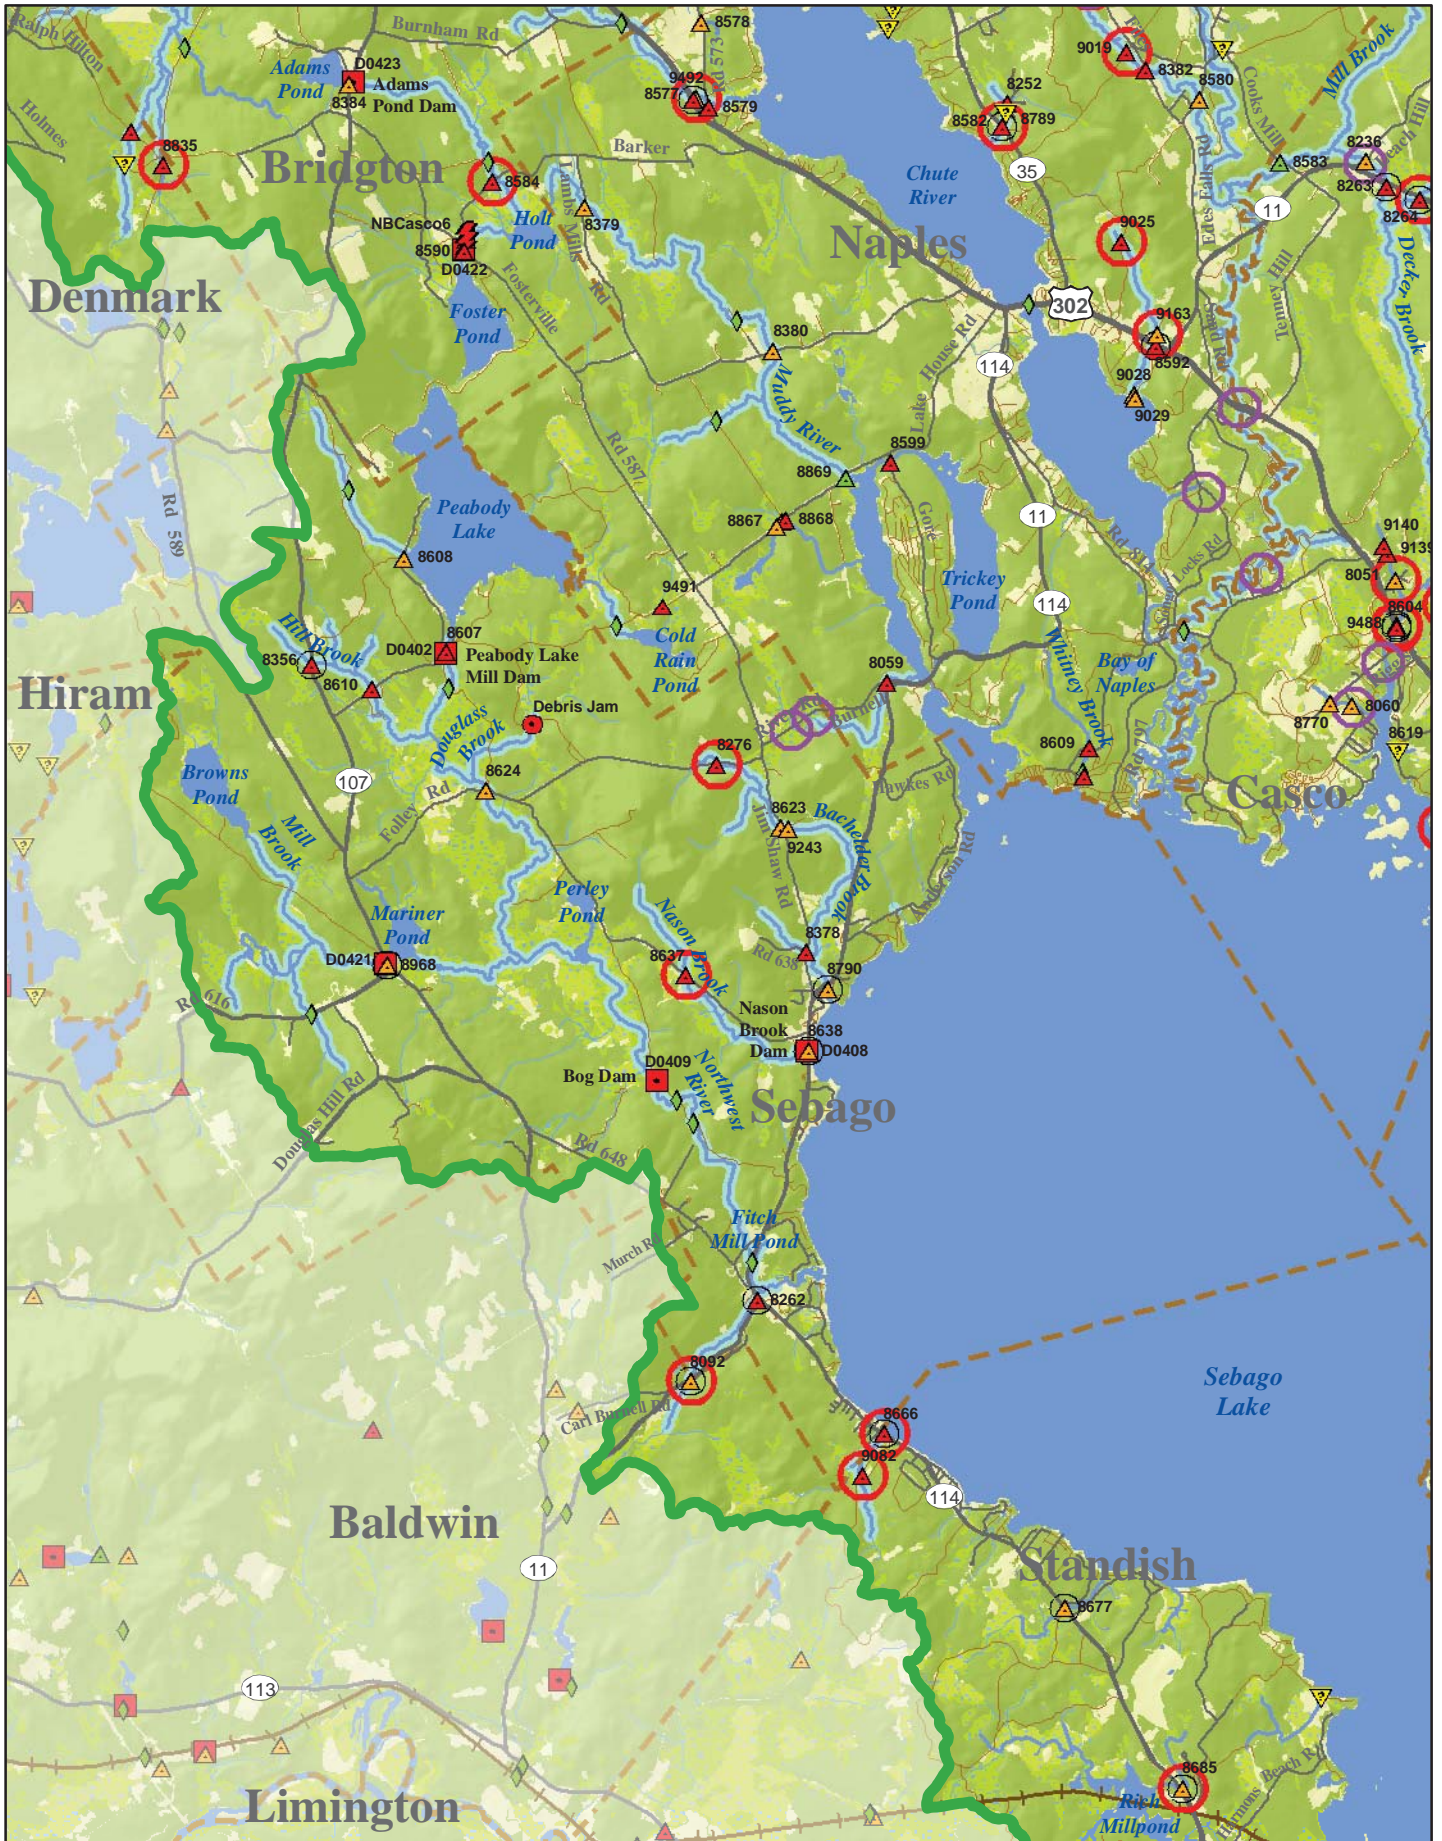
Site ID	Town	Habitat Priority	Basic Structure Type	Barrier Class	Survey Date	Road Name	Road Type & Class	Stream	UTM East	UTM North	Stream Type	Number Of Culverts	Material	Condition
8637	Sebago	High	Culvert	Severe	7/22/2010	Folley Rd	Town / Unpaved	Nason Brook	367294	4861252	Perennial	1	Plastic	
8624	Sebago	High	Culvert	Potential	7/15/2010	Folley Rd	Town / Unpaved	Northwest River	364763	4863604	Perennial	1	Metal	
8623	Sebago	High	Multiple Culverts	Potential	8/4/2010	Kimball Corner Rd	Town / Paved	Bachelder Brook	368500	4863132	Perennial	2	Metal	
8378	Sebago	High	Culvert	Severe	7/22/2010	Kimball Corner Rd	Town / Paved	Unnamed	368819	4861551	Perennial	1	Metal	
9243	Sebago	High	Culvert	Potential	8/4/2010	Memory Lane	Private / Unpaved	Bachelder Brook	368590	4863114	Perennial	1	Metal	Rust
8610	Sebago	High	Culvert	Severe	7/15/2010	Peabody Pond Rd	Town / Paved	Hill Brook	363318	4864884	Perennial	1	Metal

8608	Sebago	High	Culvert	Potential	7/15/2010	Peabody Pond Rd	Town / Unpaved	Lakin Brook	363726	4866564	Perennial	1	Metal	
8276	Sebago	High	Culvert	Severe	8/4/2010	Peaked Mountain Rd	Town / Unpaved	Bachelder Brook	367693	4863930	Perennial	1	Metal	
8790	Sebago	High	Culvert	Potential	7/22/2010	Rt. 114	State / Paved	Bachelder Brook	369095	4861084	Perennial	1	Metal	
8638	Sebago	High	Culvert	Potential	7/22/2010	Rt. 114	State / Paved	Nason Brook	368851	4860292	Perennial	1	Concrete	
8356	Sebago	High	Multiple Culverts	Severe	7/15/2010	Rt. 117	State / Paved	Hill Brook	362541	4865200	Perennial	2	Concrete	
8262	Sebago	High	Culvert	Severe	7/22/2010	Rt. 117	State / Paved	Stoney Brook	368203	4857131	Perennial	1	Metal	
8968	Sebago	High	Culvert	Potential	9/15/2010	Rte 107	State / Paved	Mill Brook	363515	4861384	Perennial	1	Concrete	
8607	Sebago	High	Culvert	Severe	7/15/2010	Tiger Hill Rd	Town / Unpaved	Northwest River	364263	4865357	Perennial	1	Metal

NBCasco9043	Sebago	High	Debris Jam	Severe	7/15/2010		NA	Douglass Brook	365357	4864422	Perennial			
D0421	Sebago	High	Dam	Severe	9/15/2010		NA	Mill Brook	363496	4861391	Perennial		Concrete	
D0408	Sebago	High	Dam	Severe	7/22/2010		NA	Nason Brook	368849	4860285	Perennial			
D0402	Sebago	High	Dam	Severe	7/15/2010		NA	Northwest River	364262	4865330	Perennial			
D0409	Sebago	High	Dam	Severe	7/22/2010		NA	Northwest River	366931	4859900	Perennial

Site ID	Specific Structure Type	Inlet Condition	Inlet Blocked	Primary Inlet Span FT	Crossing Structure Length FT	Outlet Condition	Outlet Drop FT	Crossing Substrate	Fill Height FT	Estimated Stream Width FT	Upstream Miles to Next Barriers	Up-Stream Barriers	Total Upstream Miles	Down-stream Barriers	Dam Name	Hydraulic Height FT
8637	Round Culvert	At Grade	25%	3.0	40.7	Perched	0.2	None		9.9	0.849	0	0.849	3		
8624	Open Bottom Arch	At Grade	No	15.4	50.2	Perched	1.3	Comparable	3.9		3.257	6	9.666	2		
8623	Round Culvert	At Grade	No	3.9	40.4	At Grade		None		8.0	1.333	1	1.539	3		
8378	Round Culvert	At Grade	No	3.6	40.4	Perched	1.1	None	26.2	5.0	0.501	0	0.501	2		
9243	Round Culvert	At Grade	No	3.9	14.4	At Grade		None	1.4	2.0	0.058	2	1.596	2		
8610	Round Culvert	At Grade	No	5.9	40.7	Perched	0.1	None	1.3	3.1	1.265	1	1.689	3		
8608	Round Culvert	At Grade	No	4.9	49.2	At Grade		None	2.6		1.471	0	1.471	5		
8276	Round Culvert	At Grade	No	3.0	30.5	Perched	0.1	None	1.6	5.3	0.205	0	0.205	4

8790	Round Culvert	At Grade	No	8.7	80.4	At Grade		Comparable	6.9	7.2	2.030	4	4.127	1		
8638	Box Culvert	At Grade	No	4.0	44.3	At Grade		Comparable		22.7	0.005	2	2.412	1		
8356	Round Culvert	At Grade	No	3.3	50.9	Perched	0.5	None	3.6		0.424	0	0.424	4		
8262	Round Culvert	Inlet Drop	No	5.6	107.6	Perched	1.1	None		4.0	0.888	1	1.319	1		
8968	Box Culvert	At Grade	No	9.4	30.5	At Grade		None		4.3	0.007	1	4.628	2		
8607	Pipe Arch Culvert	At Grade	No	9.0	30.2	Perched	0.3	Comparable	2.0		3.165	1	4.636	4		
NBCasco9043										7.7	0.067	0	0.067	3		
D0421										3.5	4.621	0	4.621	3	Unnamed	1.6
D0408										8.9	1.558	1	2.407	2	Nason Brook Dam	2.6
D0402										4.2	0.017	2	4.652	3	Peabody Lake Mill Dam	6.0
D0409										3.9	6.804	9	21.098	1	Bog Dam	1.3
