# Concord Gully Brook

SURVEY **NATERSHED**

Prepared for the Town of Freeport March 2013

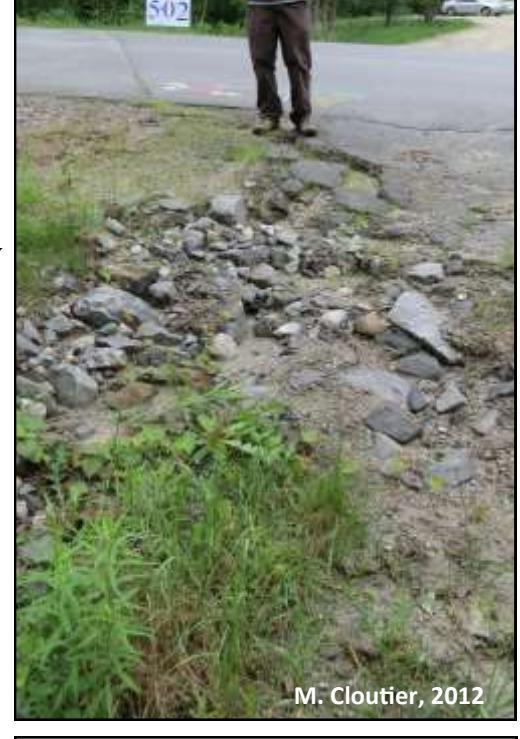
Figure 1. Stormwater runoff from eroding road shoulders is one way sediment can be transported into Concord Gully Brook.

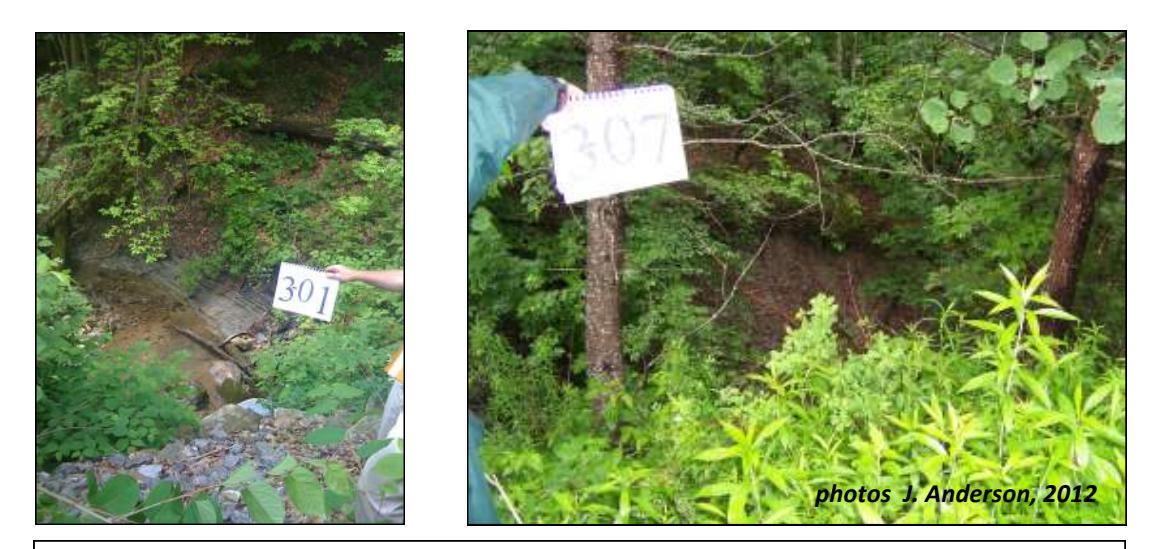
Table 3.	Total Soil Loss From High and Medium Im	pact Sites		
		Soil load	Phosphorus	
Site	Location	tons/year	load lbs/year	Impact
3-1	West St @ culvert crossing	0.44	0.37	High
3-7	Behind L.L. Bean distibution center	1.03	0.88	High
1-5	Holbrook Street	0.11	0.09	Medium
1-11	Independence Road catch basin	0.34	0.29	Medium
1-15	Corner of Meetinghouse Road and Route 1	0.38	0.32	Medium
2-1	West St above cemetary	0.29	0.25	Medium
3-2	Top of Torrey Hill Range Road	0.22	0.19	Medium
3-5	End of Cottage Street where pavement ends	0.25	0.21	Medium
5-1	Pine St across from Stagecoach Road	0.19	0.16	Medium
5-2	Pine St across from Stagecoach Road	0.33	0.28	Medium
5-5	Corner of Pine St and Route 1	0.42	0.36	Medium
5-10	Culvert crossing @ Varney Road	0.54	0.46	Medium
5-13	Concord Road with empty buildings	0.65	0.56	Medium
5-15	Trail behind L.L. Bean distribution center	0.54	0.46	Medium
	Totals	5.73	4.87

Figure 7. High impact sites 3-1 (left) and 3-7. Both sites contain perched culverts and experience flash flows of NPS stormwater which results in severe bank scour. Site 3-1 also has a large population of Japanese Knotweed, an invasive species.

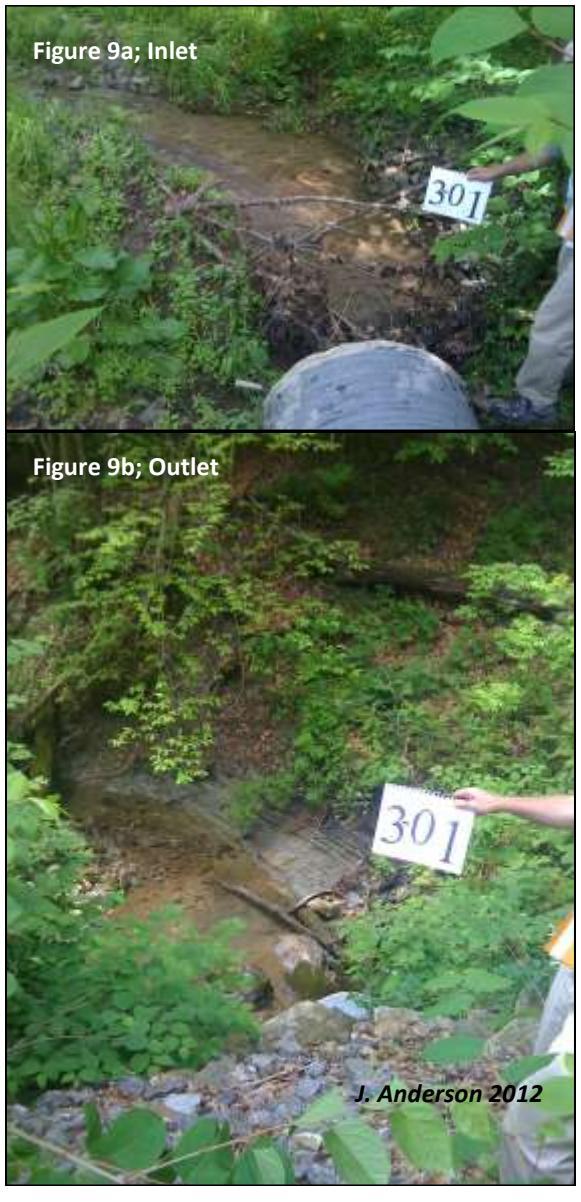
At the culvert crossing on West Street, south of Woodlawn Cemetery, Porter's Landing Brook transitions from a narrow and shallow brook with a broad floodplain to a deep ravine with undercut banks. The culvert is undersized and has been slip-lined, a common and practical treatment of installing a thermoplastic (polyethylene) liner inside a deteriorating culvert. The upstream portion has a moderately sized floodplain and winding brook. The tributary watershed has high IC (Depot Street parking area as one example), resulting in flash flows during heavy rain events. The undersized culvert creates a pressure washer effect on the outlet side (Figure 9b). Notice the bank scour to the left of the number card. NPS stormwater also enters from West Street and Torre Hill Road, eroding existing ditching and depositing directly to the brook. Compounding issues on site is an established patch of Japanese Knotweed (Polygonum cuspidatum), a highly aggressive invasive species that contractors should be

Figure 9a (upstream) and 9b (downstream) showing contrasts of inlet and outlet of culvert area.

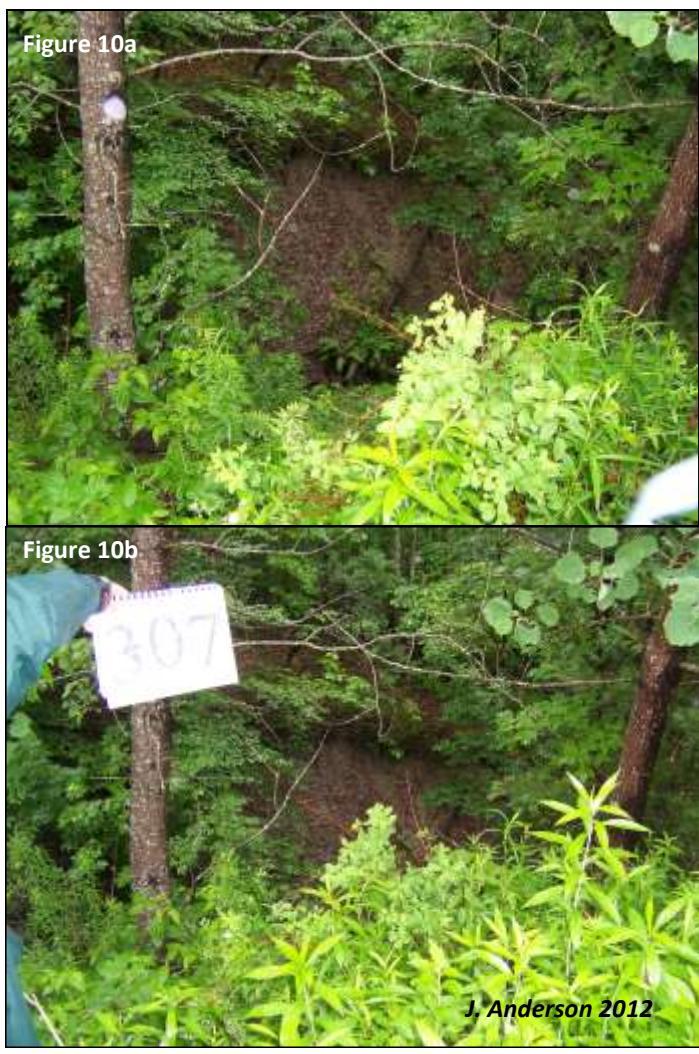
Figures 10a and 10b; Site 3-7. Eroded banking opposite culvert outlet behind L.L. Bean Distribution Center.

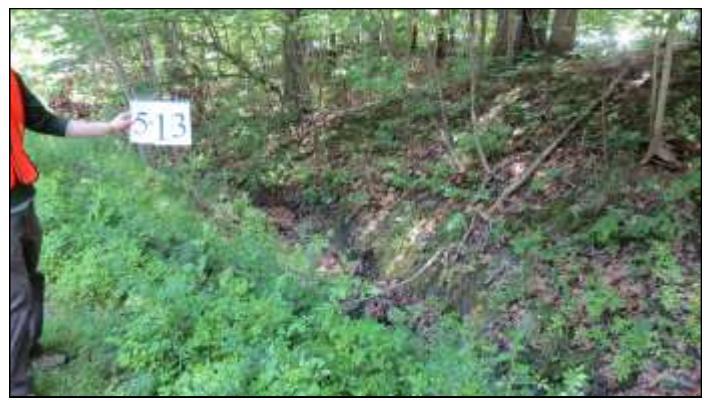
At the southern end of Mallet Avenue, the road splits off into two driveways with residential buildings. NPS stormwater flows down Mallet Avenue from Lower Main Street and adjacent commercial properties. The roadbed is fractured and fatigued. There is little or no

Figure 11; Site 5-13. Mallet Avenue ends here, but NPS stormwater flow continues and has eroded a gully which leads directly to Tributary C.

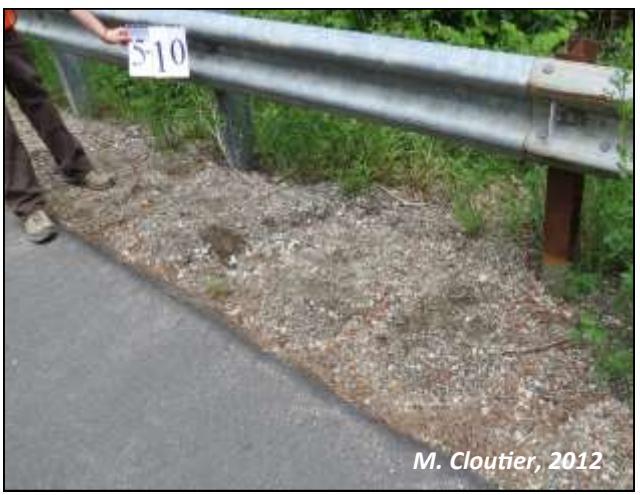
The culvert crossing at Varney Road is relatively new. The site was reconstructed following the breach and eventual failure of the road section in 2009. While the site appears stable, improvements can be made on the road itself. There is considerable space to incorporate BMPs in ditching and turnouts. These actions could divert NPS stormwater flowing down Varney Street into vegetation prior to entering the brook. Costs could be relatively low and maintenance minimal with benefits such as stormwater reduction and treatment. The invasive species Japanese Knotweed is also prevalent here in addition to multiflora rose (*Rosa multiflora*) and Japanese barberry (*Berberis thunbergii*). Again, any soil

Figure 12. Eroding road shoulder at culvert crossing on Varney Road.

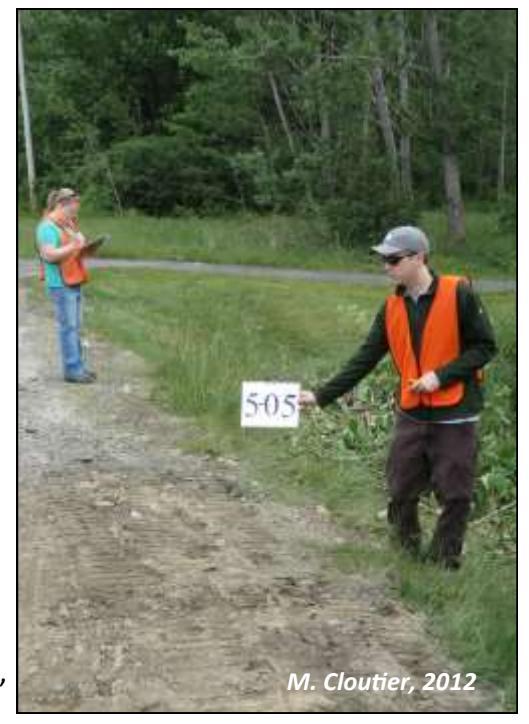
The intersection of Pine Street and Route 1 sees considerable activity due to its proximity to 1295 and the interchange area. Landuse here includes mixed commercial with a gas station, numerous hotels and a condominium complex all in the vicinity of the headwaters of the mainstem of Concord Gully Brook. The Maine Department of Transportation (MDOT) reconstructed areas of the road and shoulder in 2012 (Figure 13). The intersection area has the potential to act as a larger treatment site, accepting NPS stormwater from Route 1 and Pine Street. This area is highly visible and may also benefit the town by providing an education opportunity for water quality efforts. Again, Japanese Knotweed is prevalent on the banks of the brook and along the road shoulder closest to the stream.

Figure 13. Bare shoulders from recent construction by MDOT with headwaters of Concord Gully Brook to the right of surveyors.

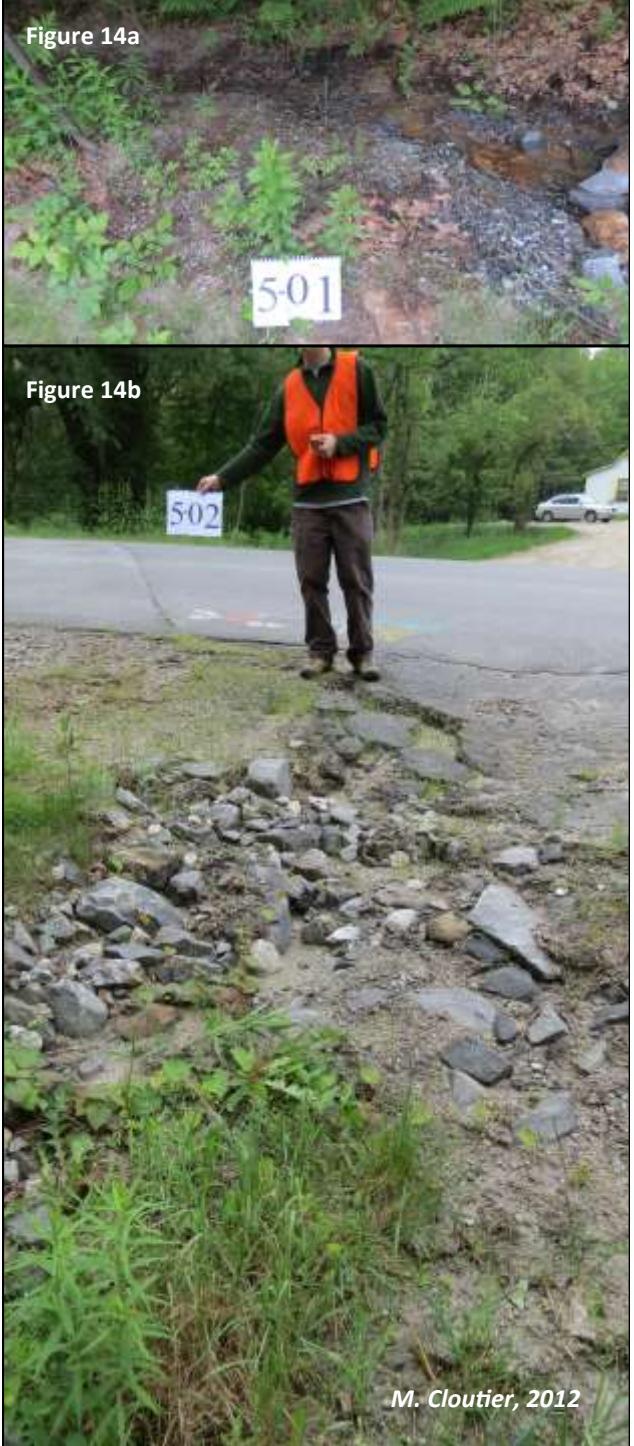
This area is located in the headwaters of the mainstem of Concord Gully Brook. The roadbed itself is stable but the shoulders are bare and the pavement is fractured at edges in some areas. NPS stormwater flow can be significant during heavy rain events which adds to the deterioration of the road shoulders (Figures 14a and 14b). Erosion of sediment from the shoulder is being deposited directly into Concord Gully Brook. Like the Varney Road culvert crossing, there is space and opportunity for BMPs that incorporate ditch turnouts into vegetation, revegetation of road shoulders to reduce the amount of bare soil, and reinforcing areas susceptible to flash flows with riprap or other suitable materials.

Figures 14a and 14b. Eroded sediment being deposited directly into the headwater streams of Concord Gully Brook and deteriorating road shoulders at pavement edge.

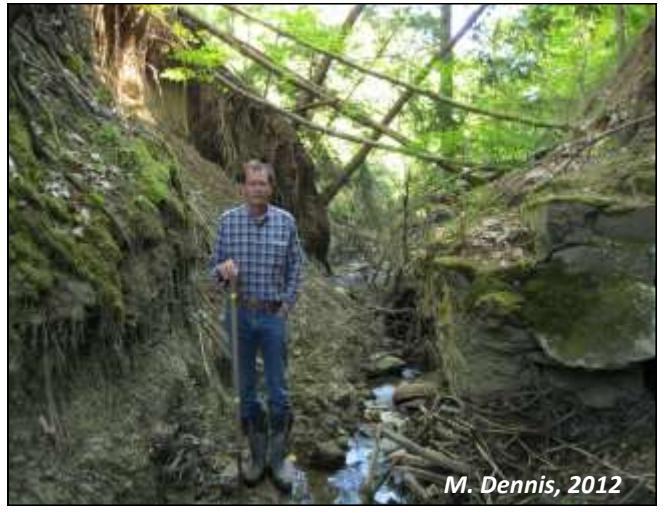
been eroded away with a cut-face bank slope reaching 20' high on either side. The existing concrete culvert is no longer active and the thalweg (the line of the streambed that defines its deepest channel) has realigned north and now cuts into the banking causing further failure of the wall (Figure 20).

Figure 19. Potential restoration site on the mainstem of Concord Gully Brook. The old crossing of the Brunswick and Freeport line of the Androscoggin and Kennebec Electric Railway has been eroded away with significant soil loss. The concrete culvert is to the right of the surveyor.

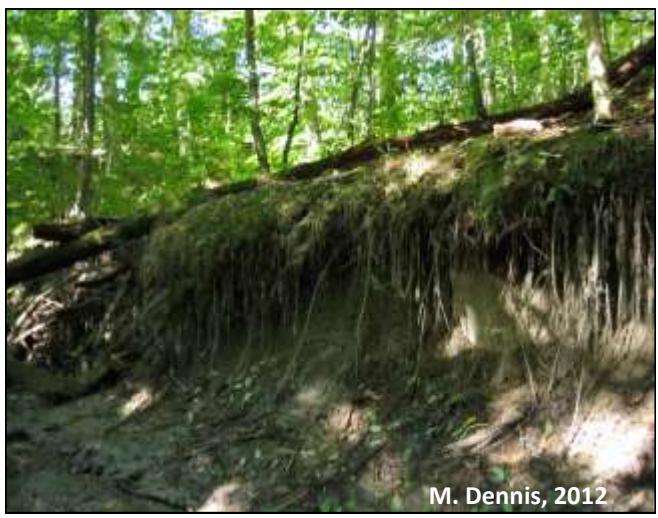
A second area is Tributary "A", Reach B1, which is locally known as Porter's Landing Brook. High-energy stormwater flows contribute to substantial degradation and instability to the system. The combination of high volume flows, Belgrade very fine sandy loam and Buxton silt loam soils on steep grades, and proximity to lower reaches of the mainstem of Concord Gully Brook, makes this tributary especially vulnerable to impacts and also has the ability to severely impact areas downstream with heavy sediment loads and NPS pollution (Figure 20).

Figure 20. A second restoration area is Porter's Landing Brook, (Tributary "A"). This reach sees substantial degradation due to heavy stormwater flows and steep grades.

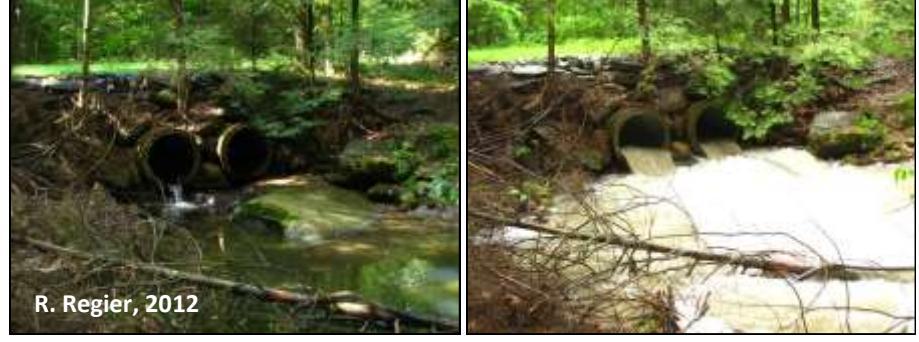
A third area is the double culvert south of the confluence with Porter's Landing Brook at the crossing of the sanitary sewer line. Here, the culvert area is characterized by high-energy flows which create channel scour and deterioration and prohibit fish and habitat movement. Three factors are present at this location:

- Perched culverts with excess drop at the outlet.
- Improperly sized culverts that create high water velocity and turbulence.
- Debris accumulation at the culvert inlet.

Figure 21. Double culverts at sanitary sewer line crossing on the mainstem of Concord Gully Brook.

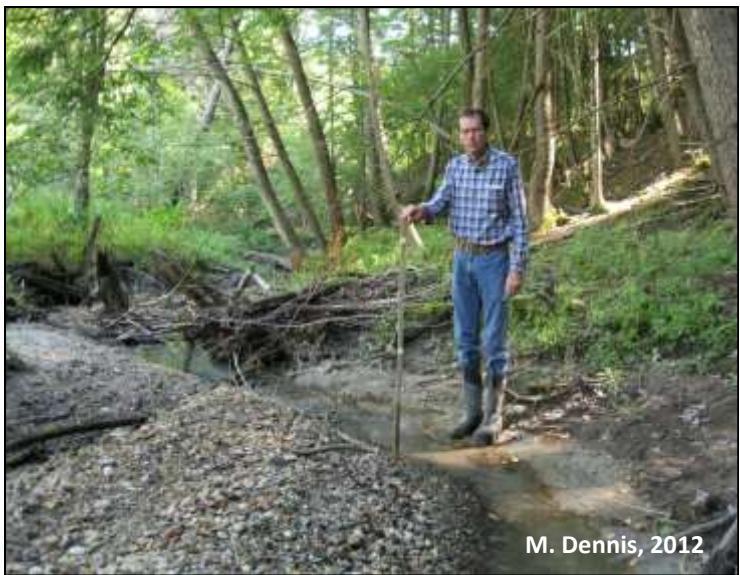
Figure 23. Typical stretch of Reach A1, with point bar deposition containing asphalt 600 feet east of Varney Road culvert crossing.

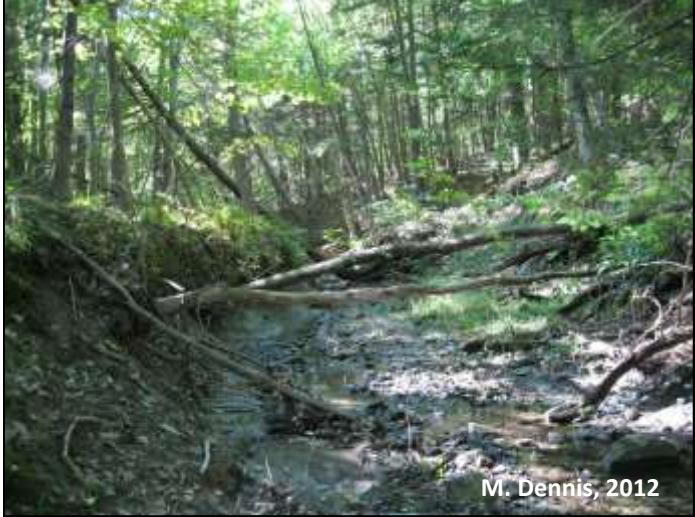
Figure 27. Typical stretch of Reach B1 downstream from West Street crossing. Significant stormwater flows are continually undermining banks, widening stream width, and lowering the elevation of the streambed.

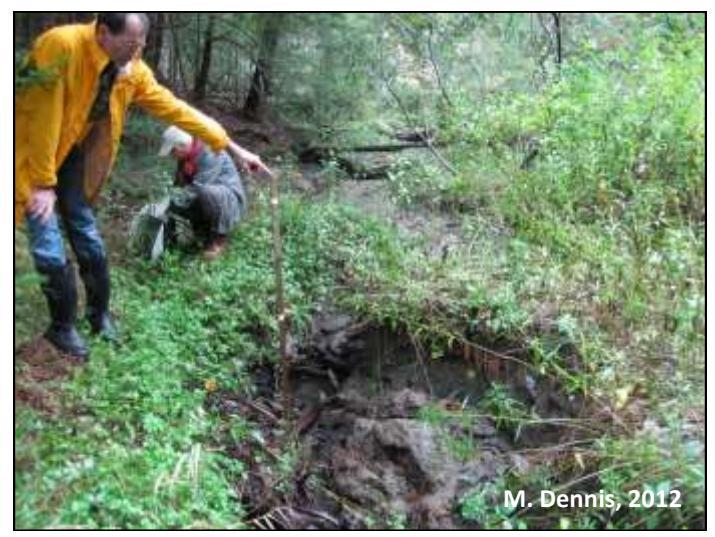
Figure 31. Cut-off channel within Reach D1, with slumping of banking prior to return to stream channel.
