West Branch Piscataqua River Watershed Survey Report

Presumpscot River Watch

September 2008

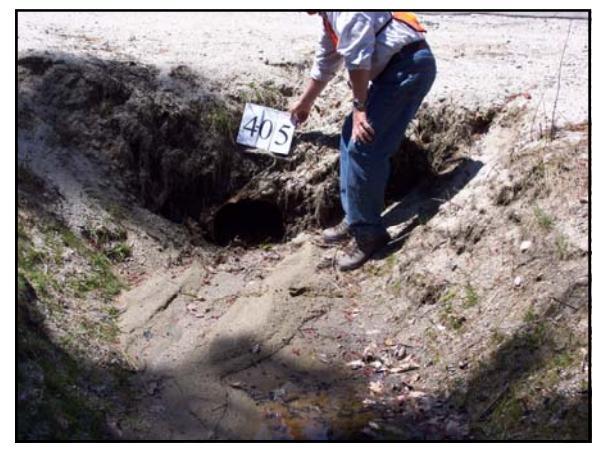
Survey teams identified a variety of problem types (Figure 5). The most commonly observed problems were related to soil erosion (Figure 6), which is the single largest pollutant source by volume to Maine's surface waters. Soil erosion can originate from a number of places, including unpaved roads and road shoulders, ATV trails and

Figure 6: *Example of erosion on a road shoulder next to a culvert*

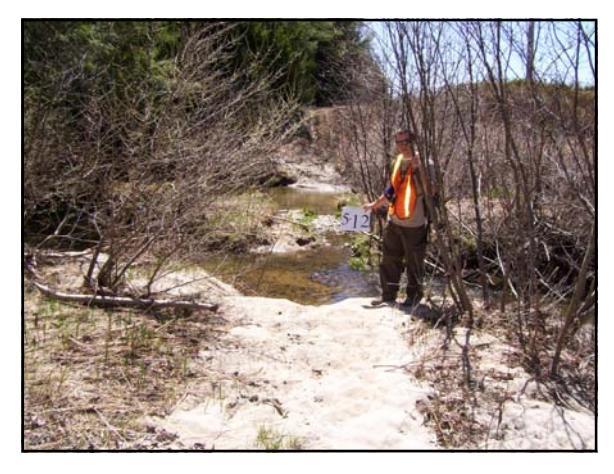
Figure 7: Example of stream bank failure at an ATV

The next most commonly observed problems were due to stream bank failure, which often results from a lack of adequate vegetated buffers needed to stabilize riparian soils (or as indicated in Figure 7, vegetation is damaged by recreational ATV activities). Impervious surfaces can also contribute to this problem by increasing and intensifying the effects of surface water runoff, which can scour and erode stream channels during peak or prolonged rain events.

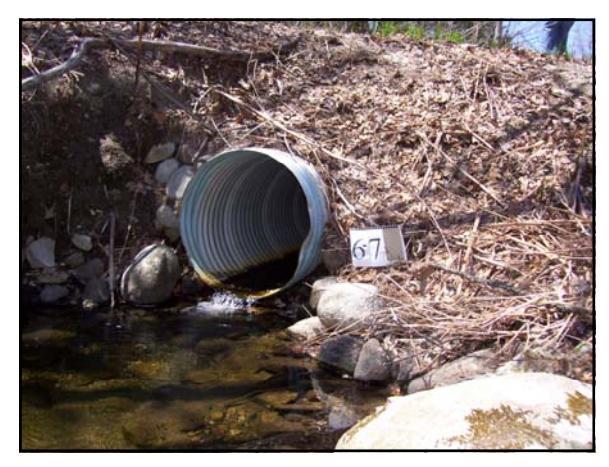
The next most frequently observed problems were culvert related (Figure 8).

Figure 8: Example of a hanging culvert.

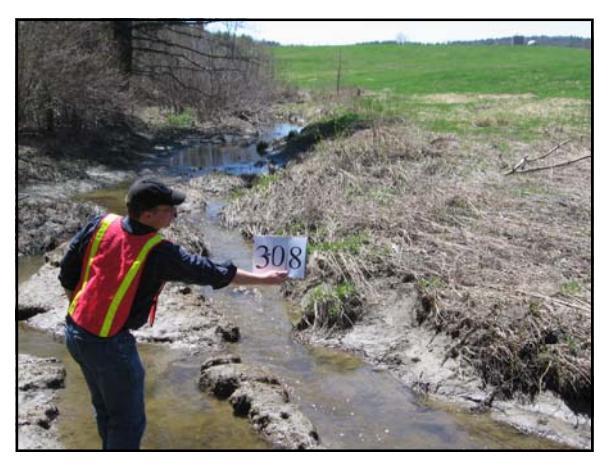
Figure 9: Example of inadequate shoreline buffer.

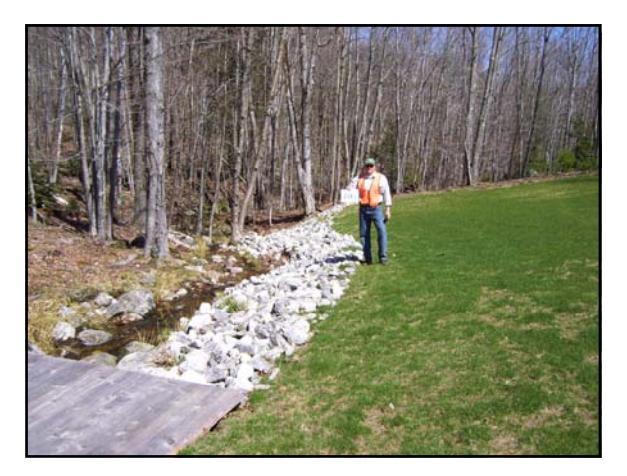
Figure 10: *Example of a manicured lawn without a buffer.*

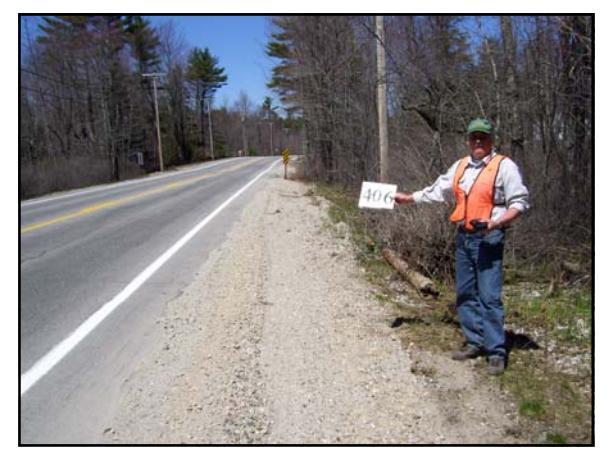
The remainder of observed polluted runoff problems in the "other" category included excessive sediment buildup (Figure 11), invasive plant species and improperly managed livestock manure.

Figure 11: *Excess sand left on the road following a cold Maine winter.*

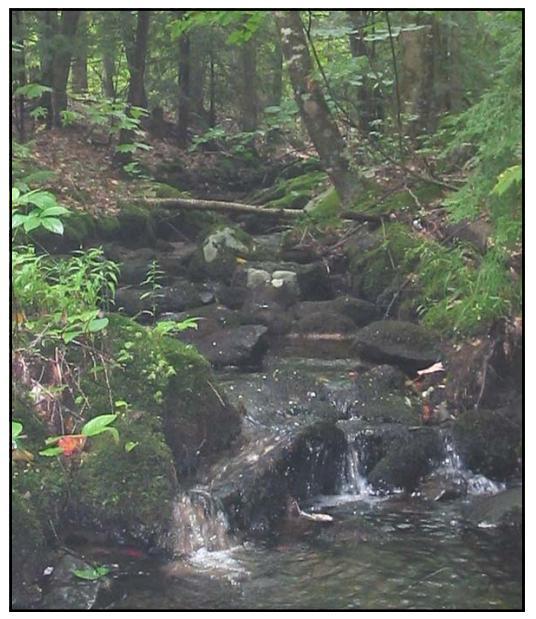
The findings from this limited assessment indicate that selected reaches in WBPR watershed are in relatively good condition from a geomorphological perspective due in large part to the presence of fairly wide forest buffers and the relatively low extent of impervious surfaces (Figure 14). However, other reaches of the river

Figure 14: One of the reaches selected for the rapid geomorphology survey
