ROYAL RIVER FISH PASSAGE STUDIES SUMMARY REPORT

**Royal River Watershed
Yarmouth, North Yarmouth, New Gloucester,
Pownal, Durham, Gray, and Auburn, Maine**

January 17, 2018

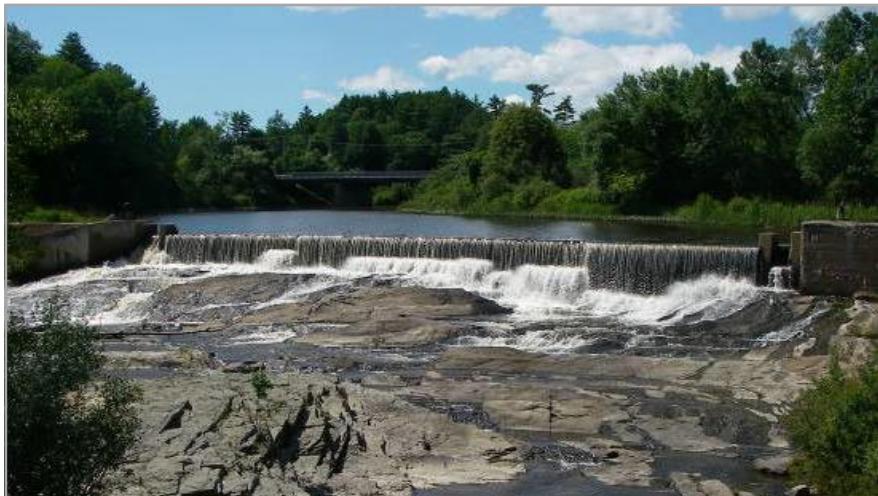
Bridge Street Dam during drawdown, 2010

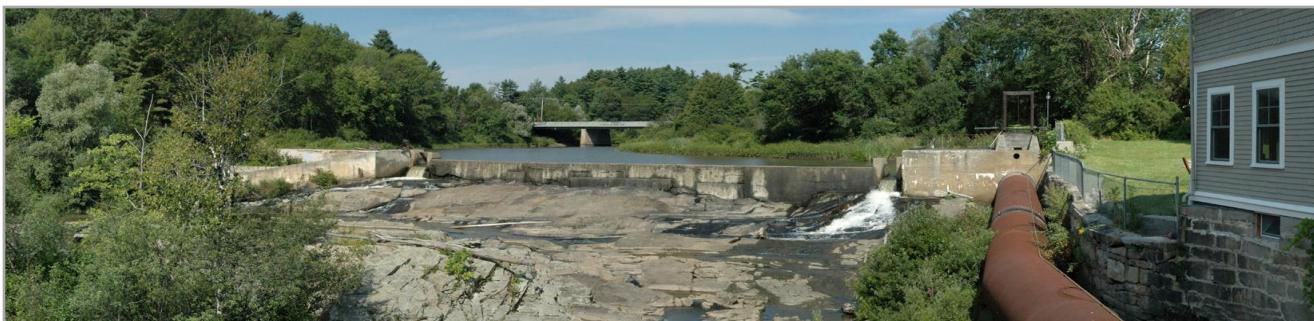
Bridge Street Dam

- The Bridge Street Dam fishway is passing water, but it is not functioning in such a way as to allow for targeted fish communities to pass both upstream and downstream due to periodic high velocities as well as lack of passage for juvenile eels and potential for injury to fish migrating downstream.

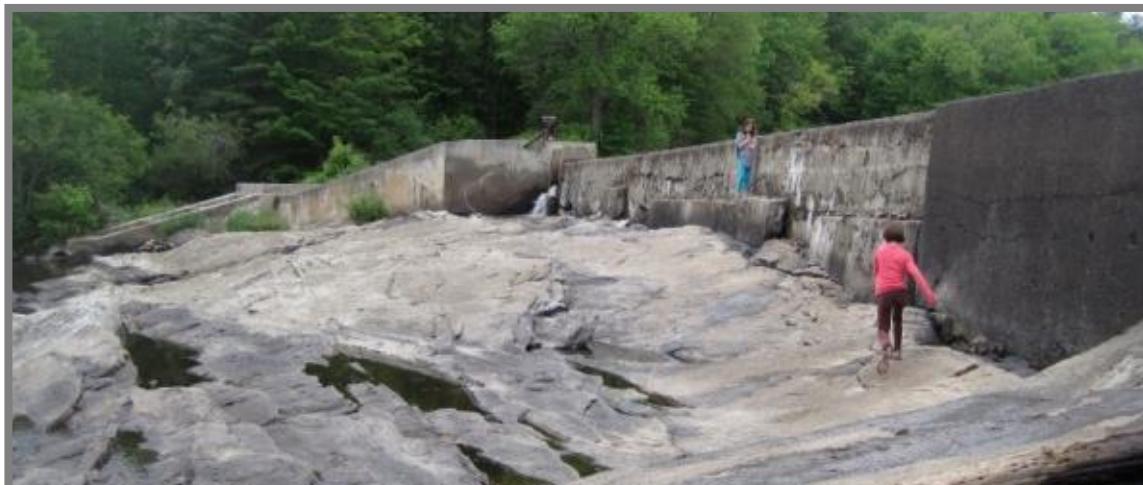
Bridge Street Dam during dewatering conditions
