2015 Post-Project Monitoring Report:  
Long Reach Lane at Long Marsh, Harpswell

Year 2 of 5

Compensation for the Martin's Point Bridge Project, Falmouth-Portland  
(PIN 16731.00)

March 2016

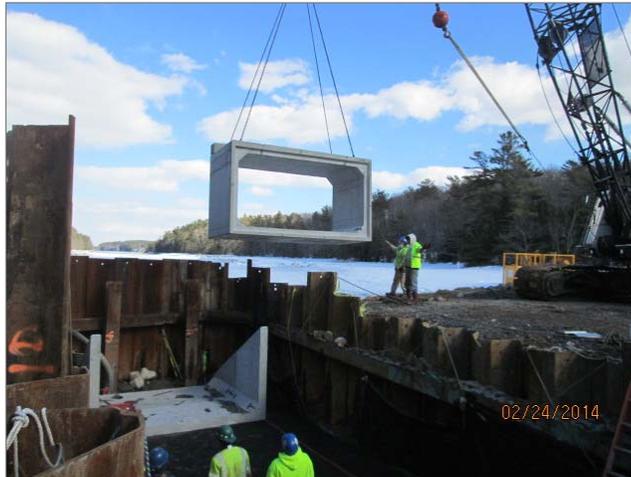
In 2012, the Maine Department of Transportation (MDOT) proposed a mitigation project at Long Reach Lane in Harpswell (Figure 1) to compensate for the functional impacts to marine wetlands associated with the construction of the Martin's Point Bridge between Falmouth and Portland. The mitigation project took place in January and February 2014, and resulted in the successful replacement of a 36" (7.1 ft<sup>2</sup> flow area) round concrete pipe beneath Long Reach Lane with a larger 6' x 12' concrete box culvert (72 ft<sup>2</sup> flow area) in February 2014 (photo MDOT, below).

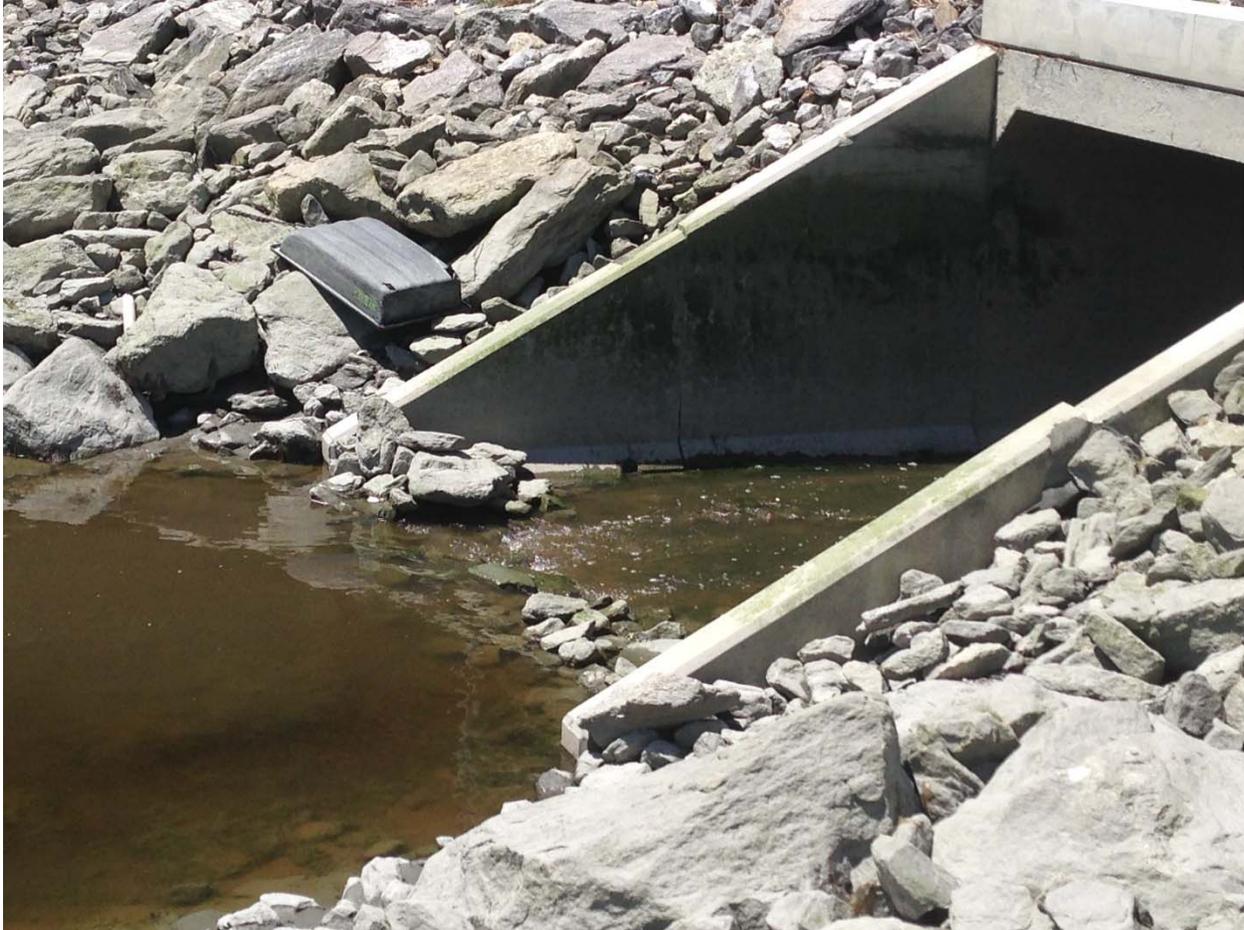
During cross section surveys on 6/25/15, CBEP staff observed a narrow band of rocks placed in a line across the culvert inlet, presumably in an effort to raise water levels upstream (photo, below). The rocks appeared to have been moved from the adjacent armored road bank and a black sled, standard equipment for shellfish harvesters, was observed next to the inlet. CBEP staff hand-removed the rocks from the culvert and placed them back on the road bank.

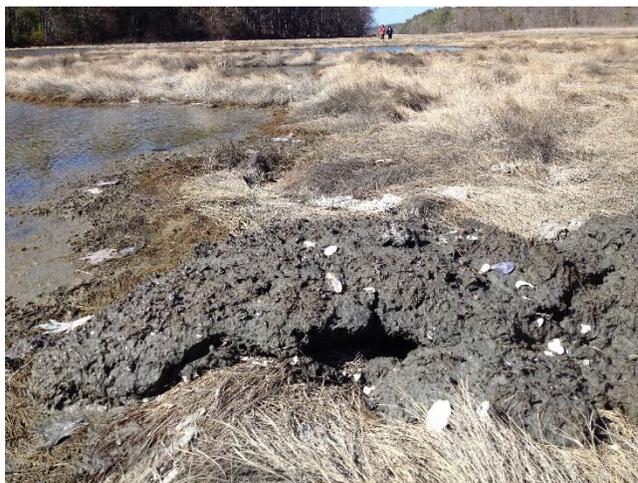
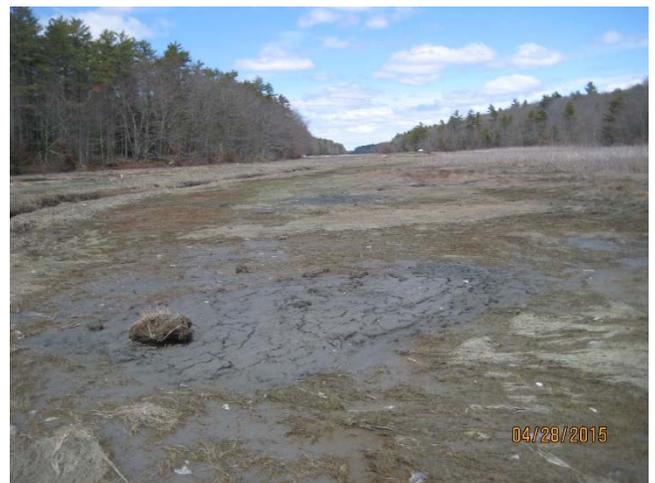
The winter of 2014–15, and associated ice formation and movement, resulted in extensive sediment deposits on the marsh surface. To document the extent of sediment deposits, CBEP hired a consultant to obtain aerial video footage of the project using a drone on 5/1/15, just as vegetation was starting to emerge. Ice movement affected the location of markers and wells at some Stations. (Video footage is available upon request).

*Peat, sediment and shell deposited on the marsh surface resulting from ice scour, at Station 2 (left, 5/1/2015), and Station 4 (right, 4/28/2015).*

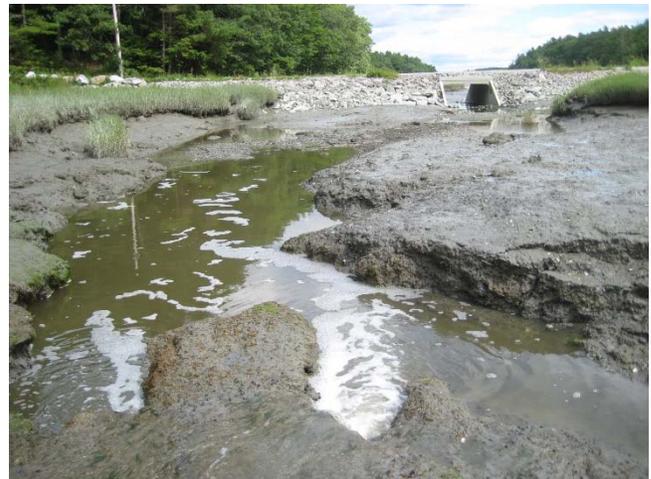
The upstream head cut moved toward the center of the channel, possibly toward the location of the original channel (CBEP; 7/23/15).

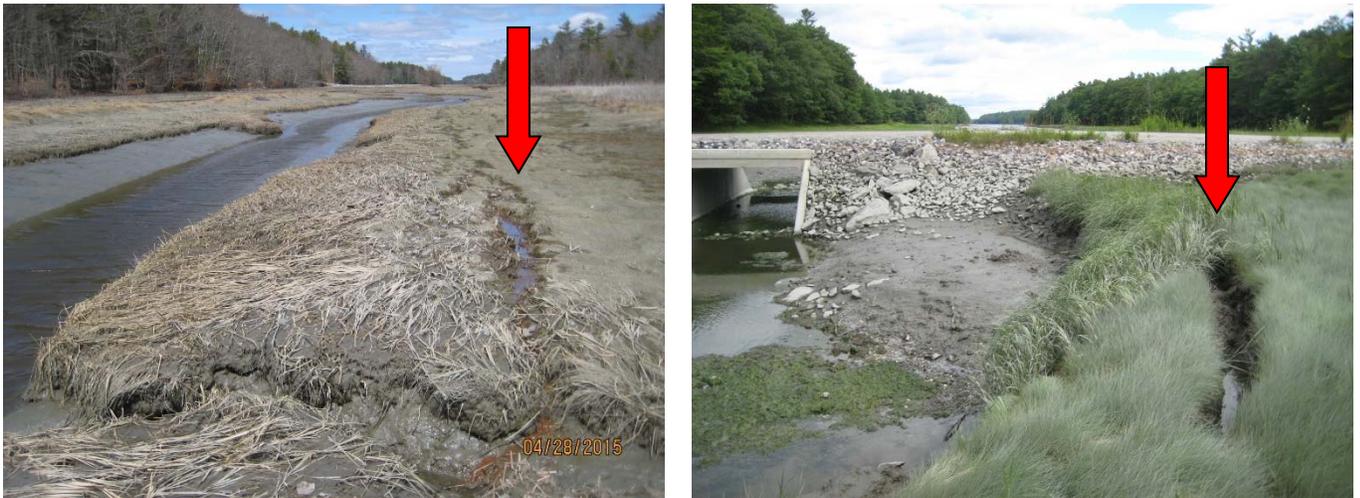
*Channel response to increased tidal exchange was not always captured in surveys. A new and expanding rill along the east side of the channel at Station 4 (left, view N) could indicate future dimensions under the new hydrologic regime. Similarly, at the culvert inlet (right, view N), large chunks of peat continue to slump off, collapsing into the creek channel, following culvert replacement.*

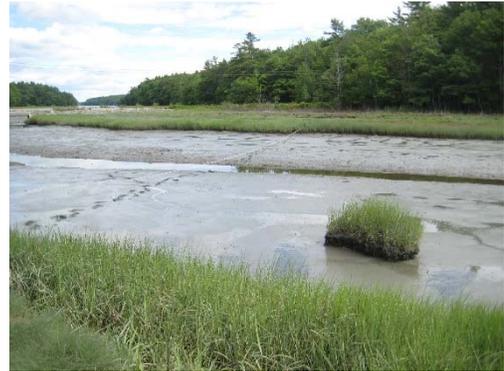
*Station 2 cross section. Most of the channel remains mudflat, with a narrow thalweg in the center. Peat from winter ice movement in foreground.*

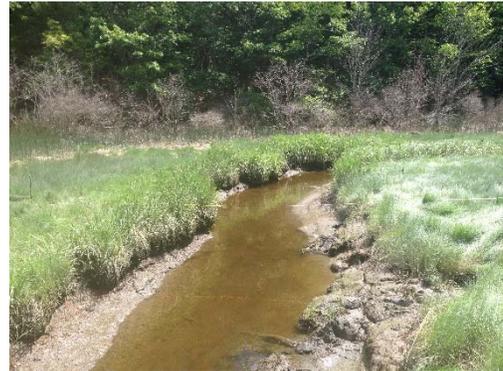
*Station 8 cross section. Remnant peat exposed on west bank (r).*

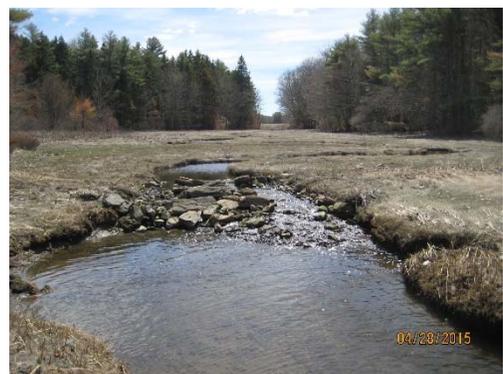
*Scour downstream of the old road bed between Stations 8 and 9.*

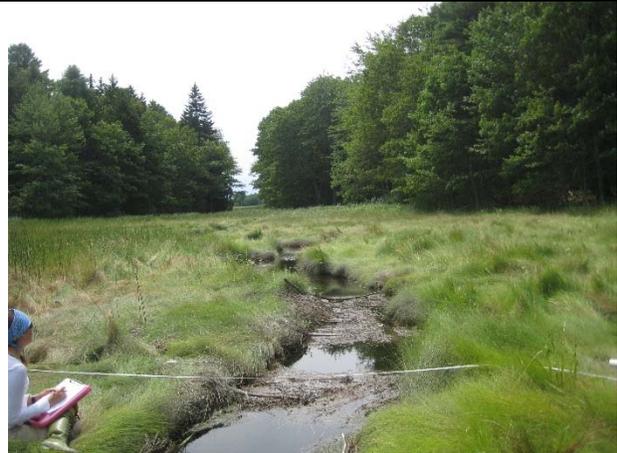
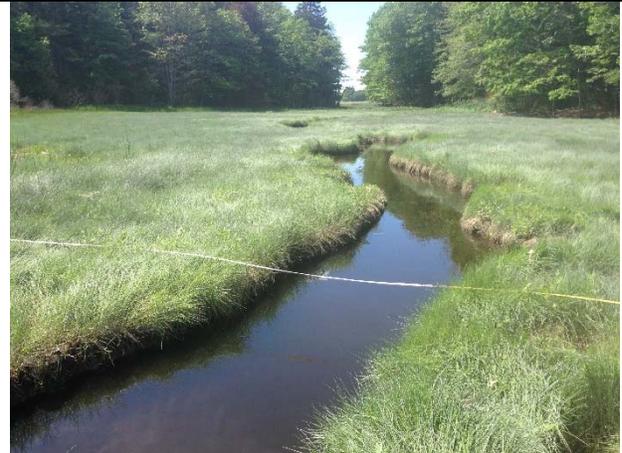
Station 9 Cross Section (view south)

- At Station 9, which is upstream of the “old road bed” crossing described in last year’s report, the channel thalweg is about a foot lower. A secondary channel-like feature appears to be forming parallel to the western edge.

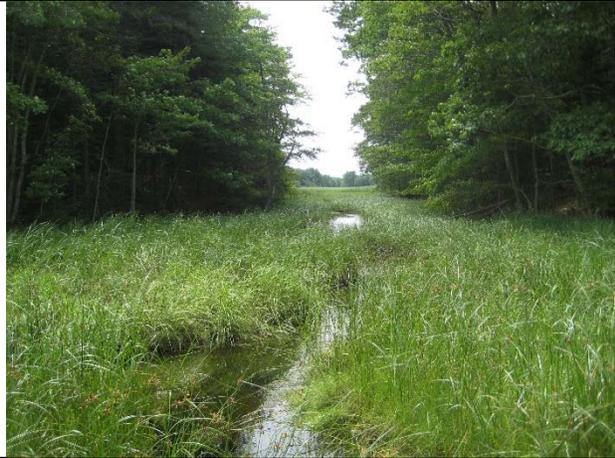
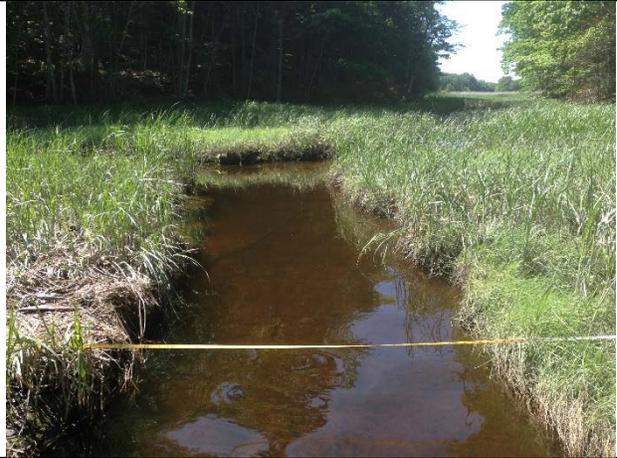
PRE-PROJECT (2013)	2015
Station 10 Cross Section (view south)

- At Station 10, which is located close to “the narrows” and also upstream of the old road bed, less scour is evident, although the base of the channel bank appears more angular than in 2013.
