MONITORING TIDAL RESTORATION OUTCOMES LONG MARSH, HARPSWELL 2013-2018

Casco Bay Monitoring Network Meeting
University of Southern Maine
April 1, 2019

Matt Craig
Casco Bay Estuary Partnership

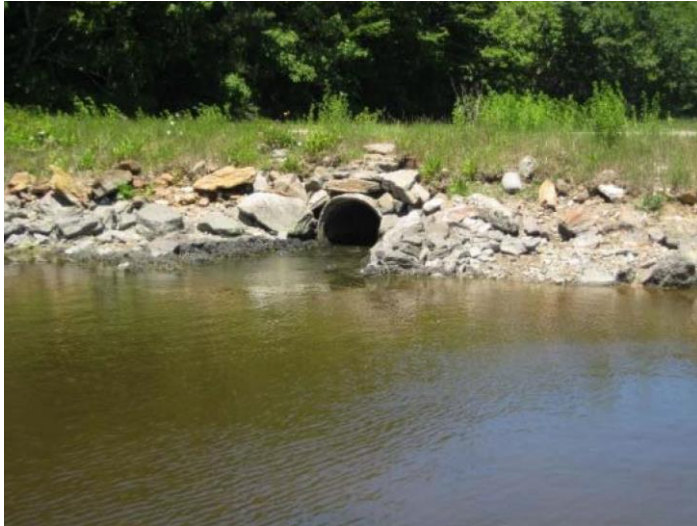
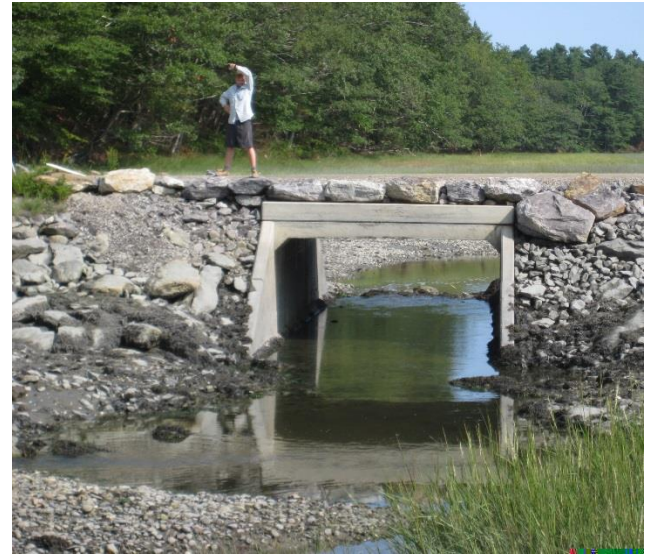
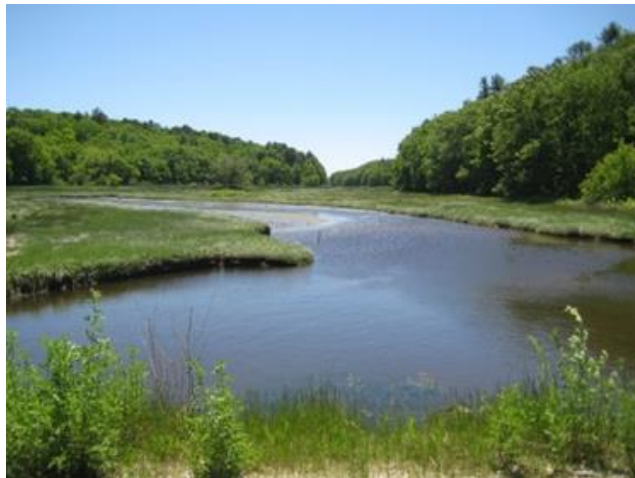
Culvert Replacement (Jan. 2014)

PRE

POST (2018)

INLET

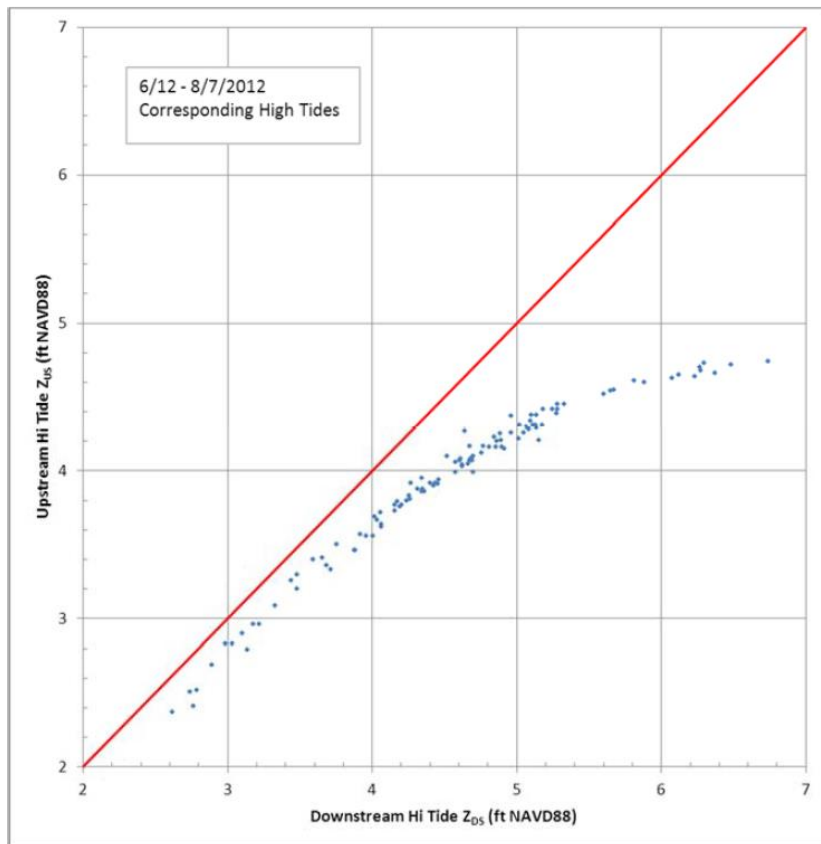
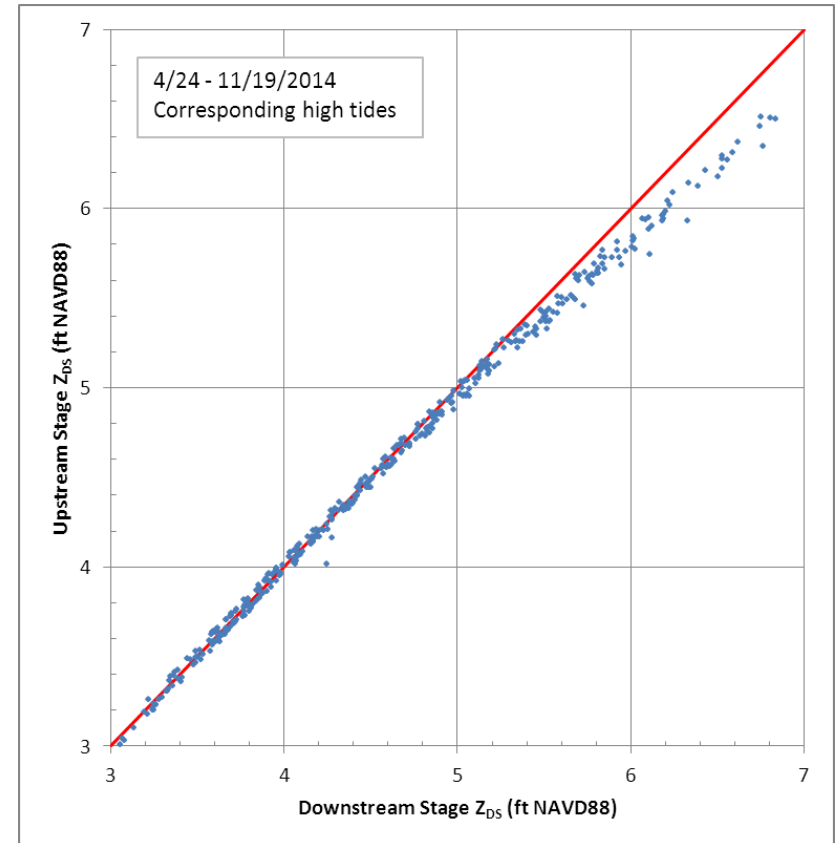
Corresponding high tide

PRE

POST

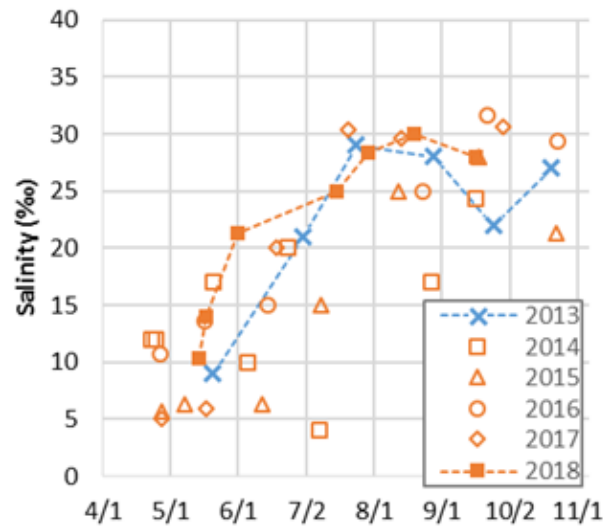
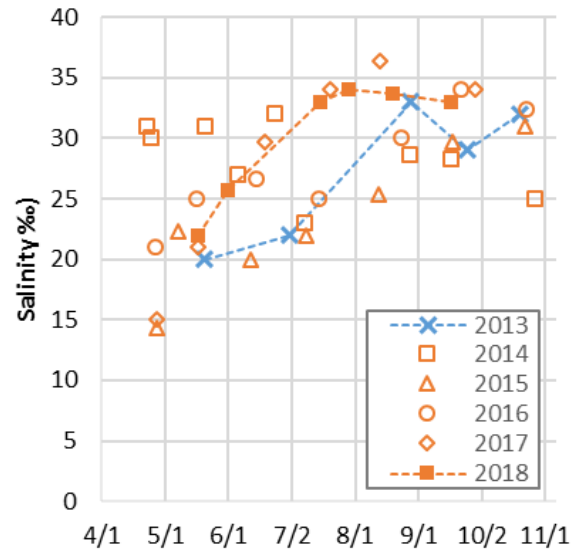
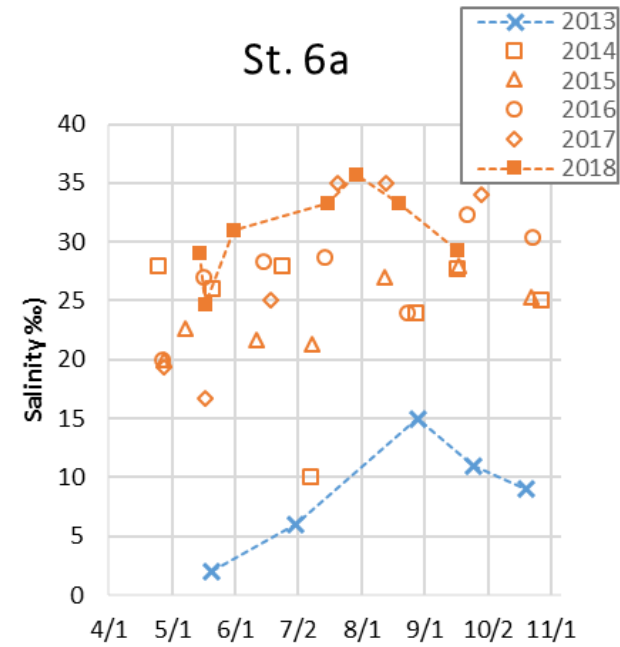
Pore water salinity

Greatest changes at sites further from the creek channel (laterally), as opposed to distance from culvert (ocean)

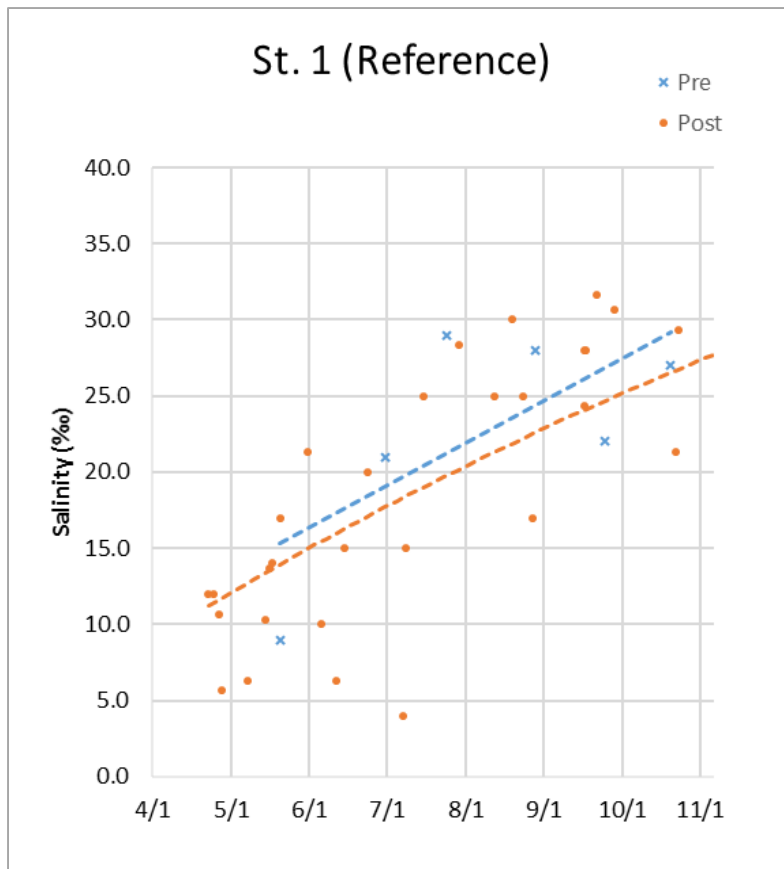
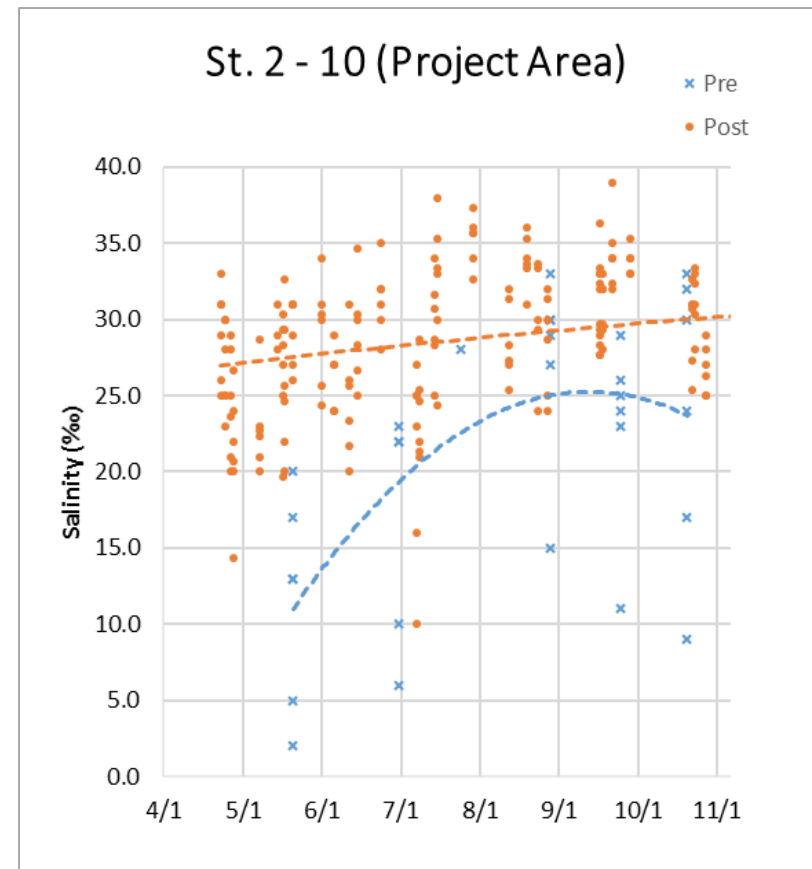
Pore water salinity

U/S marsh is now saltier overall, especially earlier in the spring (growing season) and later in the year

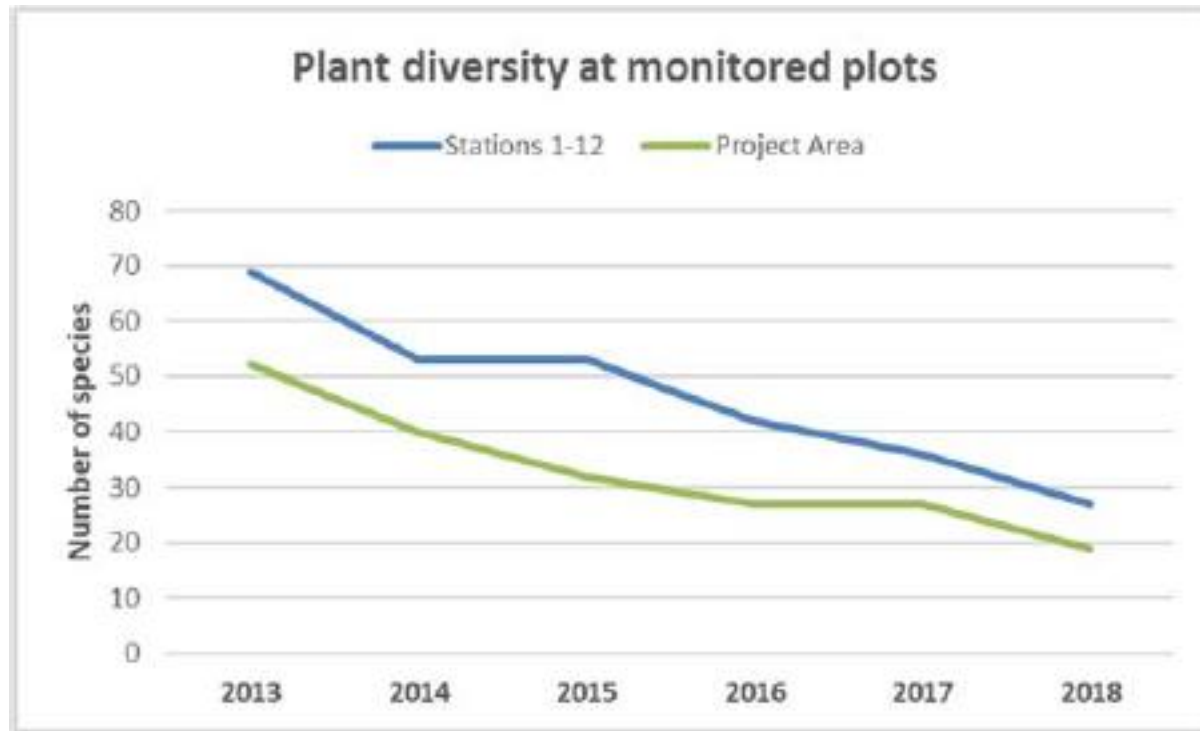
Vegetation - diversity

- Ongoing decline across all stations from 69 (2013) to 27 (2018)

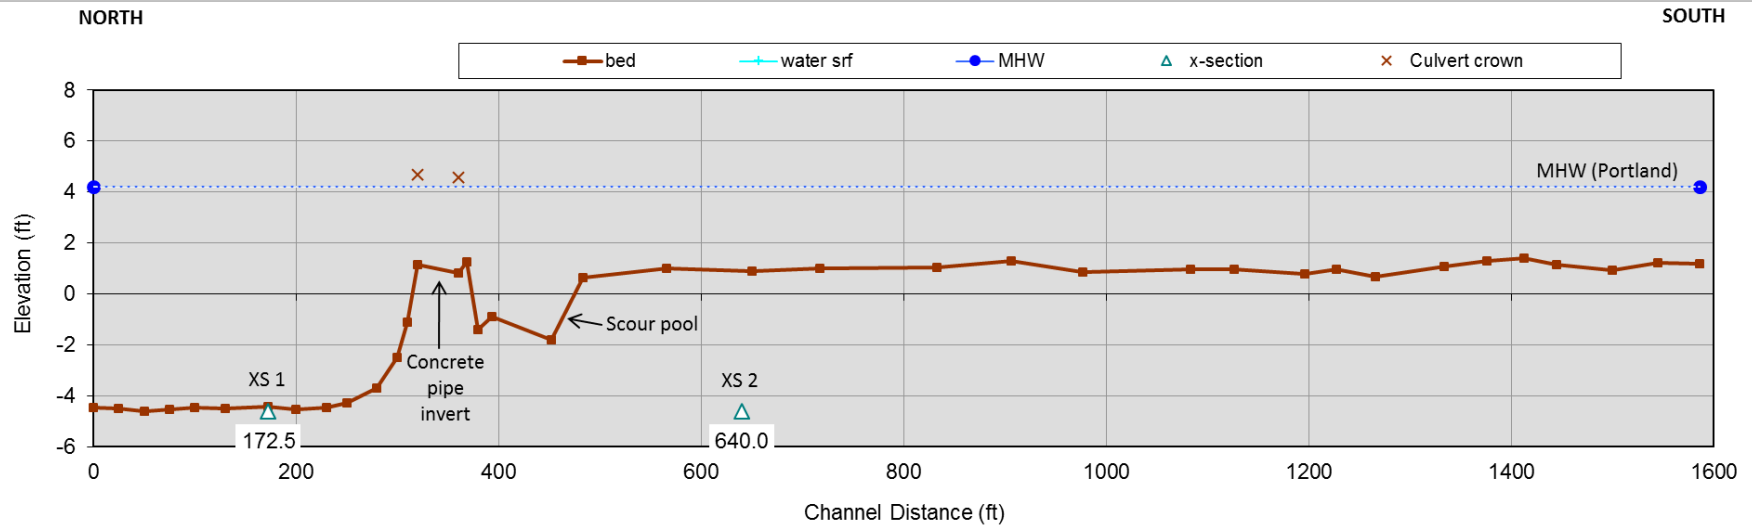
PRE

Channel morphology: longitudinal profile

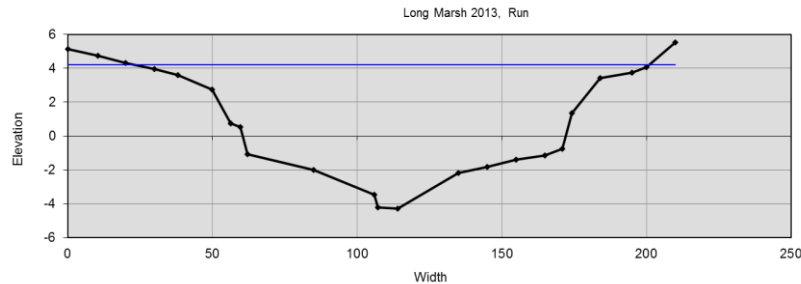
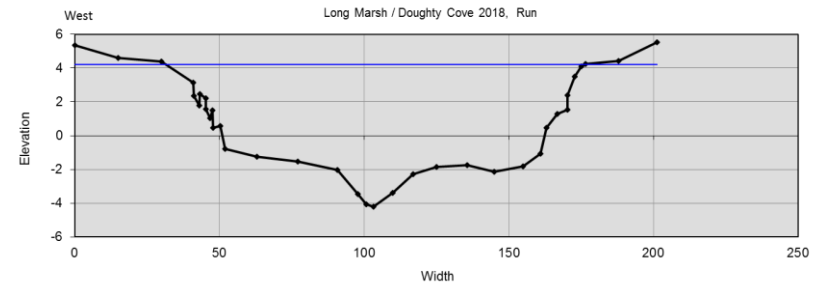
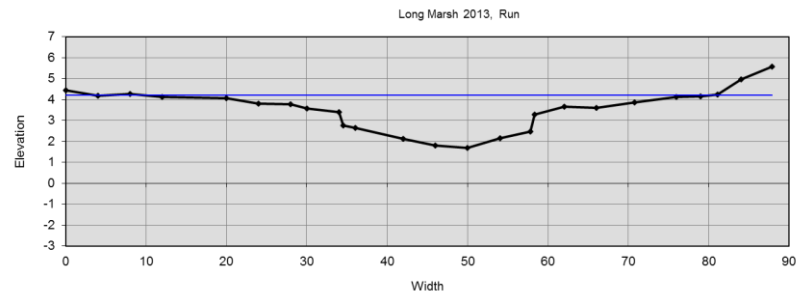
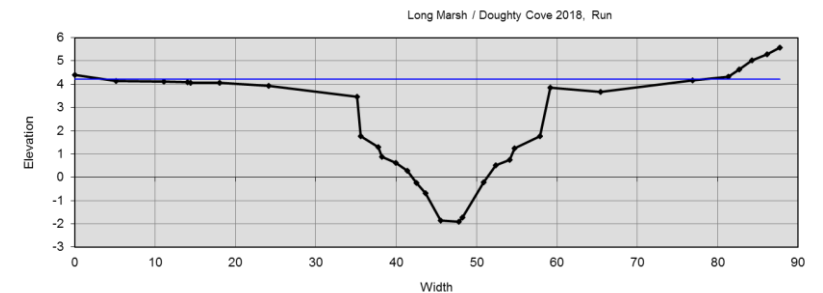
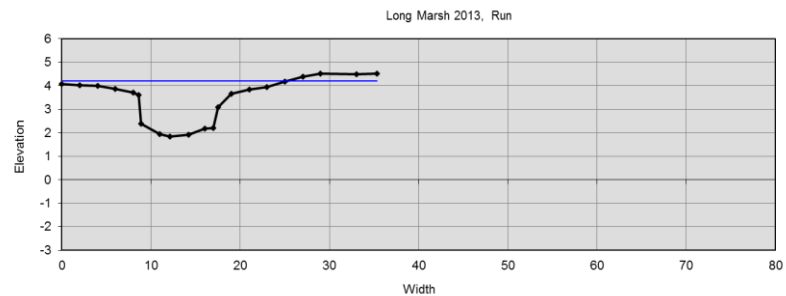
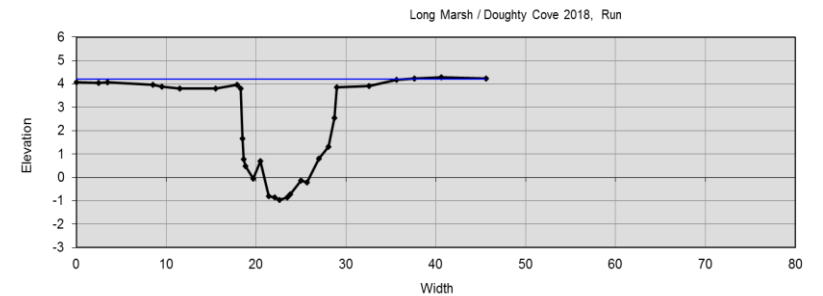
Channel morphology: cross sections

PRE

2018

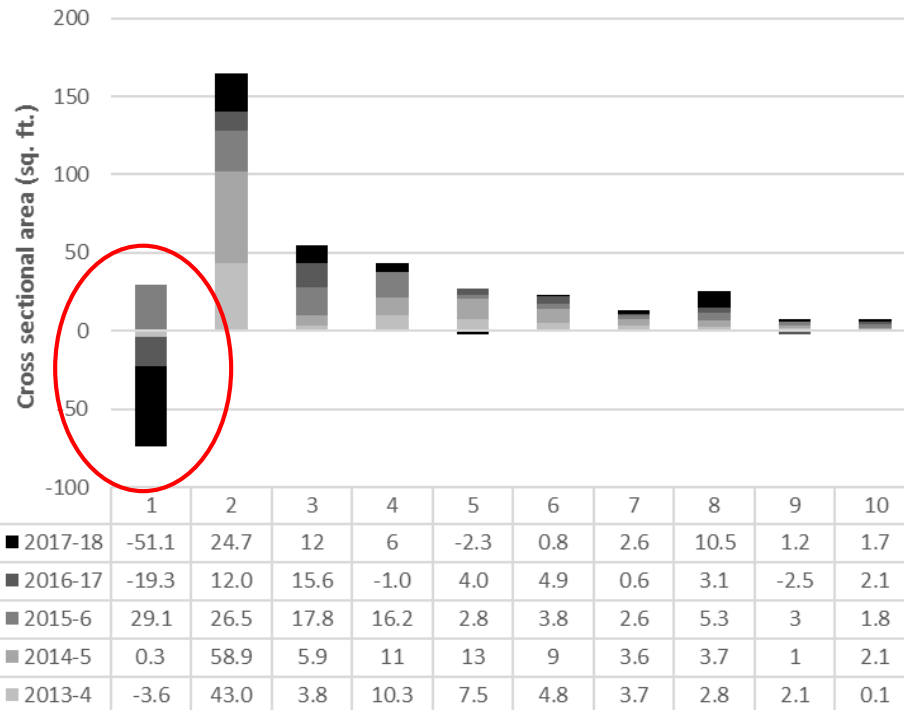
Year-to-year gross change in cross sectional area

Channel morphology: cross sectional area
