# 2019-2020 Water Quality and Eelgrass Survey Updates

Division of Environmental Assessment  
Bureau of Water Quality

MAINE DEPARTMENT OF ENVIRONMENTAL PROTECTION

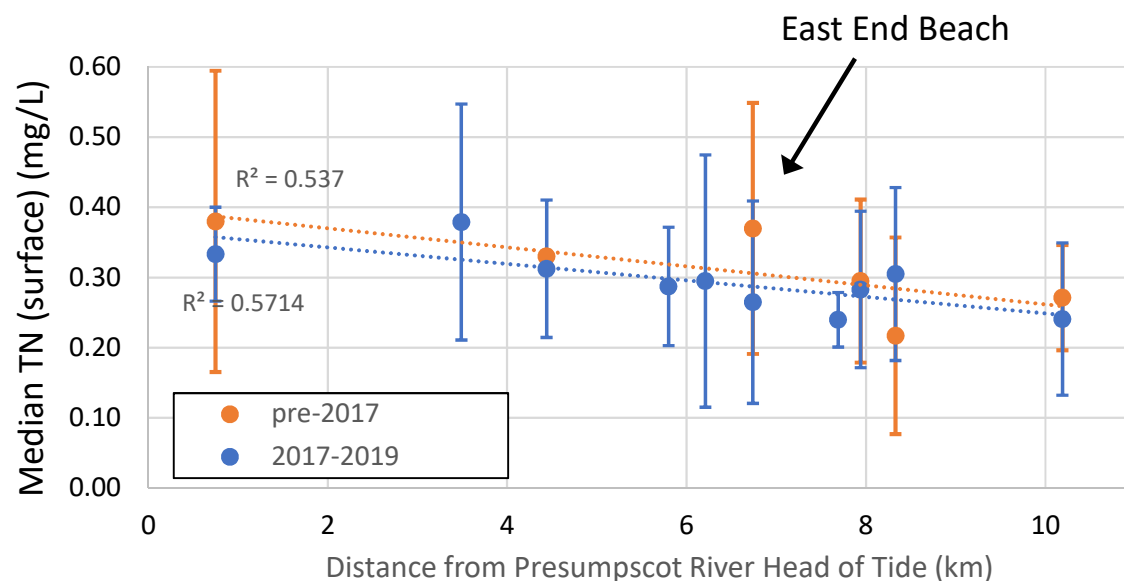
➤ Total Nitrogen values still reflect estuarine gradient with subtle difference between oligohaline to euhaline areas

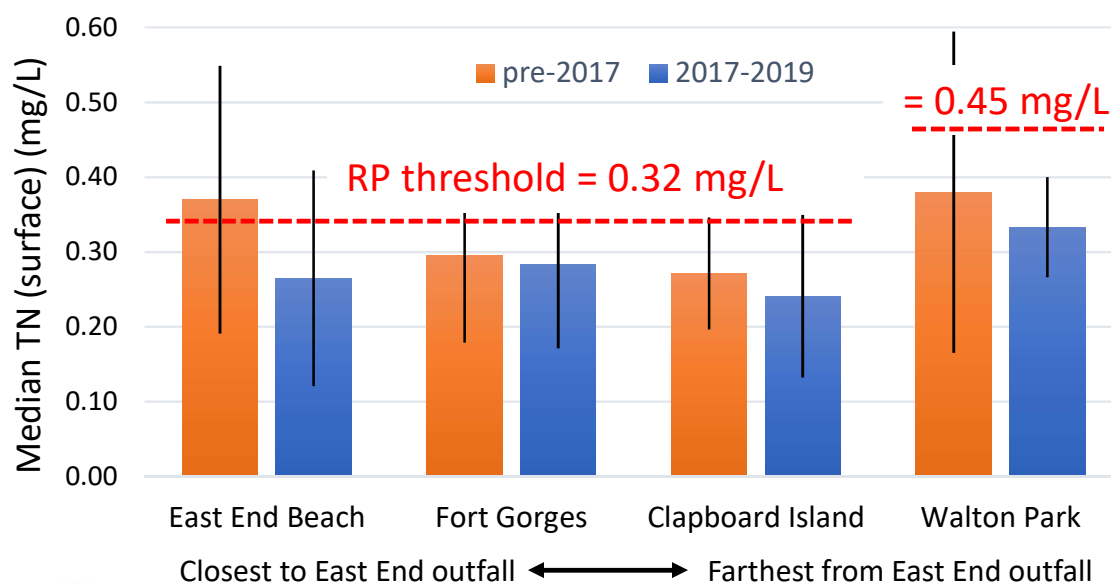
➤ East End vicinity [TN] under RP threshold in 2017-2019

➤ Since pre-2017, East End Beach site median [TN] 30% lower

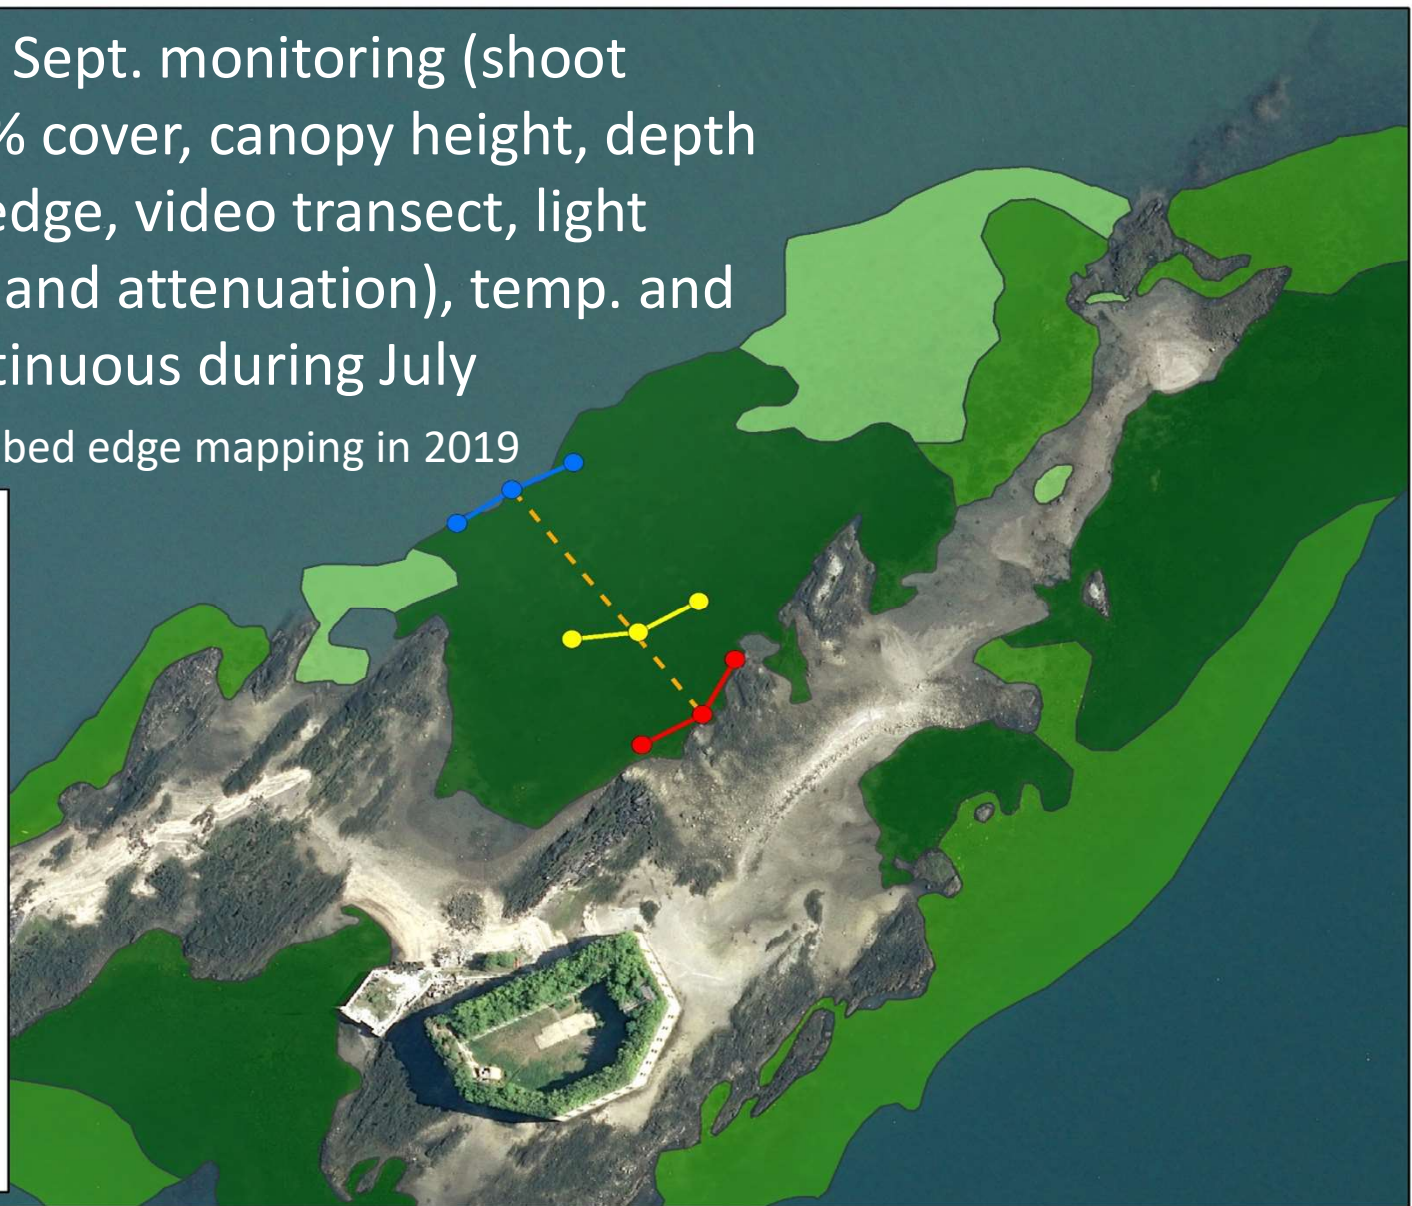
**Fig. 4: Fort Gorges  
Transects 2018**

- Transect 1
- Transect 2
- Transect 3
- - - Transect 4

**Eelgrass**

**Cover Class 2018**

- 1: 0 - 10%
- 2: 10.1 - 40%
- 3: 40.1 - 70%
- 4: >70%

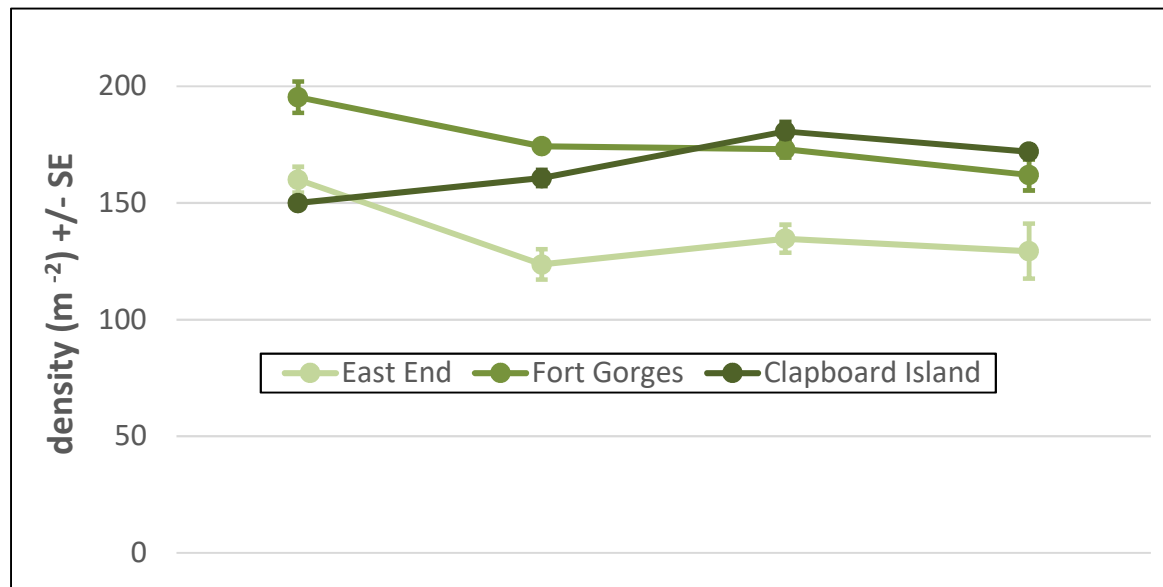
- Intermediate transect density data showed no evident within site differences, though East End least dense site in 2019

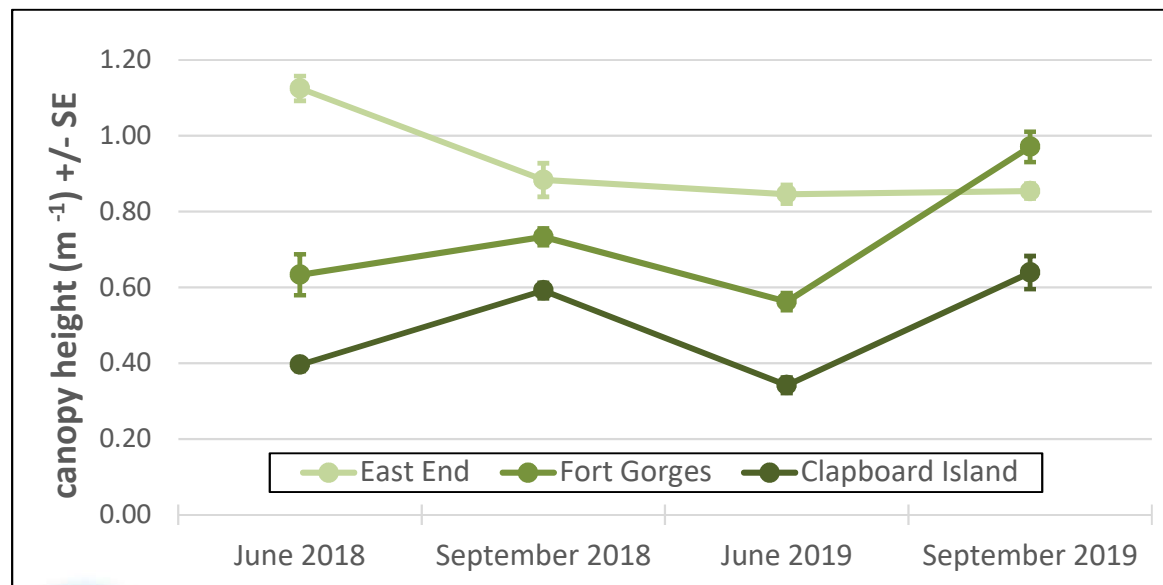
- Intermediate transect canopy height data showed longer shoots with proximity to East End, interesting uptick in canopy height in Sept. 2019

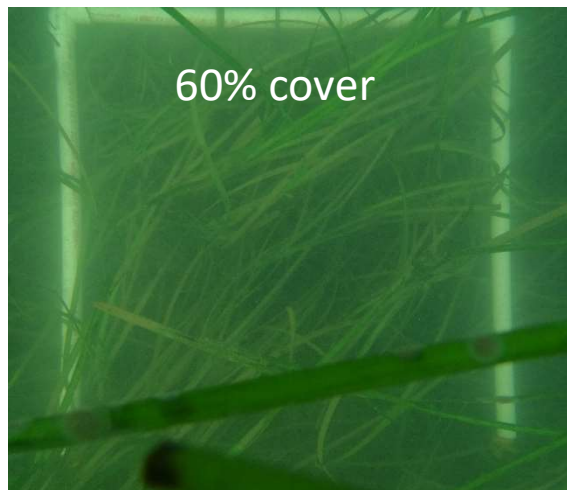
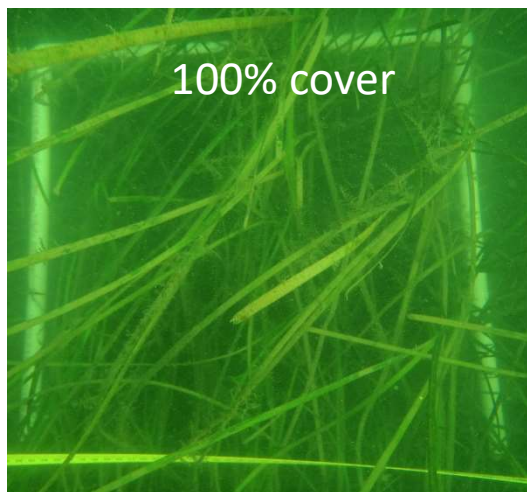
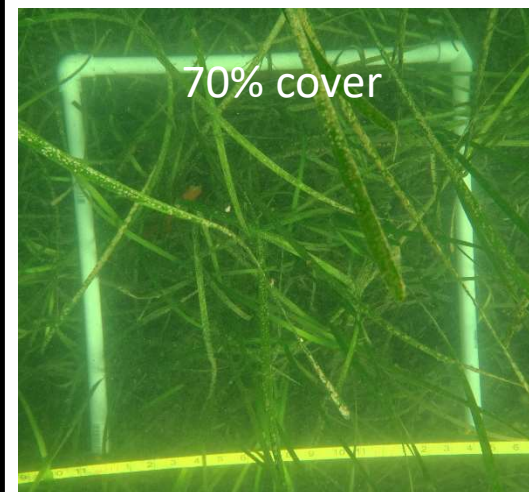
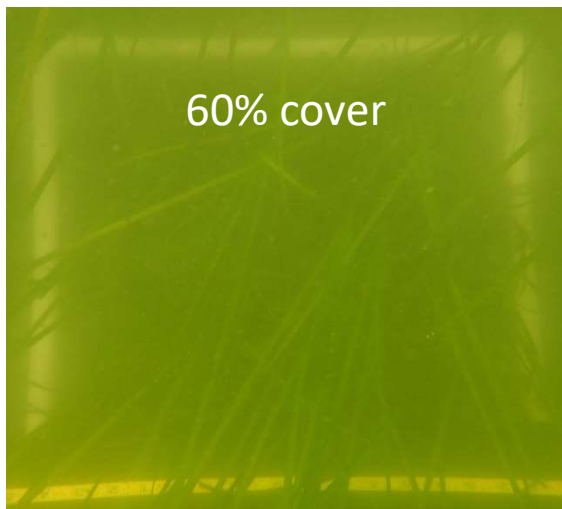
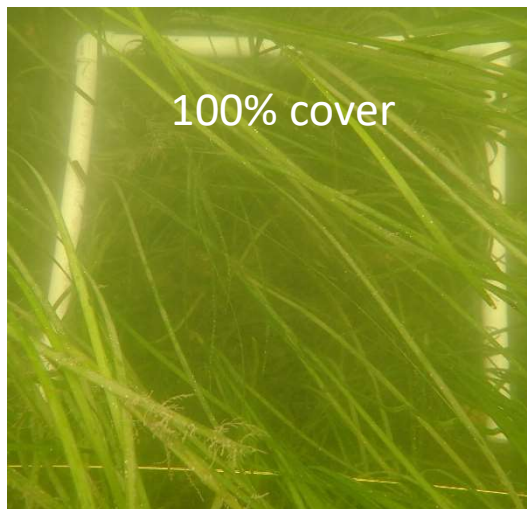
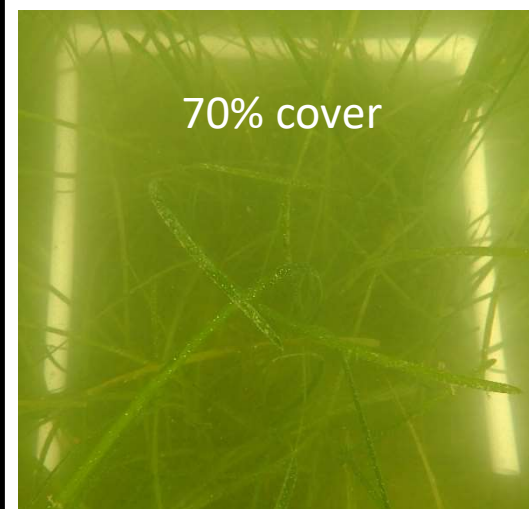
Sept. 2018

East End

Fort Gorges

Clapboard Isl.

Sept. 2019

60% cover

100% cover

70% cover
