2018 Water Quality and Eelgrass Survey Updates

Angela Brewer
Division of Environmental Assessment
Bureau of Water Quality

MAINE DEPARTMENT OF ENVIRONMENTAL PROTECTION

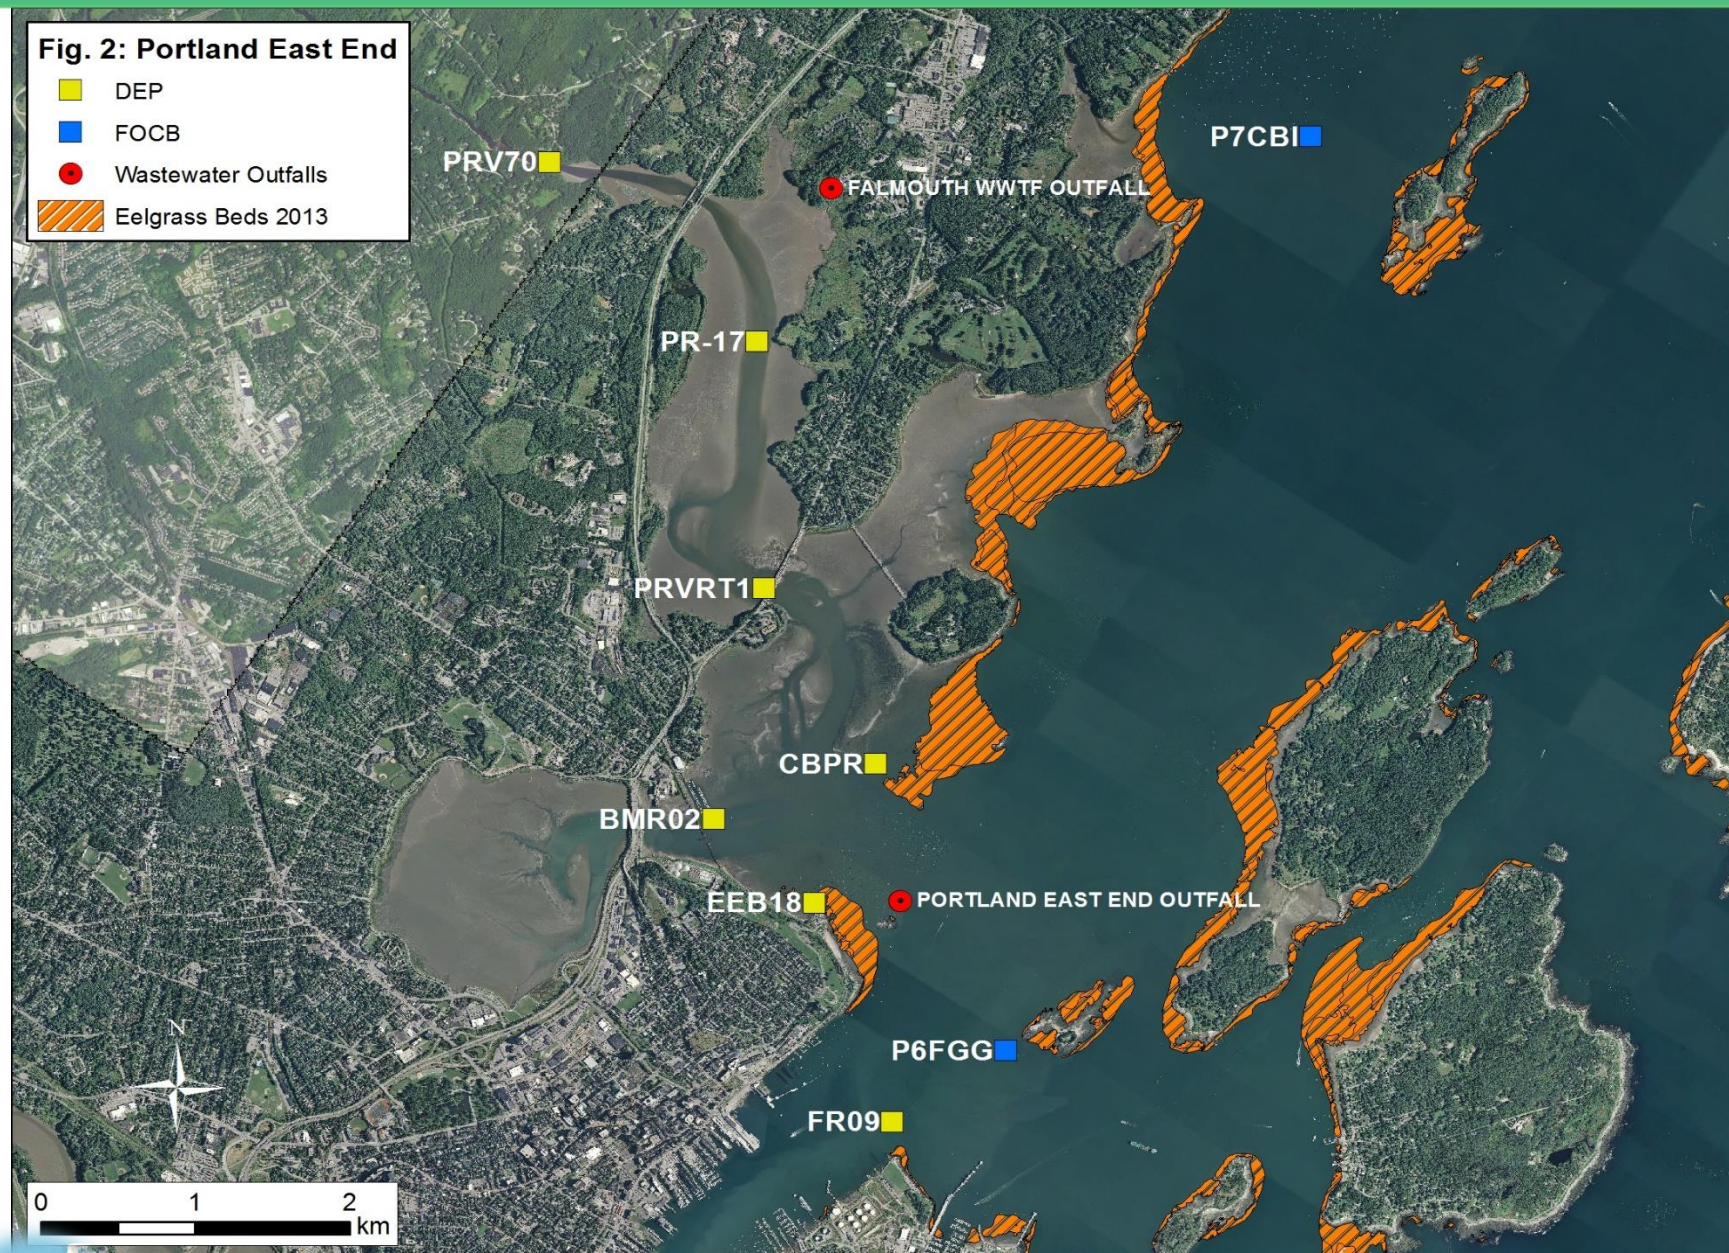
Fig. 2: Portland East End

- DEP
- FOCB
- Wastewater Outfalls
- Eelgrass Beds 2013

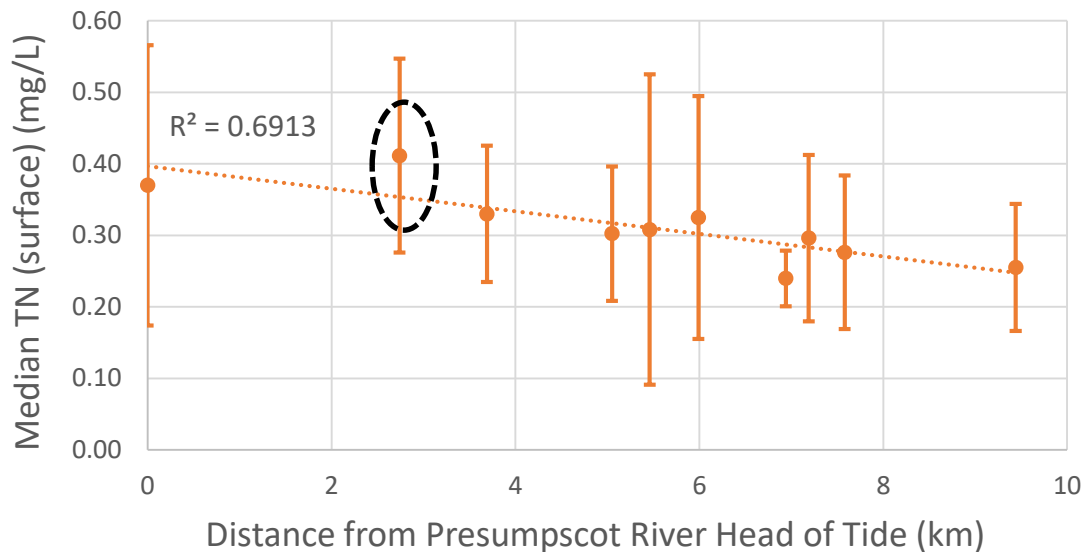
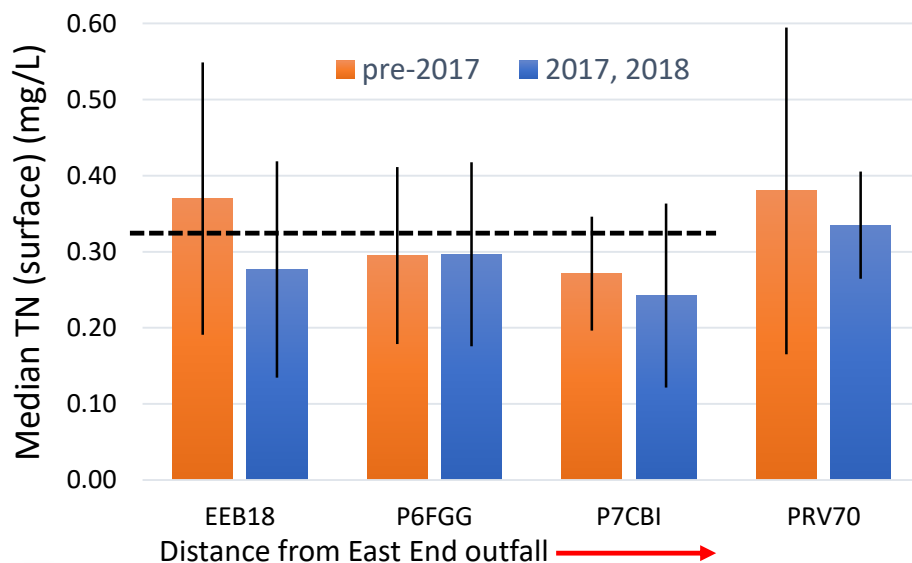
➤ Total Nitrogen values (2007-2018) more reflective of estuarine gradient with rainfall effects than of wastewater influence

➤ PWD East End TN load reduction measurable in the immediate vicinity?

➤ East End vicinity [TN] under RP threshold in 2017, 2018

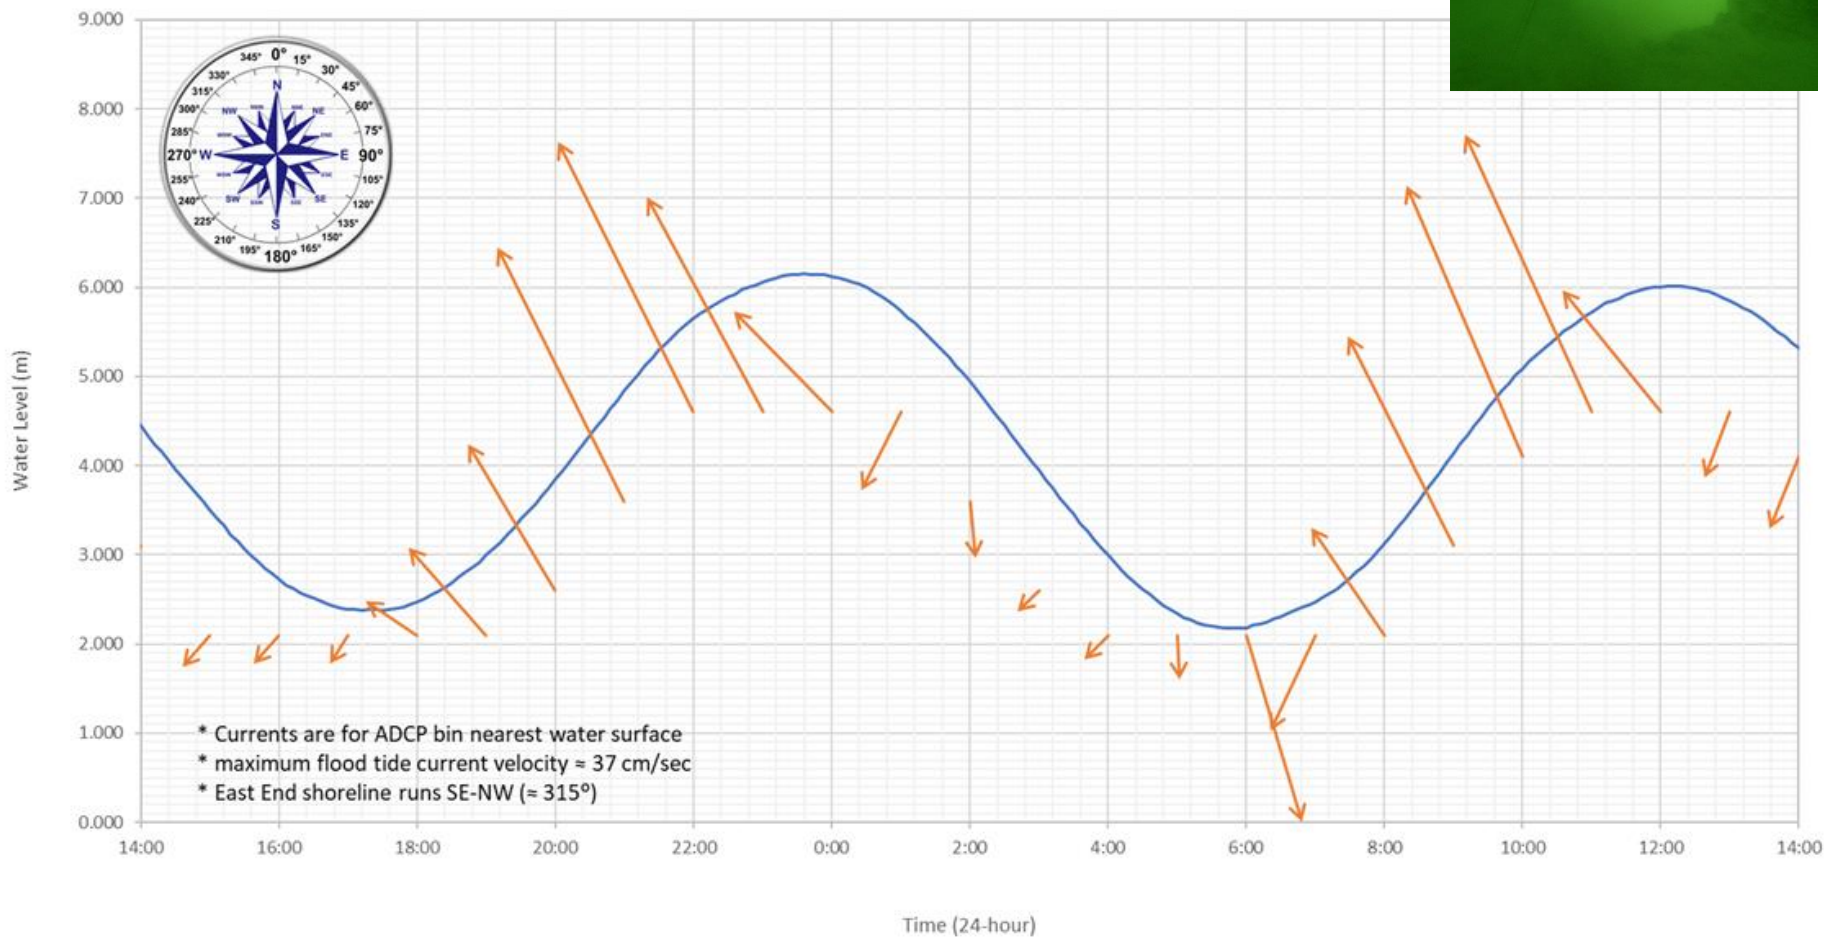
9/9/2018 - 9/10/2018 SPRING TIDE: Hourly Average Surface Currents*

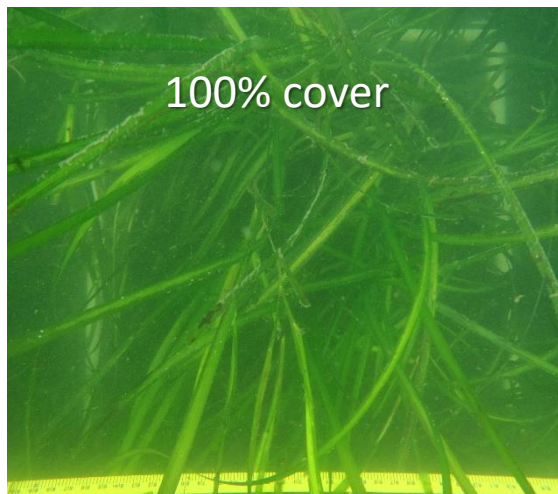
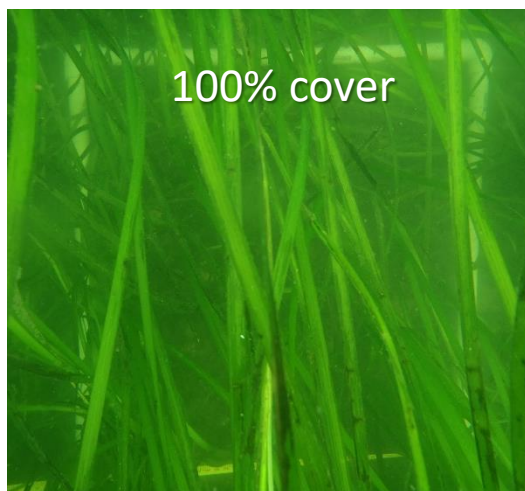
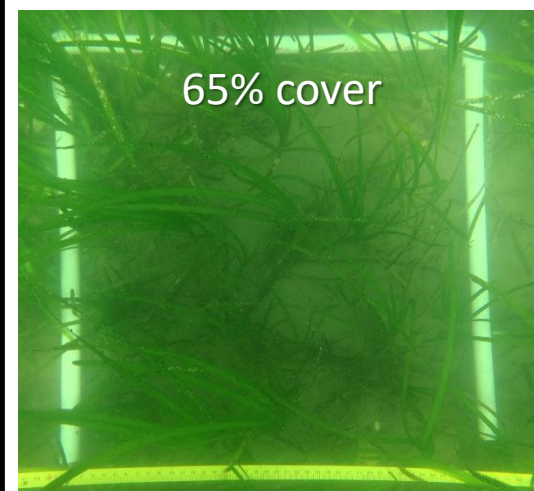
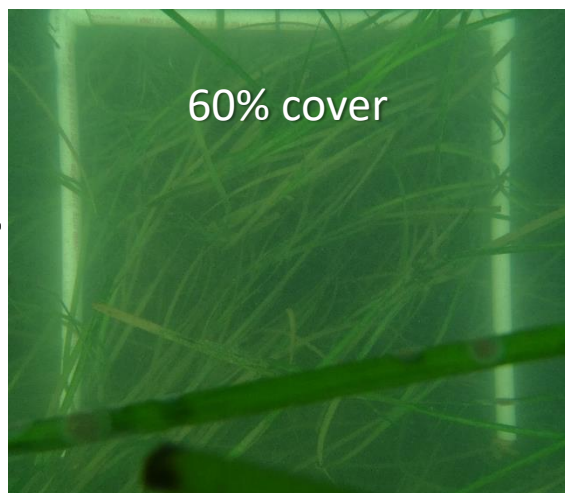
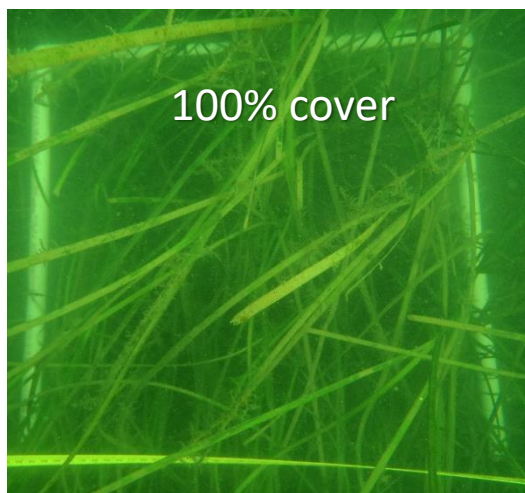
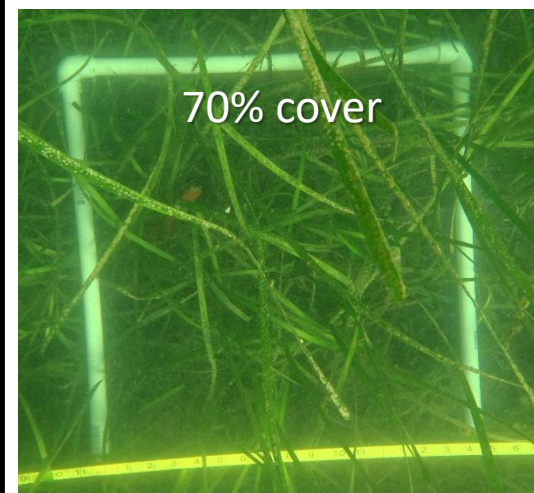
June

East End

Fort Gorges

Clapboard Isl.

Sept.

- Three eelgrass sites set up in June: East End, Fort Gorges, Clapboard Island
 - Three, 50 m-long, permanent transects / site, with 12, 0.25 m² quadrats / transect
 - June and Sept. monitoring (shoot density, % cover, canopy height, light attenuation and intensity, temp., depth at deep edge, video transect)
