**PORTLAND ISLANDS CLAM FLAT
TECHNICAL ASSISTANCE PROJECT**

Casco Bay Estuary Project

Normandeau Associates, Inc.

April 1998

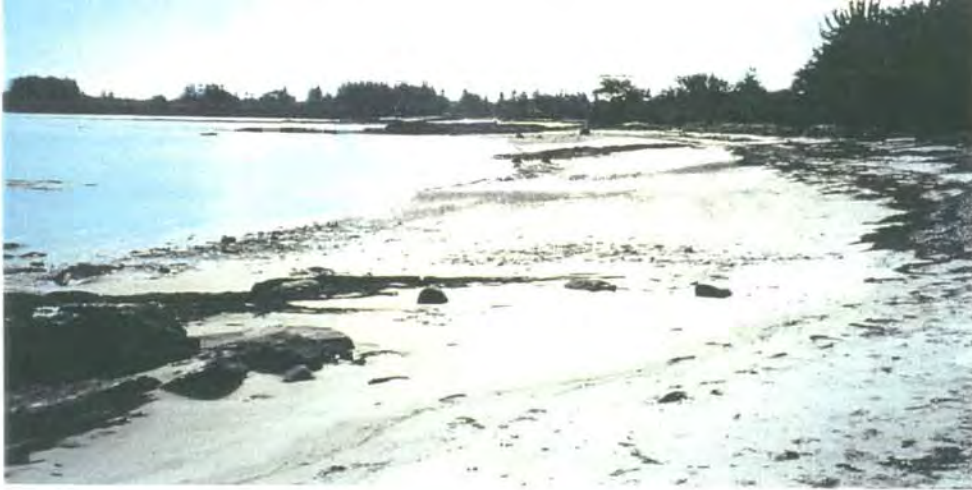
Centennial Beach, Peaks Island looking south

Centennial Beach on the western shore of Peaks Island has coarse to medium sand in the upper beach giving way to fine sand/silt substrate in the lower intertidal, similar to Northeast Beach on Cliff Island but with less ledge and fewer cobbles and boulders. The beach is approximately 2500 feet long and 250 feet wide at mean low water, roughly 16 acres. Extensive eel grass beds occur subtidally. Twenty two-foot-square sample plots were dug. Eleven stations yielded 55 clams, ranging from 15mm to 70mm (Table 2). Most clams were found in the mid-tidal zone in fine to medium sand.
