**EXPANDING AND SUSTAINING THE SHELLFISHERIES
OF CASCO BAY — PHASES II AND III
CASCO BAY ESTUARY PROJECT**

September 2003

Prepared for
CASCO BAY ESTURARY PROJECT
University of Southern Maine

Prepared by
NORMANDEAU ASSOCIATES, INC.
253 Main Street
Yarmouth, Maine 04096

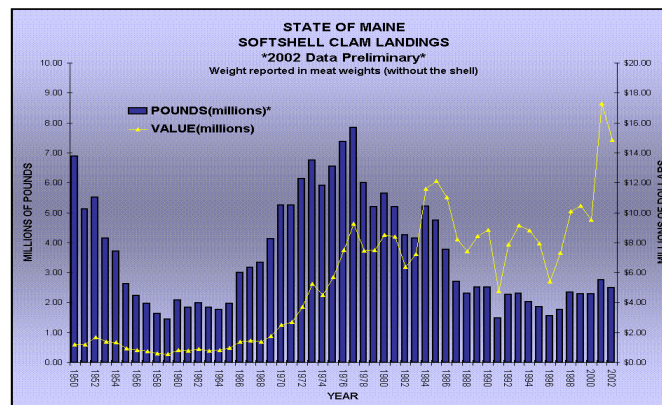
Figure 1.1-1. State Of Maine Annual Soft-shell Clam Landings (source: Maine Department of Marine Resources, 2003 — www.state.me.us/dmr)

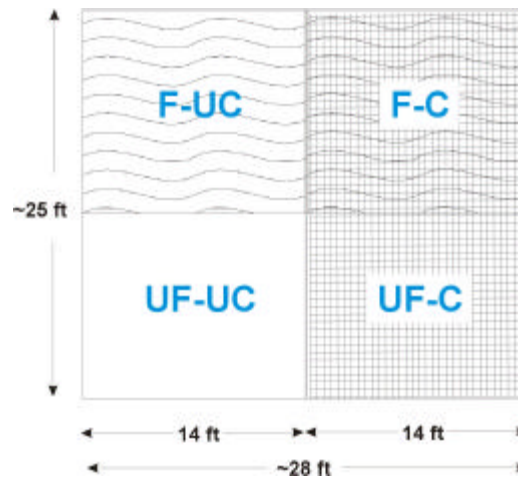
Figure 4.3-2. Standard Experimental Plot Layout

pushed through the mesh and into the mud at each corner. Mesh was also applied to the control plot even though no seed was distributed. The individual site layouts are shown in Figures 4.3-3 through 4.3-7.

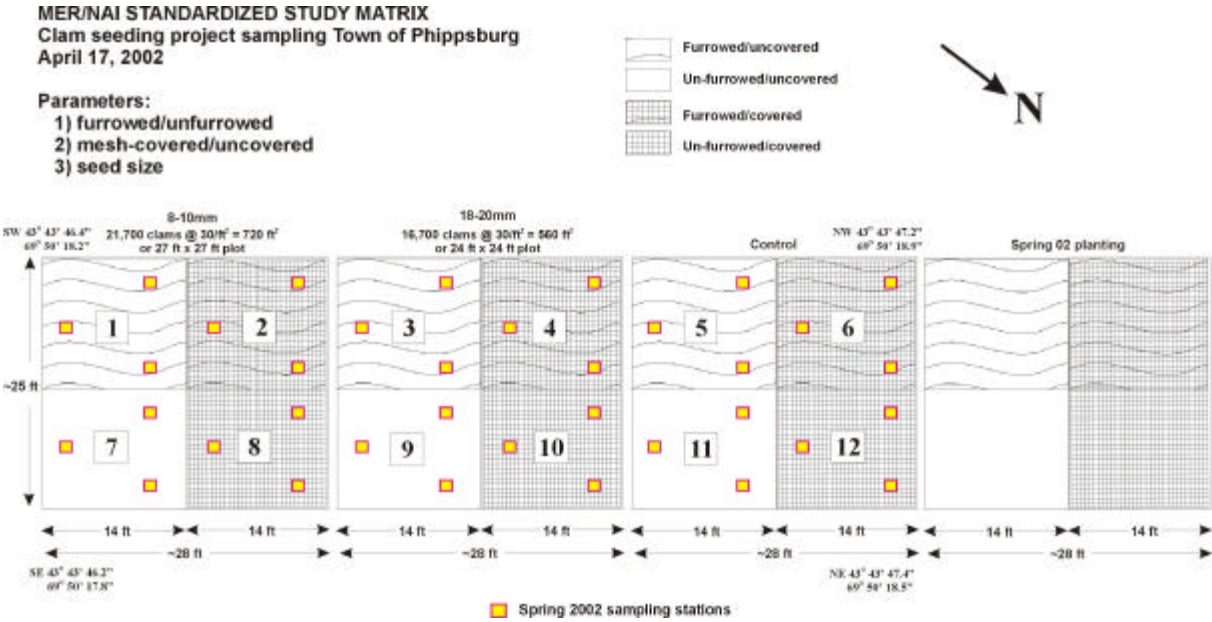
Figure 4.3-4. Experimental and Spring 2002 sampling layouts at Lobster House Cove, Phippsburg

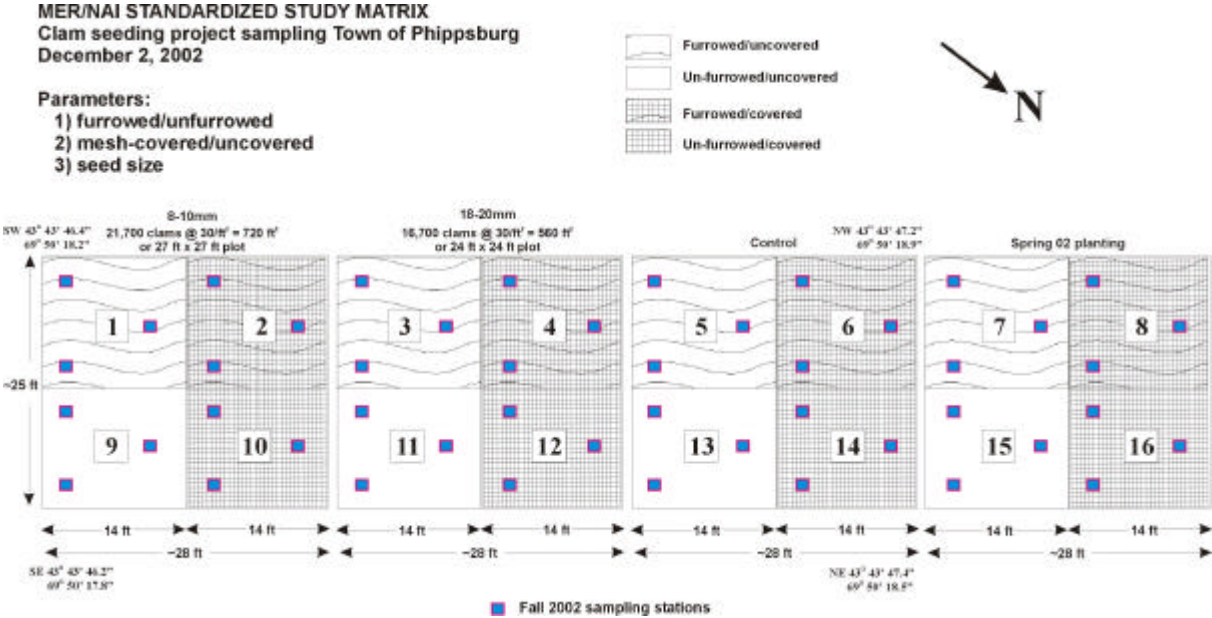
Figure 4.3-6. Fall 2002 sampling layout at Lobster House Cove, Phippsburg

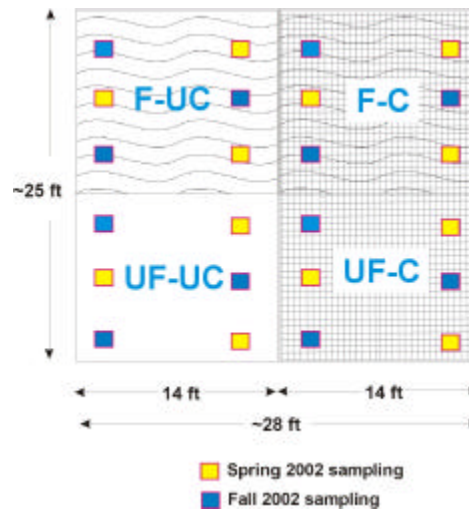
Figure 4.3-9. Spring 2002 and Fall 2002 Sampling Station Arrangement

To ensure proper identification of samples, each treatment plot was assigned a number, (in Spring 2002 from 1 through 12 and in Fall 2002 from 1 through 16), and each sampling station within the treatment was assigned a letter, A through C, tied to the treatment number, e.g., 2A, 2B, 2C, and so on. A station identification tag bearing the station number was stapled to a small stake placed at each sampling station location.

Individual samples were taken at each sampling station by marking the sampling area with the imprint of a 1-ft² wooden frame, removing all sediment within the imprint area to a depth of approximately 8-10 inches, and placing the entire sediment sample and station identification tag into a double lined plastic bag. All of the bagged samples were transported to a sieving site where the samples were sieved through approximately 1mm mesh window screen. All soft-shell clams retained by the mesh, including those outside of the study size range, were measured and recorded.
