Restoration of Riparian Buffer at the Former Smelt Hill Dam Site, Falmouth, Maine

Final Report

June 30, 2006

**Gulf of Maine
Council on the
Marine Environment**

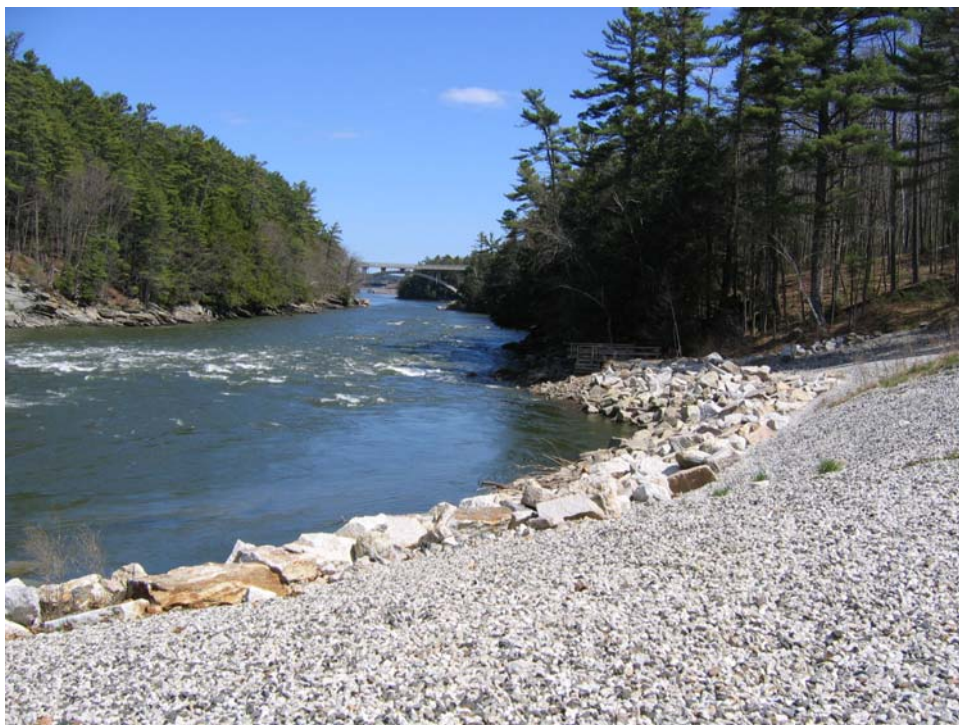
May 2005. Presumpscot River southern shore facing downstream at site of Smelt Hill dam removal.

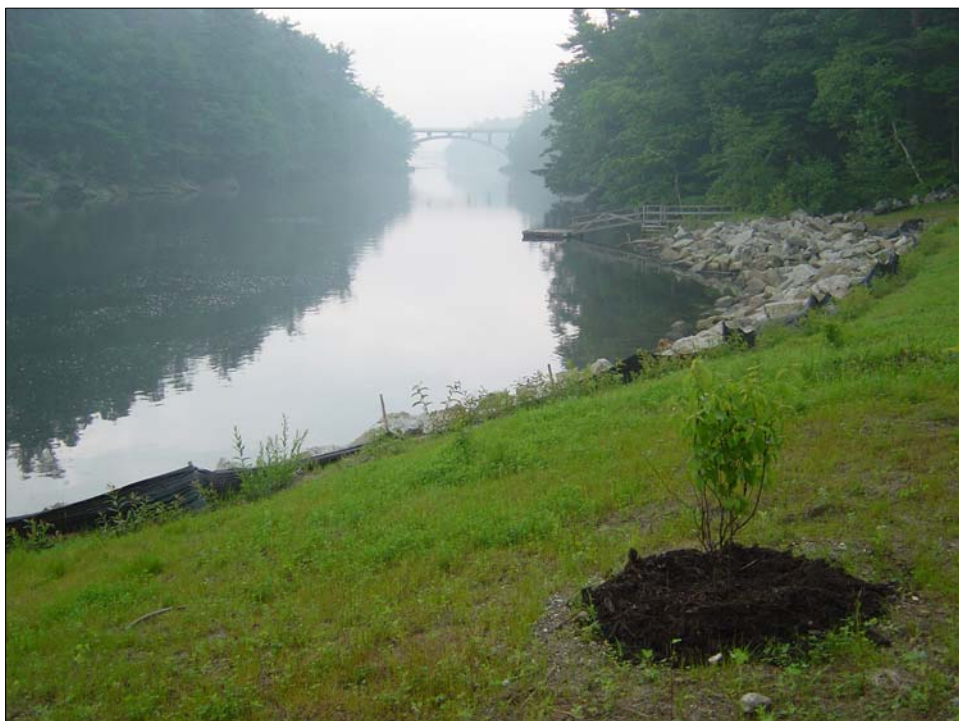
June 2006. Presumpscot River southern shore facing downstream at site of Smelt Hill dam removal. Note willow waddles planted during fall 2005 flourishing in front of silt fence along the length of the site.

- Phase I:
 - 100% of the willow waddles planted in the fall of 2005 show extensive leafing and appear to be establishing a solid vegetated strip along the length of the riverbank.

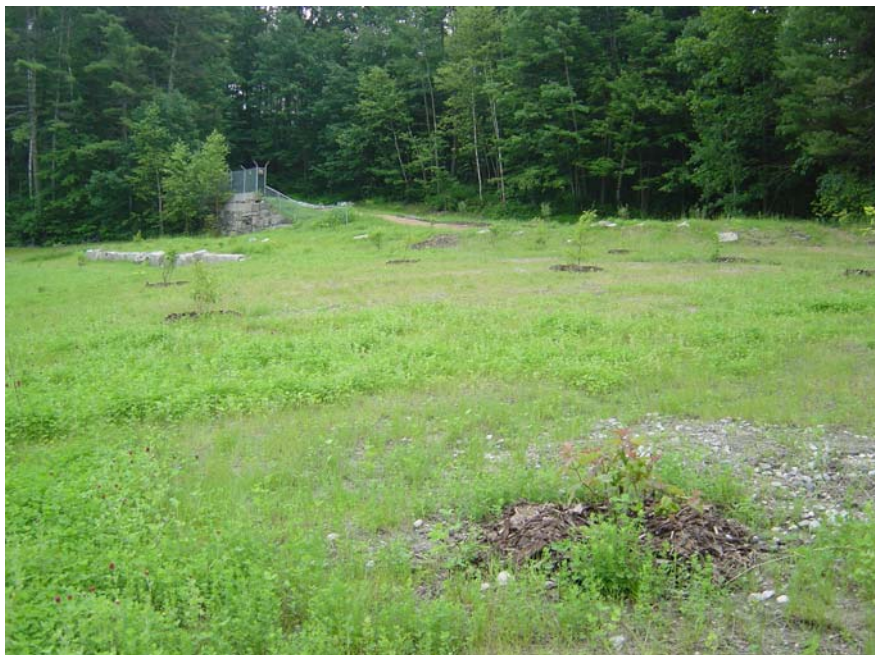
June 29, 2006. Site post- Phase II implementation. Note granite wall to the left, which was unearthed during Phase I regrading activities.
