Recommendations for Future Restoration and Management Efforts for Mill Brook, Westbrook, Maine

Includes Appendices of Data Sets and Reports from Various Organizations
on the Status of Mill Brook

May 16, 2008

Casco Bay Estuary Partnership
Habitat Restoration Committee

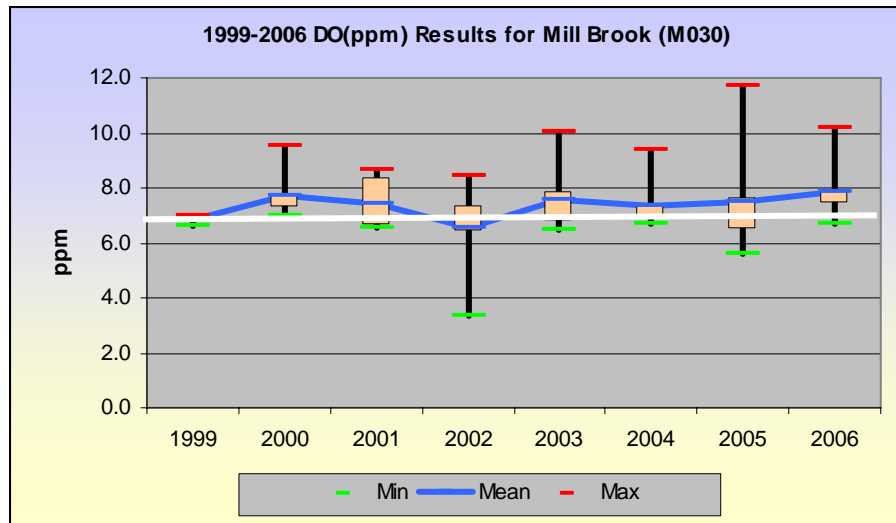
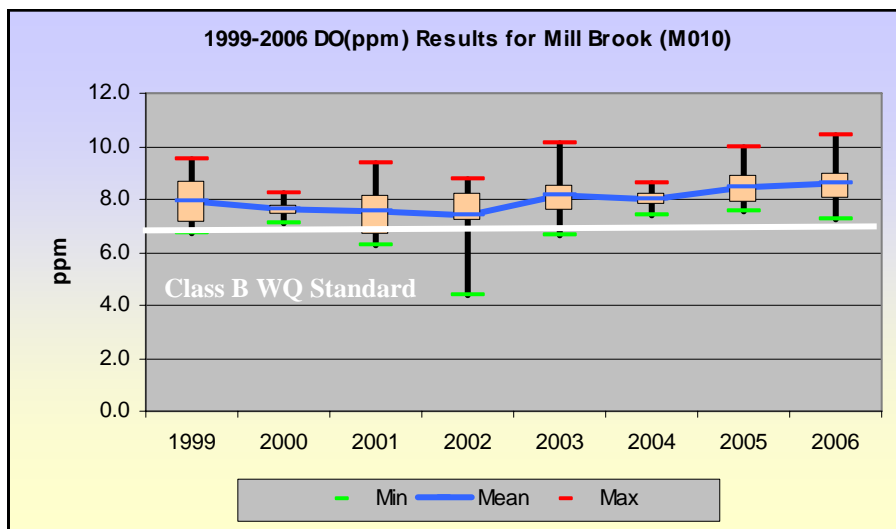
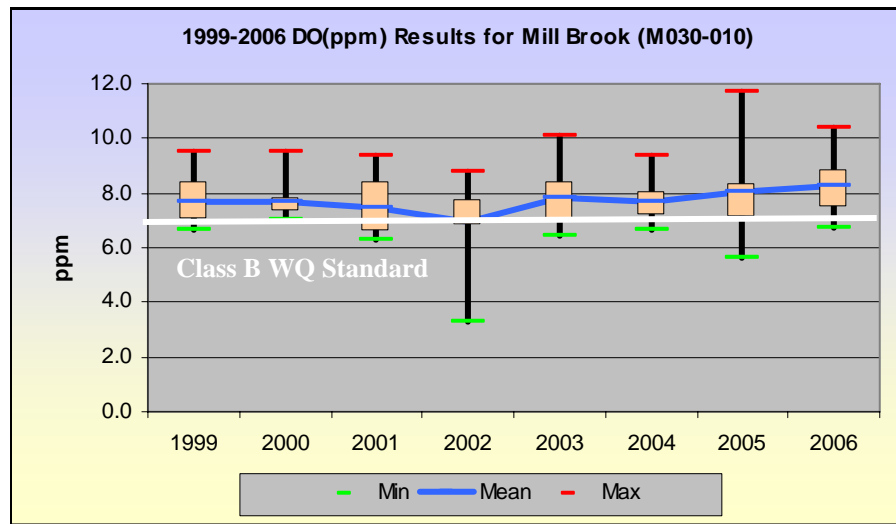
Figure 5. Dissolved oxygen summary data for two Mill Brook sites: M030 (at Hwy 302) and M010 (at E. Bridge St.), individually, and combined (bottom graph). Data provided by Presumpscot River Watch.

- D. O. measurements reflect early morning conditions in Mill Brook (Figure 5 [page 10]). Measurements were made between 6:00 and 9:00 AM, with very few exceptions.

- D. O. measurements taken near Mill Brook’s confluence with the Presumpscot River (site M010) did not detect any violations of Class B standards (i.e., drop lower than 7 ppm) during half of the years included in the analysis. Median values at this site generally were higher than those at the Hwy 302 site (M030) on an annual basis.

- D. O. measurements taken at the Hwy 302 site (M030) detected some violations of Class B standards (i.e., drop lower than 7 ppm) during 7 out of 8 years included in the analysis. A small number of D. O. measurements lower than 4 ppm were detected at this site in 2002. Median values at this site generally were higher than those at the Hwy 302 site (M030) on an annual basis.

- D. O. measurements at the downstream end of Mill Brook (site M010) may have generally been higher because it was a greater distance downstream of Highland Lake which likely had warm water flowing out of its outlet during warm parts of the year. (Cold water can hold more D. O. than warm water.) The existence of a healthy riparian forest and inputs of cold groundwater seeps, probably helped D. O. levels improve from upstream to downstream. This is an interesting finding due to

the fact that the lower sections of Mill Brook are flatter and have less riffle (aerating) habitats than the upper portions of Mill Brook.

- Most D. O. results met state standard of 7 ppm (or greater) for Class B streams when combining the results of both the upstream (near Hwy 302; site M030) and downstream (near E. Bridge St.; site M010) monitoring sites.

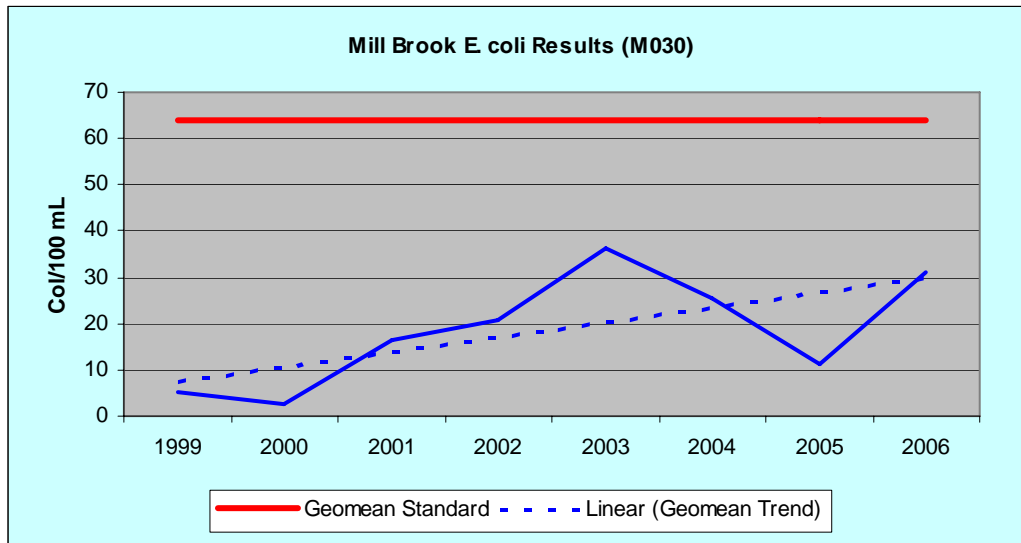
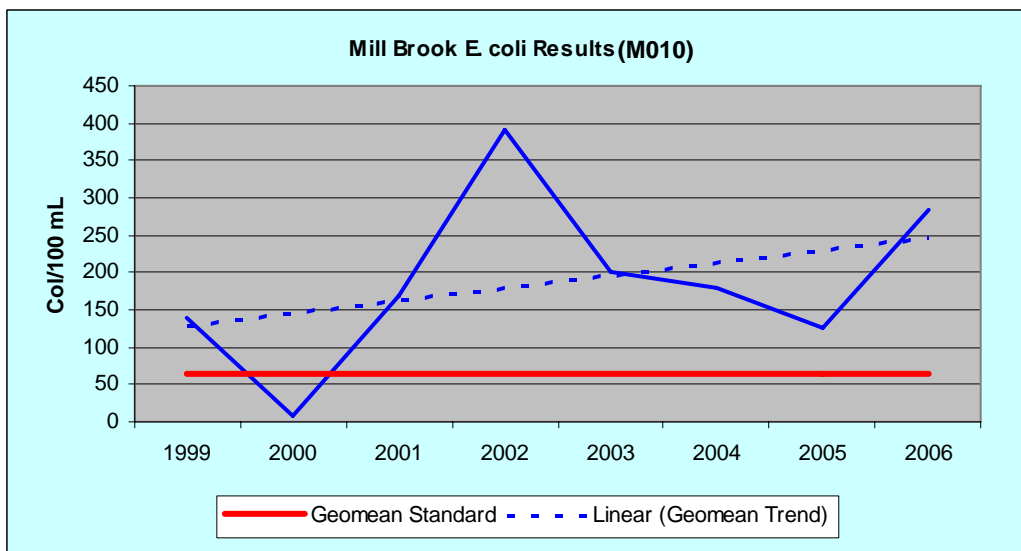
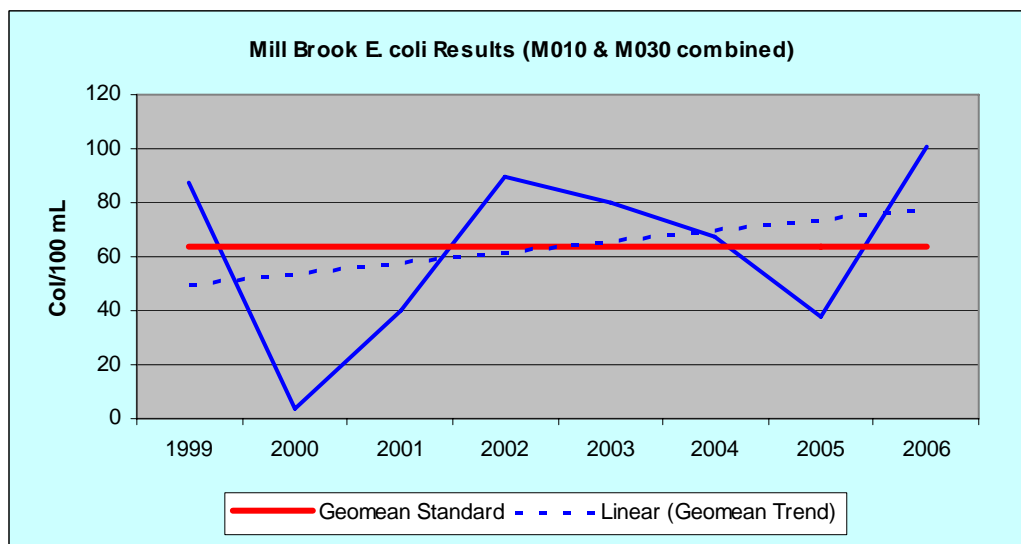
Figure 6. *E. coli* bacteria summary data for two Mill Brook sites: M030 (at Hwy 302) and M010 (at E. Bridge St.), individually, and combined (bottom graph). Data provided by Presumpscot River Watch.

- E. coli bacteria numbers exhibited a large range of readings within each year, likely influenced by sampling during both dry and wet weather (Figure 6 [page 11]).
- While between year variability was rather high, trend lines indicated that an increase in E. coli bacteria appeared to be occurring between 1999 and 2006 at each of the two monitoring sites.
- E. coli numbers were generally higher at the downstream site (M010), sometimes by an order of magnitude, than at the upstream site (M030).
- The number of E. coli bacteria exceedances increased during 1999-2006 (Table 2). This increase may be partly due to a 2005 change in DEP Class B instantaneous standards from 427 to 236 col/100 mL as well as greater seasonal rainfall amounts during period from 2004-2006.
