PLEASANT RIVER

WATERSHED MANAGEMENT PLAN

Cumberland County Soil & Water Conservation District

Prepared by Heather True
June 2011

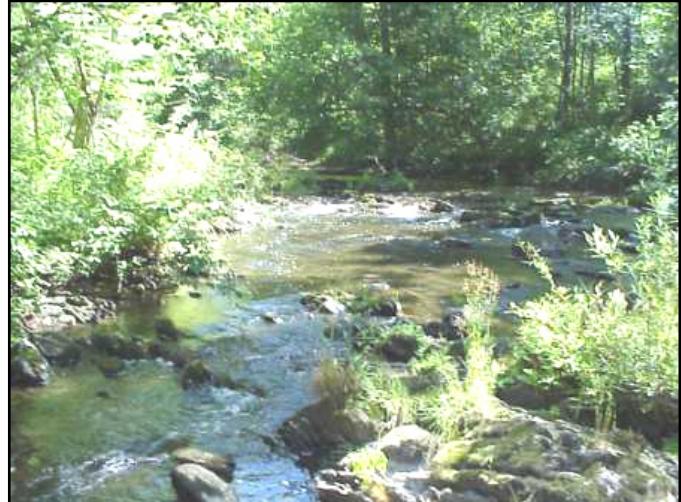
Site of Maine DEP macroinvertebrate sampling location, upstream of Pope Road crossing (Photo Credit: Maine DEP)

In addition to PRW's water quality monitoring program, MEDEP also conducts biomonitoring along the Pleasant River and Baker Brook. Biomonitoring consists of sampling the number and diversity of aquatic organisms to assess the condition of the ecosystem. MEDEP conducts biomonitoring approximately

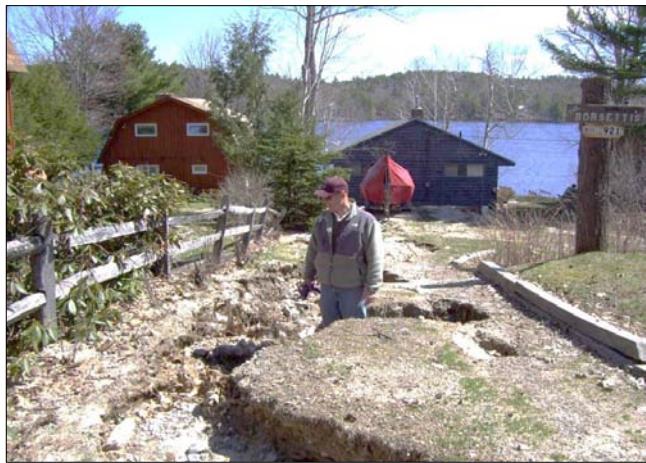
Sediment from erosion sites such as this one on Little Sebago Lake in Windham is the biggest source of pollution to surface waters in Maine.

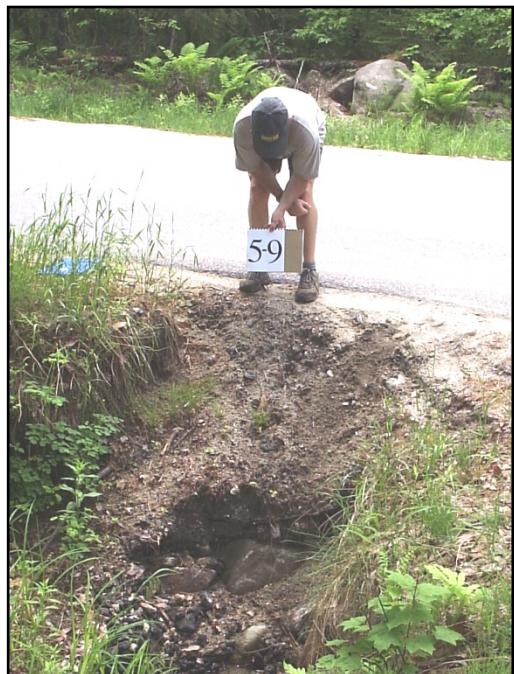
A Pleasant River Watershed Survey volunteer documents road shoulder erosion above a culvert washing into a tributary of the Pleasant River.

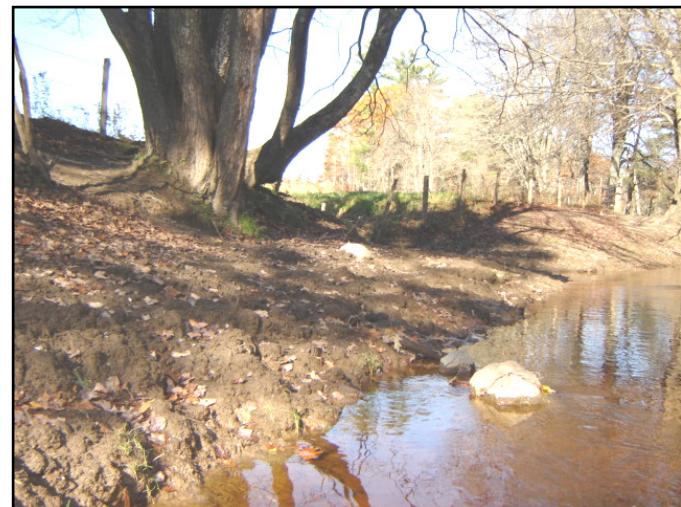
Signs of cattle access to main stem of Pleasant River resulting in stream bank erosion.

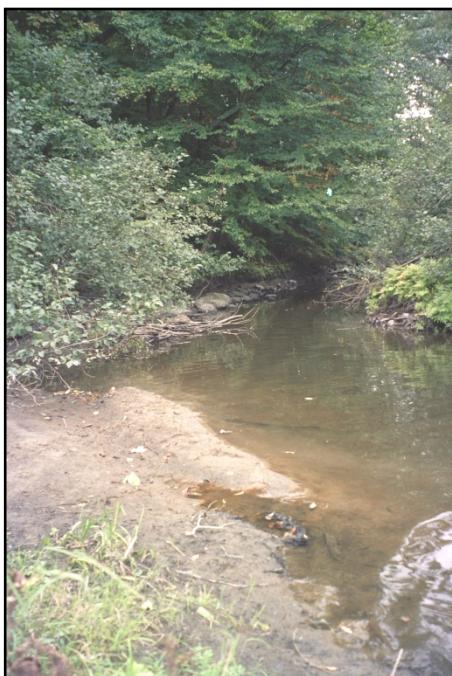
Sediment delta along stretch of Pleasant River in which Brook Floater habitat has been documented. Photo Credit: Maine Dept. IF&W

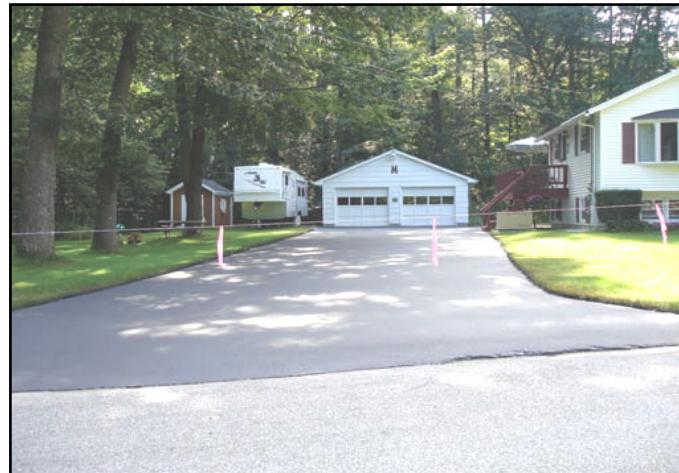
Recently seal-coated driveway in the Pleasant River Watershed; Stormwater picks up harmful polycyclic aromatic hydrocarbons (PAHs) from seal-coating washing them into nearby streams and waterbodies.

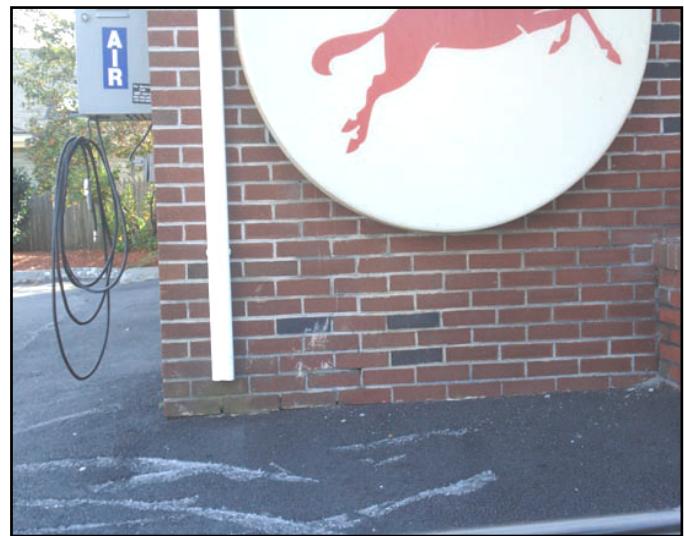
Downspouts draining onto impervious surfaces rather than being filtered into the ground are considered potential "hotspots" due to the potential pollutants the stormwater can pick up and wash into the Pleasant River.

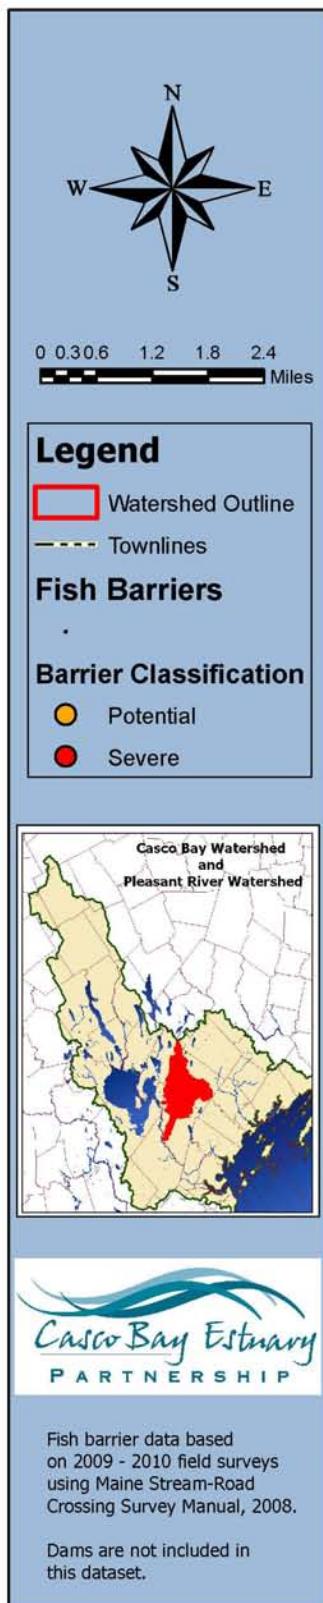
Appendix A: Pleasant River Fish Barriers Map

**Pleasant River Watershed Fish Barriers
Casco Bay Watershed, Maine**
