Casco Bay Watershed

Fish Barrier Priorities Atlas

March 2012

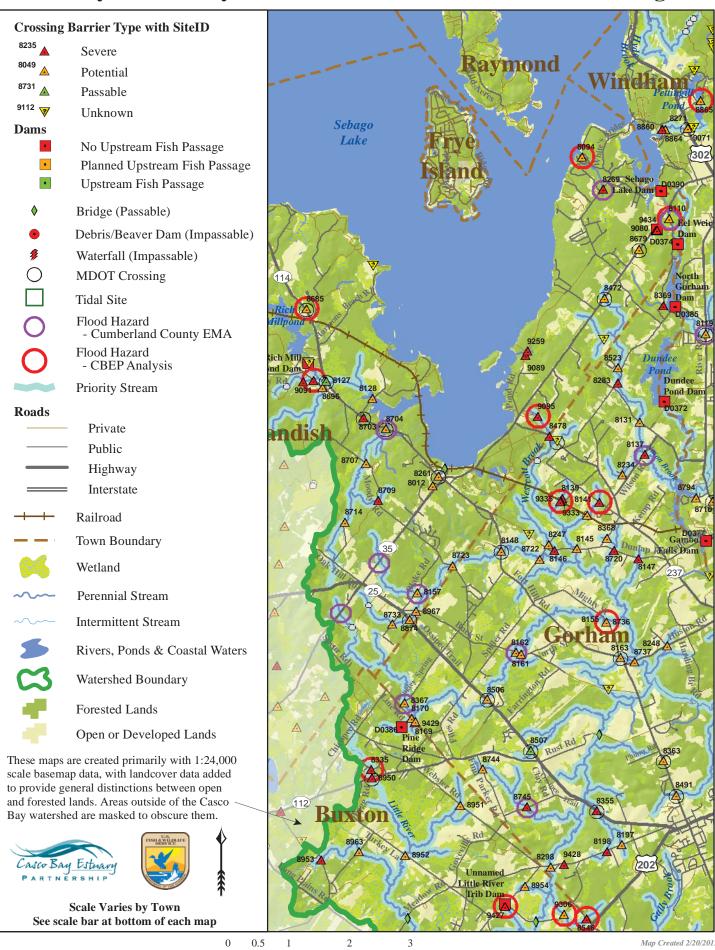
Index Map

Road-stream crossings are shown with SiteID numbers to help identify them in the barrier database. Dams, in most cases, have labels both of SiteID and the dam's common name, if one is known. *Severe* barriers are defined as those road/stream crossings where fundamental physical barriers exist at either the inlet or outlet of the crossing, including inlets or outlets "perched" above the stream channel, and inlets blocked at least 50%, usually by debris. *Potential* barriers cover a wide spectrum of road-stream crossing situations where fish passage problems are likely to exist at some flows for some species or age groups of fish, and passage of other aquatic organisms such as amphibians and macroinvertebrates is likely also limited. Sites that were inaccessible to survey crews, and therefore not surveyed, are shown as unsurveyed, but are included in our analysis as *Potential* barriers. Dams are classified by whether or not they have effective facilities in place to provide upstream fish passage. Natural barriers, including waterfalls, debris jams (including woody debris or rock and fine sediments), and beaver dams were assessed when in close proximity to surveyed crossings and dams, and are mapped as well.

USFWS-GOMCP and CBEP staff consulted with state fisheries biologists to identify streams with important fish habitat, primarily for brook trout or Atlantic salmon, or both. These *priority streams* are highlighted on the maps. The scope of the road/stream crossing barrier assessment was limited to perennial streams, those with continuous flow year round. Although intermittent streams were not surveyed, fish using priority streams also rely on connectivity with intermittent tributaries at various times of year. There are likely to be additional barriers on important intermittent streams that have not been assessed.
