Casco Bay Watershed

Fish Barrier Priorities Atlas

March 2012

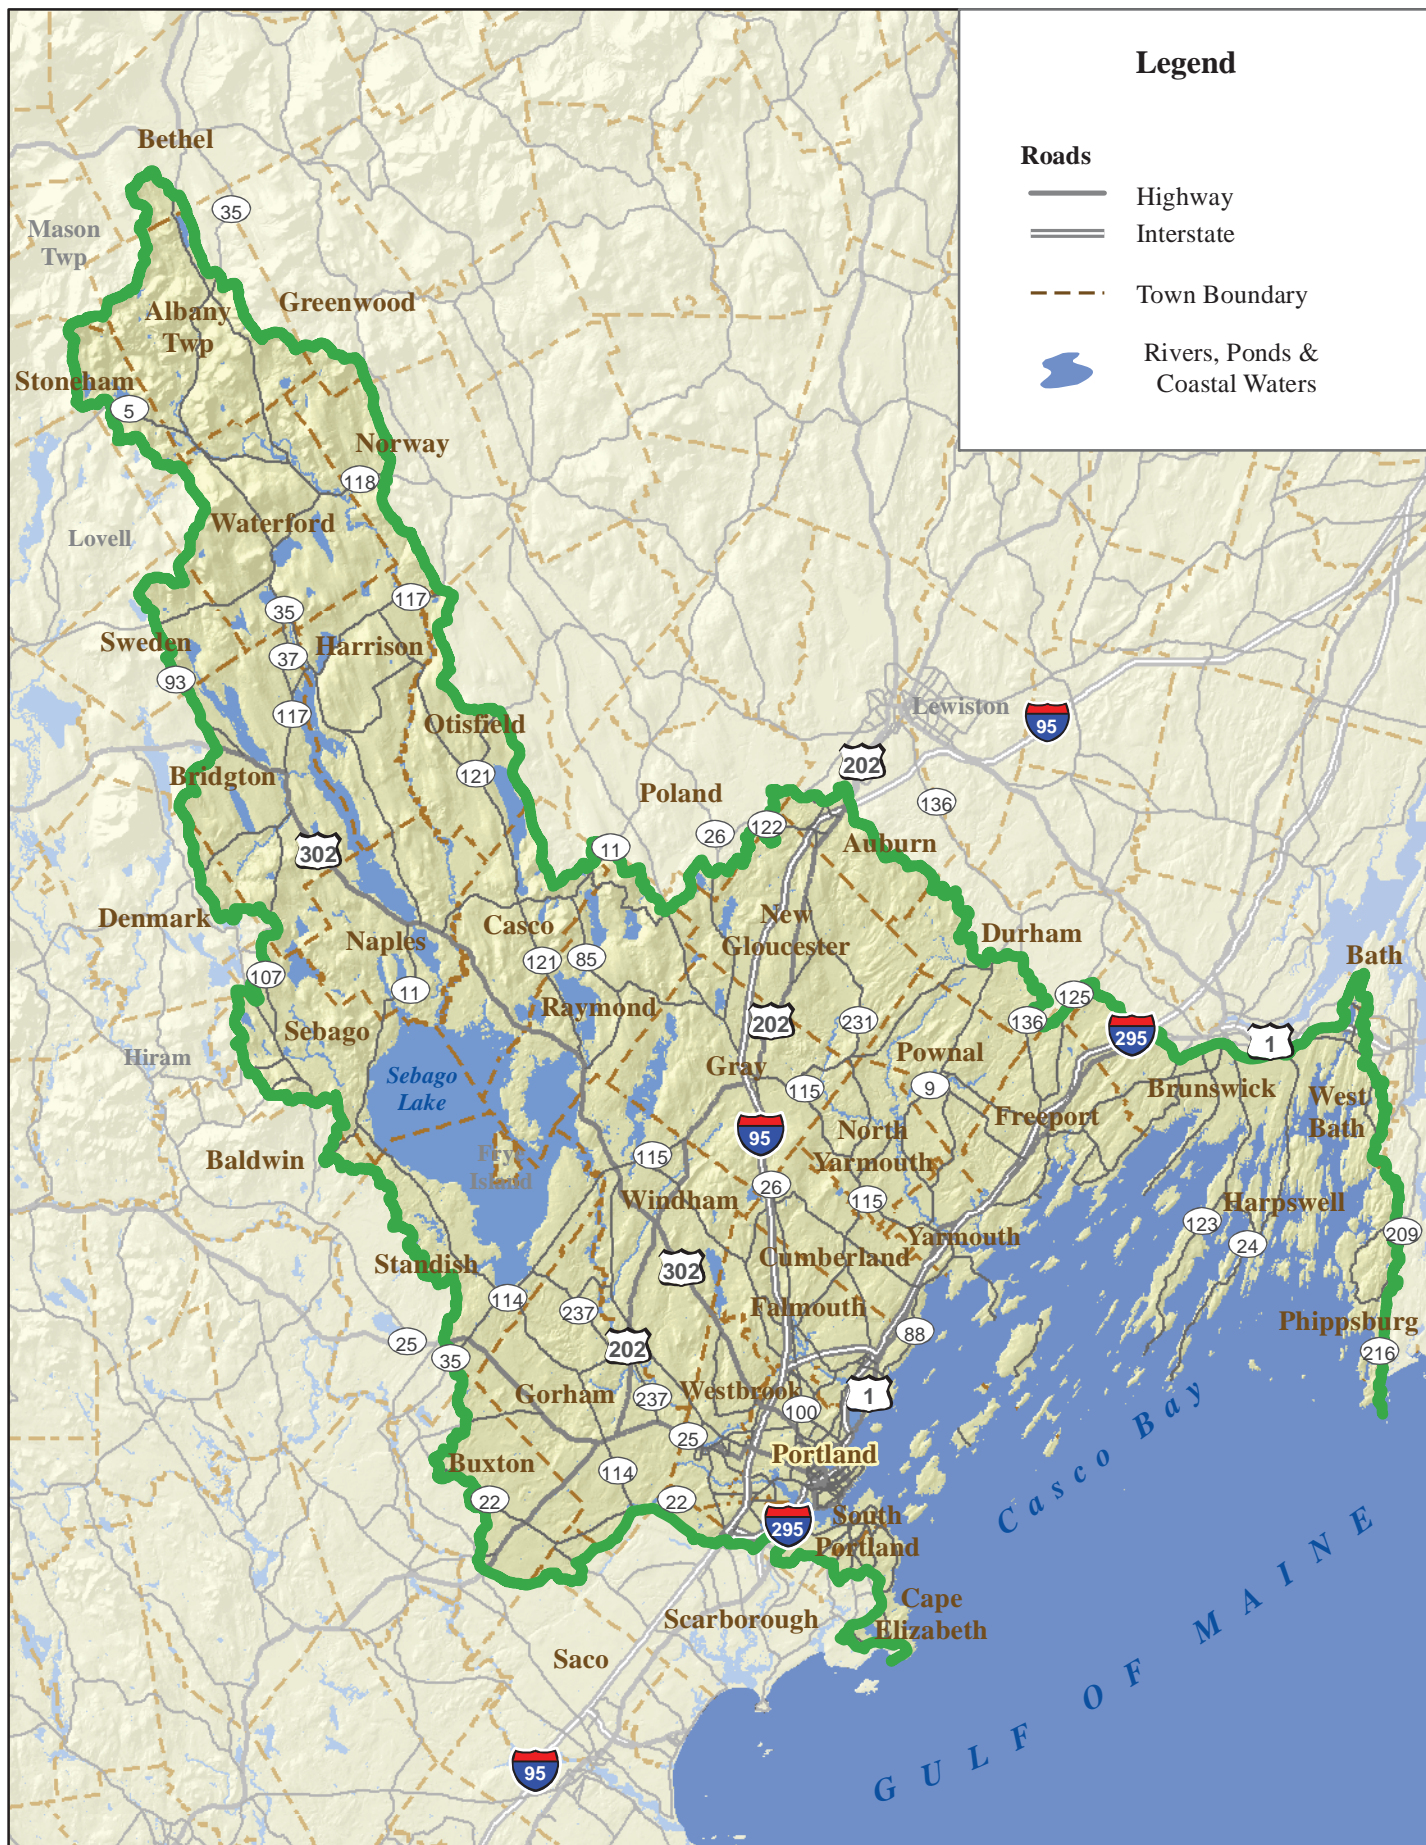
Index Map

Casco Bay Barriers by Town
