# **2017 Forest Lake Watershed Survey**

## **September 2017 ~ Forest Lake Association**

Prepared by  
Debi Curry, Secretary  
Forest Lake Association  
2017 Watershed Survey Steering Committee

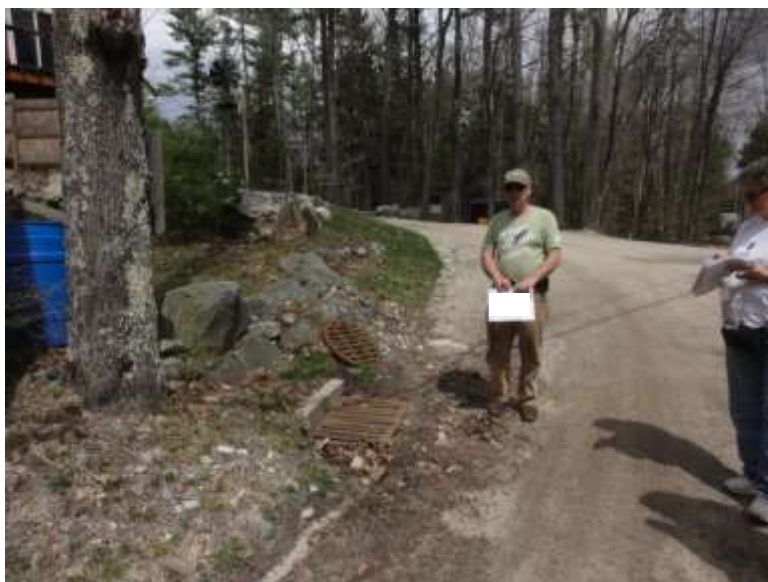
#### Surface Erosion: Rill

Surveyors identified a total of twenty-five (25) private road sites, almost all of which were associated with gravel roads as opposed to pavement or other surfaces. Rill erosion, winter sand, and gully erosion accounted for 38% of the problems reported on private roads.

Rill erosion forms small channels, often only .3 cm deep. Rills are caused when water running across the surface of the ground gathers in a natural depression in the soil, and the concentrated water flows through and further erodes the depression.

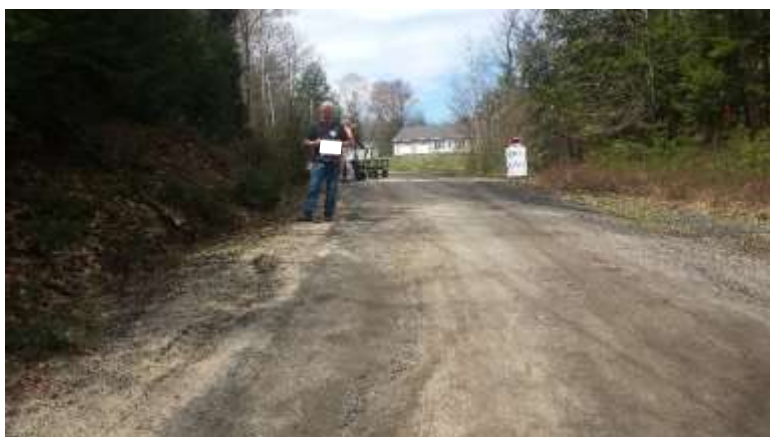
### Winter Sand

Phosphorus is attached to winter sand. Winter sand along the road shoulder can also interrupt the flow of stormwater and cause erosion of the road surface or shoulder. When grading the road, blade the edge of the shoulder to eliminate any build-up of sand and gravel.

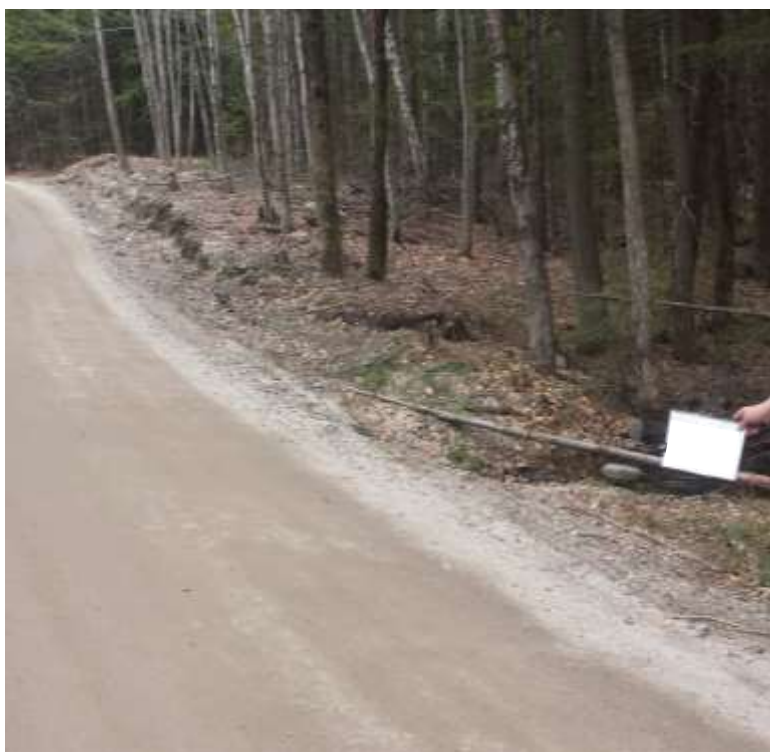
### Gully Erosion

Gully erosion is similar to rill erosion; it can occur when sheet flow becomes concentrated in large defined channels. This may occur in unrepaired rill erosion areas. It is associated with larger volumes of soil erosion.
