**Merepoint Boat Launch Facility Eelgrass Mitigation Measures:
Final Project Assessment**

Prepared for

Department of Inland Fisheries and Wildlife
284 State Street
Augusta, ME 04333-0041

MER Assessment Corporation

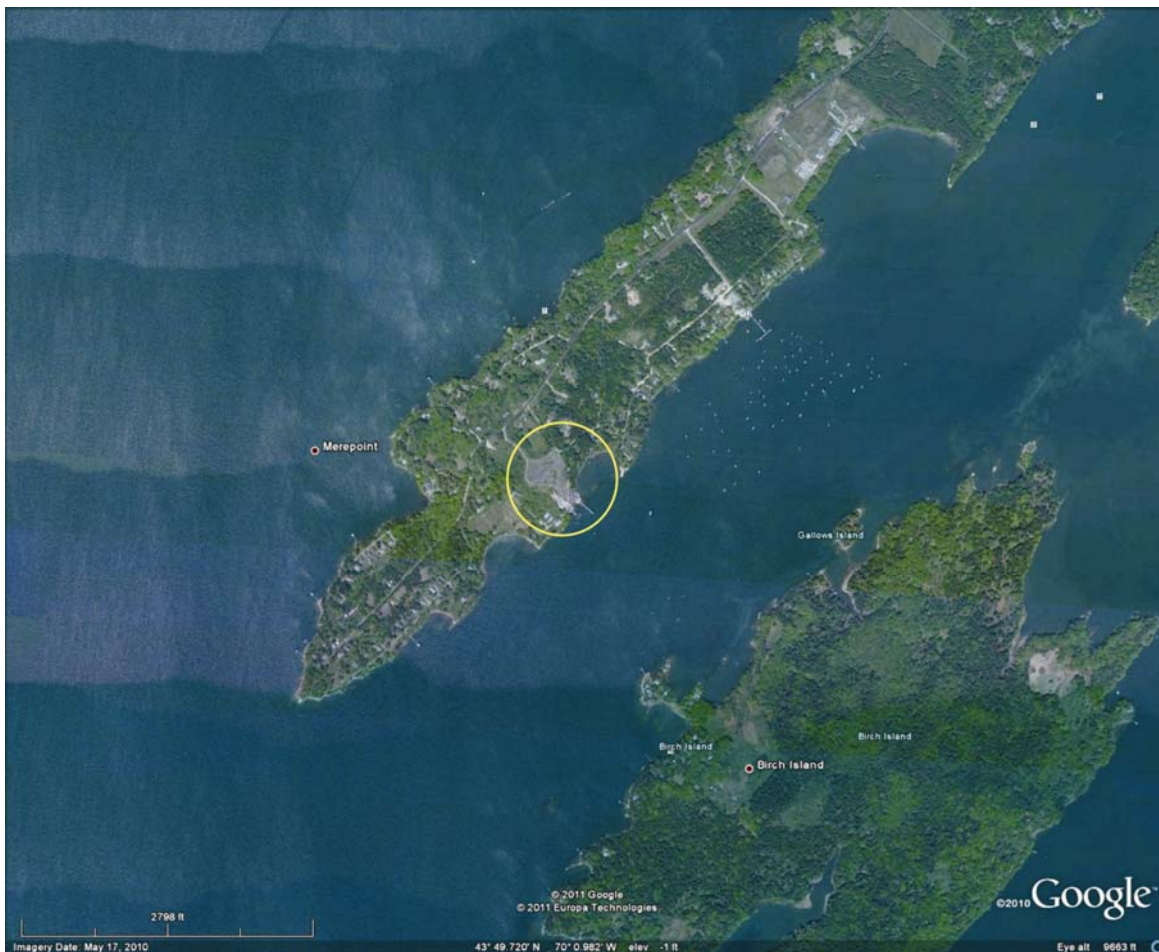
Figure 2 Completed Merepoint Boat Launching Facility (center) at Merepoint, Brunswick, Maine (Google Earth image)

The Maine Department of Inland Fisheries and Wildlife (IF&W) was issued a permit approval for the development and installation of the Merepoint Boat Launching (MPBL) facility at Merepoint, Brunswick, Maine on 13 April 2007. The location of the MPBL is shown in Figures 1 and 2, below.

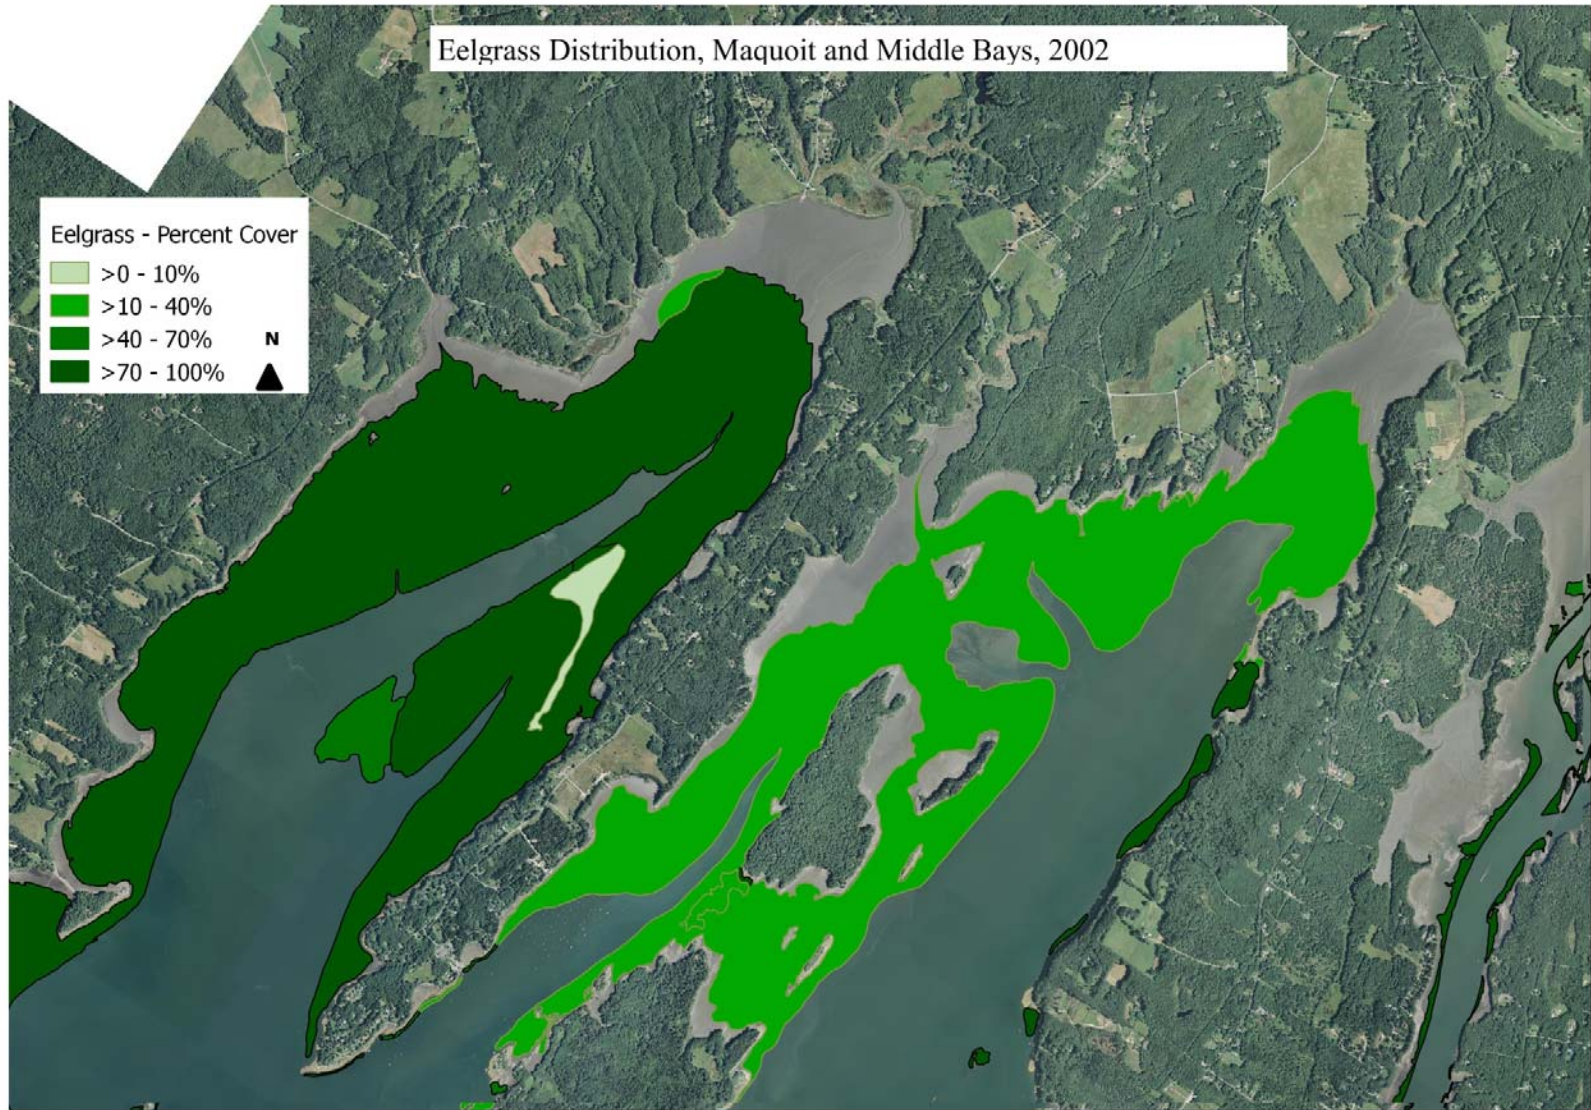
Figure 3. 2013 Sewall aerial photo Maquoit Bay and Middle Bay area in 2013 showing photo-interpreted eelgrass distribution in 2002 per Seth Barker (formerly with Maine DMR).

The most striking results were those of the aerial photography of Maquoit, Merepoint and Middle bays done by Sewall Company with photo-interpretation by Seth Barker, formerly of the Maine DMR conducted as a collaborative effort between the CBEP and the Maine DEP. The comparison of coverage between the dense and expansive meadows seen in 2002 and the limited eelgrass observed in Maquoit Bay and essentially barren condition of Merepoint and Middle Bays seen in 2013 clearly shows the catastrophic loss that has occurred.

The unexplained reversal in recovery and general decline in eelgrass over all the monitored areas observed in 2012 led to the decision in 2013 to change the 2013 effort from a strictly monitoring survey to one that included investigation into the possible cause for observed decline. As already explained, the investigation focused on eelgrass metrics and sediment chemistry. The small amount of eelgrass found during the study limited acquisition of data on eelgrass; however, the sediment chemistry data did reveal sulfide levels in all areas above the 600 μ M level that is considered toxic to eelgrass, but it remains unclear whether this is cause or effect. The most striking results of the 2013 project are the aerial photography and photo-interpretation of eelgrass distribution in Maquoit, Merepoint and upper Middle Bays. Figure 3 on the following page is the 2013 Sewall Company aerial photo of the area with the photo-interpretation of eelgrass distribution in 2002 done by Seth Barker, formerly with Maine DMR; Figure 4 is the same aerial photograph with Seth Barker's 2013 photo-interpretation of eelgrass distribution in 2013.

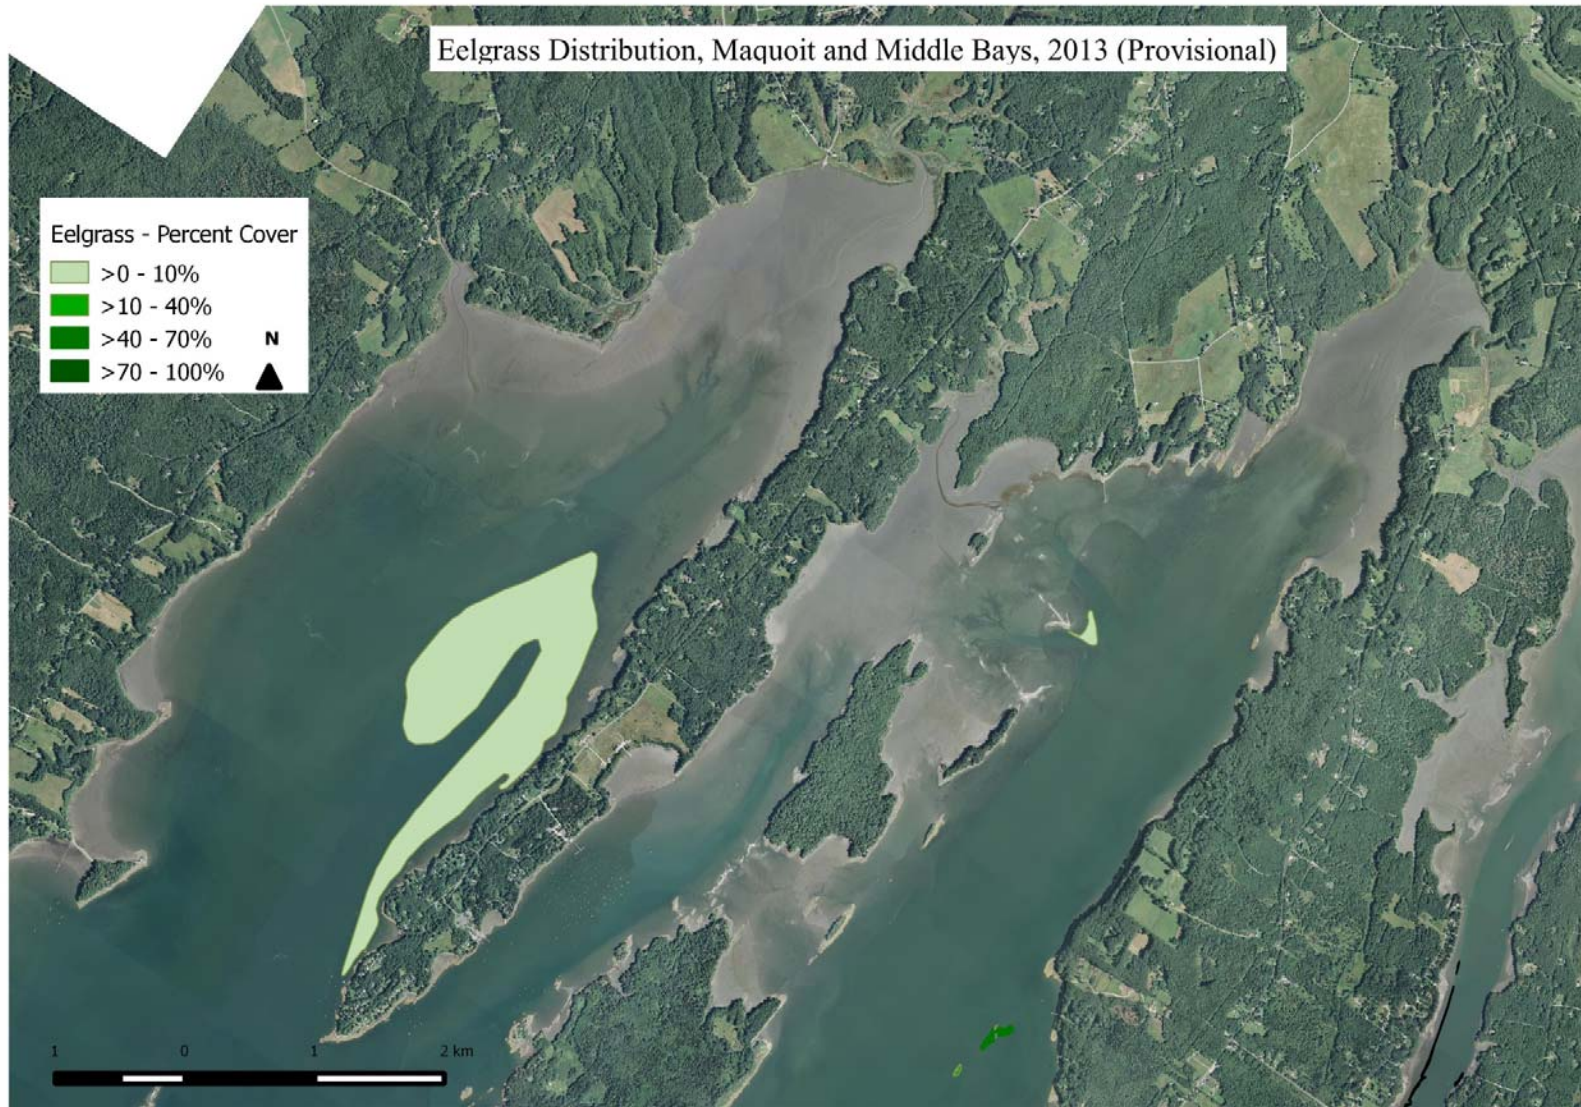
Figure 4. 2013 Sewall aerial photo Maquoit Bay and Middle Bay area in 2013 showing photo-interpreted eelgrass distribution in 2002 per Seth Barker (formerly with Maine DMR).
