New Meadows River Lower Watershed Survey Report

**Prepared by
Cumberland County Soil and Water Conservation District
Maine Department of Environmental Protection
New Meadows River Watershed Project**

March 2003

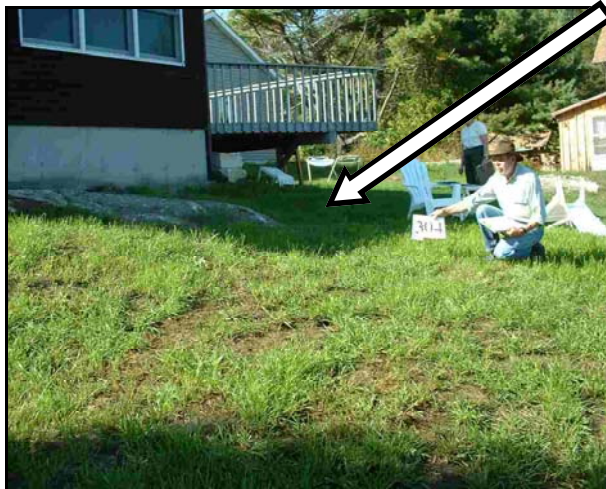
Problems:

- Runoff from roof causing moderate surface erosion
- Patchy bare soil with direct flow to River
- Lack of vegetated buffer on shoreline

Solutions:

- Install drywell at gutter spout
- Vegetate and mulch bare soil next to house
- Establish vegetated buffer

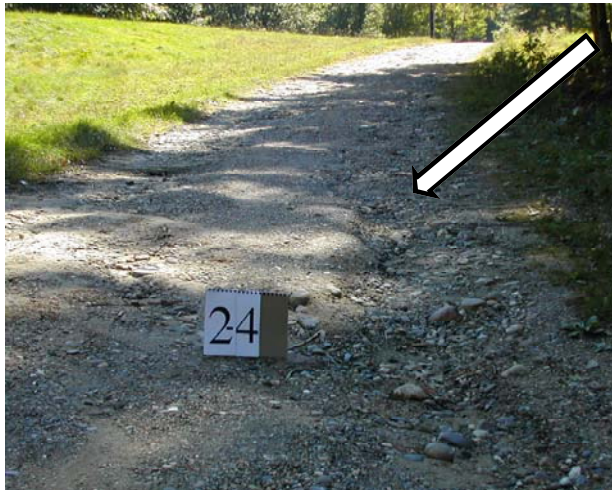
Problems

- Moderate surface erosion
- Poor driveway shaping and ruts cause water to concentrate and erode the surface
- Direct flow of sediment to New Meadows River

Preserve water quality and save time, money, and wear and tear on your vehicle by having a well crowned driveway. Use adequate surface material and add diversions to direct runoff into vegetated buffers.

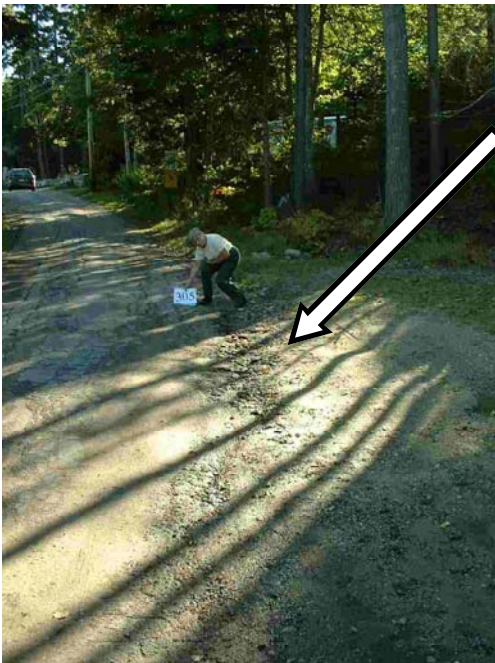
Problems:

- Moderate road shoulder and surface erosion
- Clogged culvert
- Lack of ditch
- Direct stormwater flow to New Meadows River

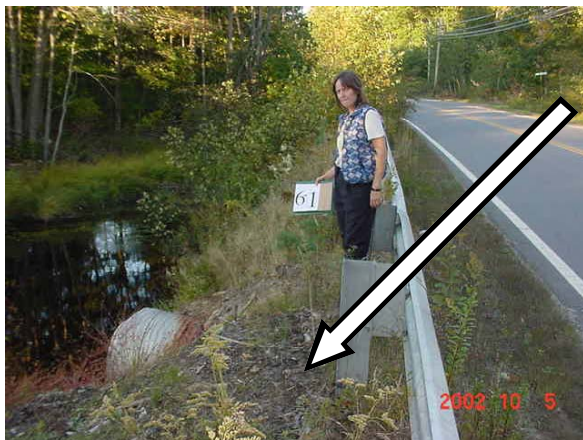
Problems:

- Unstable and eroding culvert
- Eroding road shoulder
- Stormwater from road runs directly to tributary

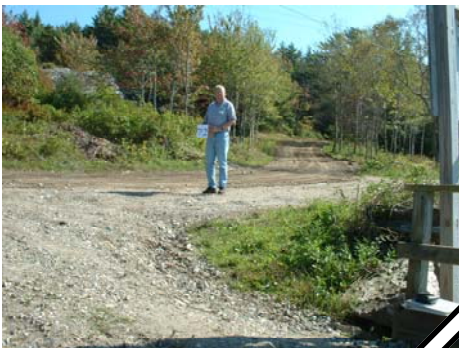
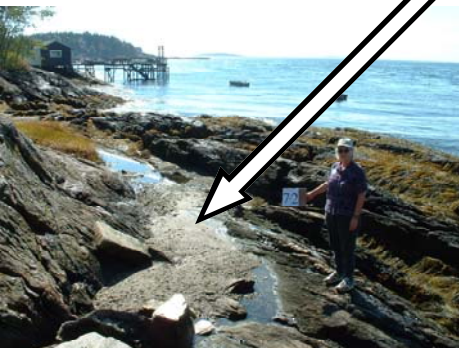
Problems:

- Severe surface erosion on road
- Severe ditch erosion
- Direct flow of runoff and sediment to New Meadows River

Solutions:

- Use a more cohesive/less erodable surface material
- Install waterbars to divert runoff into wooded areas
- Regrade the road away from the water to encourage infiltration in established buffer.

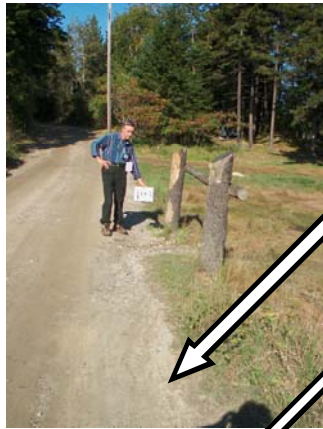
Problems:

- Moderate road surface erosion
- Runoff and sediment travel directly into cove
- Erosion occurring around culvert outlet

Solutions:

- Add new surface material and grade away from the cove
- Install runoff diverters, such as waterbars or open top culvert
- Stabilize culvert inlet/outlet
- Add vegetation with strong/extensive root system to hold soil in place
