# East Branch Piscataqua River Watershed Survey Report

Presumpscot River Watch

May 2008

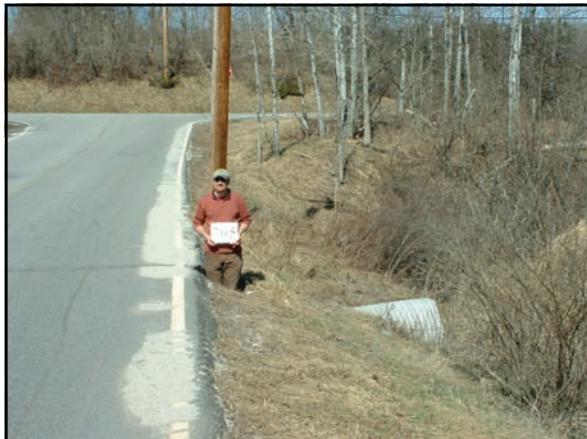
Survey teams identified a variety of problem types (Figure 3). The most commonly observed problems were related to soil erosion (Figure 4), which is the single largest pollutant source by volume to Maine’s surface waters. Soil erosion can originate from

a number of places, including unpaved roads and road shoulders, ATV trails and unstable stream banks to name just a few. Because the nutrient phosphorus is often attached to soil particles, erosion can result in algal blooms.

**Figure 4:** example of erosion on a road shoulder

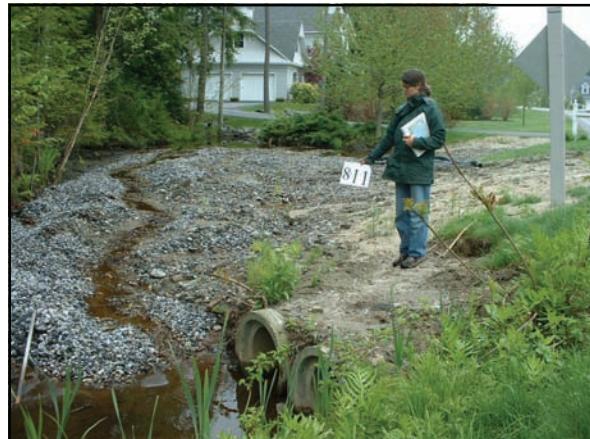
**Figure 5:** example of residential impact (and an inadequate vegetated buffer between pollution source and stream).

The next most commonly observed problems were due to direct overland flow of polluted runoff to the stream (Figure 5). As rainwater or melting snow flows across paved or unpaved surfaces it can carry a variety of pollutant types into nearby streams. Pollutants can include oil and grease from roads and parking lots; pesticides and herbicides from lawns, gardens and playing fields; and bacteria and viruses from improperly handled animal waste or malfunctioning septic systems (see Appendix D for a more complete list).

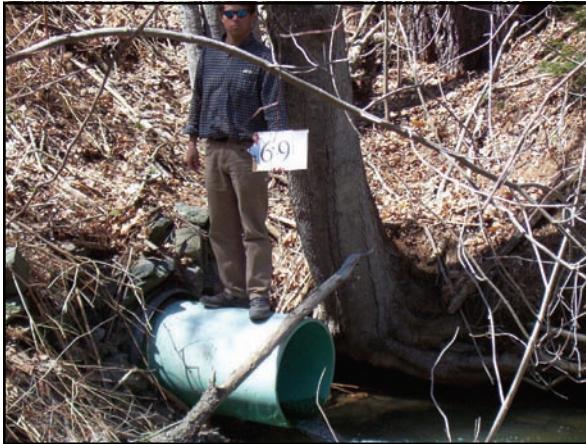
The next most frequently observed problems were culvert related (Figure 6). Culverts are underground pipes that convey water from one area to another, usually under a road or driveway. They are an important part of the storm water collection

system because they can help alleviate roadway flooding and soil erosion. However, culverts can also be sources of polluted runoff if not properly designed, installed and maintained by altering the water flow characteristics of stream channels and resulting in stream bank erosion. Inadequate shoreline buffers were the next most commonly observed problems (Figures 7 and 8). Shoreline buffers are strips of vegetated land that are left in their “natural” state and are important because they stabilize soil and prevent or reduce other pollutants from entering a stream.

**Figure 6:** example of a hanging culvert.

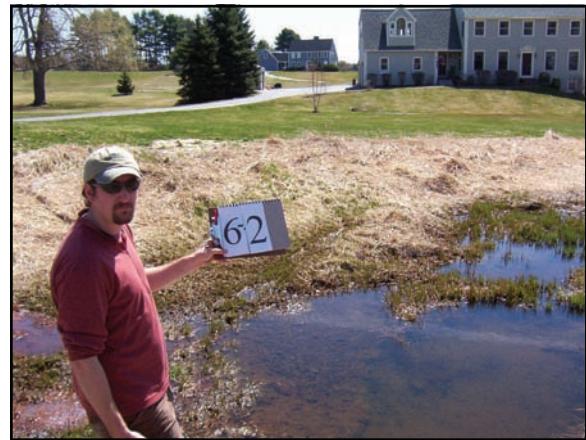
**Figure 7:** example of inadequate shoreline buffer.

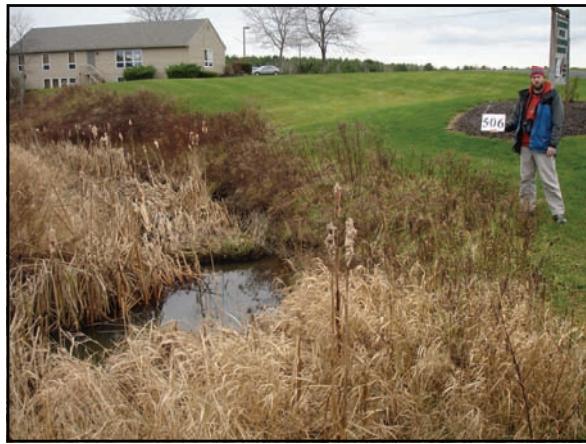
**Figure 8:** example of a manicured lawn utilizing high impact fertilizer.

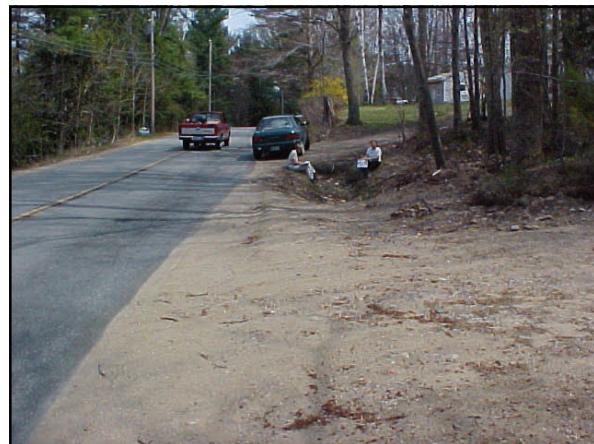
The remainder of observed polluted runoff problems included stream side dumping, excess road sand (Figure 9), stream channel alteration and several others (algae in stream, stream bank instability, overflowing drainage ditch, thermal pollution, stream siltation, and a nearby horse paddock).

**Figure 9:** excess sand left on the road following a cold Maine winter.

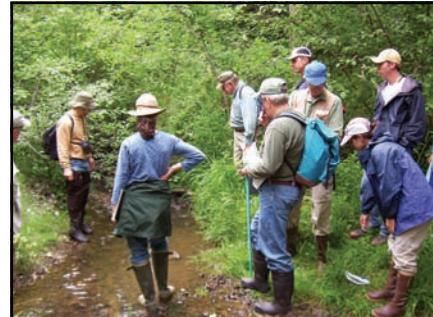
1. There was a fairly substantial riparian zone even though much of the river was bordered by agricultural fields.
2. Streambanks were generally stable.
3. The substrate conditions were sandy and clayey and for the most part did not appear to provide valuable salmonid habitat.

PRW and partners participate in the East Branch PR rapid geomorphic assessment.

If restoration is considered viable for the East Branch Piscataqua River, it is recommended that further geomorphic assessment and investigation be conducted.
