# Urban Streams Nonpoint Source Assessments in Maine Final Report

# **Urban Streams Nonpoint Source Assessments in Maine**

## **Final Report**

2/16/2005

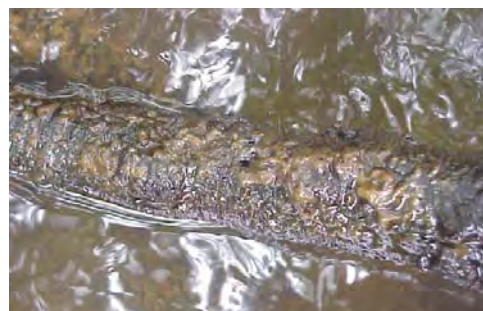
Fig. 2. Growth on log at upstream (algae) station (June 2004)

sampled for algae statewide, similar mats have been observed only at Blood Brook, which drains historic iron deposits in Katahdin Iron Works TWP. A revisit to the site in early July 2004 showed the same conditions.

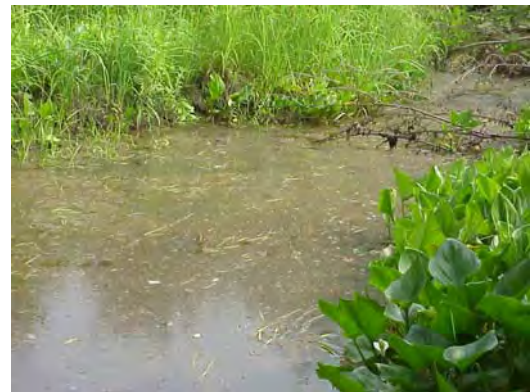
Fig. 19. Barberry Creek as it emerges from wetland (June 2003).

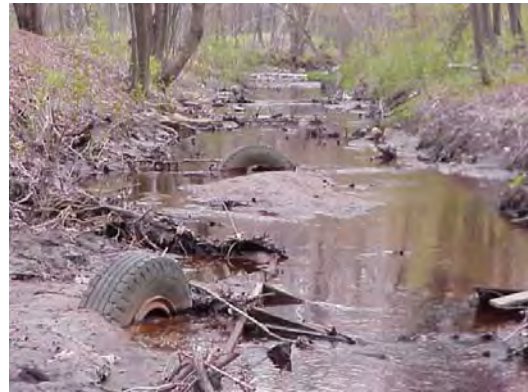
Fig. 22. Sedimentation problems at upstream station (May 2004)

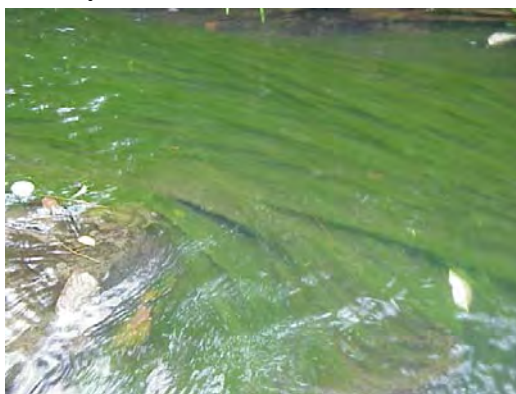
5, 8 and 10), leading to a reduction in the DO carrying capacity of stream water. Excessive algal growth was observed in July 2003 when the entire stream bed was covered by a thick mat of green filamentous algae (Fig. 20). A repeat visit in July 2004 showed less algal growth which, however, still far exceeded growth observed at any other Urban Stream station. An analysis of water flow patterns at this station (Fig. 12) showed that the flow regime is homogeneous with a very low velocity, all but eliminating any possibility for re-aeration of the water. And chemical analyses (Tables 5 - 6) showed that nutrients (TN and TP) are above levels recommended by EPA for this region of Maine, contributing to excessive algal growth. These data and observations combined provide a good explanation for the observed pattern of DO concentrations at the downstream station.
