State of Casco Bay

CASCO BAY ESTUARY PARTNERSHIP

STATE OF CASCO BAY

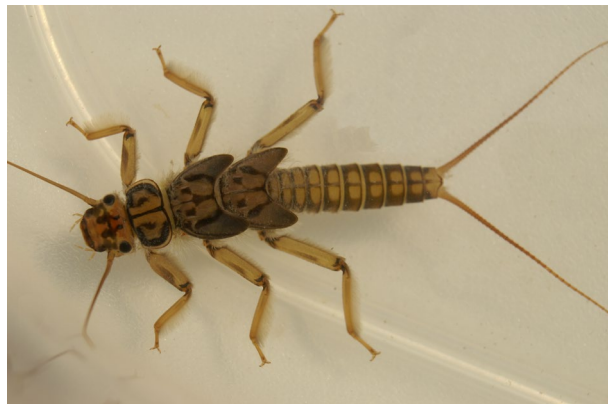
Water Quality and Land Use

Maine biomonitoring data

What stream insects and other invertebrates live in the stream?

Used as an indicator of water quality

Higher impervious is associated with less healthy streams

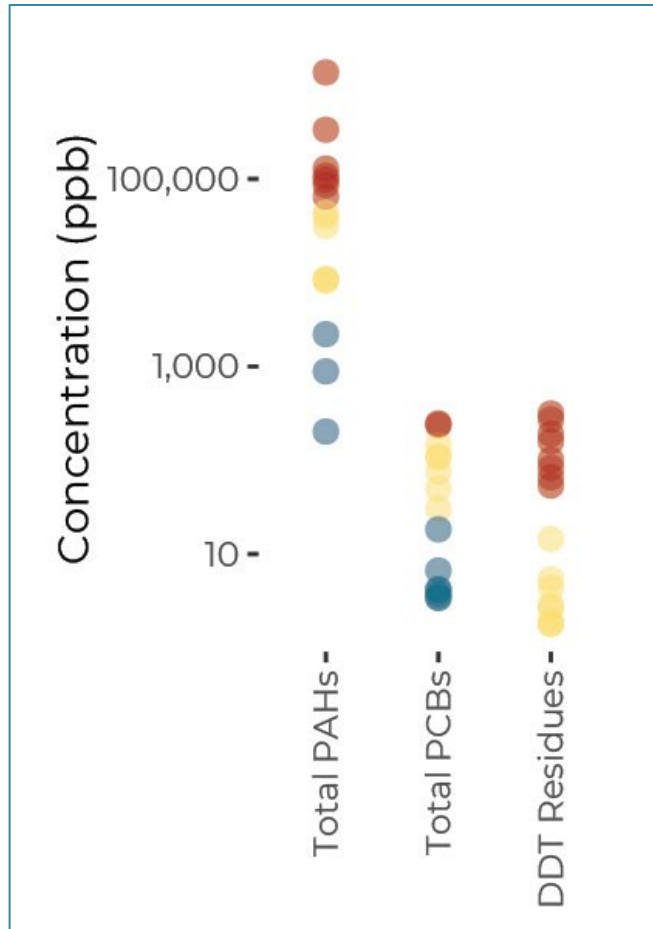
Portland Harbor Deep Sediments

Deep sediments act like a time capsule, preserving contaminants released decades ago

Levels in Portland deep sediments are much higher than surface sediments

Investments in clean water benefit the Harbor

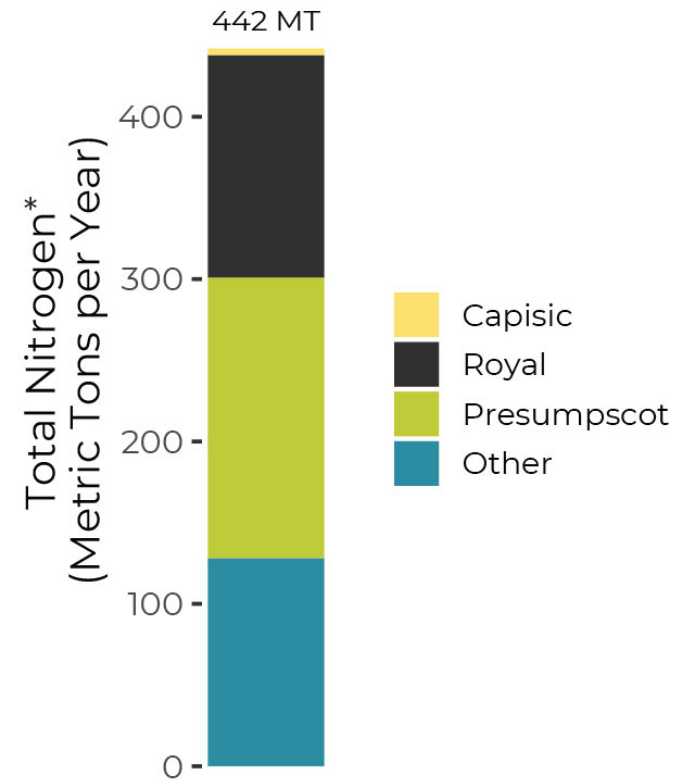
Documented Nitrogen Loads from Three Sources

Tributaries

Wastewater

Atmospheric Deposition

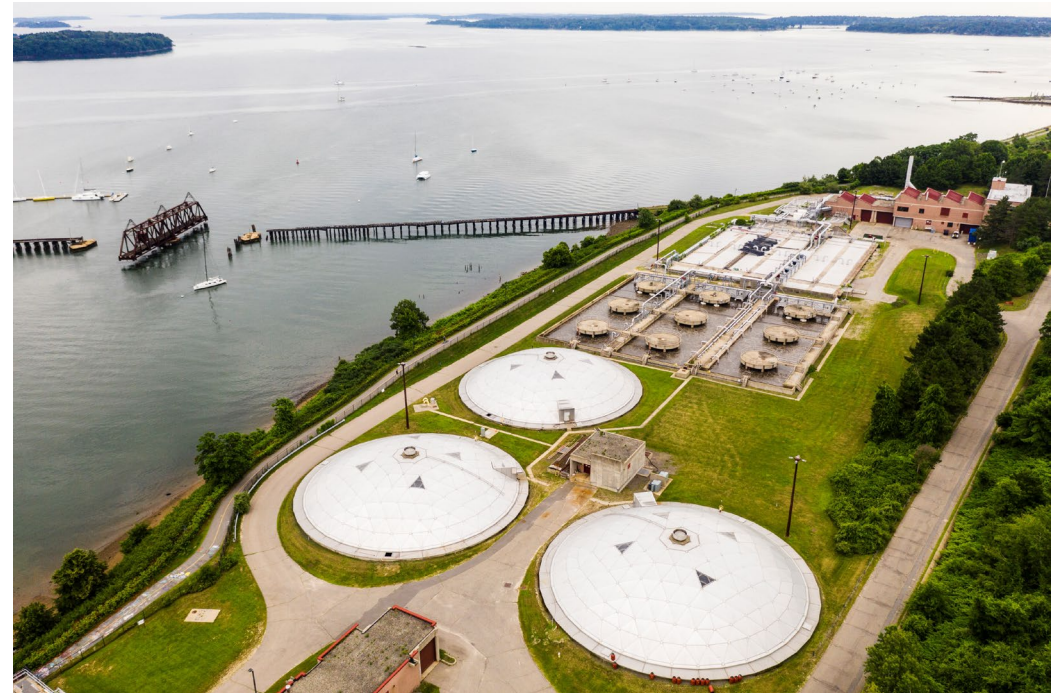
East End WWTF, Portland, ME

Updated the aeration system at the East End Wastewater Treatment Facility in 2017

Manage the plant to optimize removal of nitrogen

Summer discharges of nitrogen have dropped by nearly three quarters
