Willard Beach Water Quality Monitoring & Piped Infrastructure Improvements

Fred Dillon - Stormwater Program Coordinator

CITY OF
**SOUTH
PORTLAND**
Water Resource
Protection

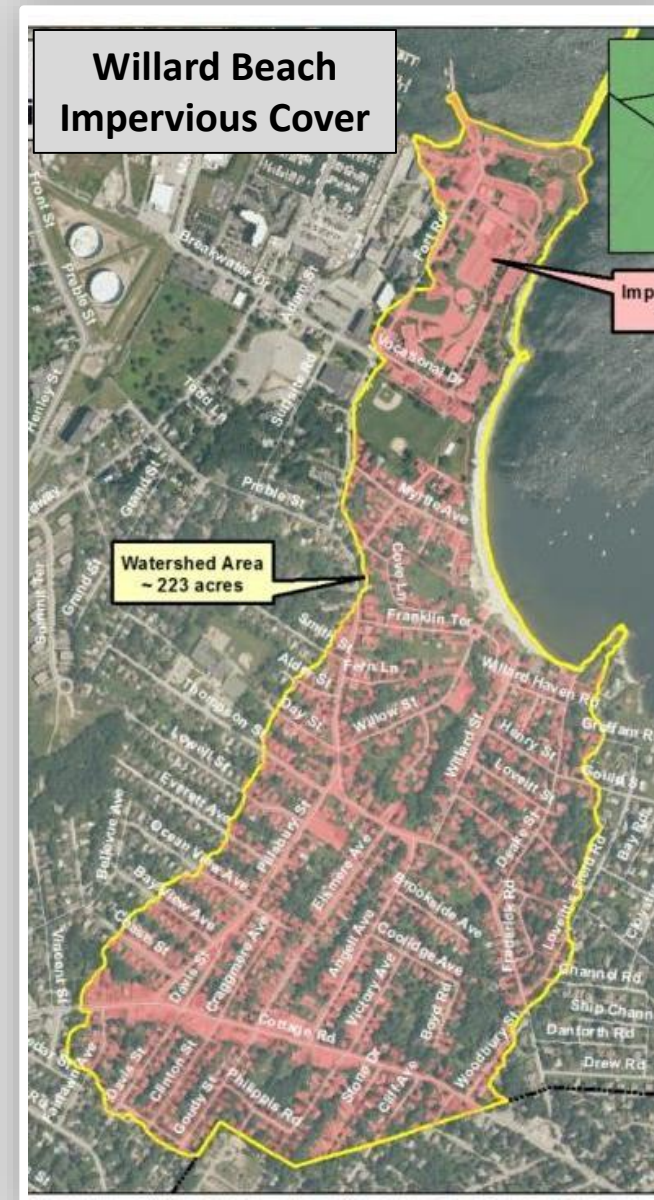
Willard Beach Watershed

- ~223 acre watershed
(41% Impervious Cover)
- ~2,000' sandy beach
- 7 public access points
- Used year-round
- WQ monitoring since 1997
- MHB participant since 2003
- *History of elevated bacteria levels w/ numerous advisories*

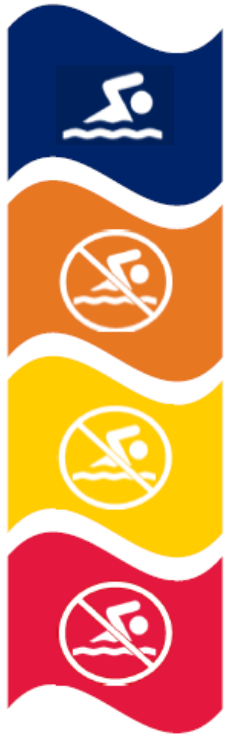
**Bathhouse Flag
Indicates Daily
Swimming Conditions**

OPEN – no advisory or closure.

ELEVATED BACTERIA ADVISORY
Bacteria levels may be unsafe.
Water contact not advised.

PRECAUTIONARY RAINFALL ADVISORY
Rainfall can increase bacteria levels.
Water contact not advised.

CLOSED – no swimming or
water contact activities.

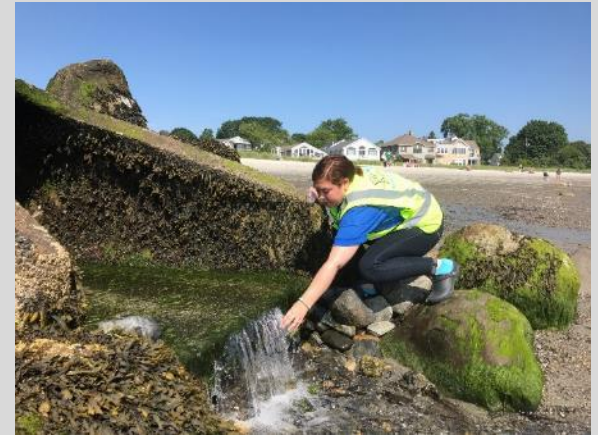
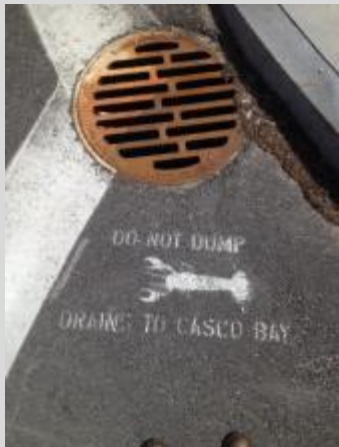
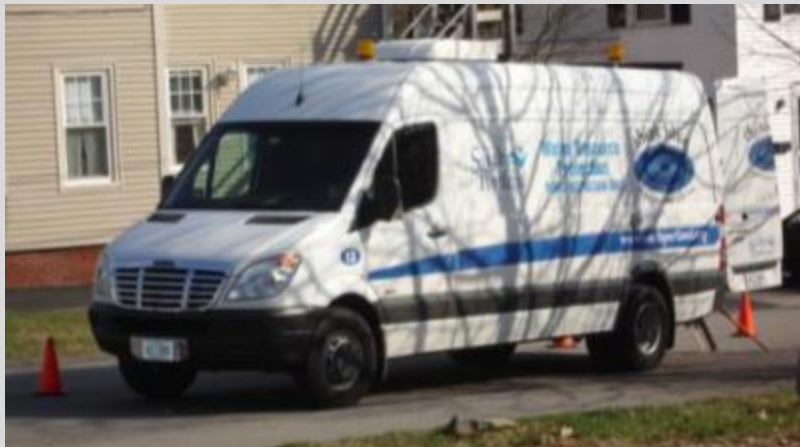
Willard Beach / South Portland, ME
Stormwater System Monitoring Locations

Watershed Area
 ~ 223 acres

Monitoring Locations:
 CB_5014
 WIL-02
 WB_17
 DM_1045
 DM_0507

Willard Beach Water Quality Sampling Locations

Beach water quality sample location varies depending on tidal conditions and is collected roughly along this transect

When WB_17 is submerged by high tide, stormwater sample is collected at next upstream structure (DM_1045)

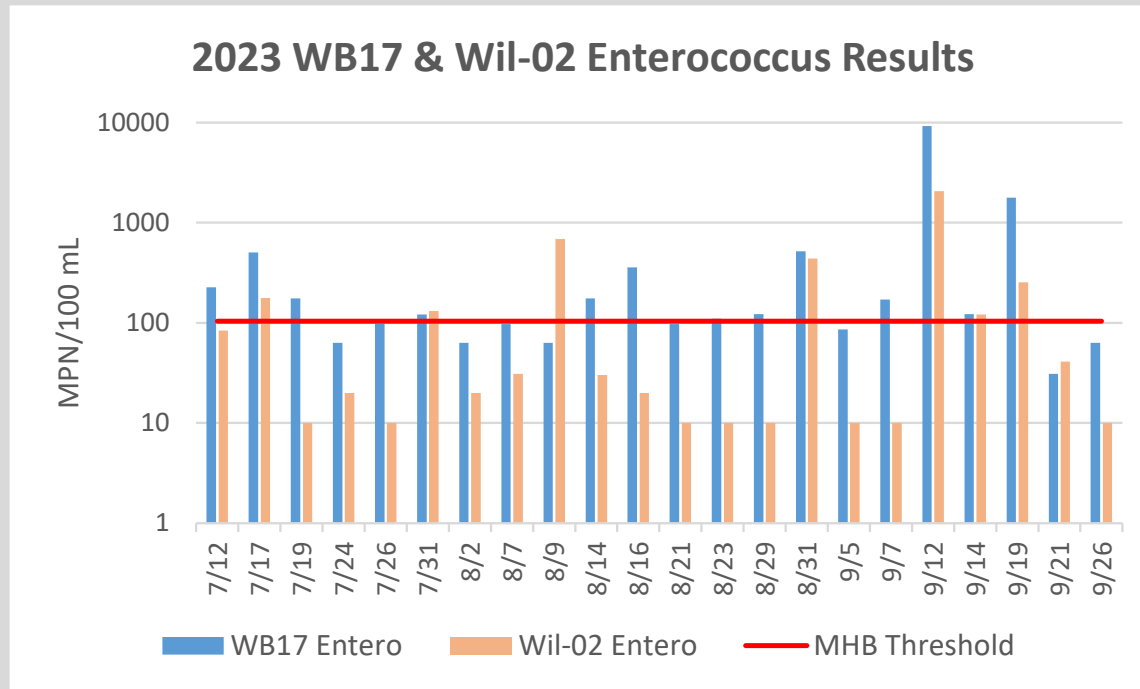
2023 Beach & WB17 Entero Results

WB17>Wil02 19

Wil02>WB17 3

WB17>MHB 13

Wil02>MHB 7

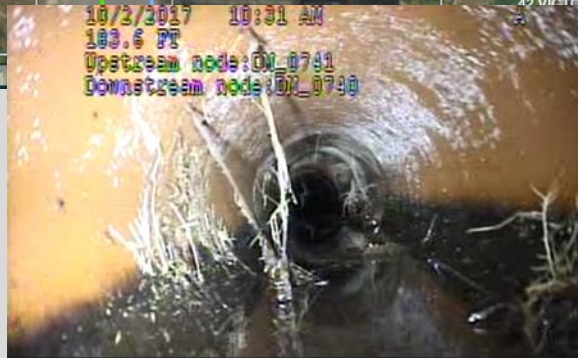
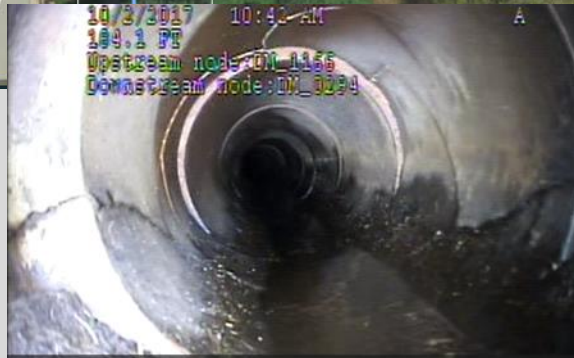
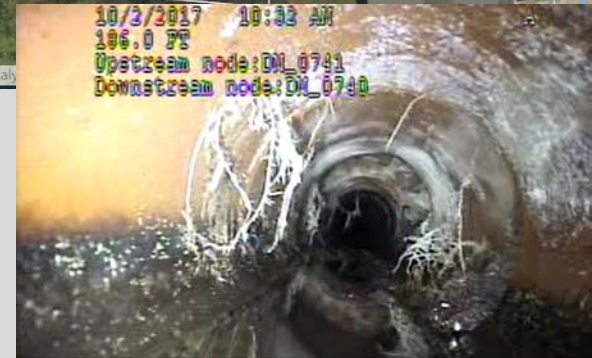
Storm Drain Lining (CWSRF)

City of South Portland Piped Infrastructure Map
