Mill Brook

Stream Habitat Walk

Cumberland County, Maine
May 31, 2003

Report Date: September 18, 2003
Prepared by the Maine Stream Team Program

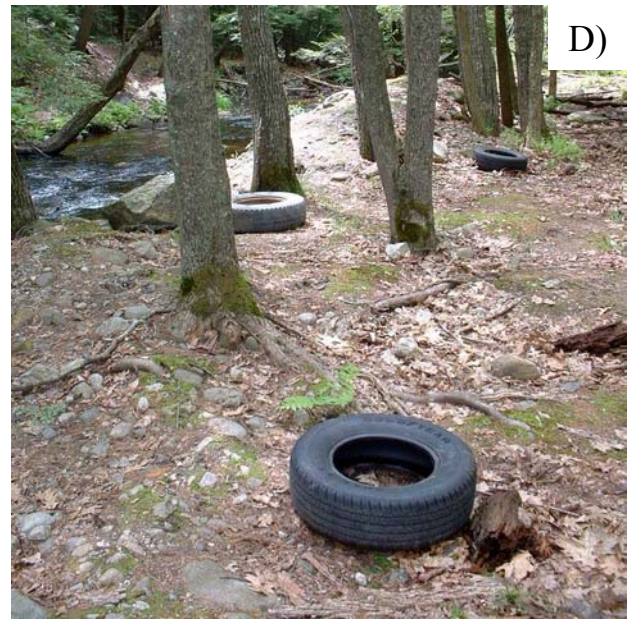
Site 1 photographs: A) scoured tree roots downstream of the Route 302 bridge/culvert; B) a woody debris dam and pool; C) a representative photograph of substrate in a run; D) trash on the streambank; E) alewives; and F) water level in the culvert (approx. 1 inch) (photo F taken on 7/14/03).

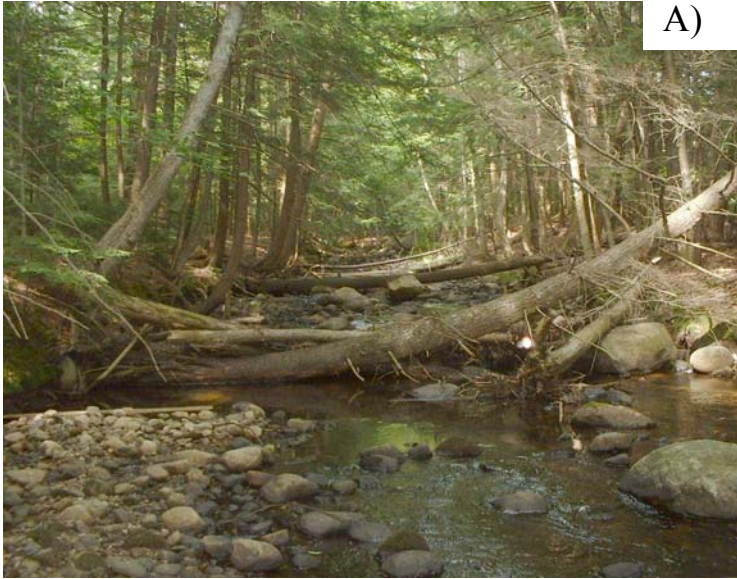
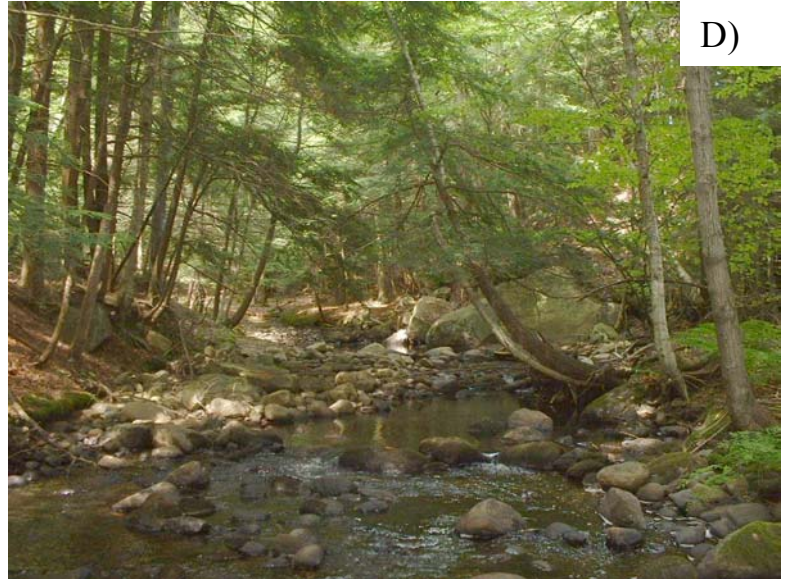
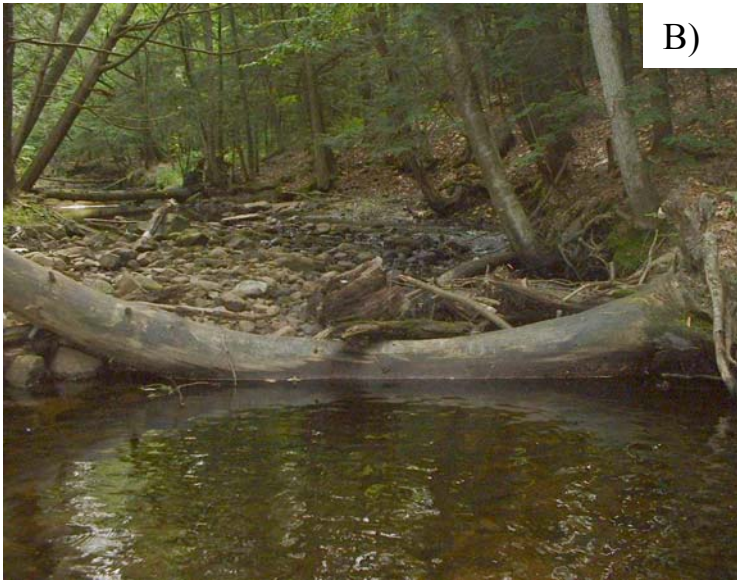
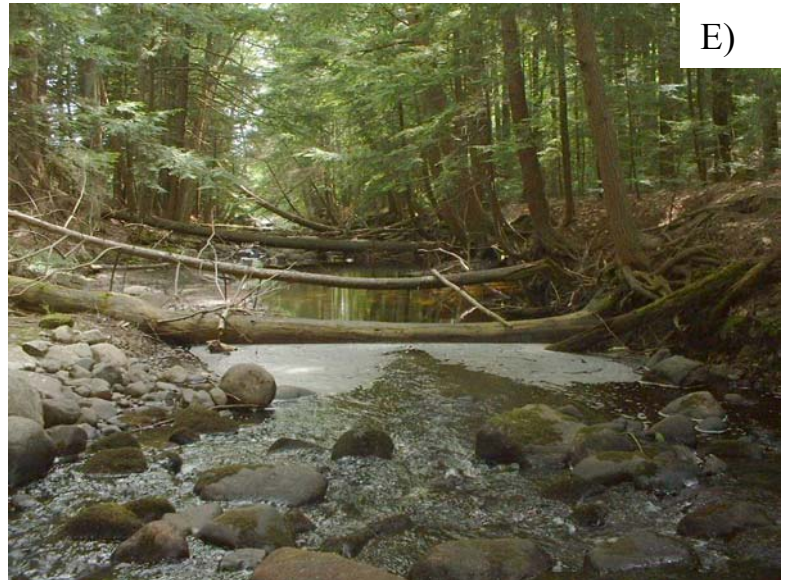
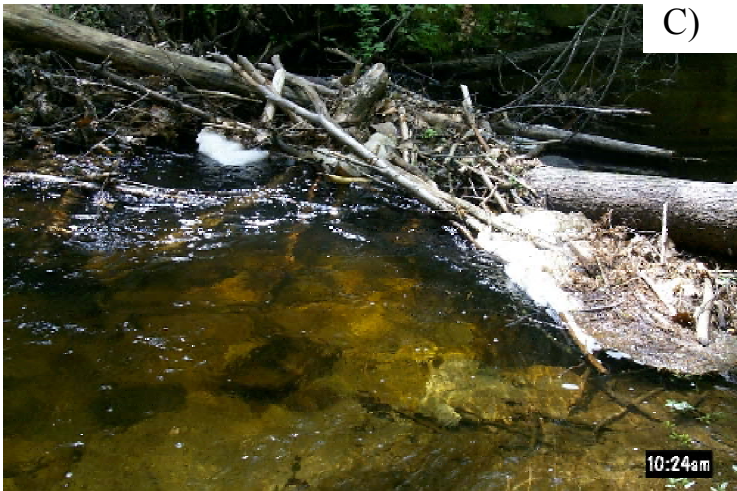
Site 3 photographs: woody debris dams (photos A, B, D, and E were taken on 7/14/03). Fallen large woody debris is important for creating stream habitat diversity and for trapping / retaining food resources for aquatic organisms. However, large numbers of fallen trees may sometimes indicate that the channel is trying to widen, in response to human impacts to the stream. More investigation may be needed to determine the types and stability of processes occurring in Mill Brook.

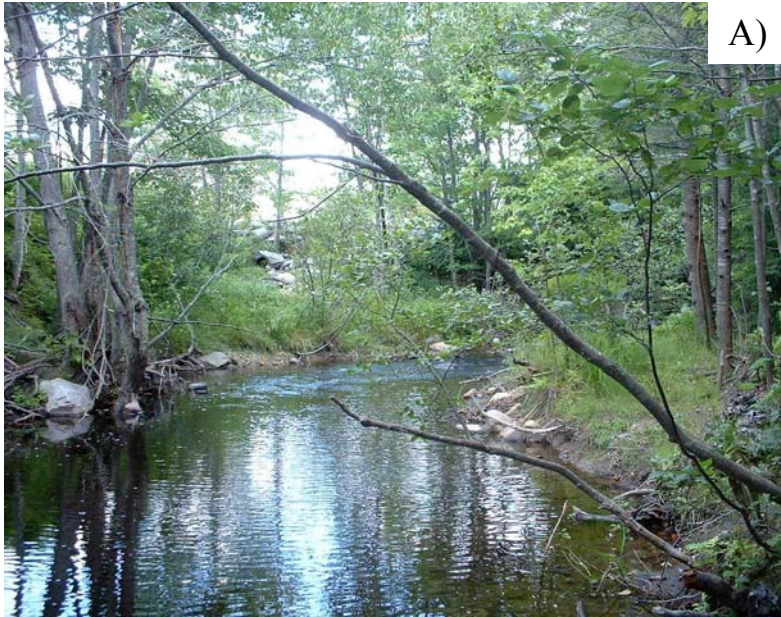
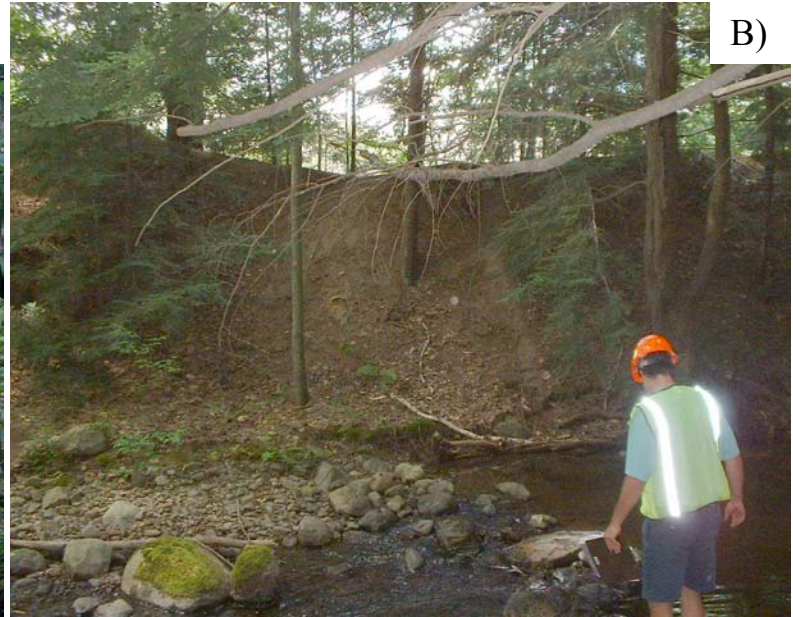
Site 4-B* photographs: A-B) Mill Brook and streamside areas in the vicinity of a gravel mining operation (note the berm wall on one side of the stream - it currently is serving as a barrier between a stormwater detention pond and the stream) and C-D) pools, riffles, and streamside forest. *These photos were taken on July 25, 2003, on a reconnaissance walk of this area, which is located downstream of Site 4 (see the map on page 2).

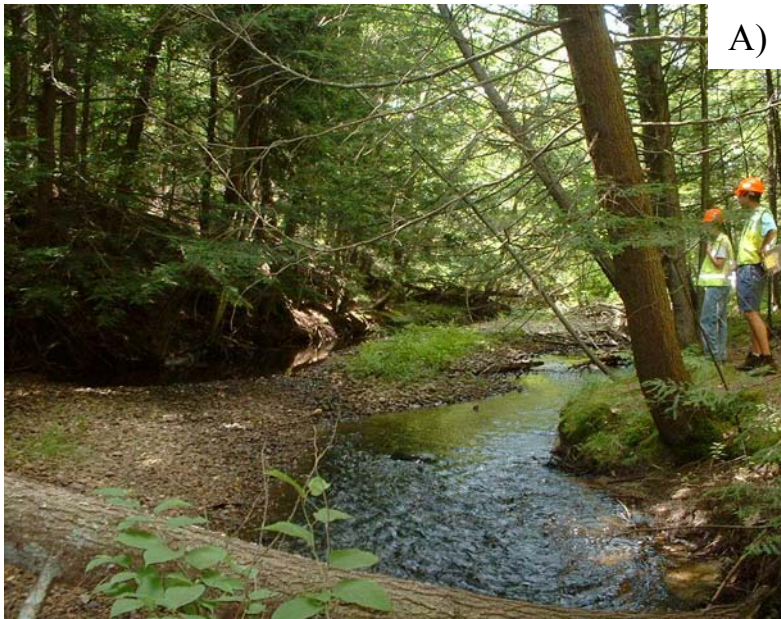
Site 4-B* photographs: A-B) signs of aggradation (that is, sediment accumulation or bar formation) in the middle of Mill Brook's channel and C-D) local ATV trail impacts. *These photos were taken on July 25, 2003, on a reconnaissance walk of this area.

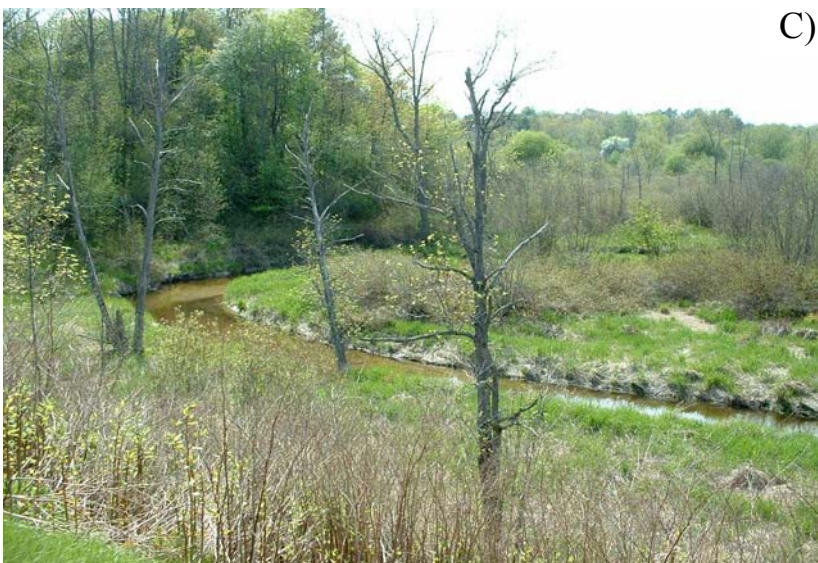
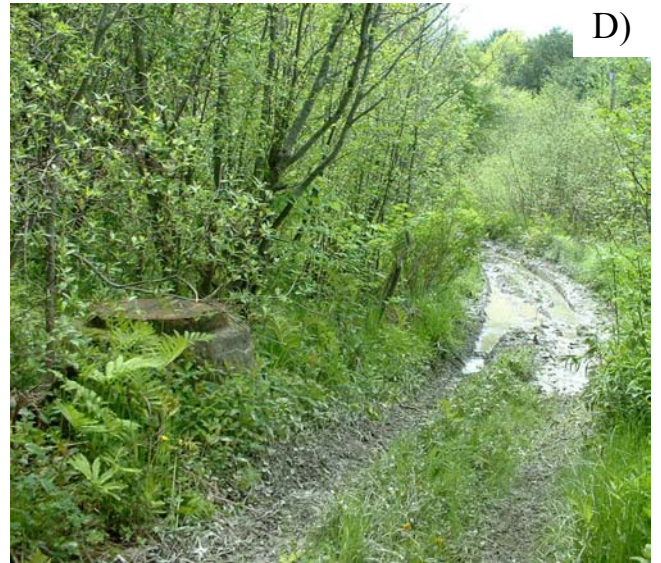
Site 6 photographs: A-C) meandering, low gradient, silty-sandy-bottomed stream; and D) a manhole above a sewer line and an ATV trail near Mill Brook. Photo C was taken on 5/20/03 and it is situated just upstream of Bridge Street.

Sites 5 & 6) Major concerns: Sediment pollution from badly eroding ATV trails, thermal stress from a general lack of many mature, tall trees in the riparian zone, and potential sewer line leaks.

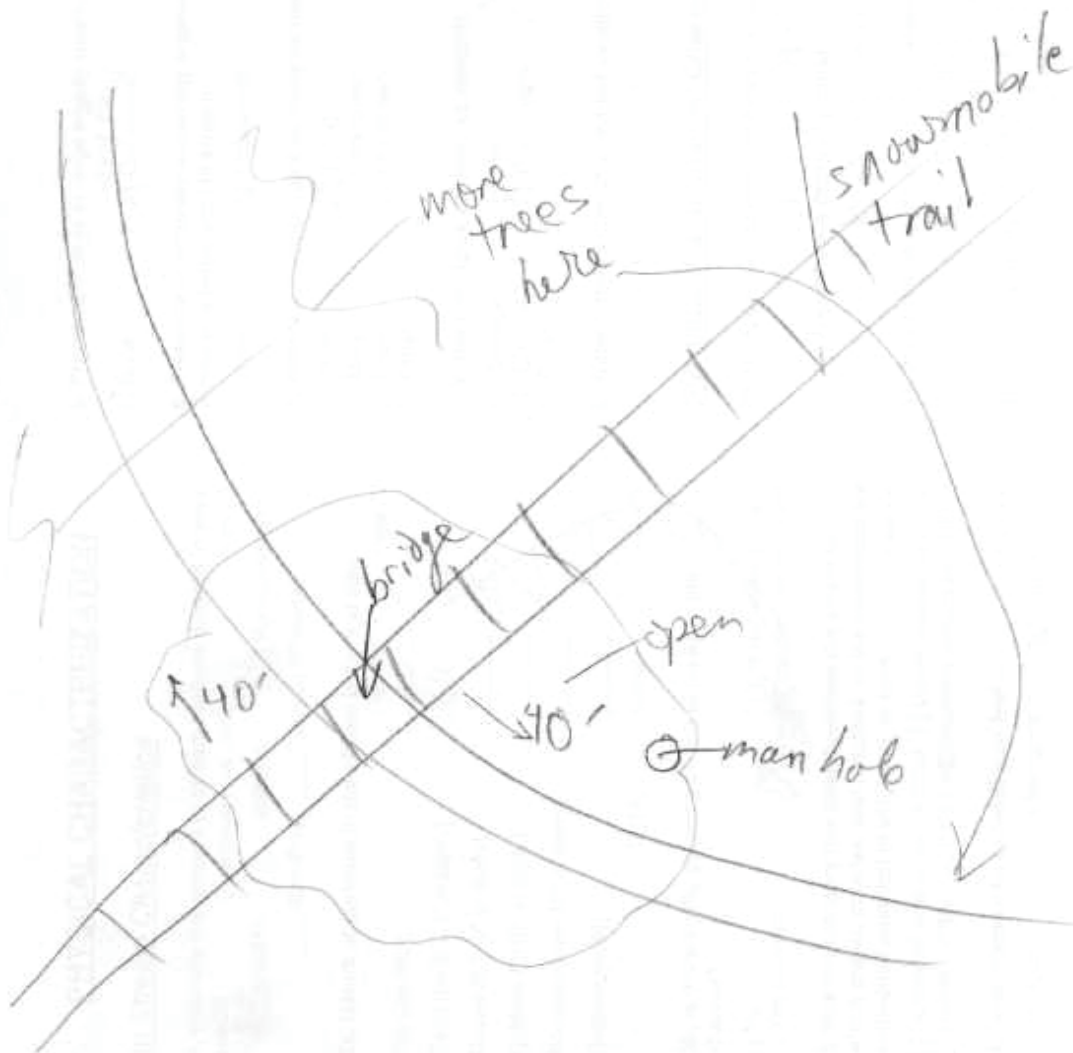
Sketch of Site

Low gradient, meandering, lots of snowmobile and ATV trails along stream

ATVs come close to stream destroying riparian areas. Leaky-sewer line. Smell evident in wet, screwed up ATV areas.
