# Mill Brook Stream Bank Stabilization and Habitat Enhancement Project September 2007

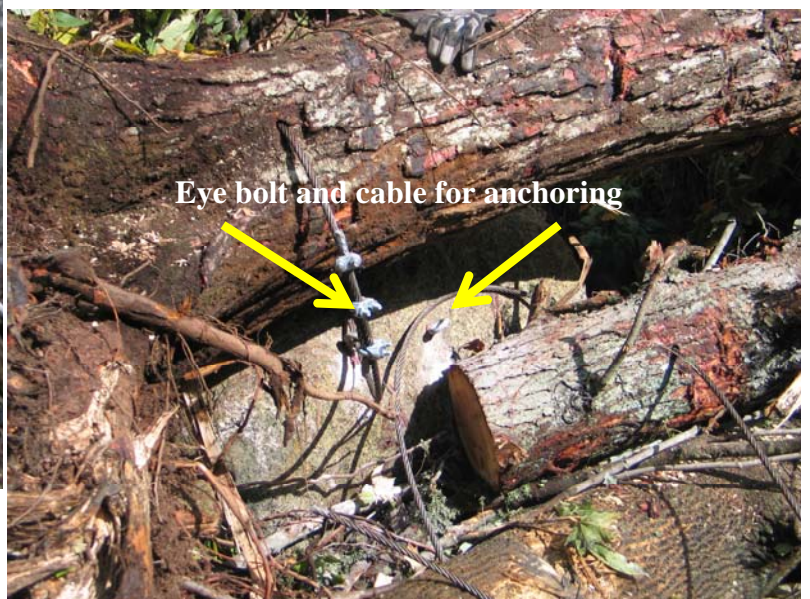
Rock vein with  
root wads  
packed around  
and behind.

Boulder placement to  
encourage pool formation and  
slow velocity.
