Cape Elizabeth Culvert and Habitat Assessment Study

March 22, 2019

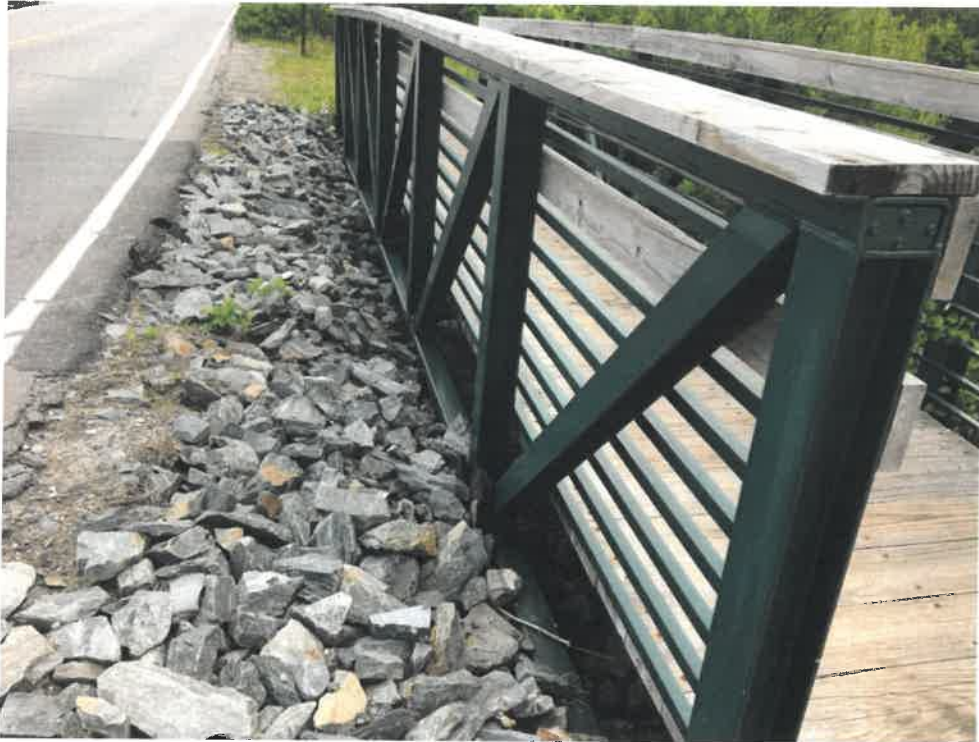
Photo 3 (06-06-18): Facing South. The presence of the footbridge directly over the culvert inlets and stone rip rap make inlet maintenance a challenge

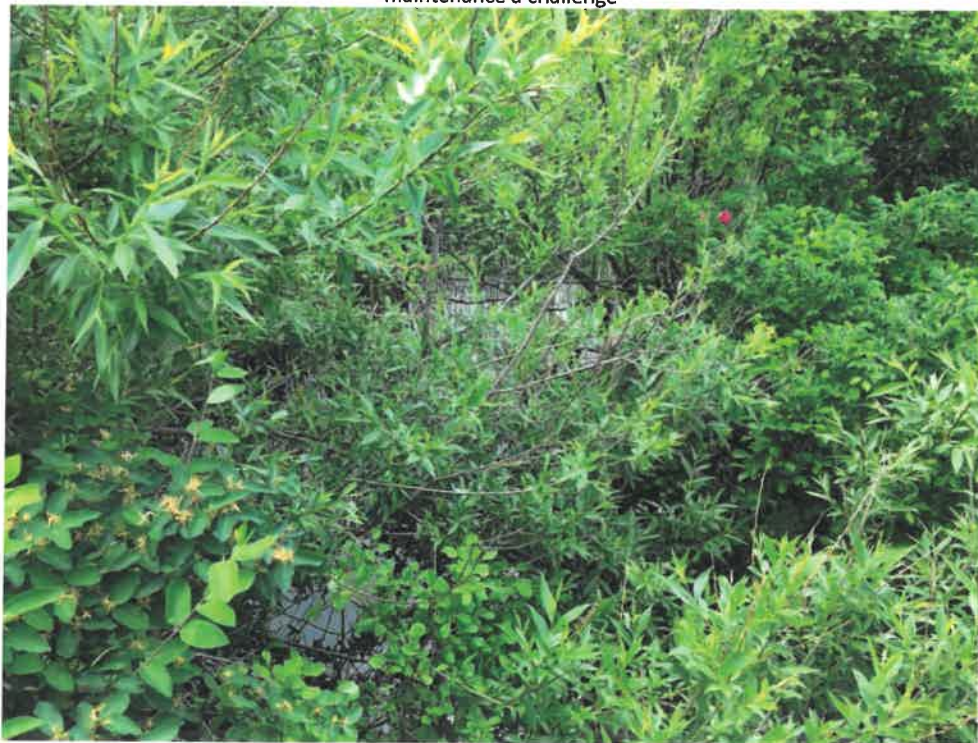
Photo 4 (06-06-18): Facing west. Thick vegetation and berm controlling ponded water up gradient of the culvert inlets.

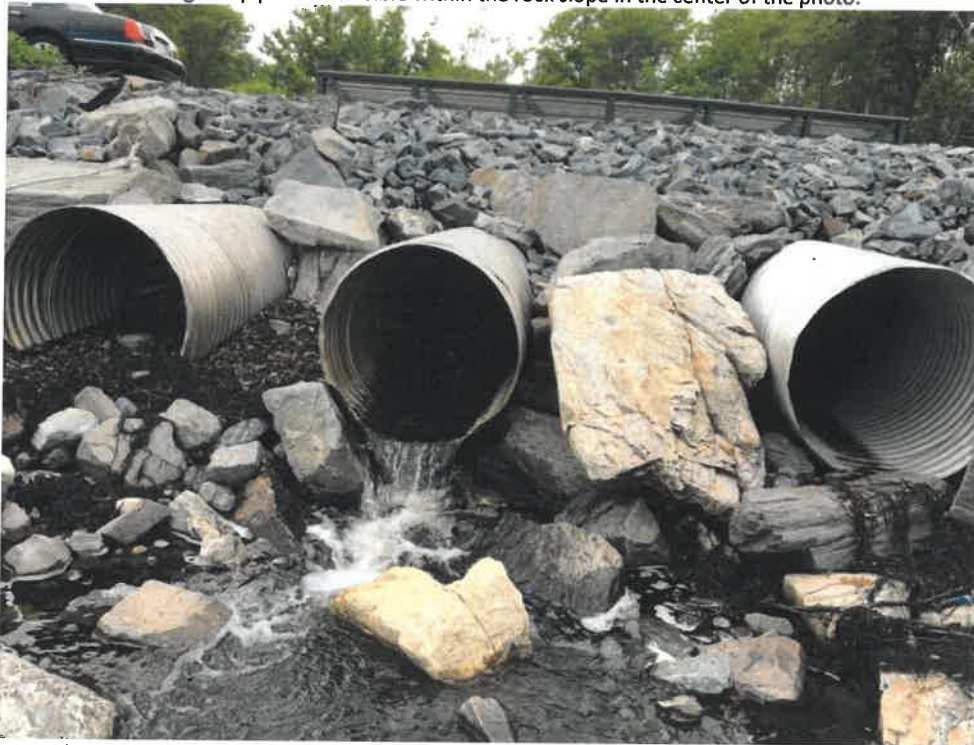
Photo 6 (06-06-18): Looking east at hanging outlet of the three, 36-inch aluminum corrugated pipe outlets on the west side of Shore Road. Seaweed and other debris frequently compromise the culverts' capacity as exemplified by only the center culvert flowing freely despite all three culverts being installed at roughly the same elevations.

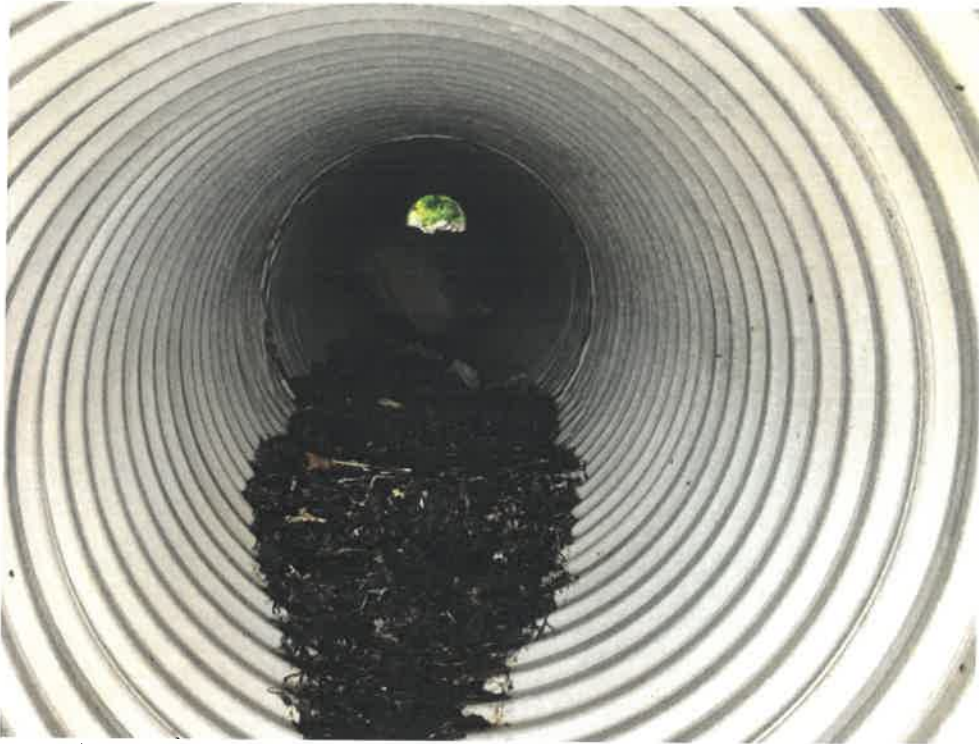
Photo 7 (06-06-18): Looking west at large rock and other ocean debris inside of northerly culvert. Being exposed directly to Casco Bay, ocean surges often push debris inside of these pipes creating an ongoing maintenance issue for the Town.

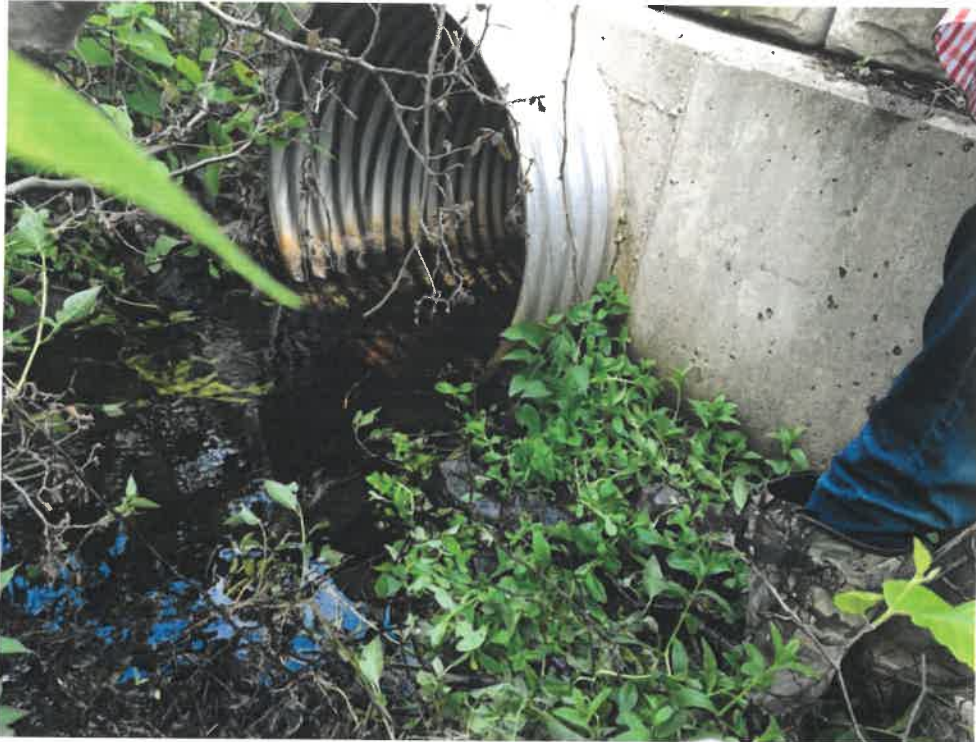
Photos 3 (06-06-18): Inlet of submerged culvert on west side of Shore Road.

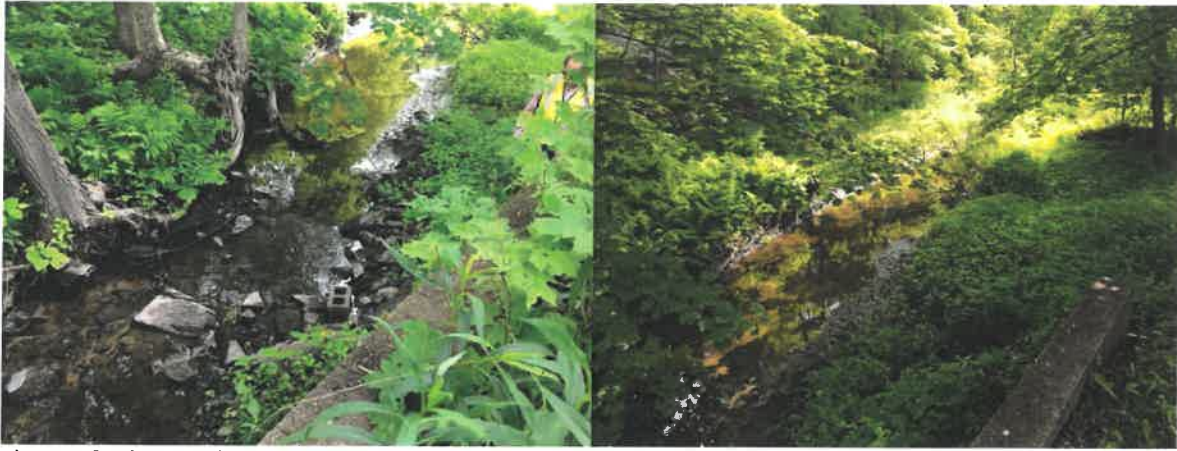
Photos 3 & 4 (06-06-18): Trout Brook, an Urban Impaired Stream, flowing to the culvert inlet on east side of Route 77. Photo 3 is taken adjacent to the inlet and shows eroded areas at the base of the mature trees lining the northern bank. Photo 4 depicts a more uniform and stable channel further upstream from the culvert inlet.

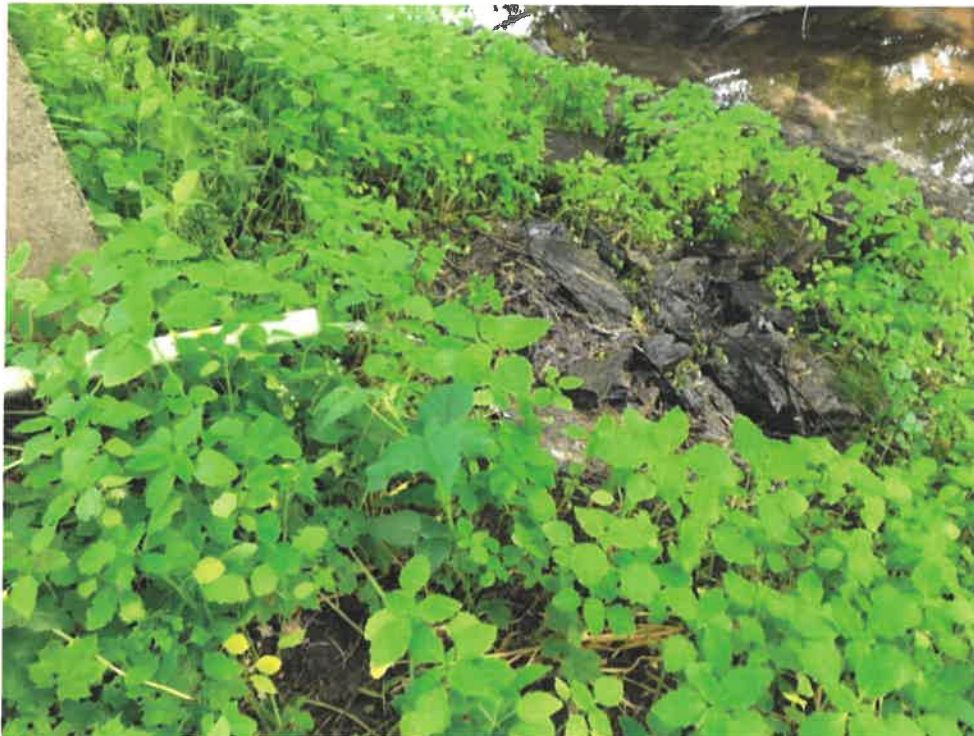
Photo 5 (06-06-18): Facing west at the east end of the concrete wingwall on the south side of the culvert inlet. Small diameter white pvc pipe is conveying groundwater flow directly into Trout Brook despite being a relatively dry weather period. Trout Brook receives surface flow and groundwater flow from residential neighborhoods and other developed areas in close proximity to the stream.

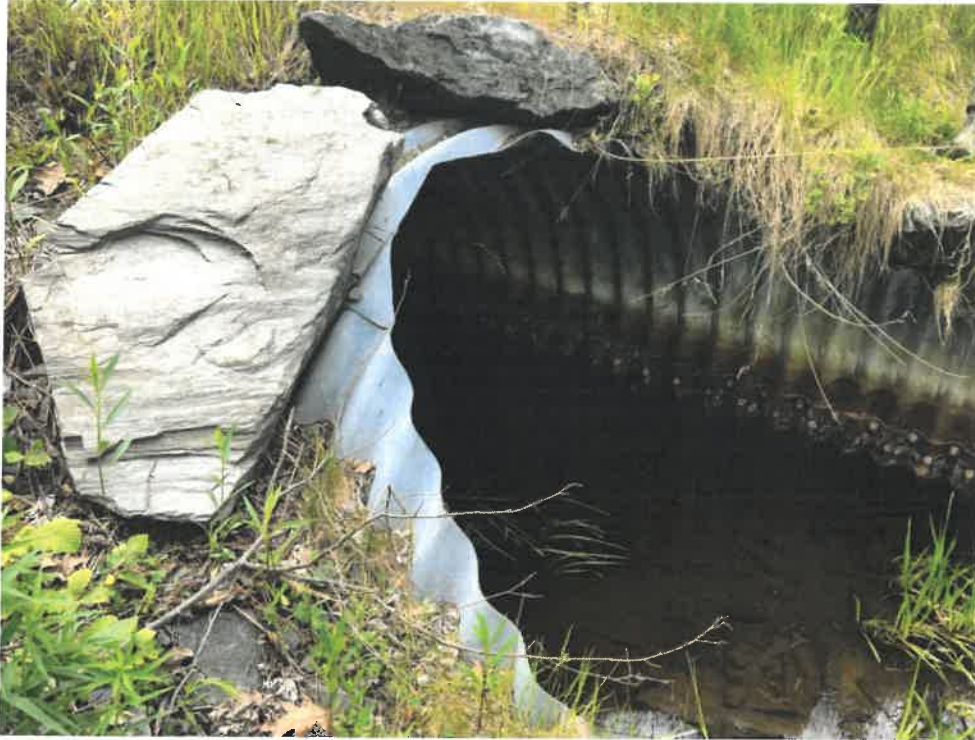
Photo 6 (06-06-18): Looking at the submerged outlet of 8 foot, 2-inch-wide by 5 foot, 9-inch-high steel plate pipe arch cross pipe. Rip rap stones are sparse, but provide a headwall.

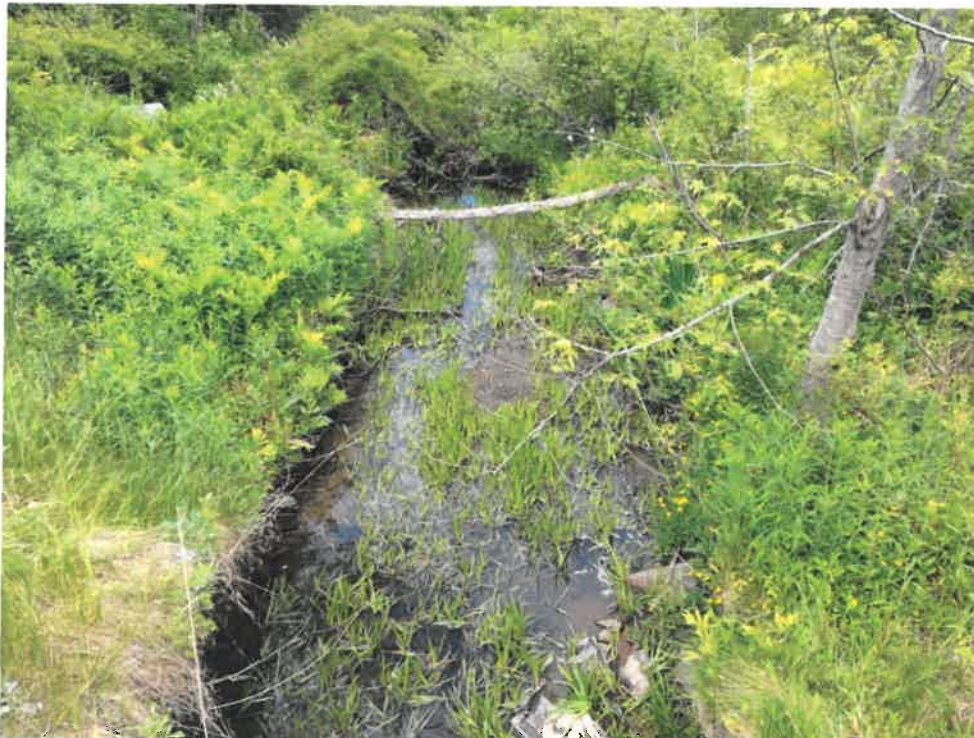
Photo 9 (06-06-18): Looking further downstream at the outlet of the steel plate pipe arch cross pipe. Vegetation and sediment deposits are present within this channel.

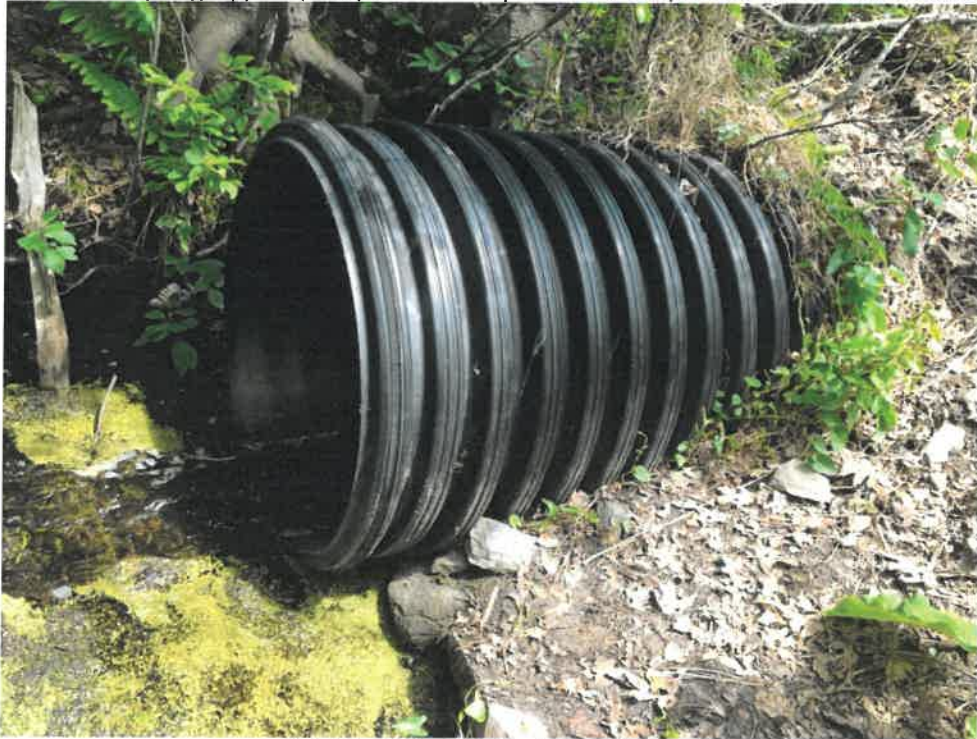
Photo 6 (06-06-18): Looking at the outlet of the 36-inch HDPE culvert on the north side of Spurwink Avenue. No formal headwall or apron at the outlet.

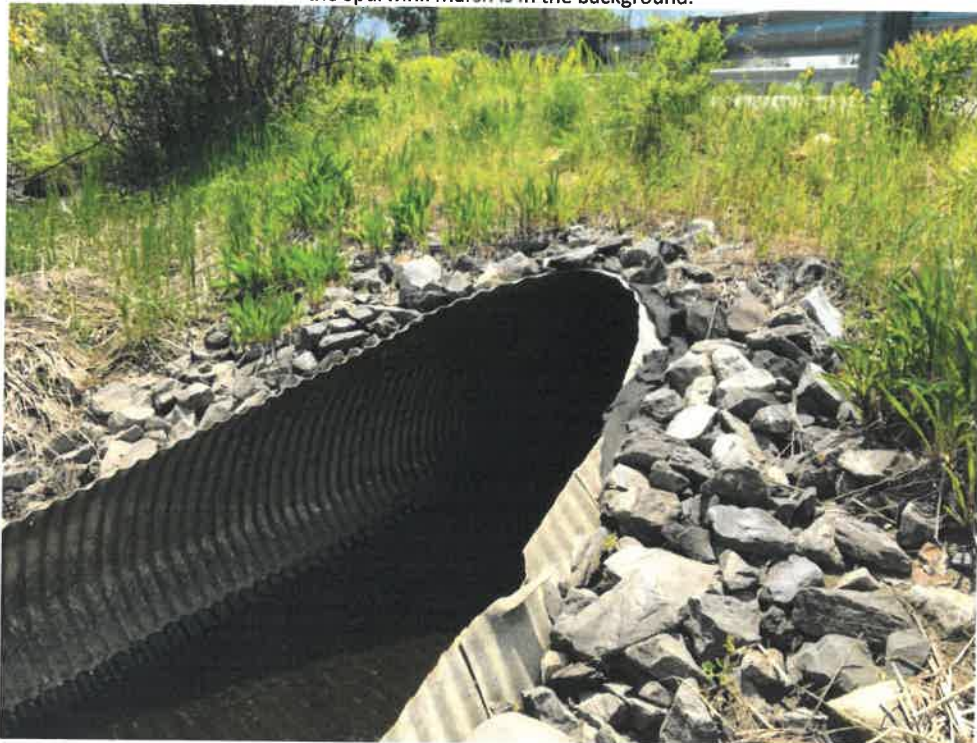
Photo 2 (06-06-18): Submerged inlet of 6-foot wide by 5-foot high corrugated aluminum elliptical pipe with flared end and rip rap headwall. Additional headwall rip rap should be added to the headwall.

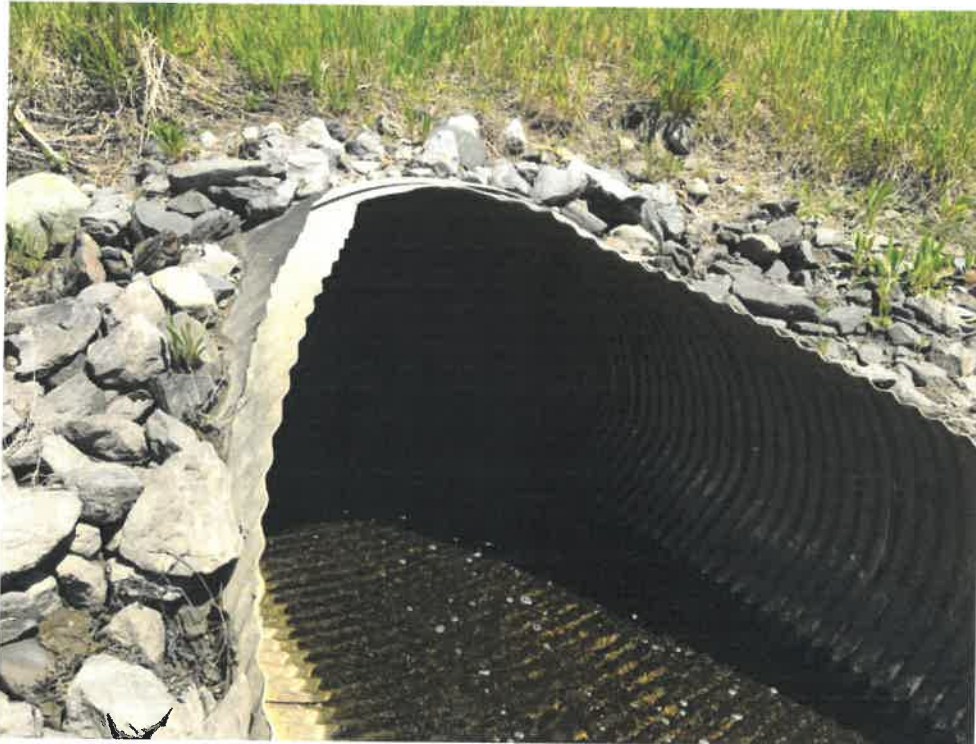
Photo 5 (06-06-18): Submerged outlet of the aluminum elliptical pipe with flared end and rip rap headwall. Additional rip rap would be desirable to bolster the area around the culvert.

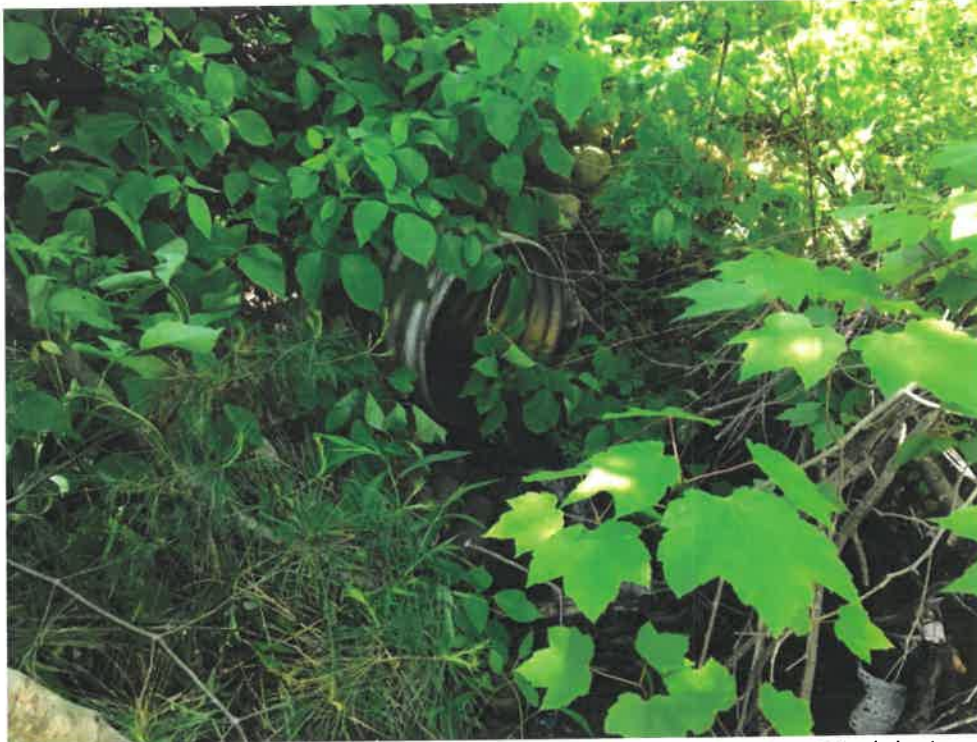
Photos 3 (06-06-18): Hanging culvert outlet on east side of Shore Road of the 24-inch corrugated aluminum pipe.

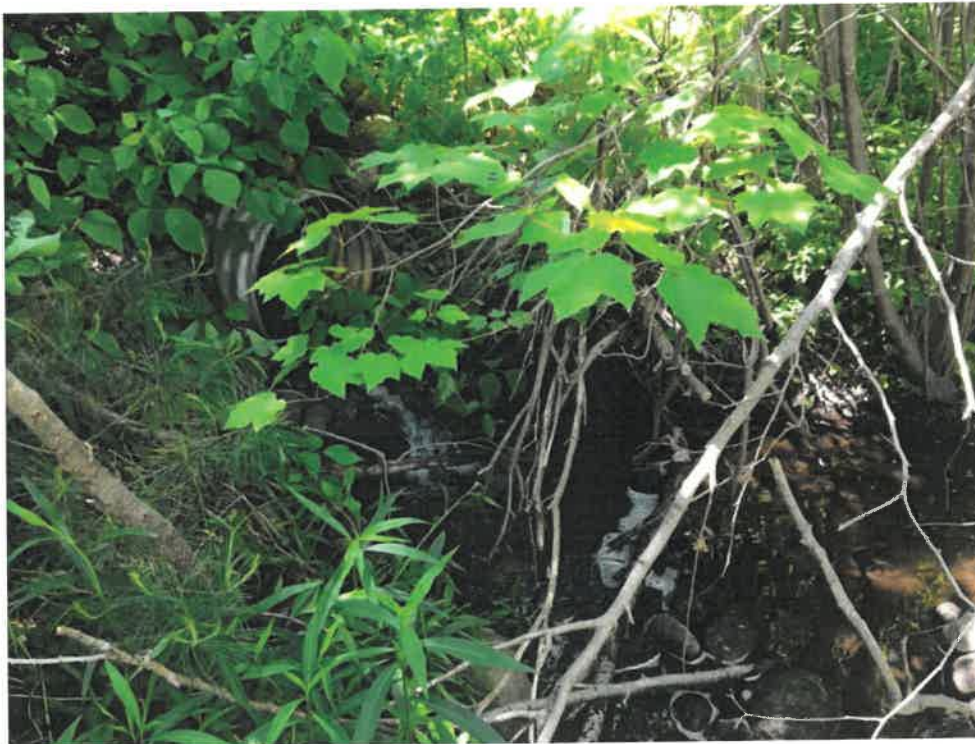
Photo 4 (06-06-18): Culvert outlet on east side of Shore Road with very thick vegetation around the culvert and in the downstream channel.

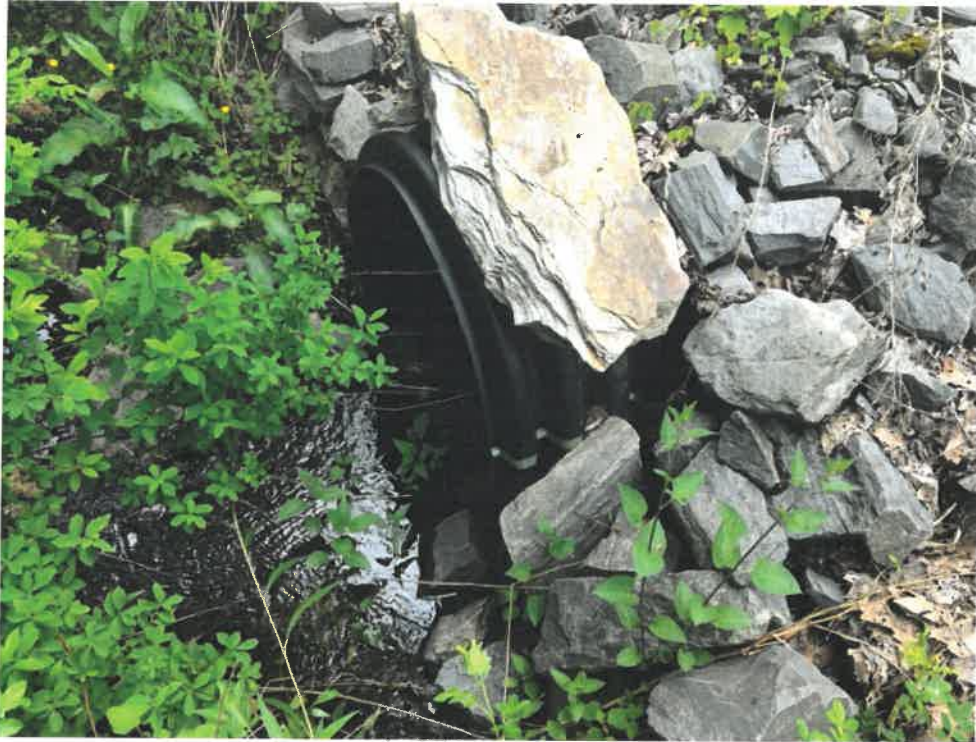
Photo 3 (06-06-18): Inlet of 30-inch High Density Polyethylene (HDPE) cross pipe with a rip rap creating a headwall and apron. Inlet is on the east side of Spurwink Avenue. Access to the culvert and the area around the inlet is relatively clear of vegetation.

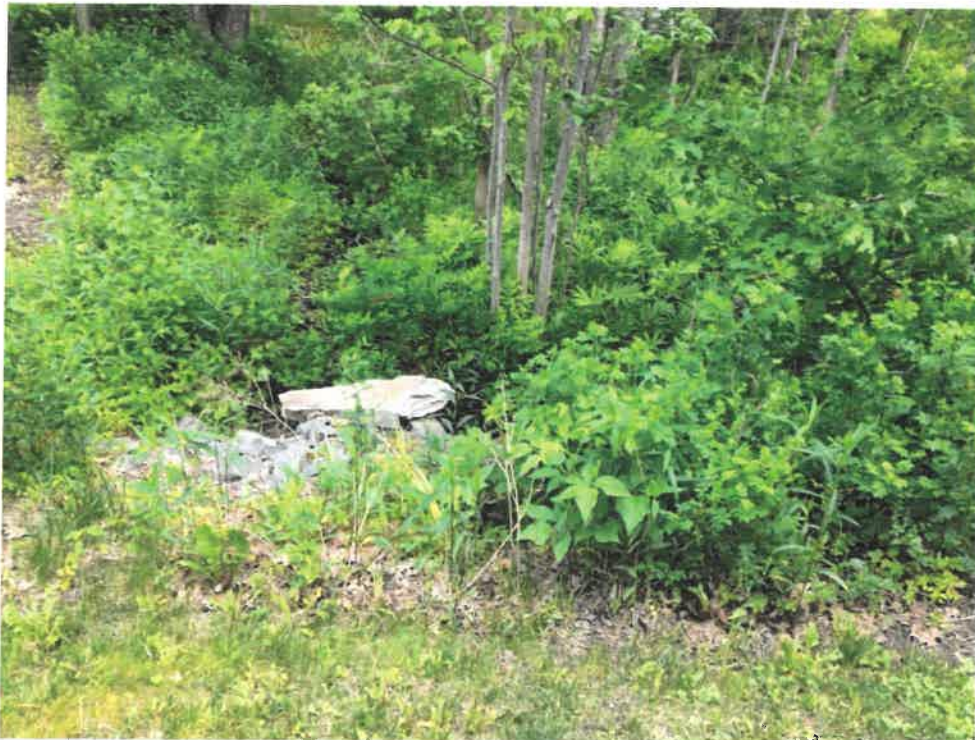
Photo 4 (06-06-18): Facing east at the inlet of 30-inch HDPE cross pipe and the vegetated channel upstream of the culvert crossing.

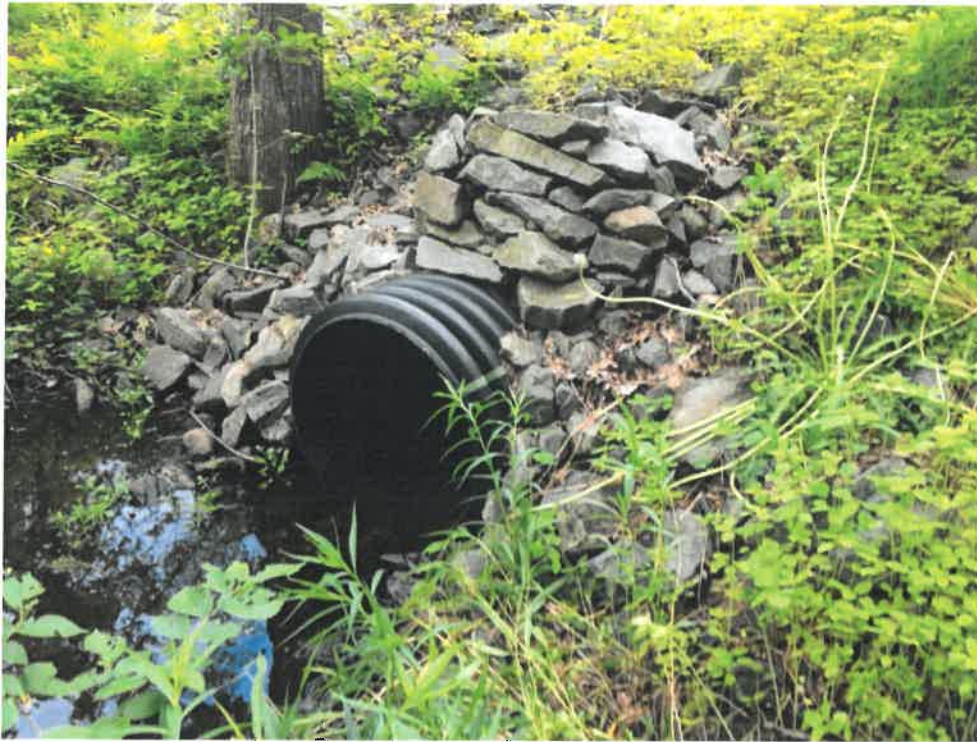
Photo 5 (06-06-18): Culvert outlet on west side of Spurwink Avenue with a rip rap headwall around the culvert.

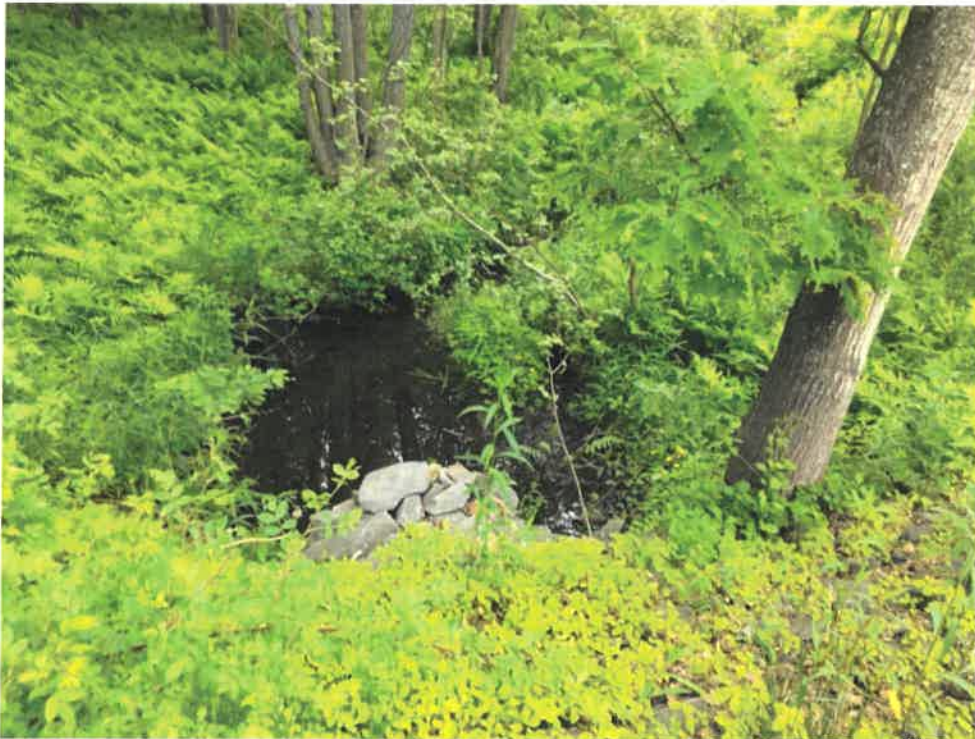
Photo 6 (06-06-18): Facing west at the stone headwall for the outlet of 30-inch HDPE cross pipe and the channel downstream of the culvert crossing. The downstream channel turns to the north (i.e., the right in this photo) as it approached the vegetation beyond the visible pool of water beyond the outlet of the culvert.

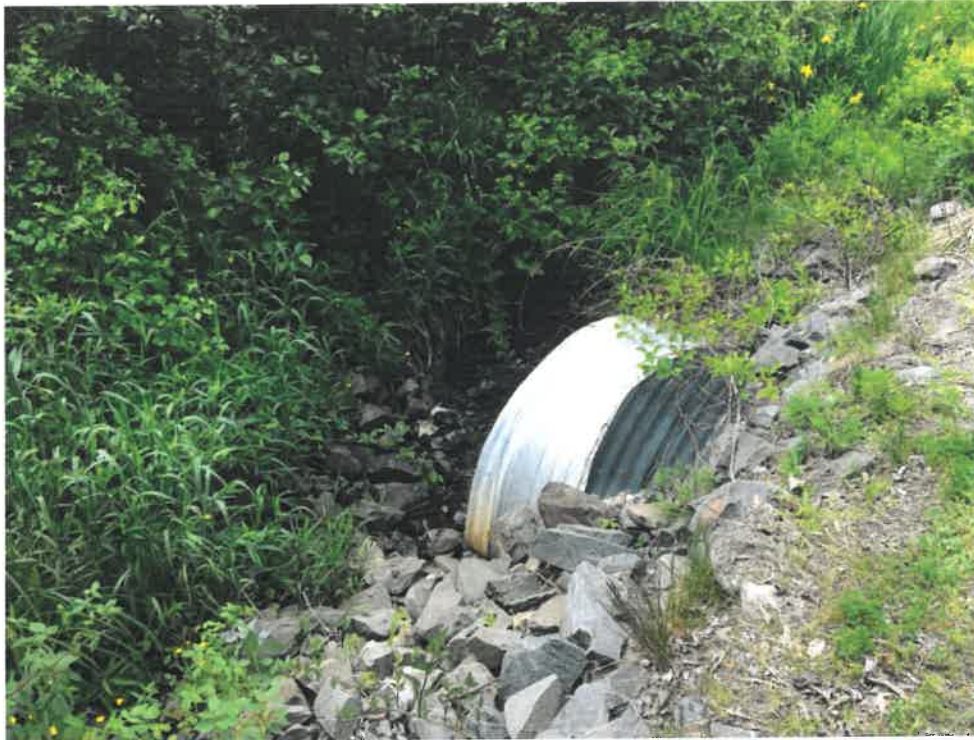
Photos 3 (06-06-18): Culvert inlet on west side of Spurwink Avenue is submerged within the corrugated aluminum pipe. Upstream vegetation obscured channel at the time of the photo.

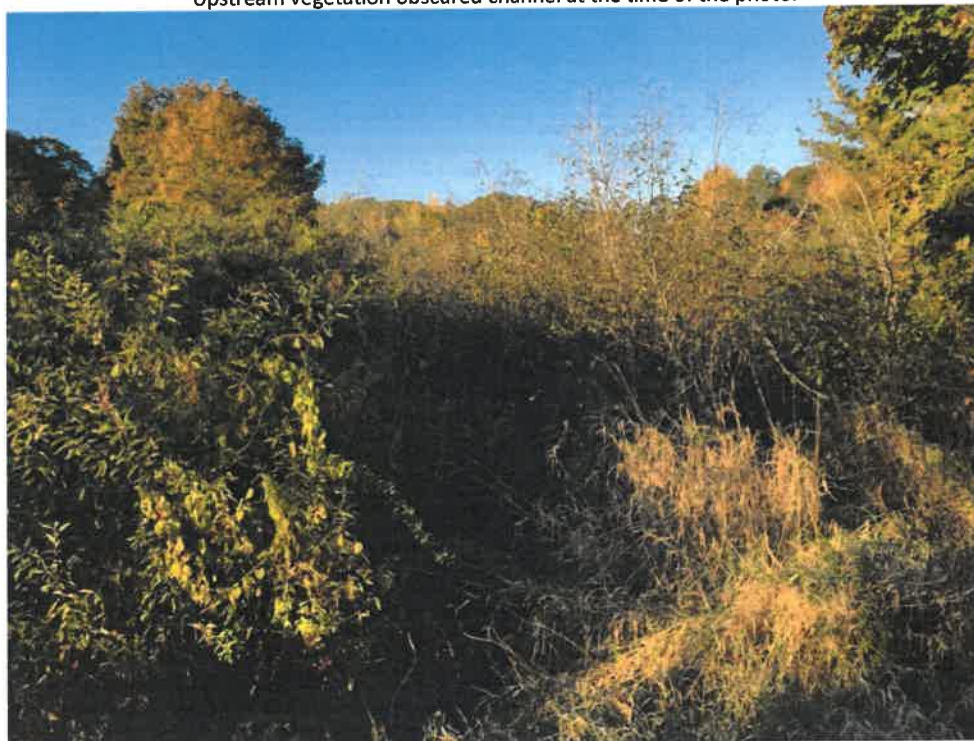
Photos 4 (10-22-18): Looking up gradient at the heavily vegetated area flowing to the culvert inlet on west side of Spurwink Avenue. Upstream vegetation obscured channel at the time of the photo.

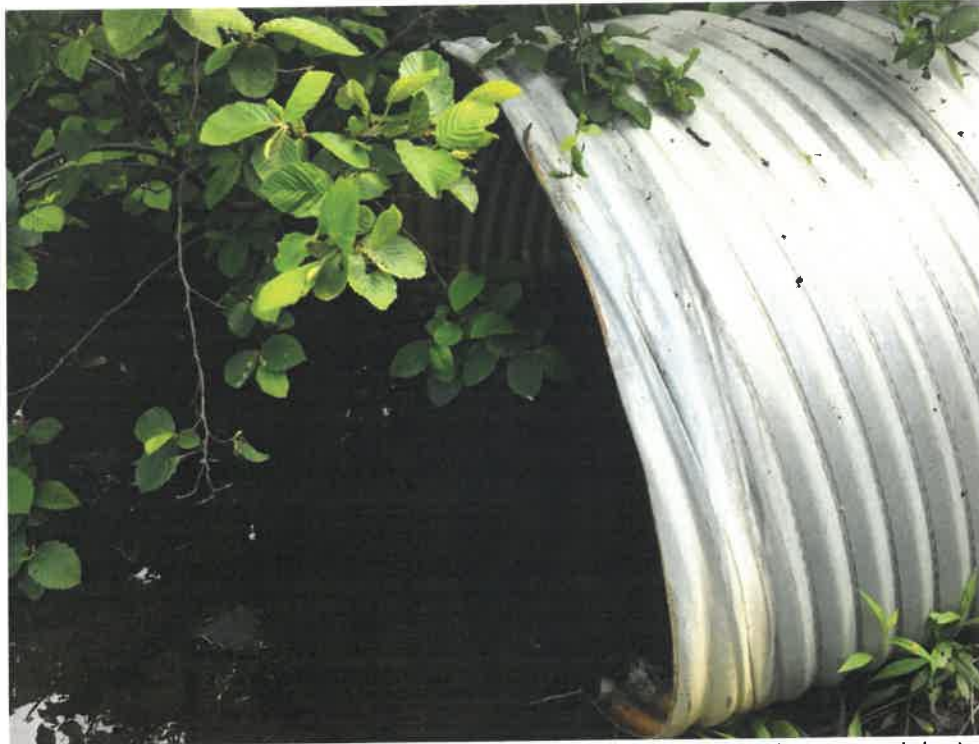
Photo 5 (06-06-18): Culvert outlet on east side of Spurwink Avenue is submerged within the corrugated aluminum pipe. Downstream vegetation obscured channel at the time of the photo.

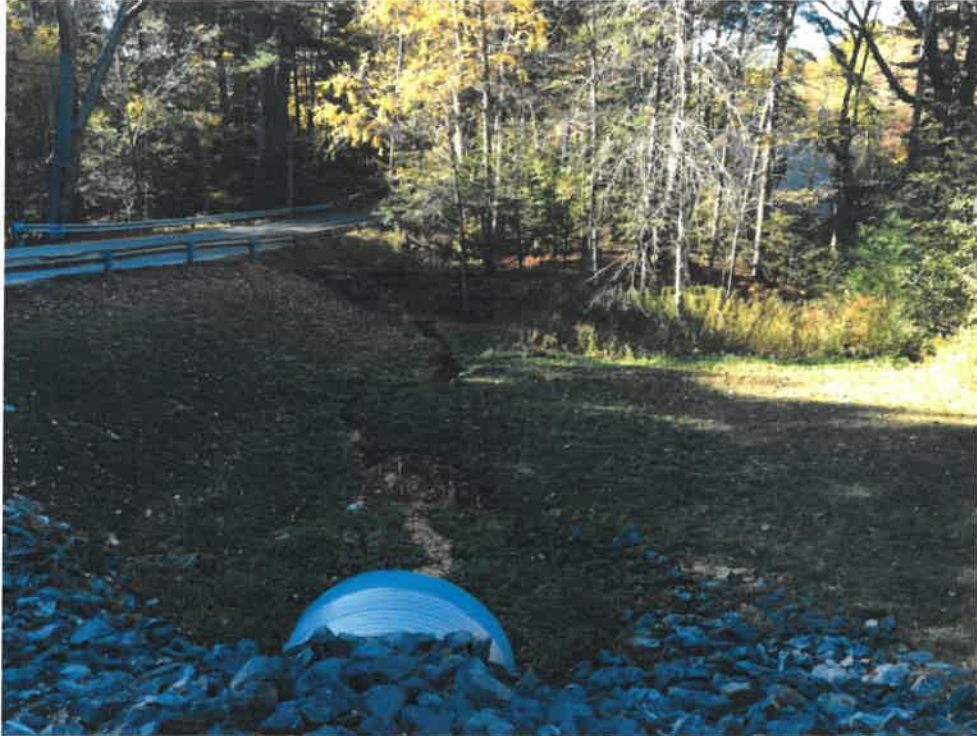
Photo 5 (10-22-18): Facing southwest at discharge flow channel of Pond Cove Brook from elliptical culvert under Hobstone Road to the Mitchell Road culvert inlet.

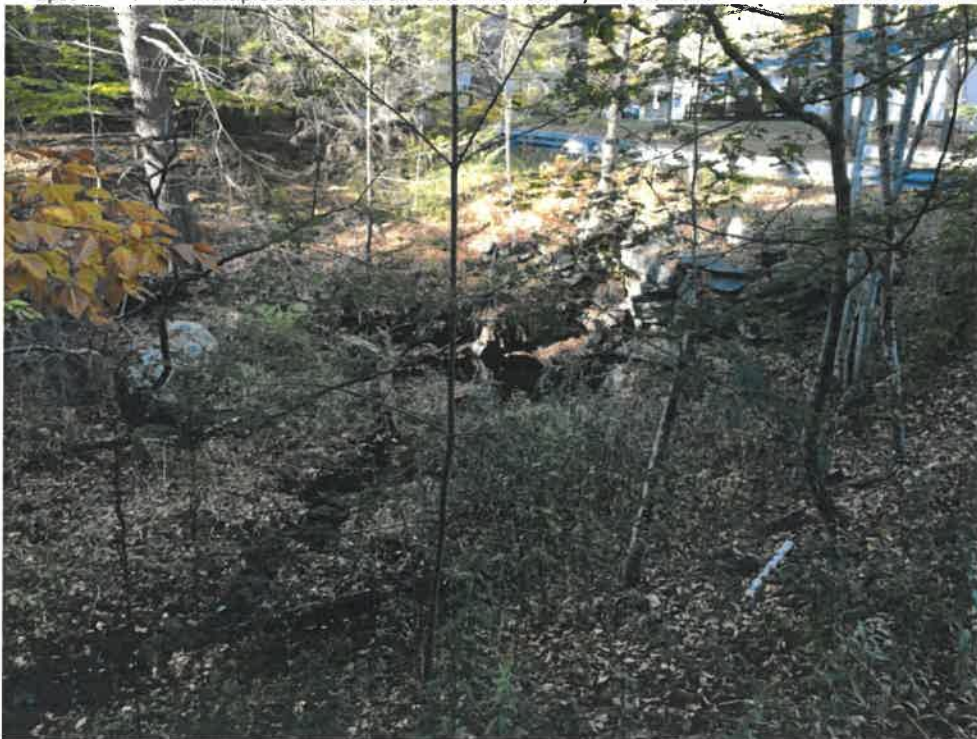
Photo 10 (10-22-18): Facing south from the nearby pump station at the downstream flow of Pond Cove Brook from the Mitchell culvert outlet.

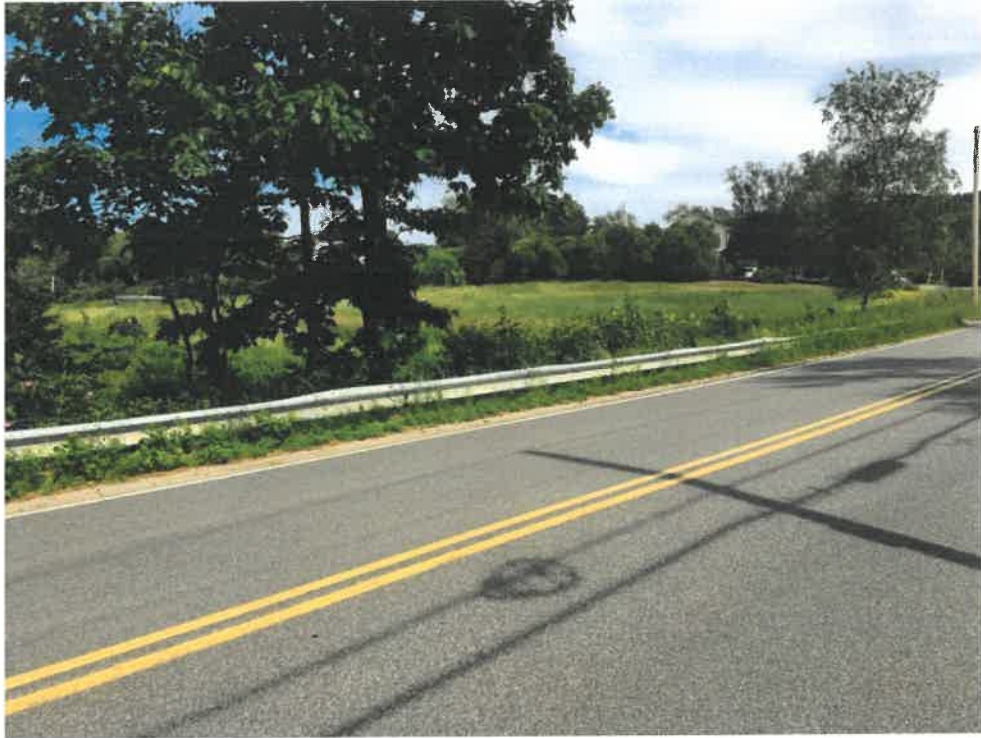
Photo 1 (06-20-18): Facing southeast at Old Ocean House Road crossing of Alewife Brook. Culvert are located relatively deep in relation to the road surface elevation with a steep roadway embankment.

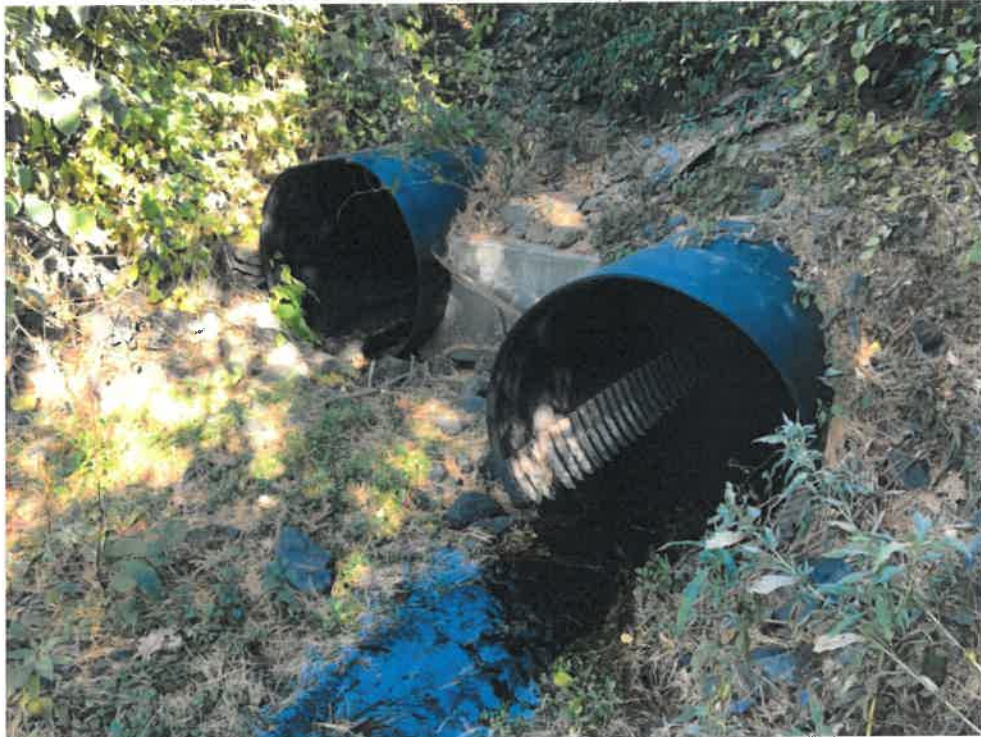
Photo 2 (10-22-18): Inlet of two 48-inch high density polyethylene liner pipes within the original corrugated aluminum cross pipes. Southerly culvert on the right-hand side conveys main flow of Alewife Brook with left-hand side culvert available for overflow capacity.

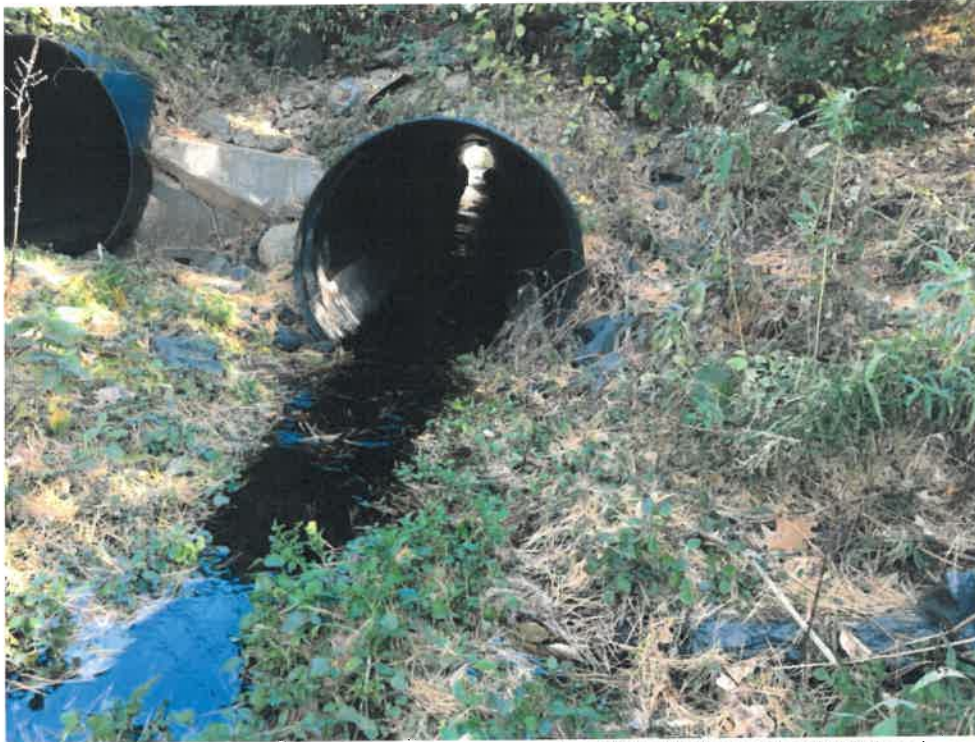
Photo 3 (10-22-18): Looking northerly through the inlet of one of the two 48-inch high density polyethylene liner pipes within the original corrugated aluminum cross pipes. The invert of the main carrying pipe is lined with a corrugated metal pipe section to reduce the velocity of flow through the pipe.

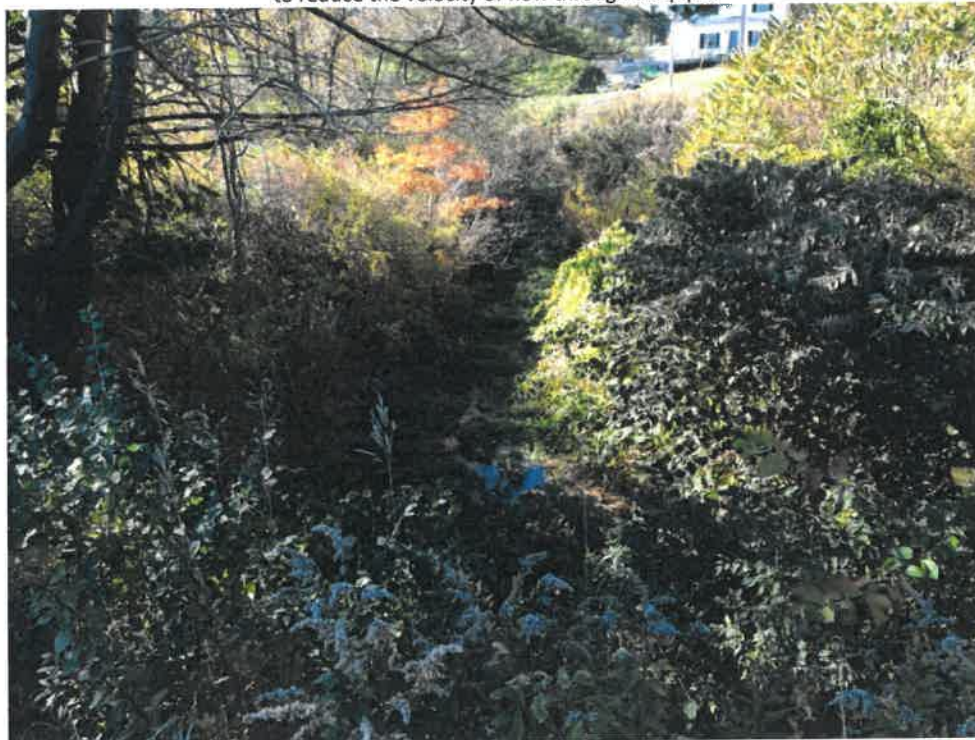
Photos 4 (10-22-18): Looking northwesterly from top of embankment at the upstream channel flowing to the two culverts inlets on the west side of Old Ocean House Road.

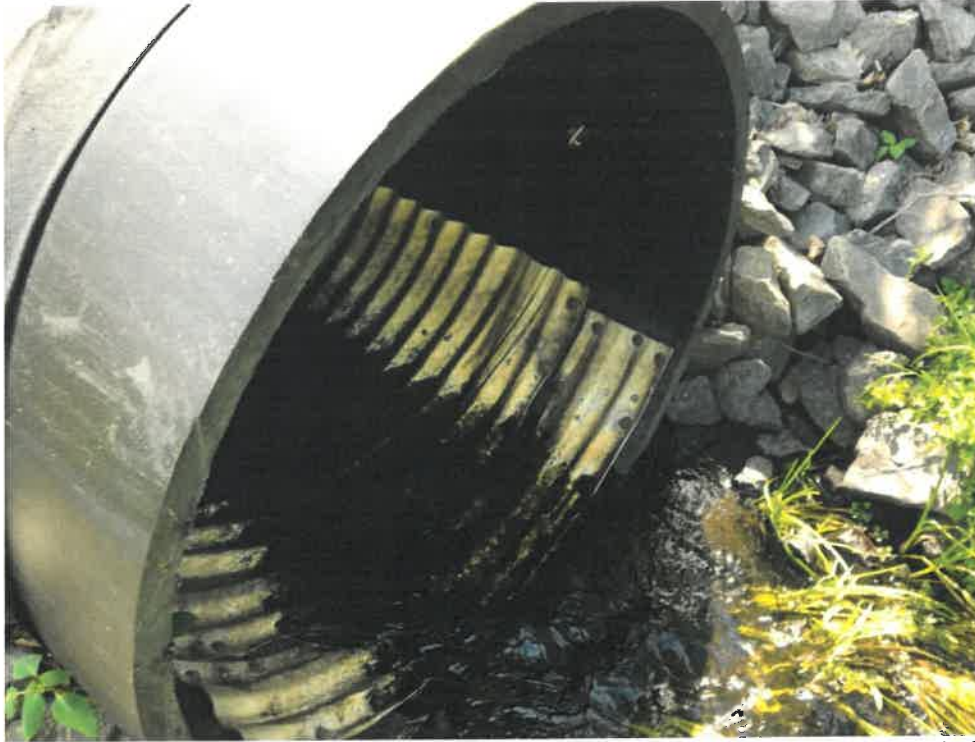
Photo 5 (06-20-18): Submerged outlet of main flow carrying culvert with corrugated metal pipe invert to slow the flow velocity through the pipe to allow fish passage.

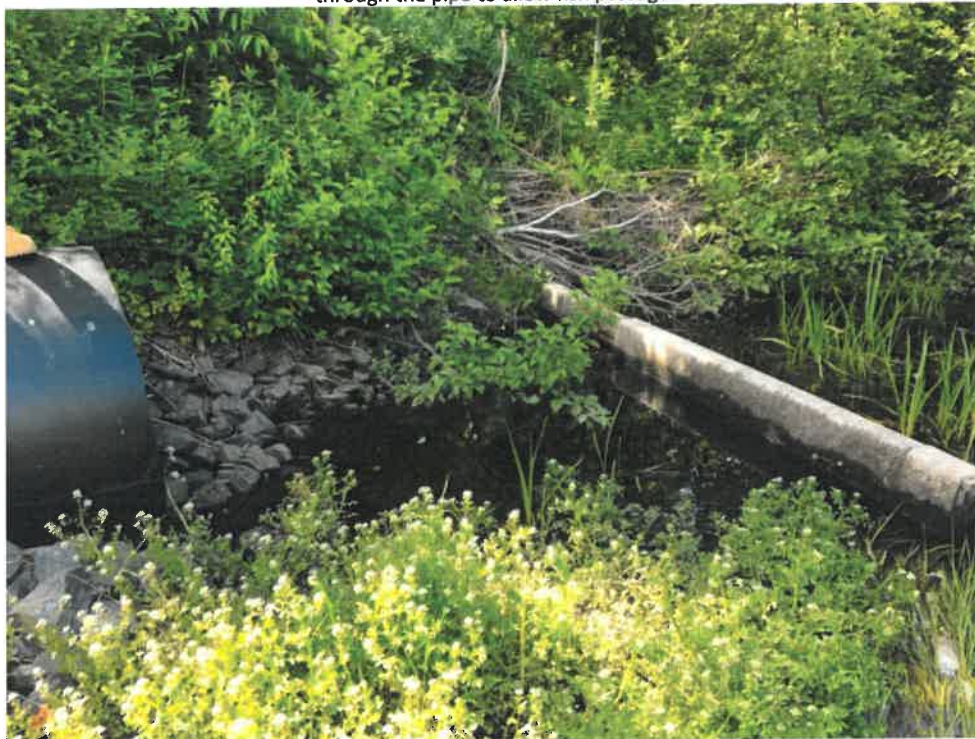
Photo 6 (06-20-18): Outlet of culverts on the east side of Old Ocean House Road. Outlet has a rip rap lined plunge pool and headwall. Concrete weir at outlet was installed to create a submerged outlet to allow alewife fish passage.

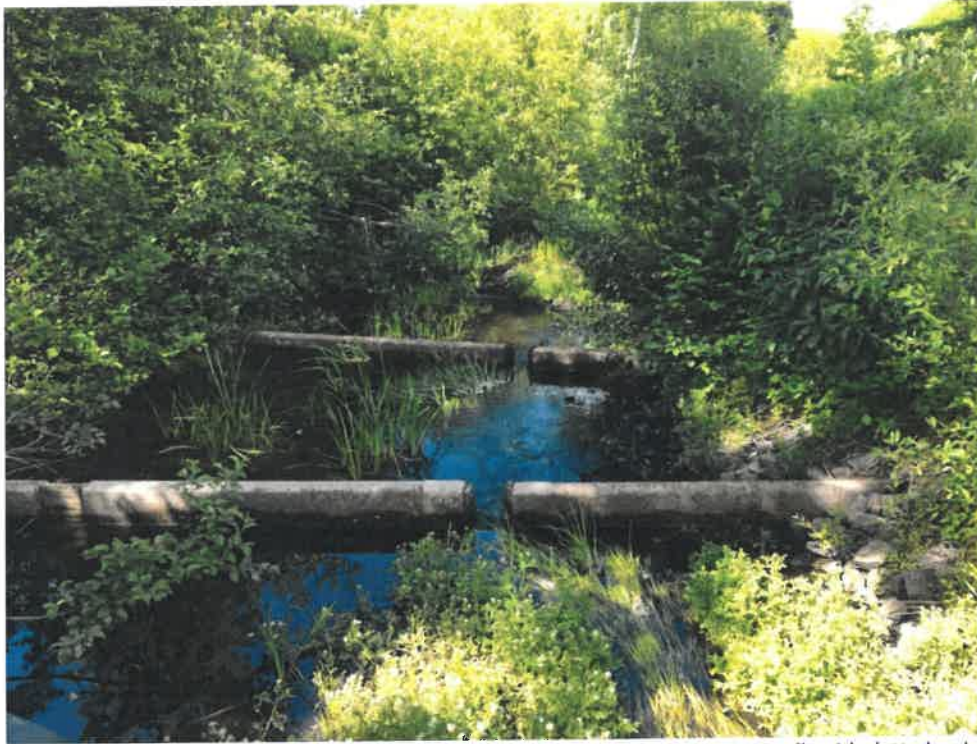
Photo 7 (06-20-18): Downstream channel of the culvert outlet flow with two concrete weir walls with slotted weirs to control elevation and flow from the culverts to dissipates energy of the outfall and reduce the velocity of the outflow to the receiving channel. The weirs also create pool areas within the channel.
