Cape Elizabeth Culvert and Habitat Assessment Study

March 22, 2019

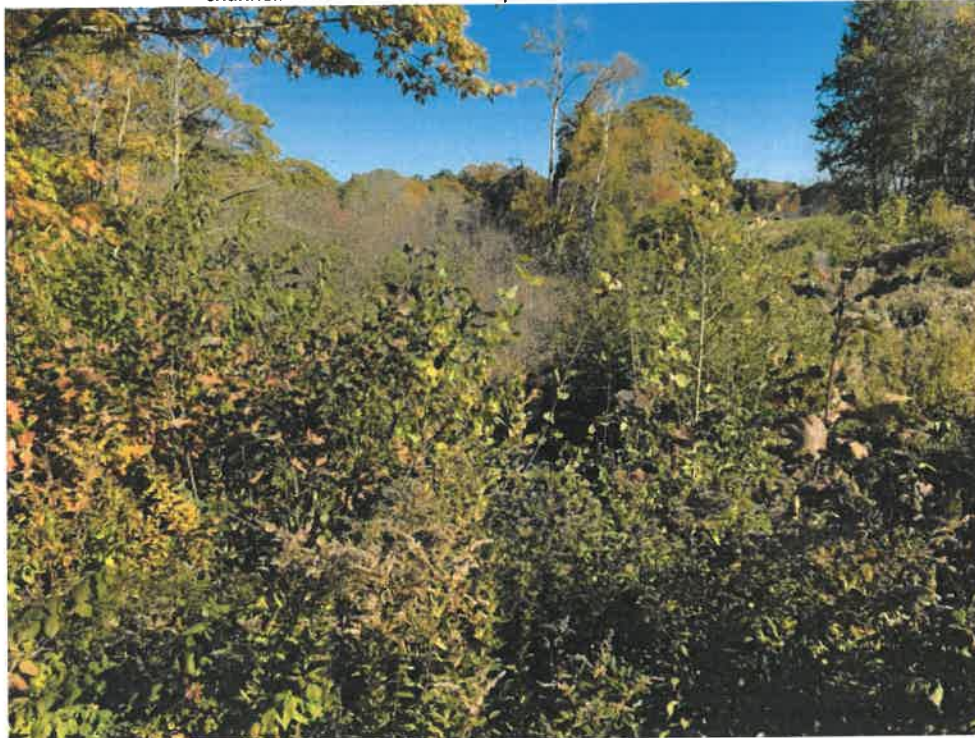
Photo 8 (10-22-18): Looking northerly at the heavily vegetated downstream channel of Alewife Brook from the culvert outlet flow.

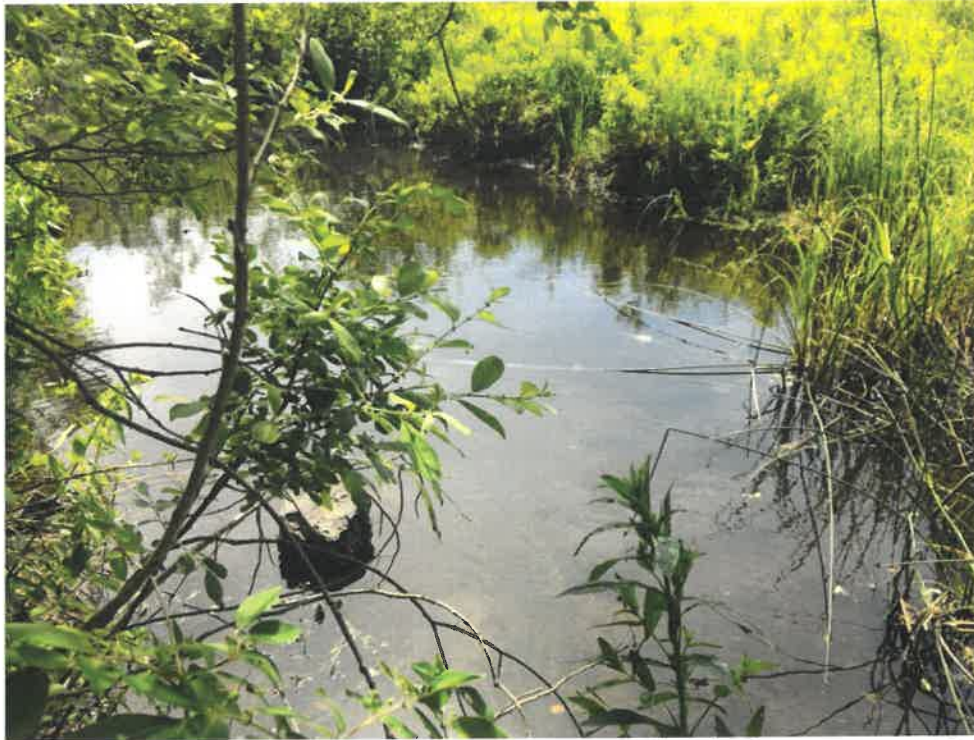
Photos 3 (06-20-18): Looking upstream at the Alewife Brook flow to the Inlet of the culvert on west side of Ocean House Road (Route 77). Alewife Brook hydraulically connects Great Pond to Casco Bay.

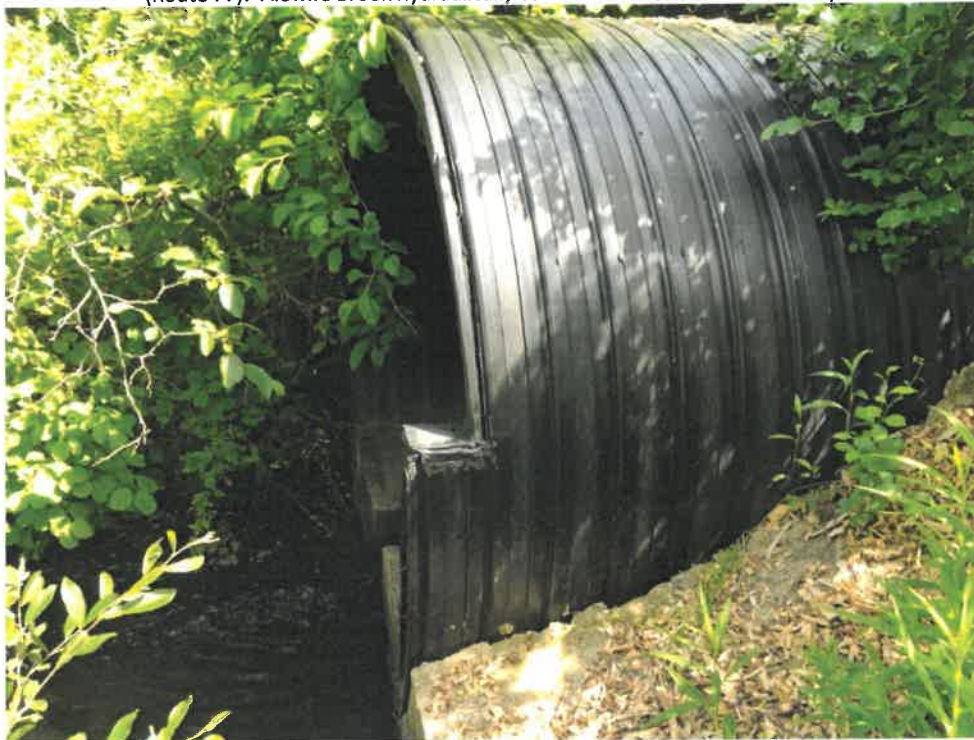
Photo 4 (06-20-18): Submerged outlet of culvert with slotted weir invert to slow the flow velocity through the pipe to allow fish passage. Culvert outlet is supported by concrete saddle.

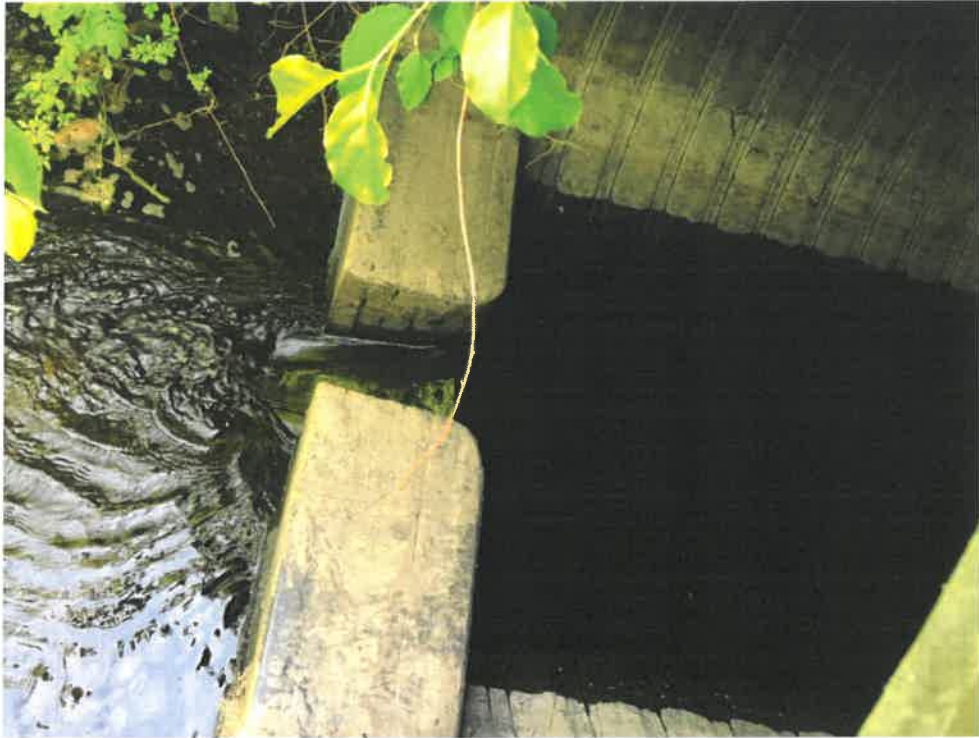
Photo 5 (06-20-18): Weir in outlet of culvert on the east side of Ocean House Road. Weir at outlet was installed to create a submerged outlet to allow Alewife fish passage.

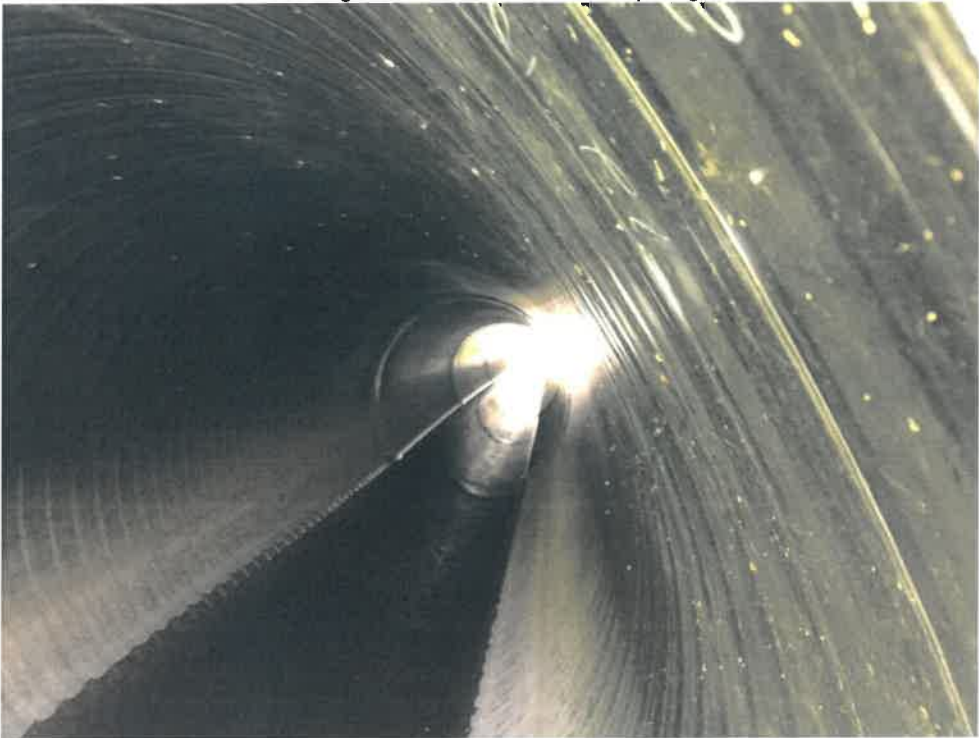
Photo 6 (06-20-18): View of the interior of the HDPE liner from the outlet toward the inlet of the pipe. Invert of the culvert is submerged.

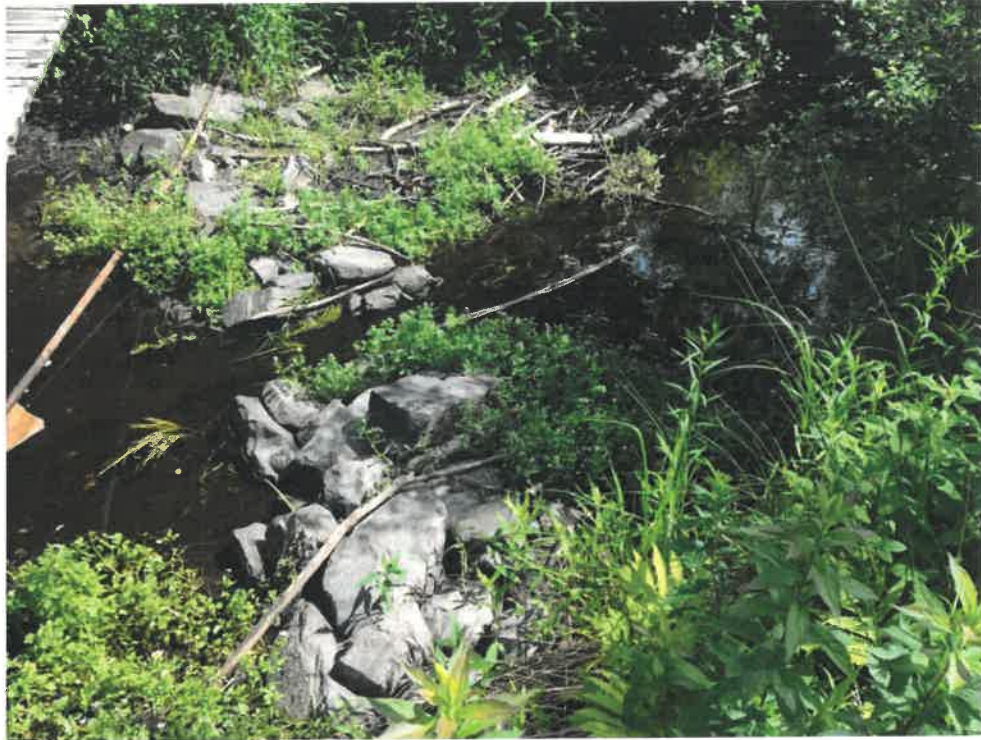
Photo 7 (06-20-18): Downstream channel of the culvert outlet flow with stone weir wall with center opening to control elevation and flow from the culverts to dissipate energy of the outfall and reduce the velocity of the outflow to the receiving channel. The weir also creates a pool area within the channel.

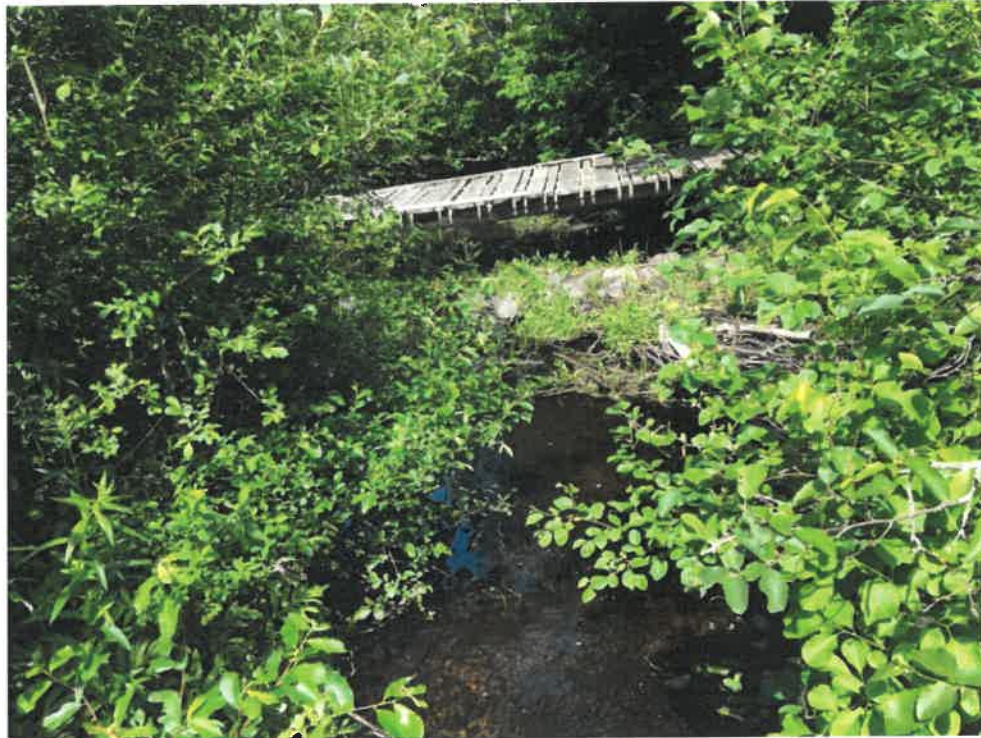
Photo 8 (06-20-18): Downstream view of Alewife Brook from outlet area of the culvert. Stone berm is upstream of a wooden footbridge crossing over the stream in the background of the photo.

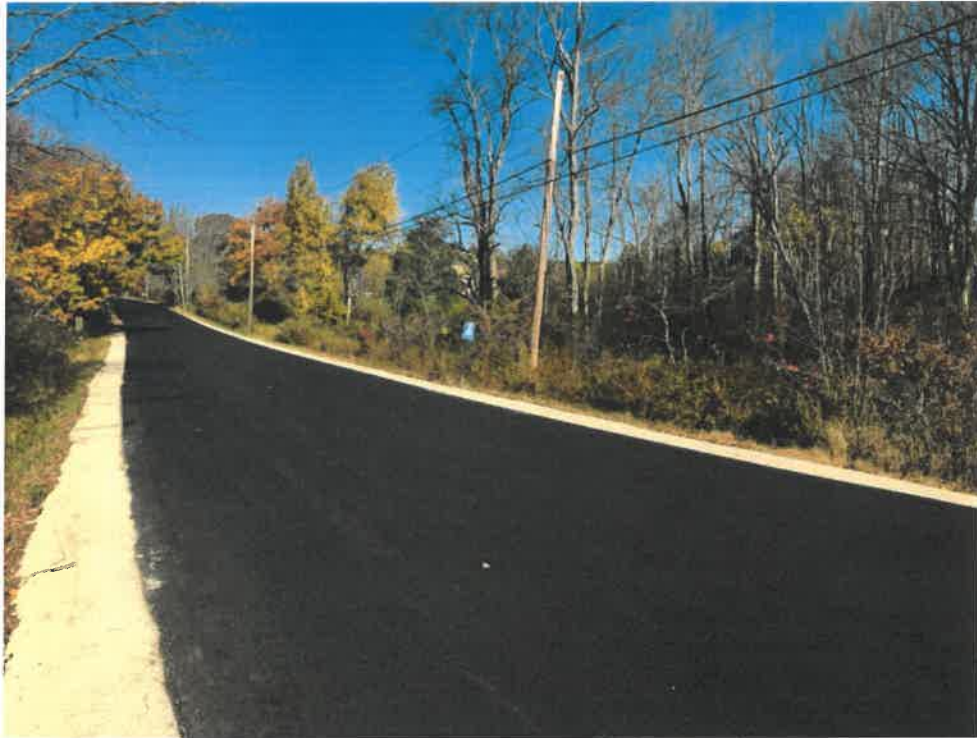
Photo 1 (10-22-18): Facing north at Eastman Road crossing of Trout Brook. Blue sign indicates that the culvert is within the Trout Brook Watershed which is an Urban Impaired Stream. Road freshly paved with new gravel shoulders.

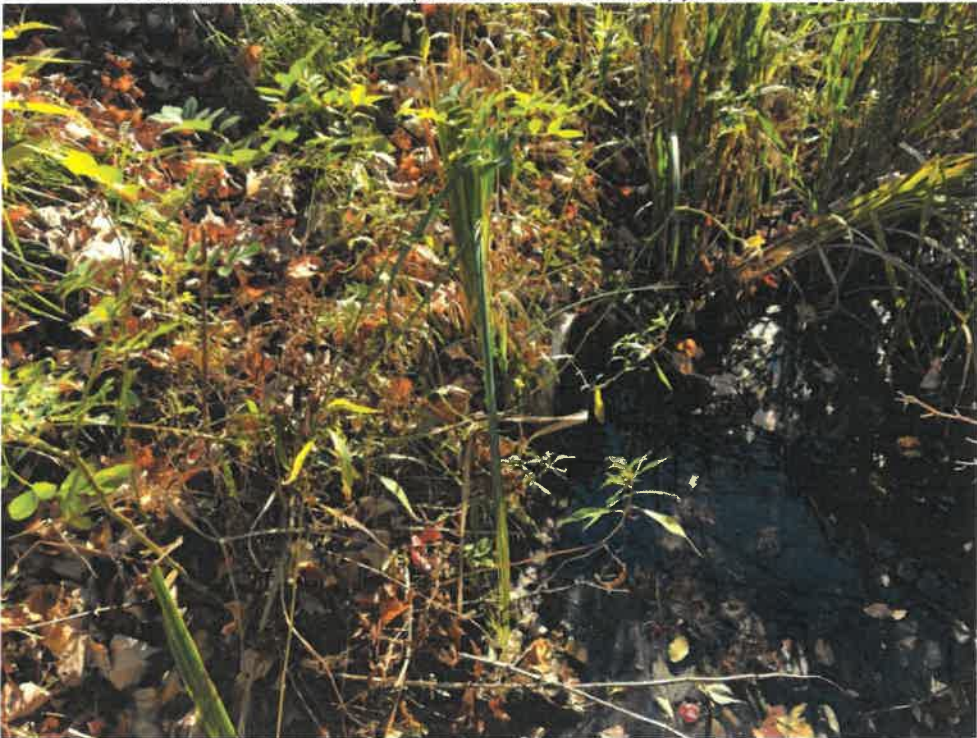
Photo 2 (10-22-18): Submerged inlet of 10-inch polyvinylchloride (pvc) culvert is barely visible due to the standing water and the vegetation surrounding the pipe. No rip rap apron or headwall. Pipe is very shallow and flat which compromises its capacity.

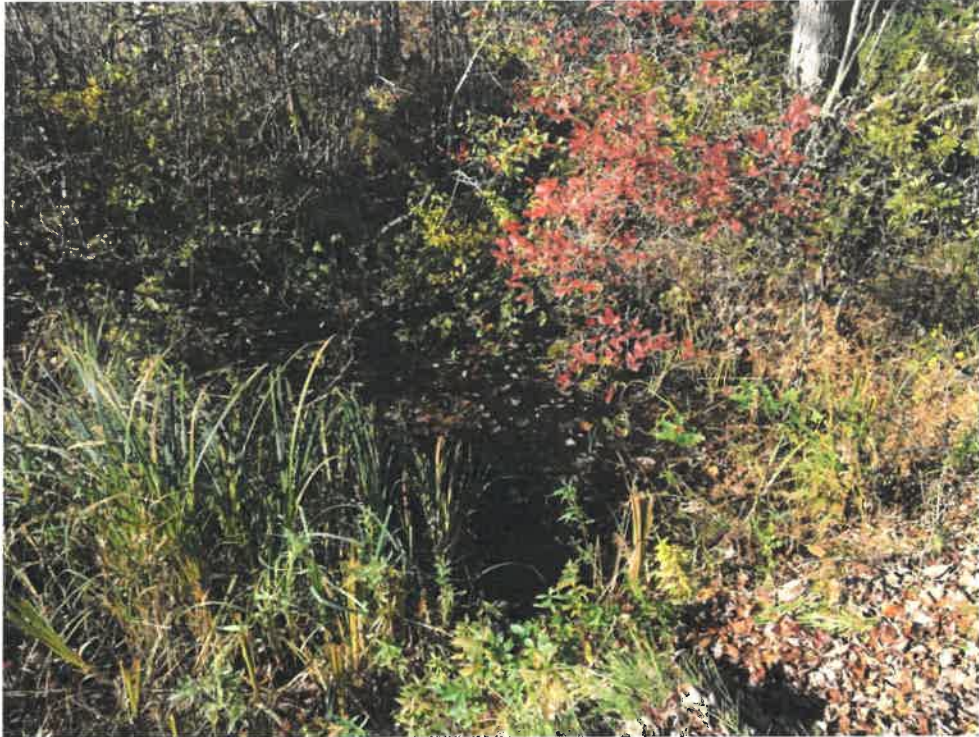
Photos 3 (10-22-18): Facing west at inlet of submerged culvert on west side of Eastman Road and up gradient area flowing toward culvert.

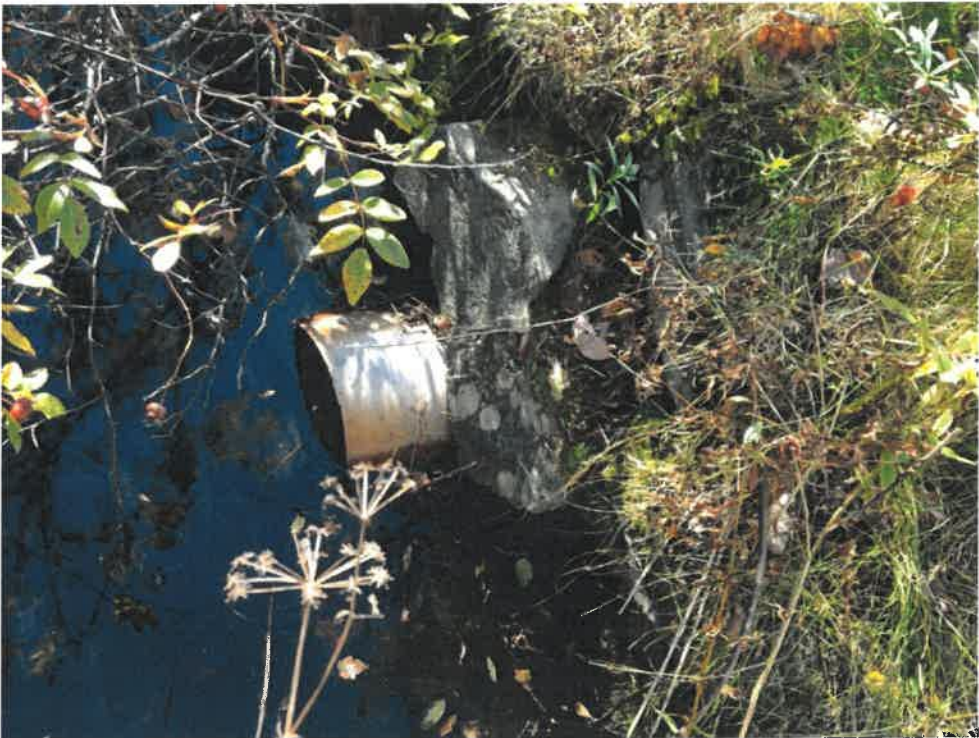
Photo 4 (10-22-18): Submerged outlet of culvert on the east side of Eastman Road. No rip rap apron has been provided. Area around the outlet has thick vegetation and standing water and is not draining well.

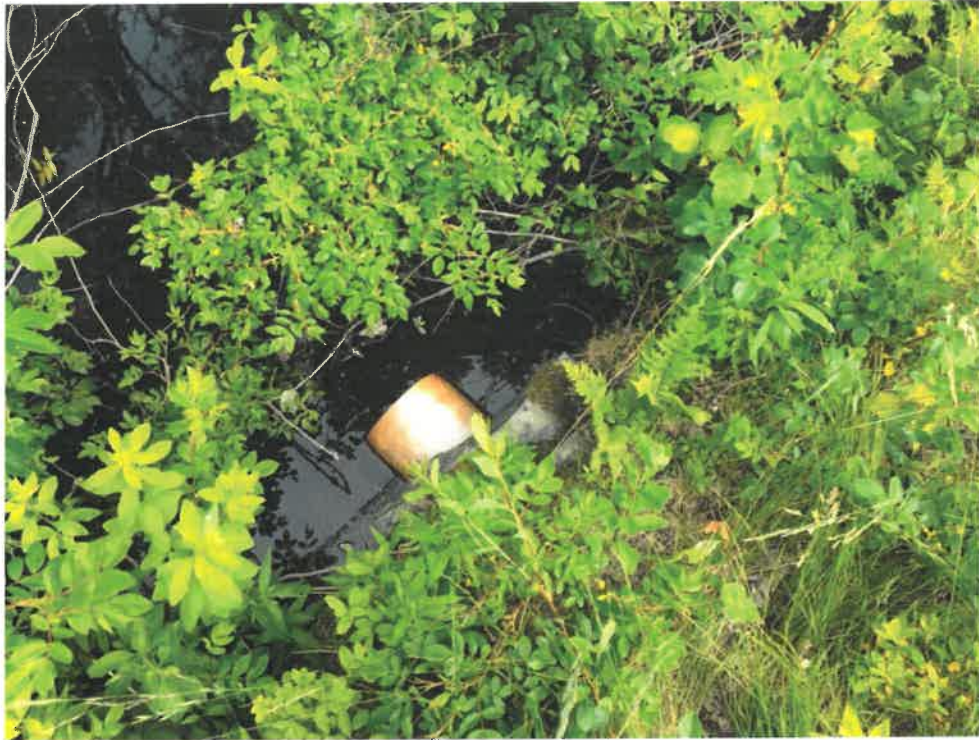
Photo 5 (06-20-18): Overhead view of submerged culvert outlet with a stone placed over the pipe to act as a headwall. Pipe is discolored due to years of exposure to sunlight.

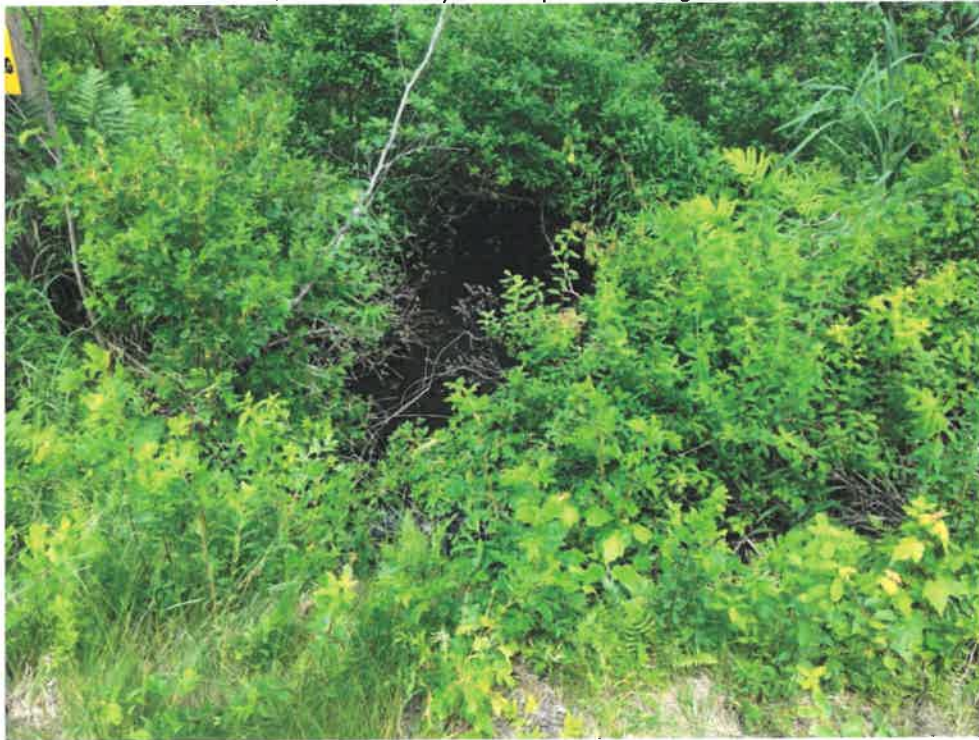
Photo 6 (06-20-18): Facing northeast at the downstream channel of the culvert outlet. Thick vegetation and likely deposited sediment within the channel create standing water with a very slow flow rate.

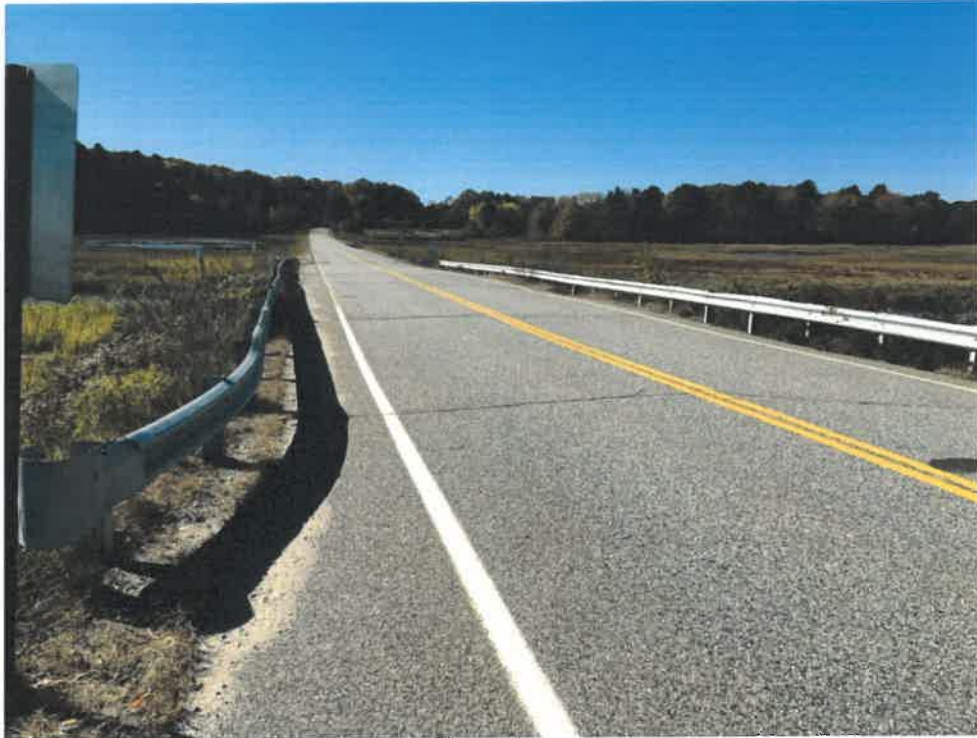
Photo 1 (10-22-18): Facing southwest at Sawyer Road culvert crossing. Road routinely floods beyond culvert crossing at low area of roadway elevation.

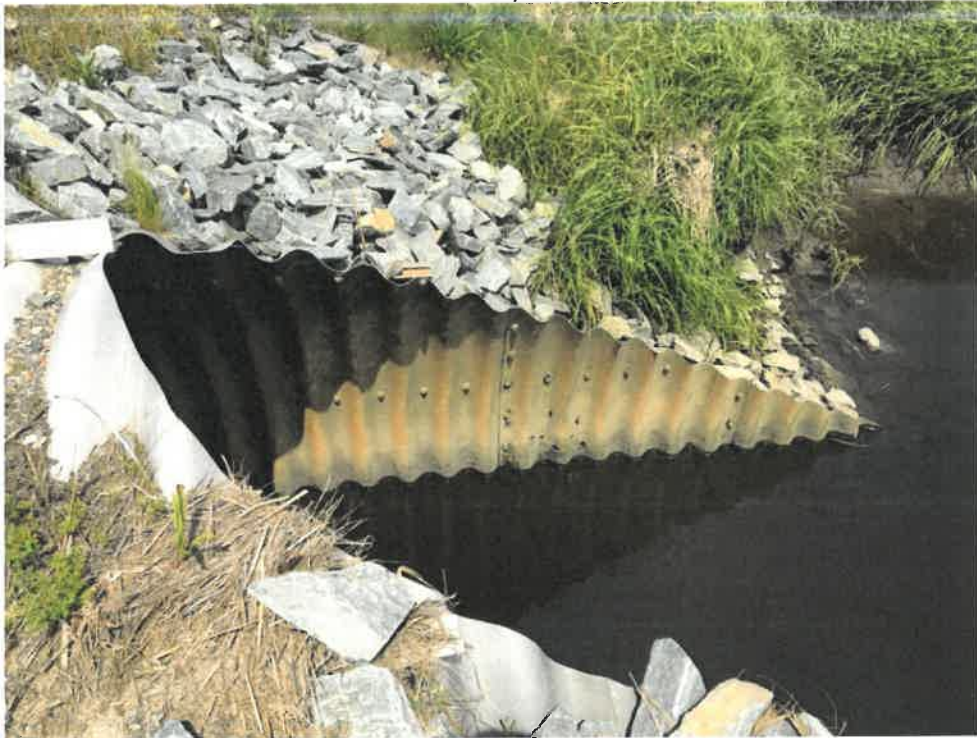
Photo 2 (06-20-18): Submerged inlet of 10.5-foot wide by 11.5-foot tall corrugated aluminum elliptical pipe with flared end and rip rap headwall on east side of Sawyer Road. Additional headwall rip rap should be added to the headwall.

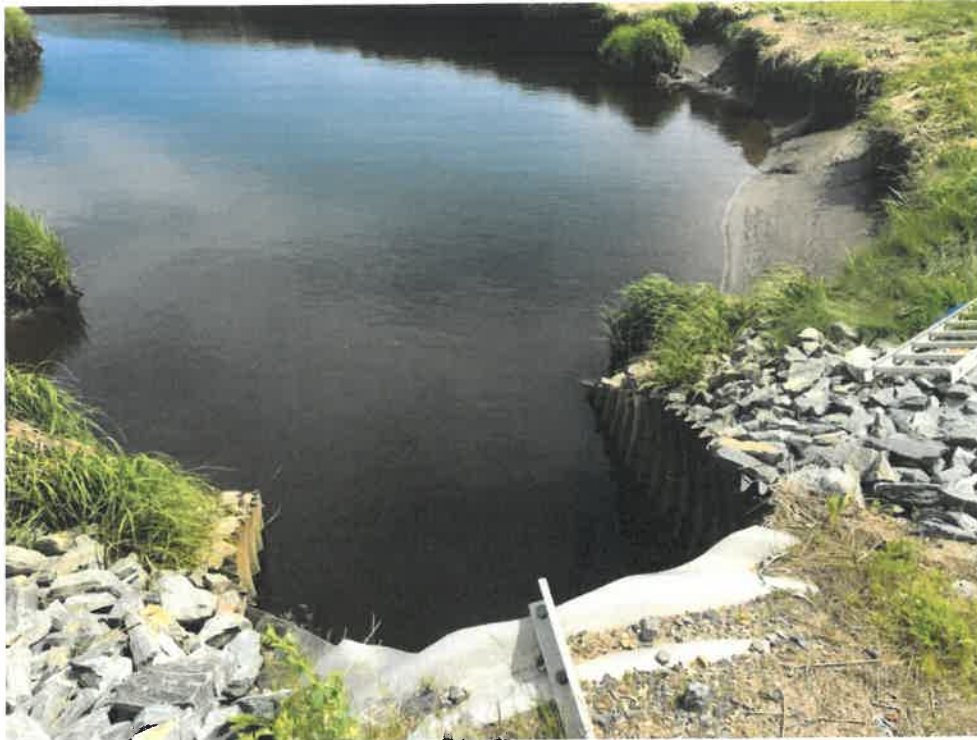
Photo 3 (06-20-18): Overhead view of the culvert inlet with tidal channel flow of the Spurwink River upstream of the culvert.

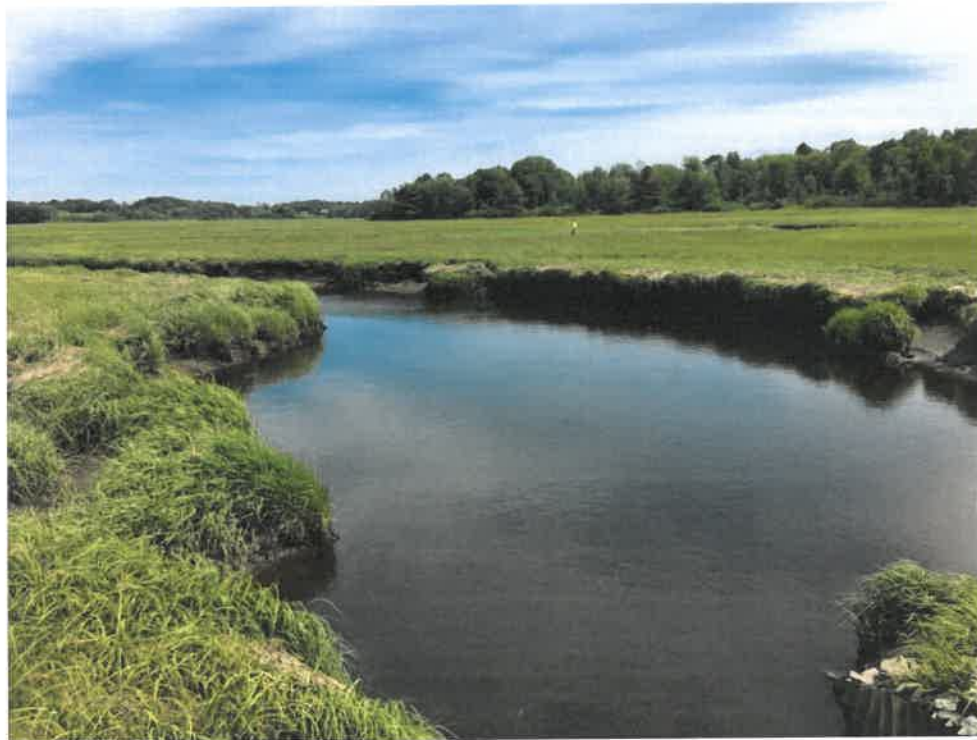
Photo 4 (06-20-18): Upstream channel of the Spurwink River weaves through the Spurwink Marsh to the east of Sawyer Road.

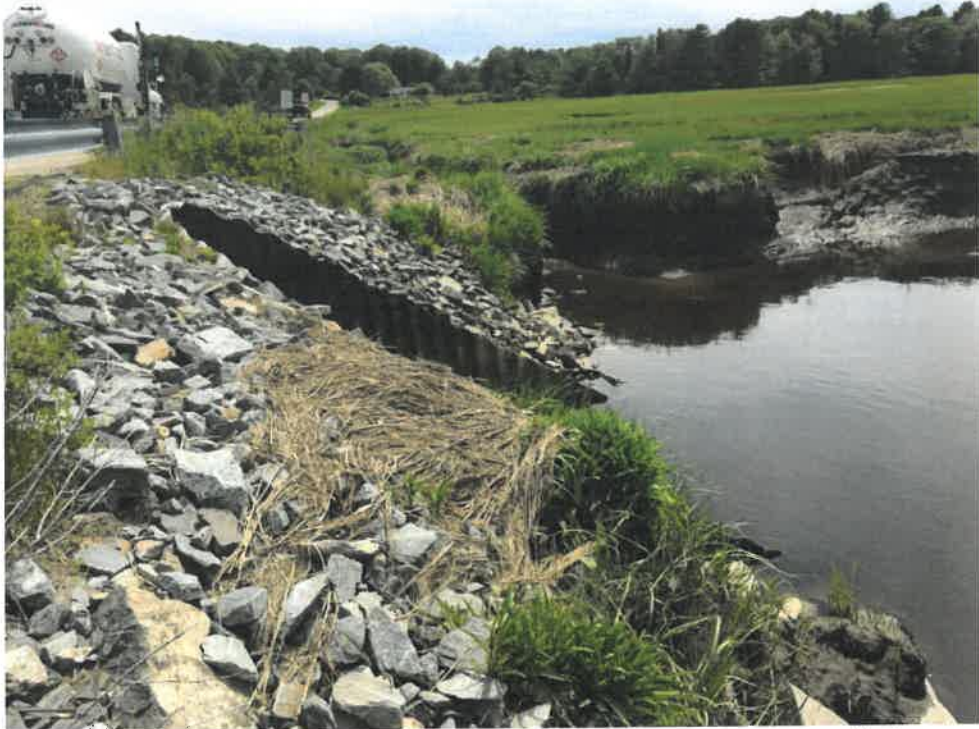
Photo 5 (06-06-18): Submerged outlet of the aluminum elliptical pipe with flared end and rip rap headwall on the west side of Sawyer Road. Quantity of rip rap appears to be sufficient on the outlet area around the culvert.

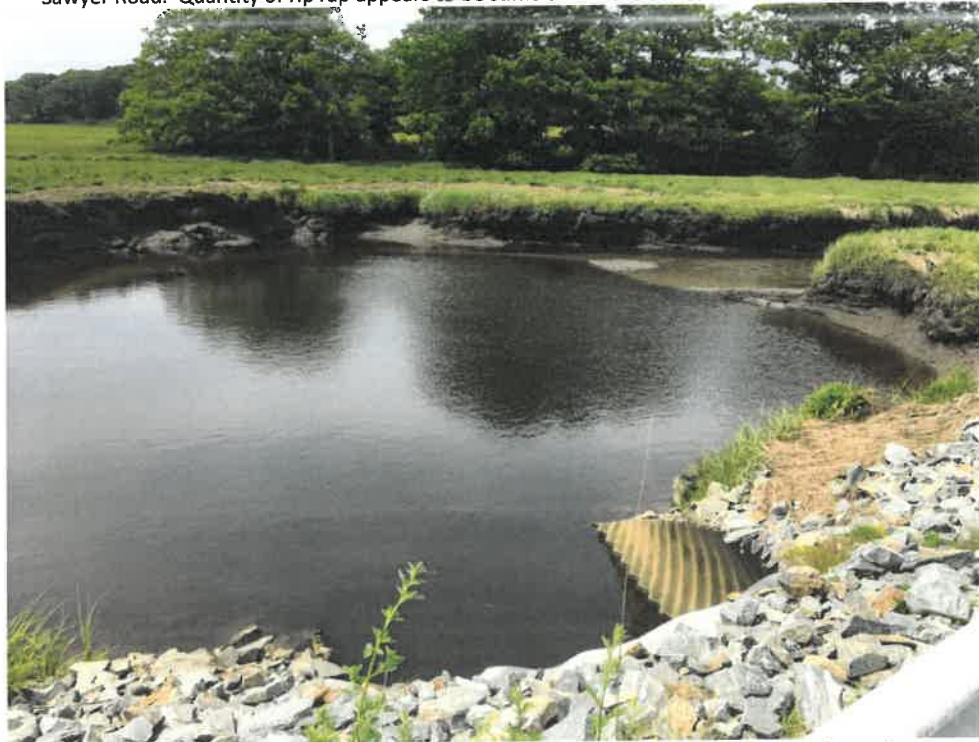
Photo 6 (06-06-18): Overhead view of culvert outlet and the widened area of the Spurwink River beyond the culvert outlet. The Spurwink River channel flows to the north (right hand side of this photo).

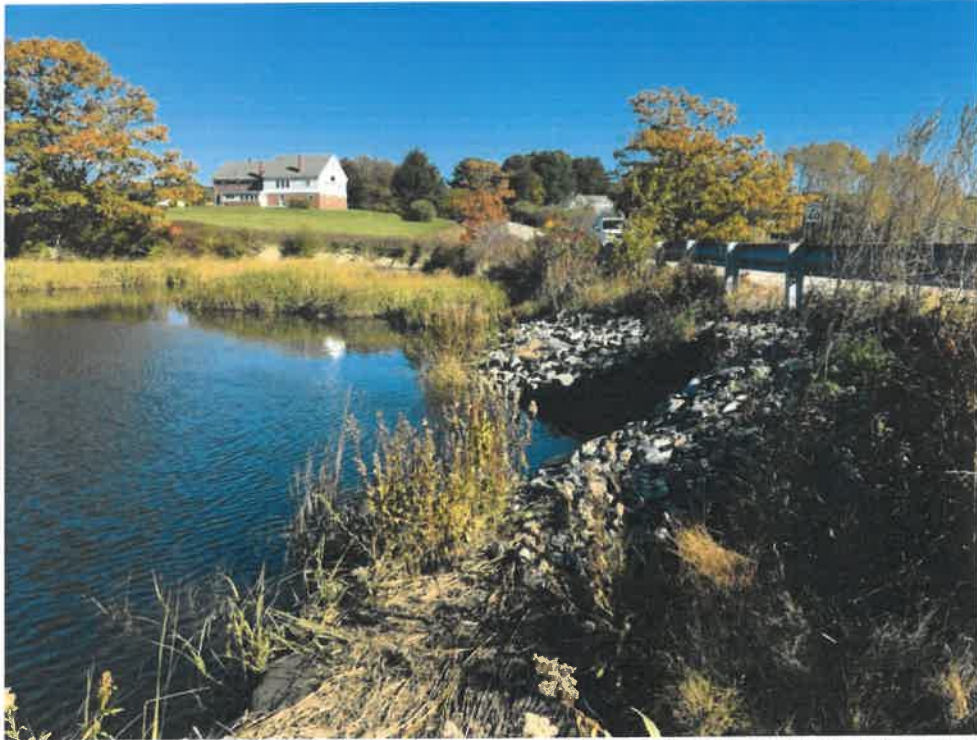
Photo 7 (10-22-18): Facing north during high tide of the Spurwink River on the outlet to the west of Sawyer Road.

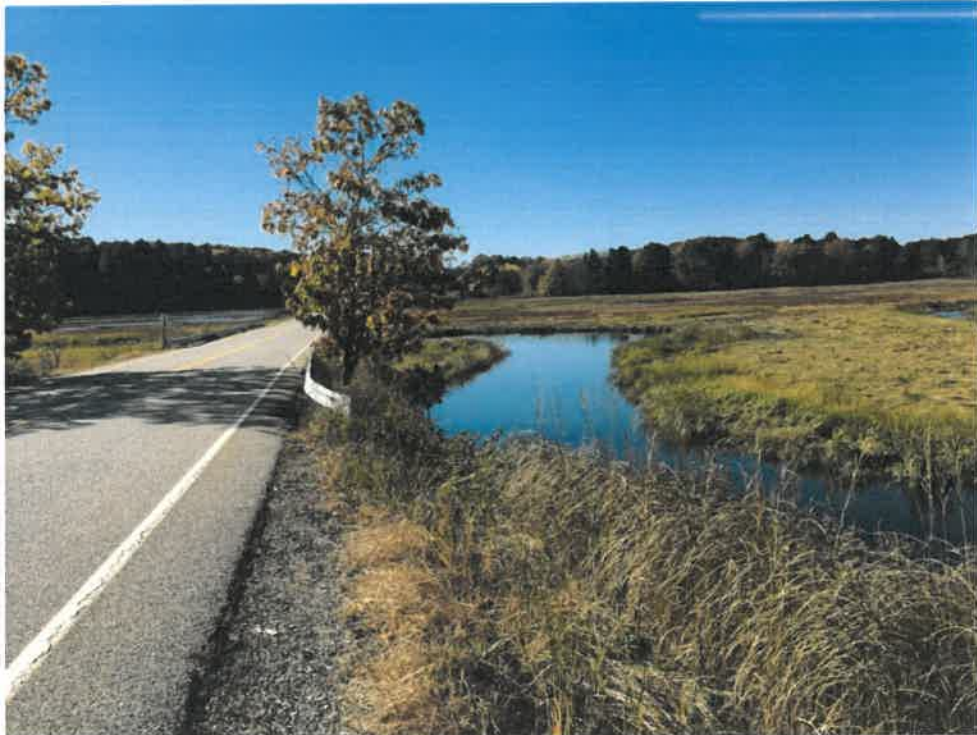
Photo 8 (10-22-18): Facing south during high tide of the Spurwink River on the outlet to the west of Sawyer Road. The Spurwink River channel downstream of culvert outlet flows through a wide pool area before flowing north parallel with Sawyer Road before turning to the west and winding toward the Atlantic Ocean.

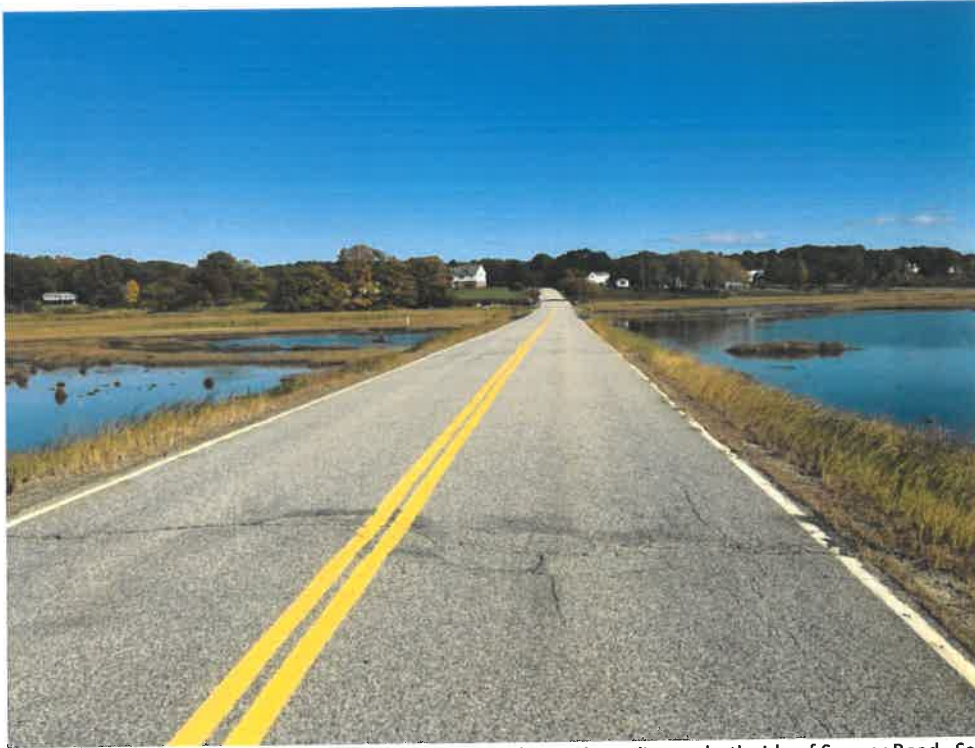
Photo 9 (10-22-18): Facing north during high tide of the Spurwink Marsh pooling on both side of Sawyer Road. Sawyer Road floods often during intense weather and tide events in the foreground of the photo as the road elevation is lower than at the culvert crossing which the inlet to the Spurwink River culvert is visible on the right side (east) of Sawyer Road.

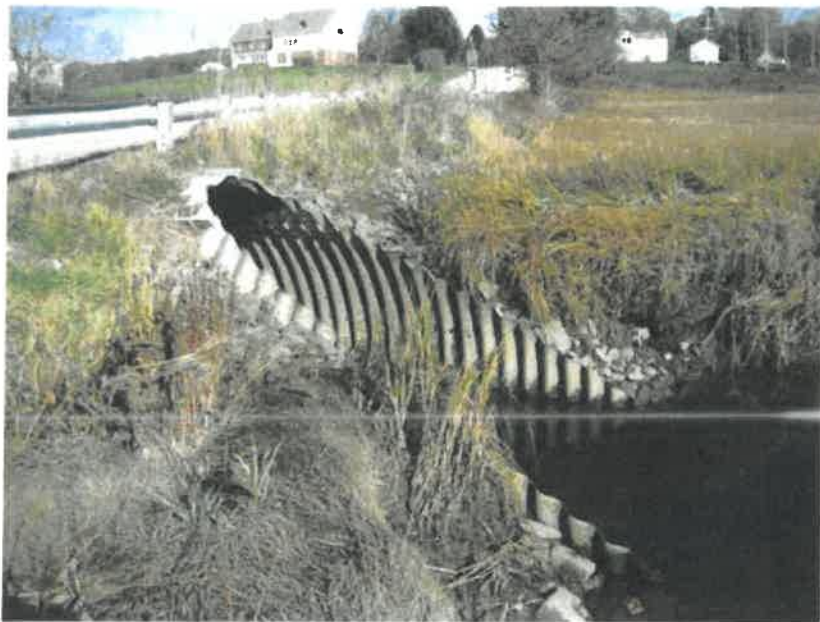
(58) DECK	N - Not Applicable
(59) SUPERSTRUCTURE	N - Not Applicable
(60) SUBSTRUCTURE	N - Not Applicable
(81) CHANNEL & CHANNEL PROTECTION	7 - Bank protection needs minor repairs
(62) CULVERT	4 - Large spalls, heavy scaling, wide cracks

Pipe itself in generally fair condition w/minor deflection of southerly side. corrosion along bolt line. Dive inspection found holes along top plate. Embankments have both eroded, beginning to effect shoulder pavement (photo). Pavement is cracked and opened up over center line of pipe. Fill has washed away from sides of pipe making it a high point allowing the pavement to break over the top. Additional rip rap is necessary to prevent further erosion. Pavement is worn and may need replacement over pipe. Too deep to wade see latest dive report.

The bridge and guardrail deficiencies should be addressed as soon as practical to ensure continued safe use of the bridge. Neglect of these deficiencies may result in a diminished function of the bridge through load posting or even closure.

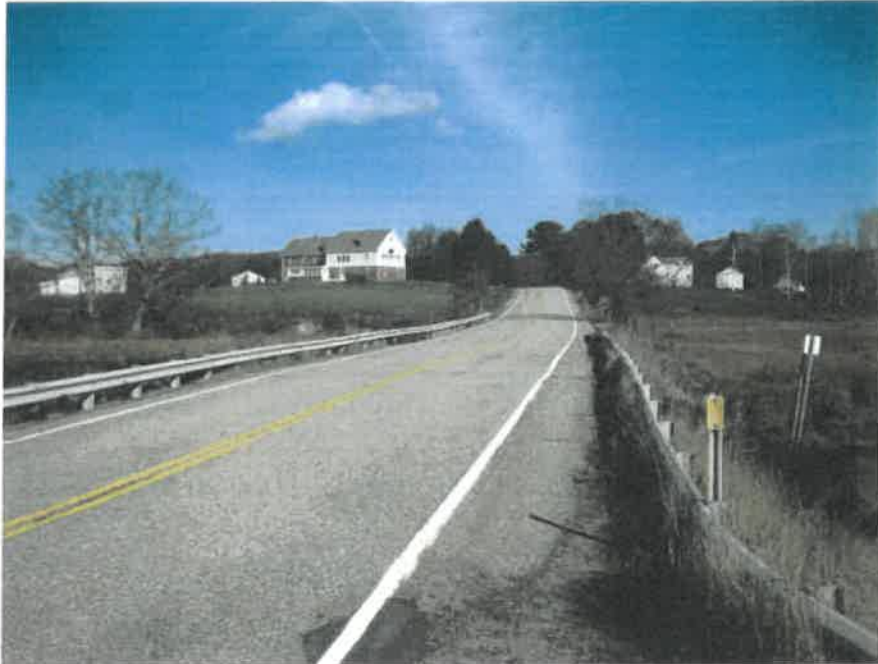
PHOTO 1
Description View of roadway facing North

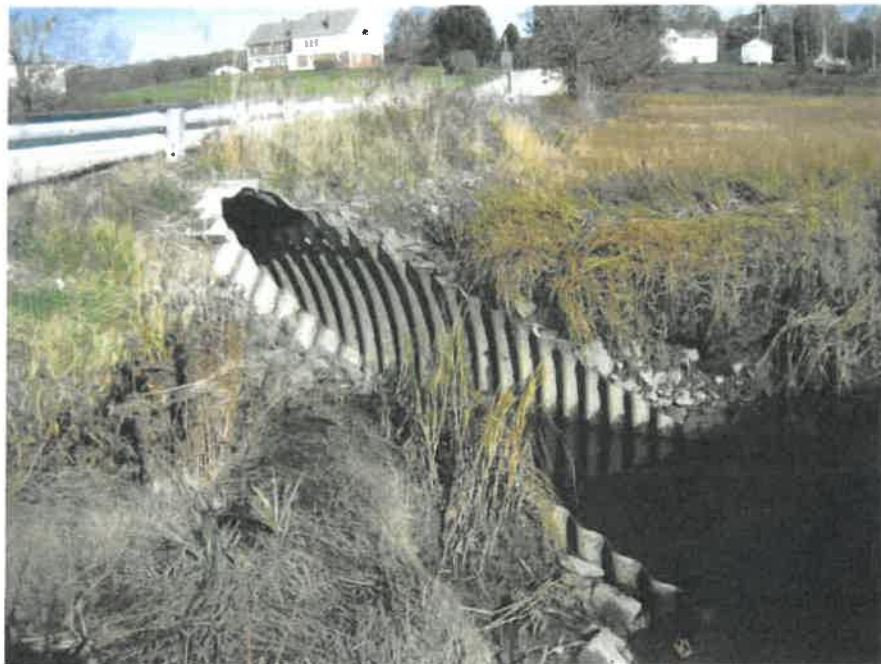
PHOTO 2
Description Down stream view

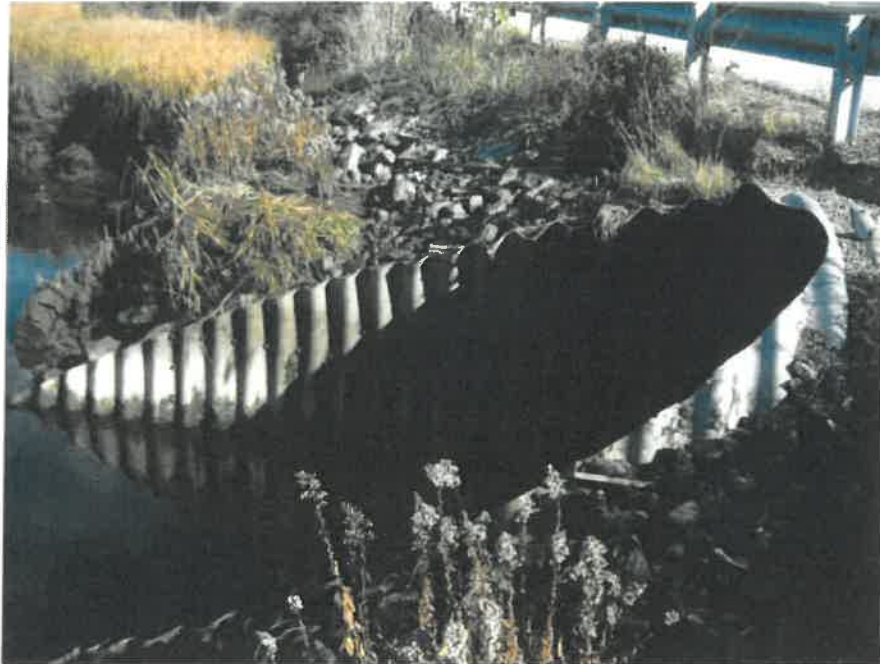
PHOTO 5

Description Up stream view

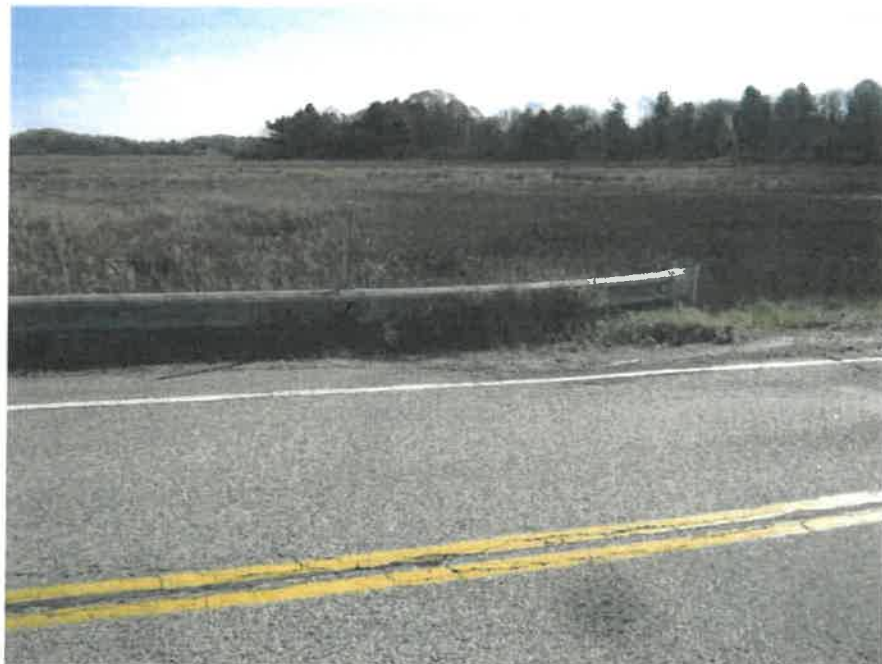
PHOTO 6

Description View showing low approach rail

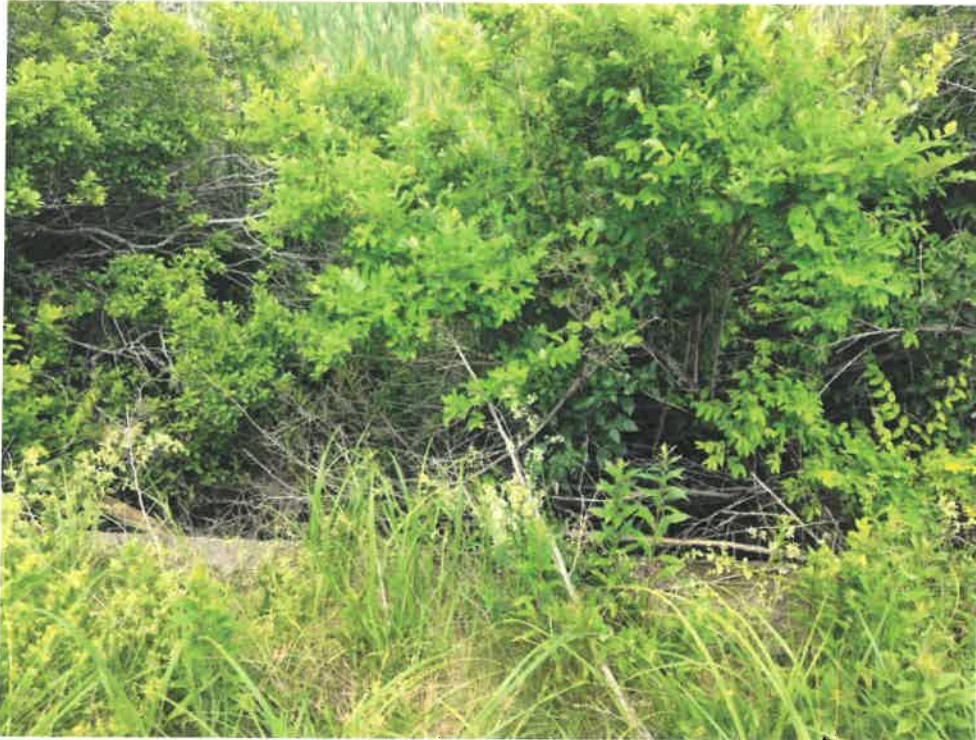
Photo 3 (06-20-18): Facing east at granite headwall of the culvert inlet with thick vegetation blocking the inlet area of the culvert. Providing a rip rap apron at the inlet would control vegetation from blocking the inlet.

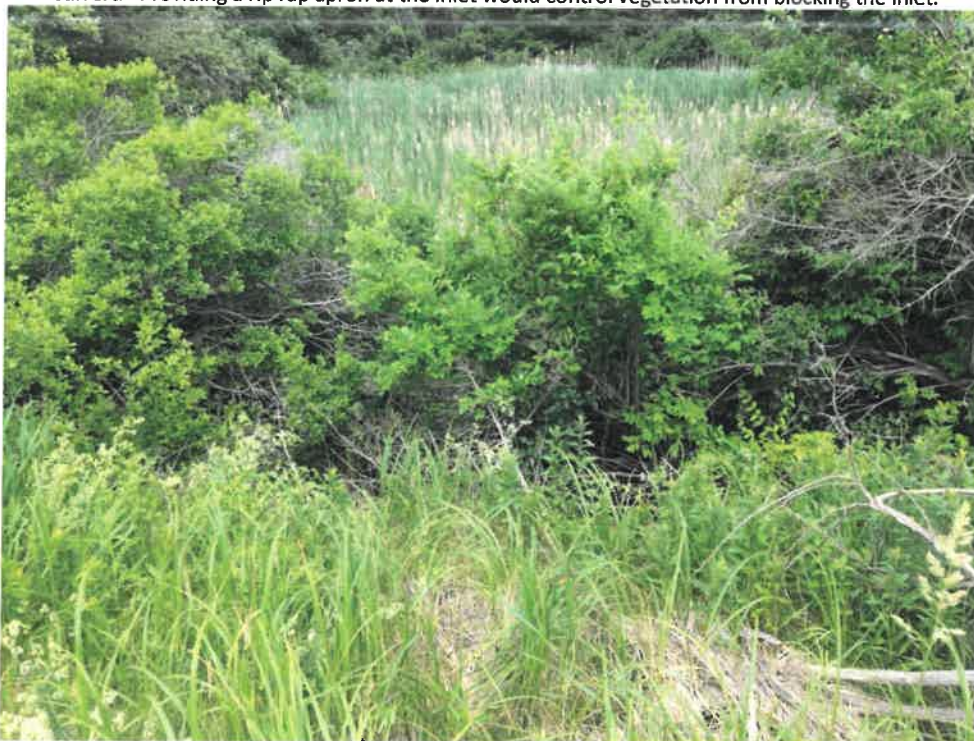
Photo 4 (06-20-18): Upstream channel of the culvert is impounded which creates a large wetland area to the east of Sawyer Road.

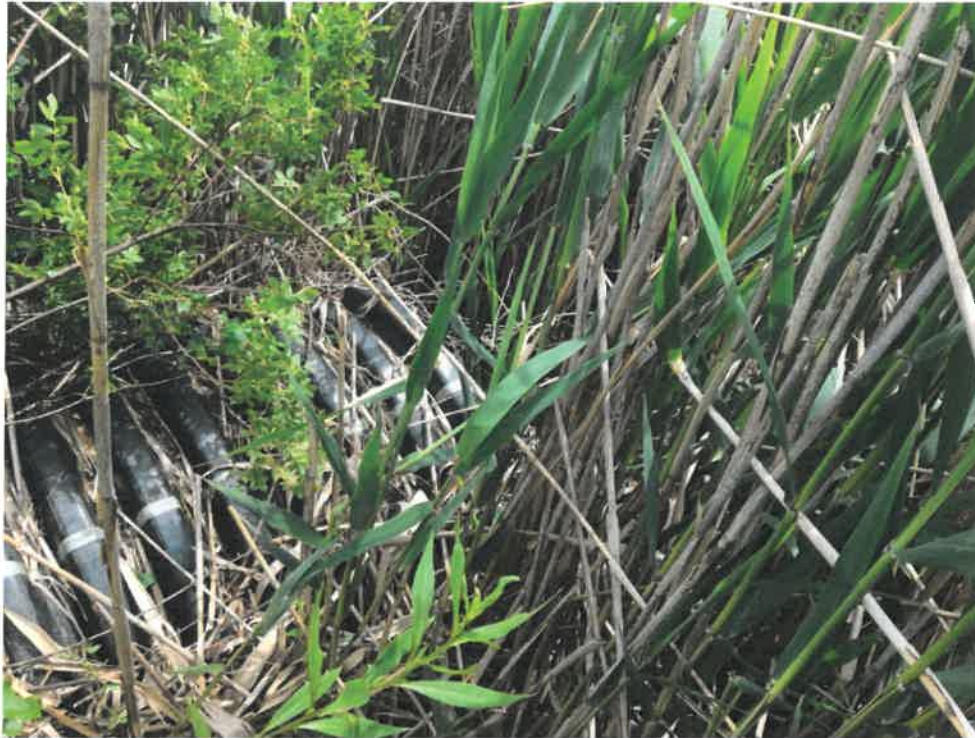
Photo 5 (06-06-18): Submerged outlet of the HDPE pipe on the west side of Sawyer Road. Thick vegetation around the end of the culvert could be better controlled with a rip rap apron.
