Cape Elizabeth Culvert and Habitat Assessment Study

March 22, 2019

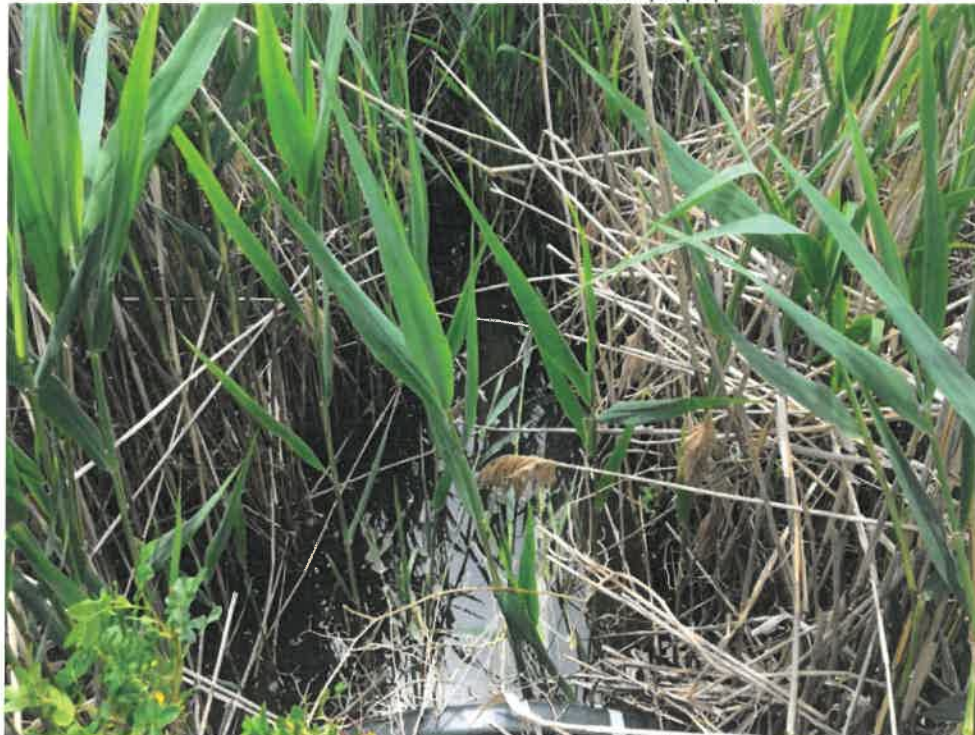
Photo 6 (06-06-18): Overhead view of culvert outlet and the vegetation beyond the culvert outlet.

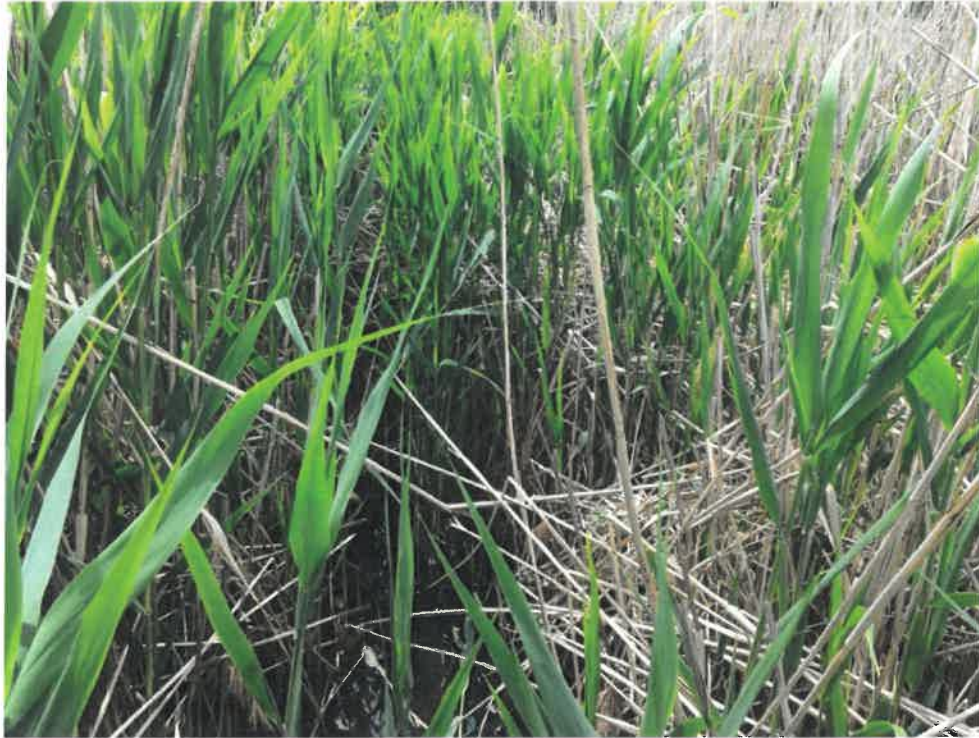
Photos 7 (06-20-18): Thich marsh vegetation dominates the downstream channel of the culvert that eventually drains to the Atlantic Ocean.

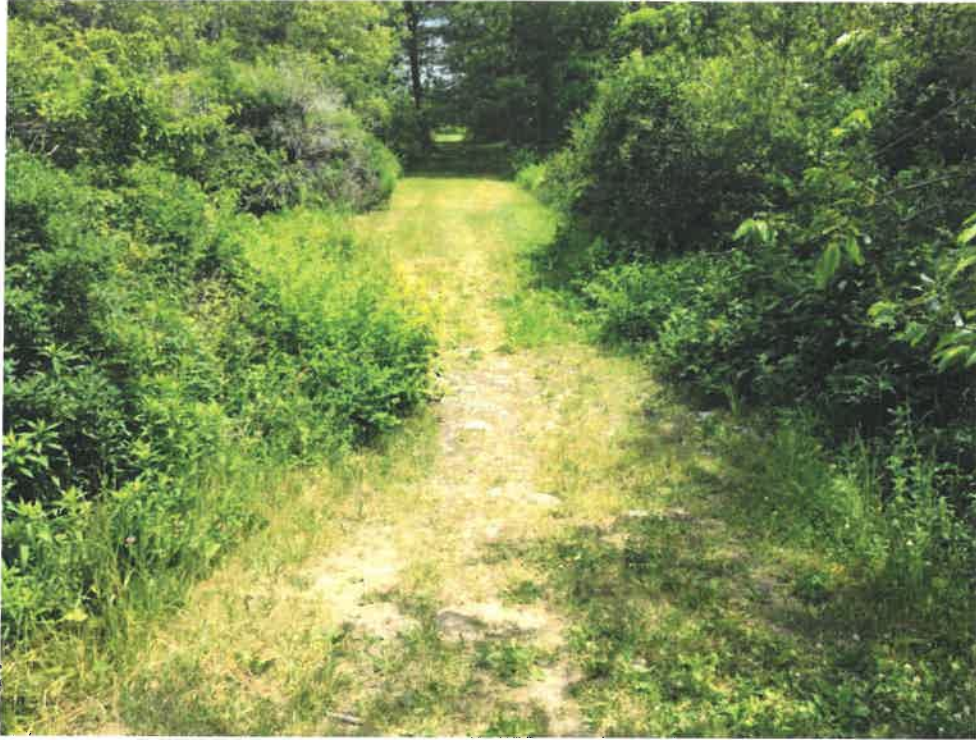
Photo 1 (06-20-18): Facing east at the Sanitary Sewer Embankment crossing which also acts as a recreational trail connection to the Town Center. Culverts are located relatively deep in relation to the top elevation of the embankment. Stones visible in cleared area is the location of the emergency spillway.

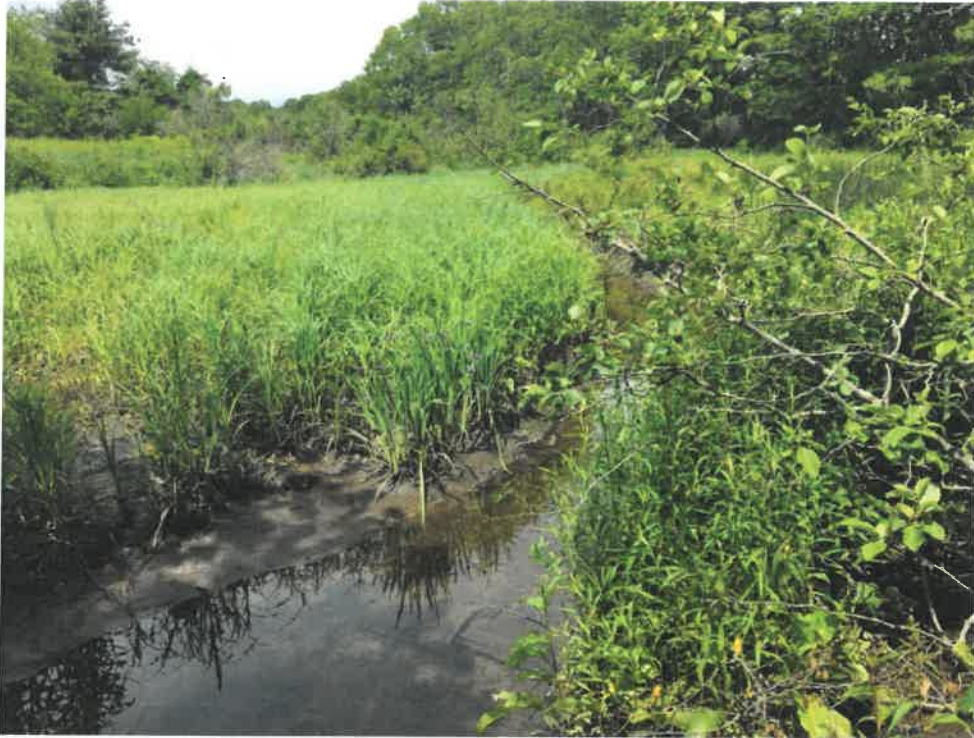
Photo 5 (06-20-18): Upstream Willow Brook channel flows southerly through a wetland area to reach culvert.

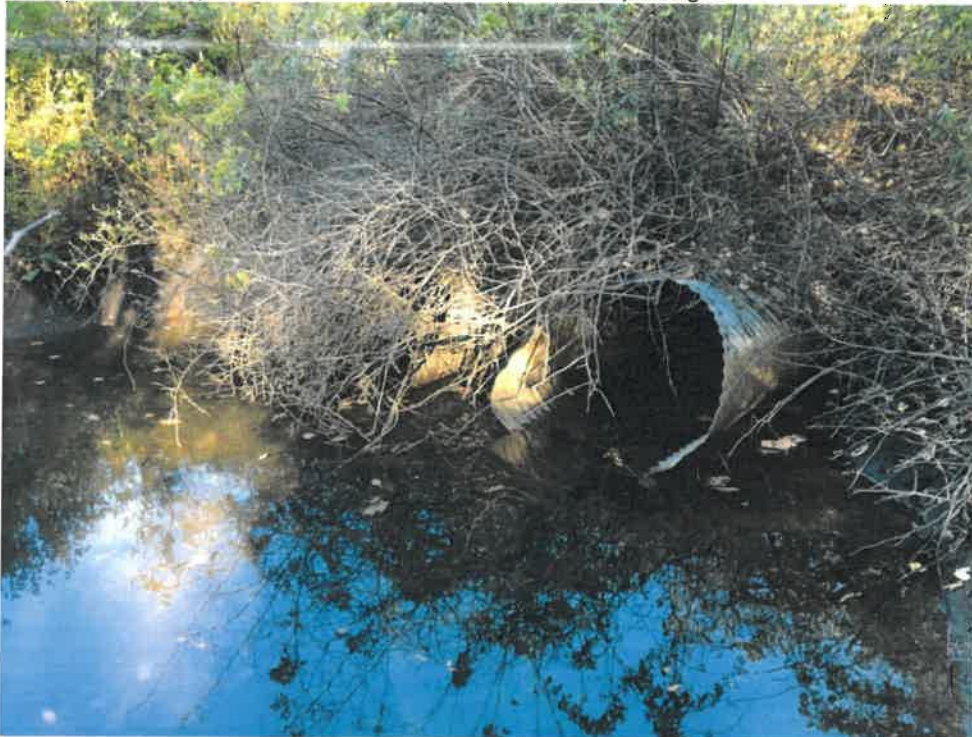
Photo 6 (10-22-18): One of the outlets of the culverts on the south side of the embankment is obscured by vegetation and partially buried in sediment. Outlet has some stone in the channel, but no formal plunge pool or visible headwall.

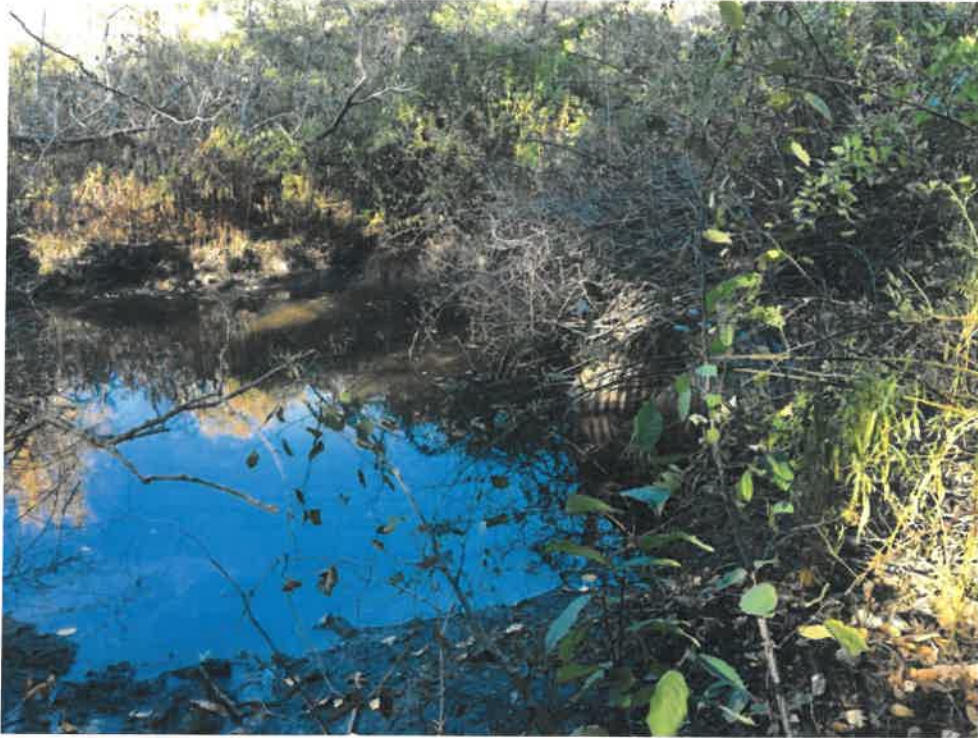
Photo 7 (10-22-18): Downstream channel of Willow Brook from the culvert outlet flow has marine sediment deposits from the tidal marsh.

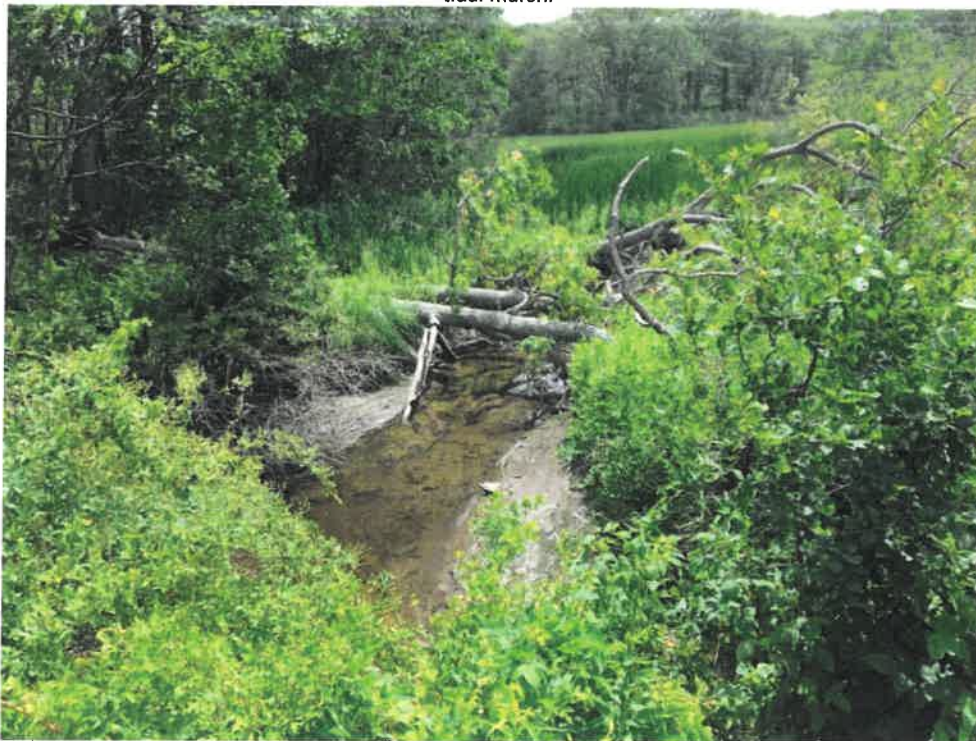
Photo 8 (06-20-18): Downstream channel of willow Brook flows through the Spurwink Marsh in the background of photo and eventually discharges in the Spurwink River and then the Atlantic Ocean.

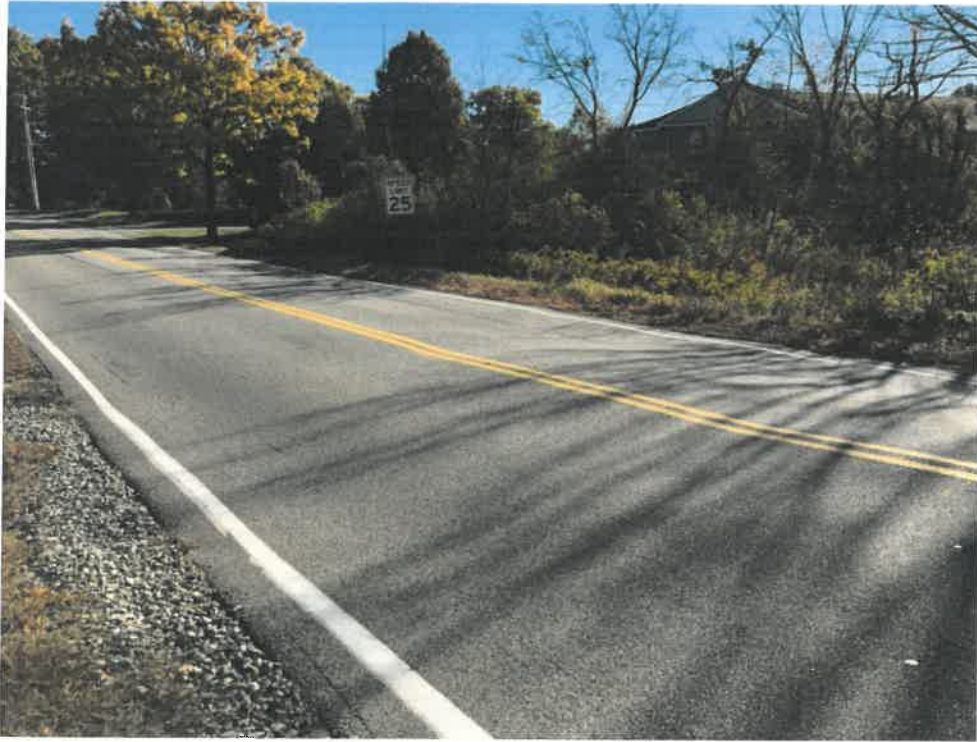
Photo 1 (10-22-18): Facing east at Scott Dyer Road at the Willow Brook culverts crossing.

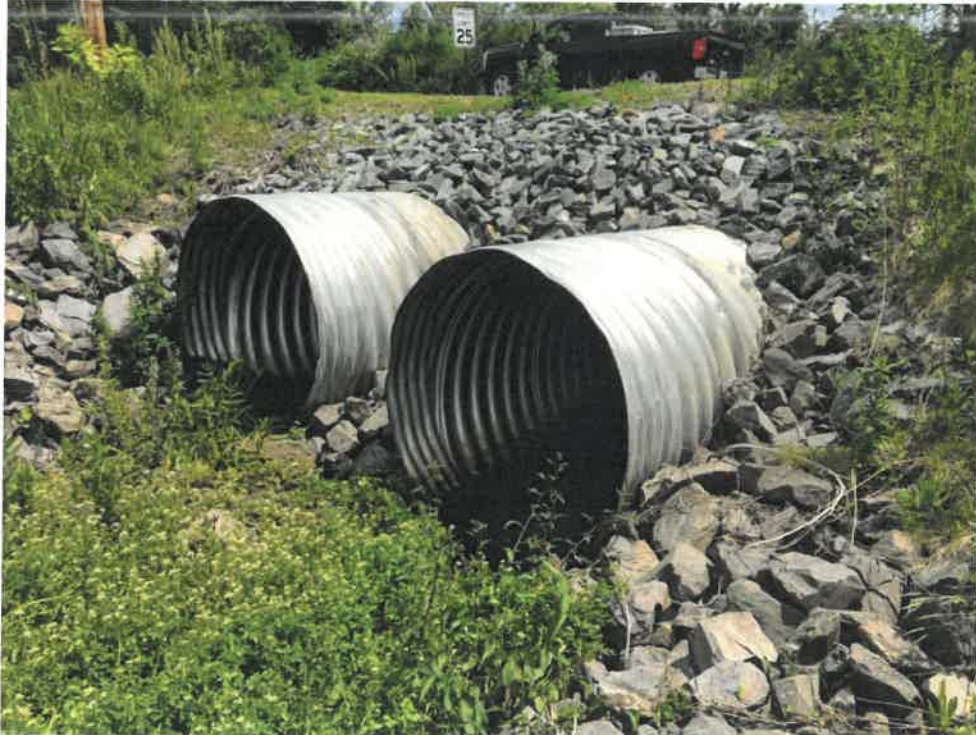
Photo 2 (06-20-18): Inlet of two, 54-inch corrugated aluminum pipes located northerly of Willow Brook. Westerly (right) pipe is set lower to carry the primary flow. Inlet has a well armored rip rap apron and headwall.

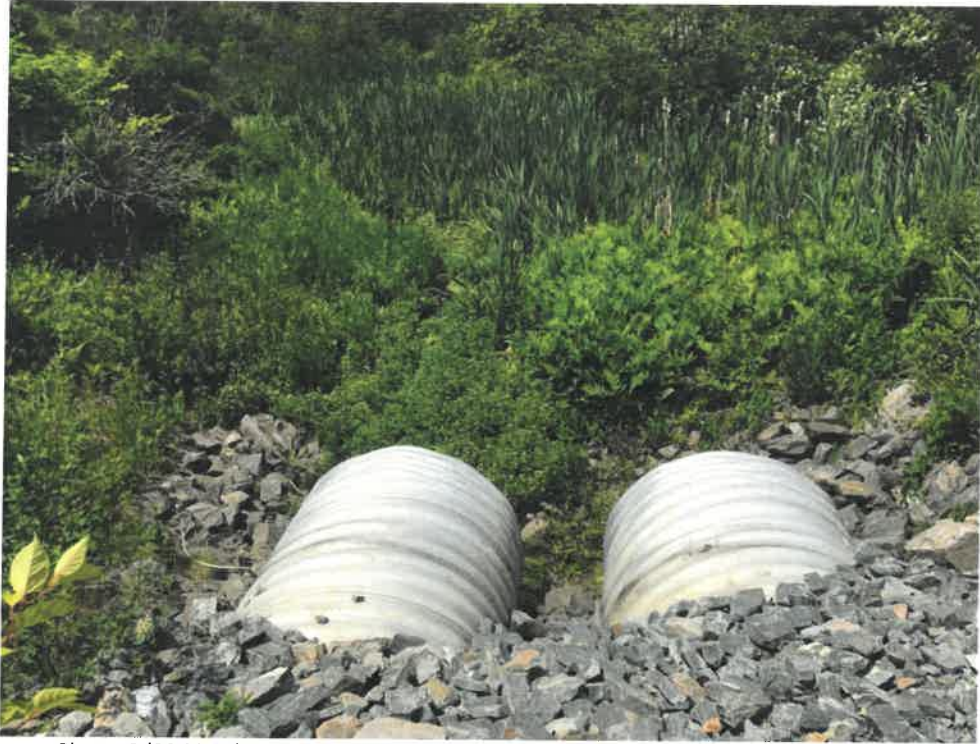
Photos 3 (06-20-18): Looking northerly from Scott Dyer Road toward the two culverts Inlets.

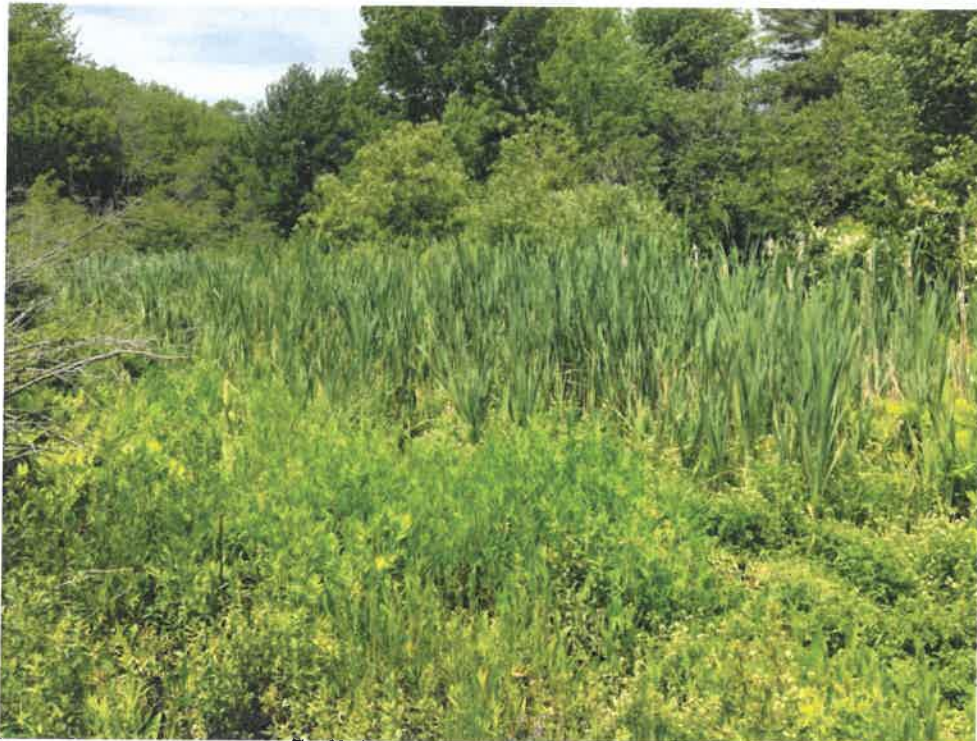
Photo 4 (06-20-18): Upstream Willow Brook channel flows southerly through a wetland area to reach culvert inlets.

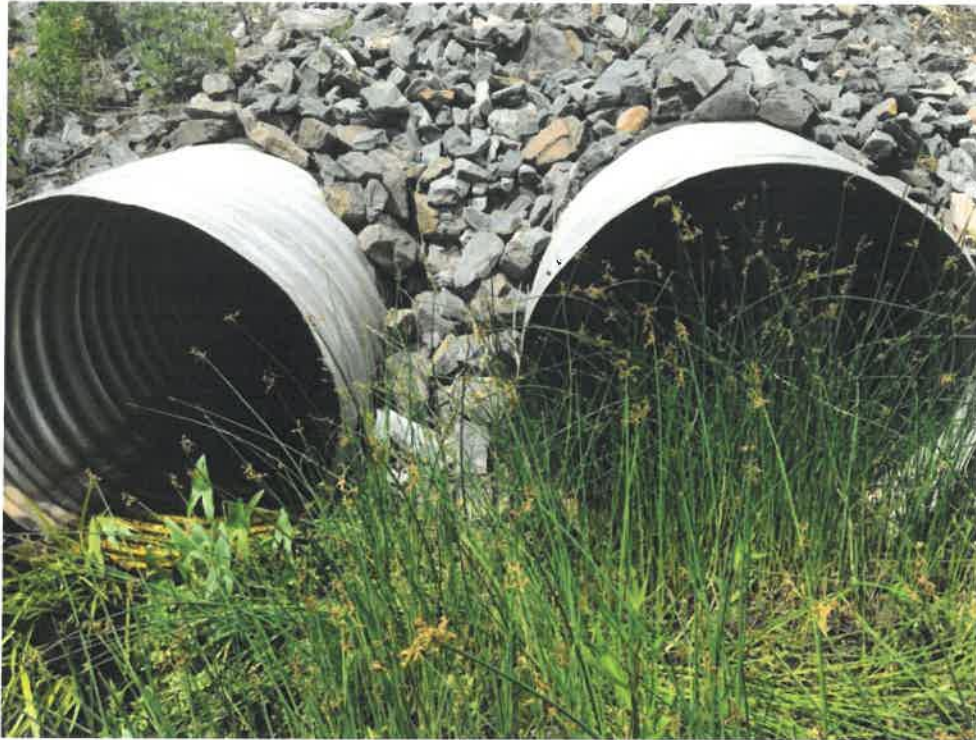
Photo 5 (06-20-18): Outlet of culverts on the south side of Scott Dyer Road. Westerly (left) pipe is set lower and carries the primary flow. Easterly culvert is partially blocked by vegetation.

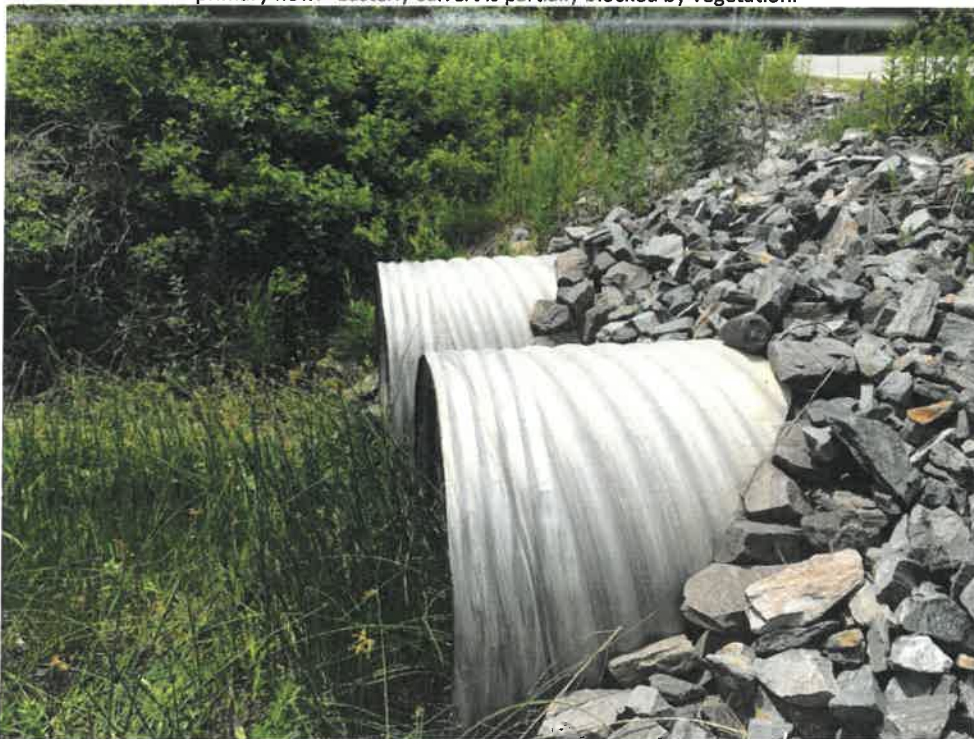
Photo 6 (06-20-18): Culvert outlet discharge of Willow Brook on the south side of Scott Dyer Road. Some limited vegetation removal and rip rap at the end of the easterly pipe would ensure that its capacity is not compromised by additional vegetation growth.

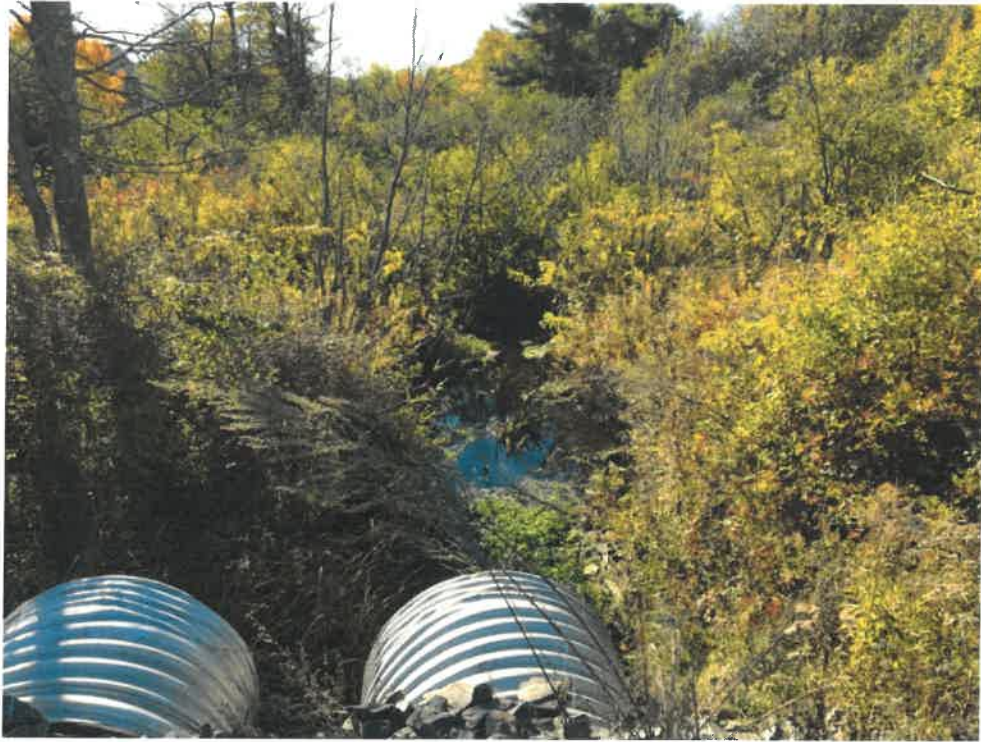
Photo 7 (10-22-18): Downstream channel of Willow Brook flows to the Spurwink Marsh and then into the Spurwink River to eventually discharge in the Spurwink River and then the Atlantic Ocean.

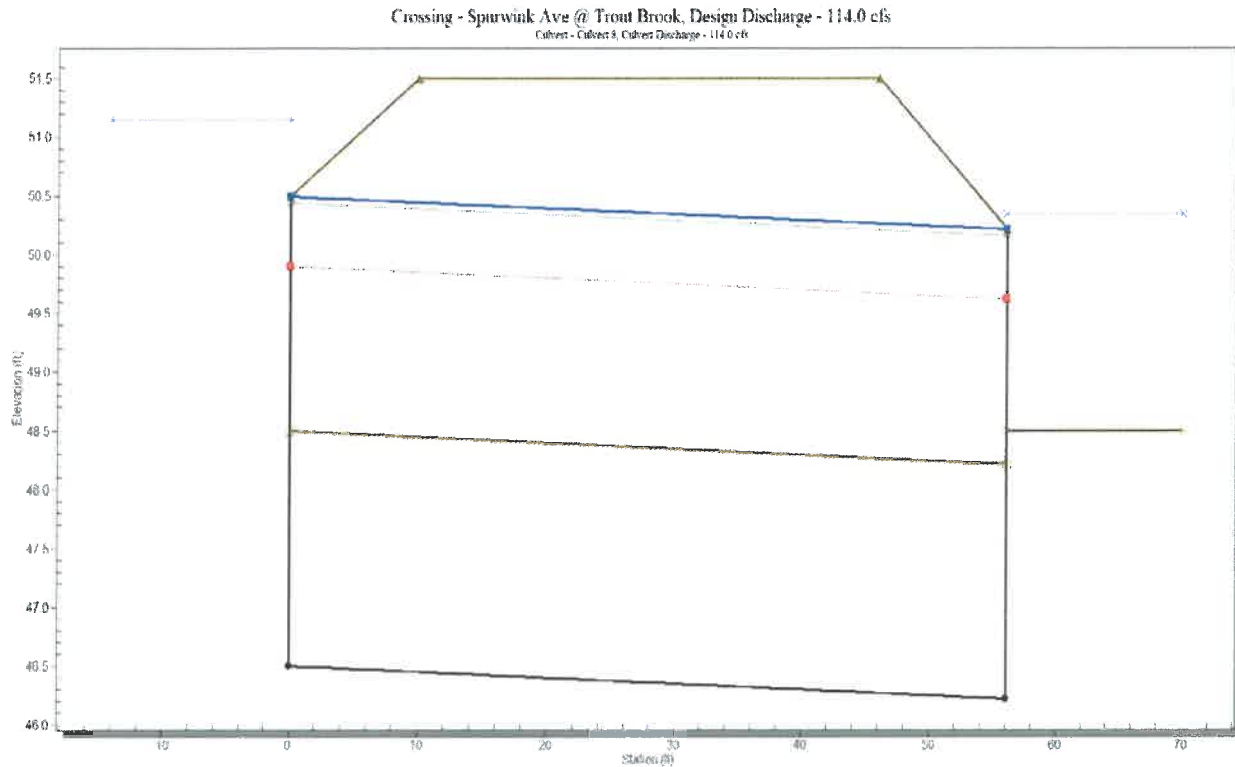
Figure 1. Q100 Headwater (Hw) elevation relative to culvert Depth (D).

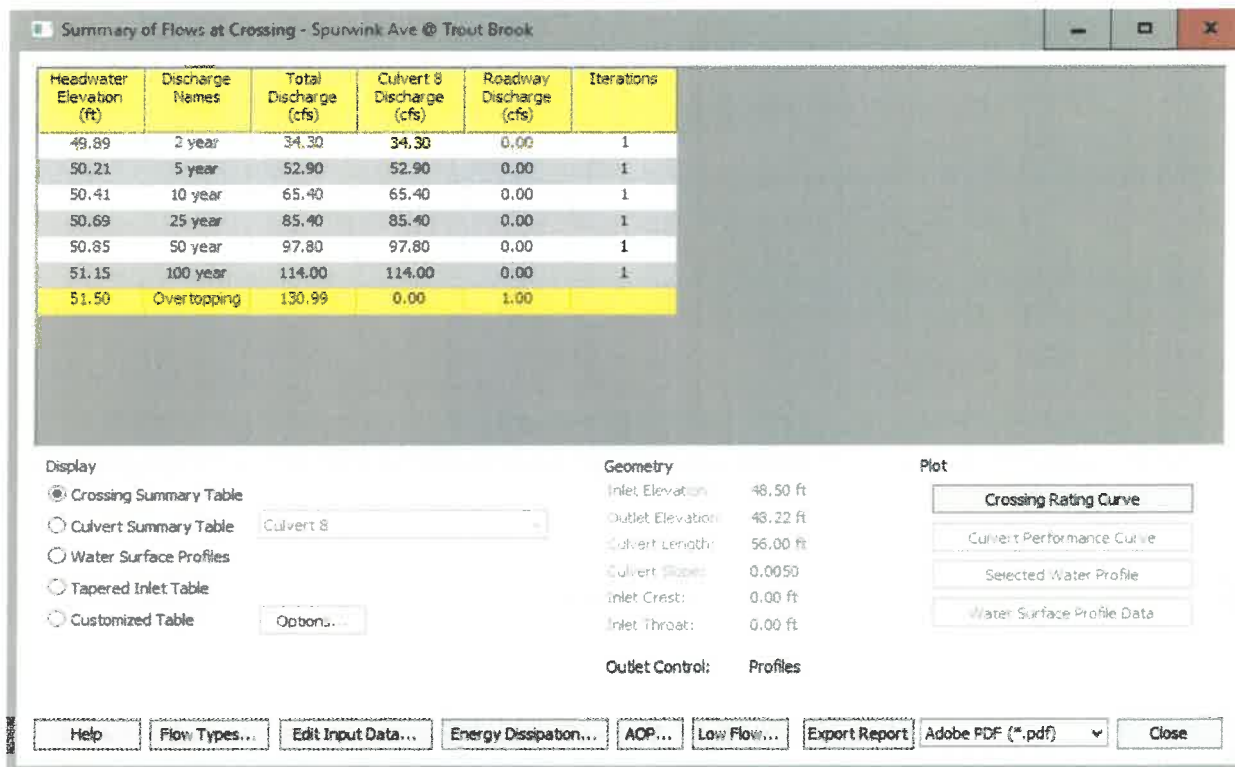
Figure 2. Summary of Flows at crossing.

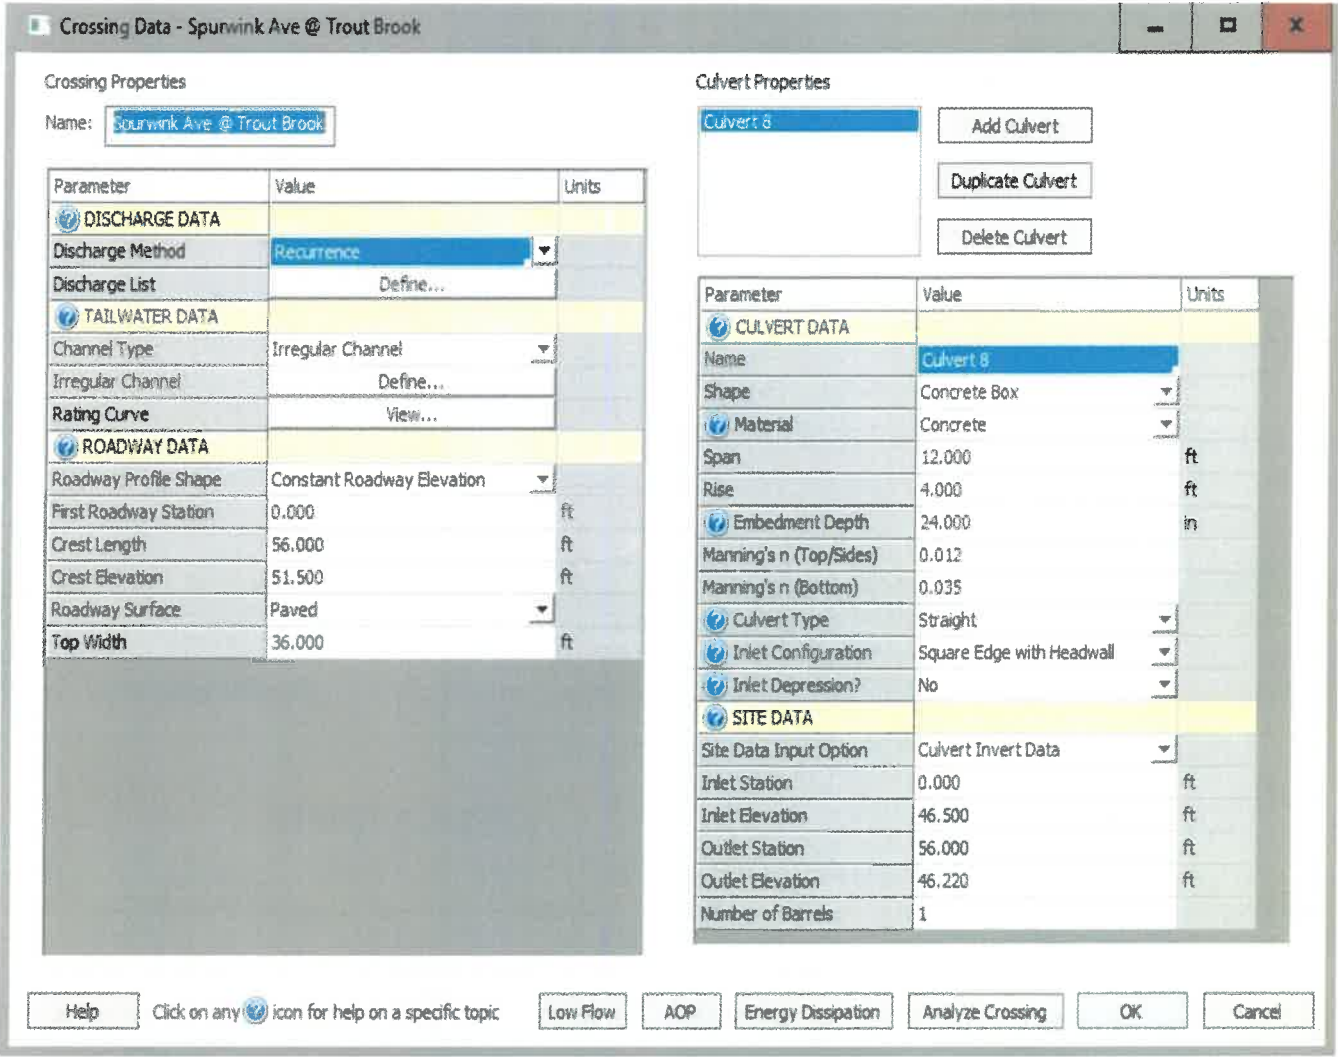
Figure 3. Crossing Properties. Assumed based on the data entered in Figures 4 & 5 and meeting 1.2 bank full width. Due to this crossing configuration, it was not reasonable to achieve the $Q_{100} H_w/D \leq 1$.

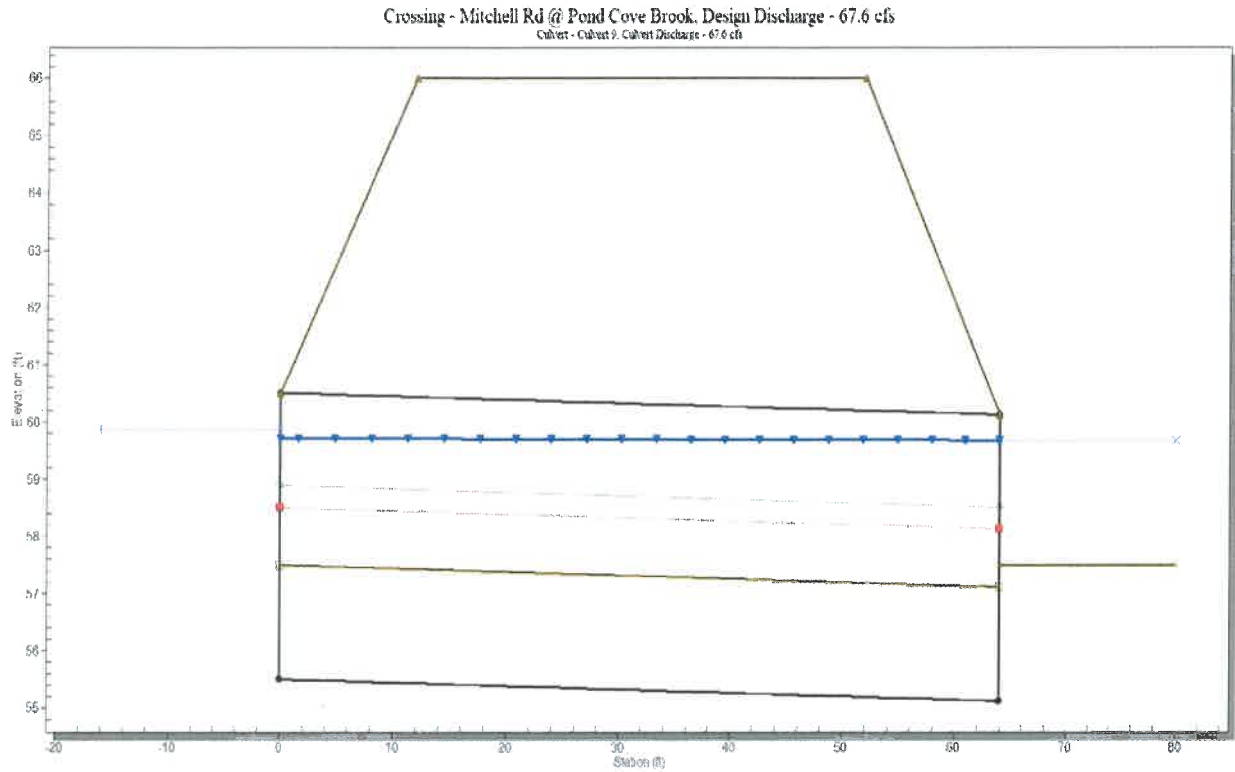
Figure 1. Q100 Headwater (Hw) elevation relative to culvert Depth (D).

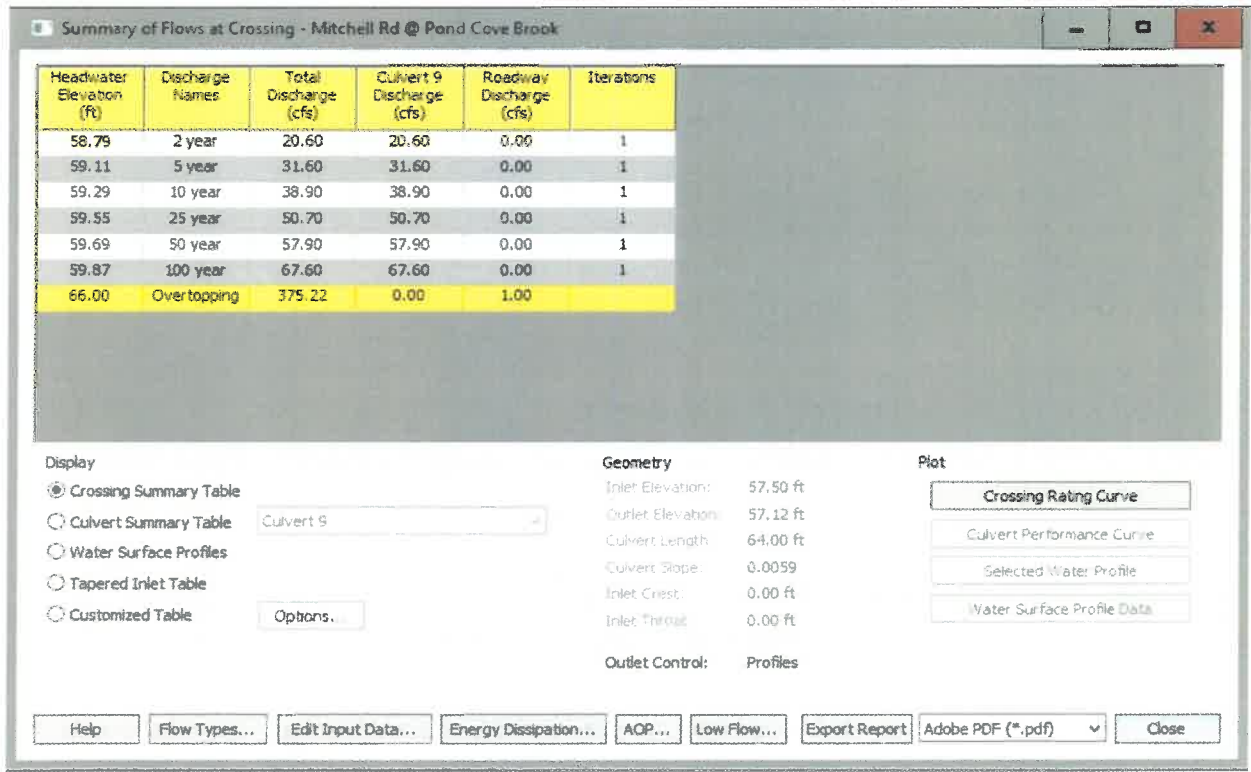
Figure 2. Summary of Flows at crossing.

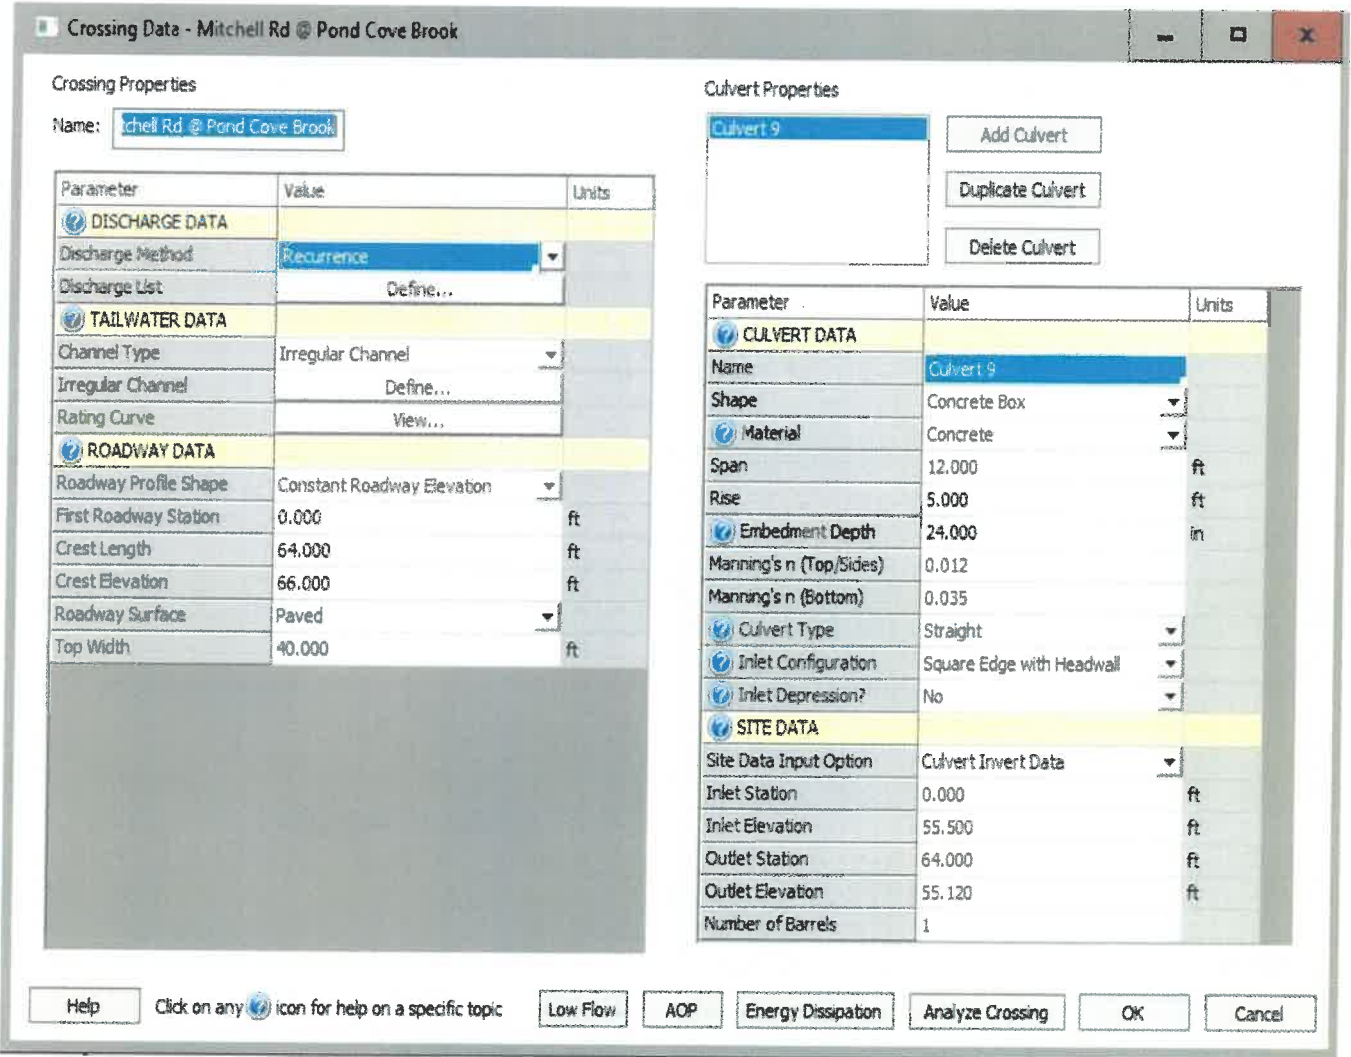
Figure 3. Crossing Properties. Assumed based on the data entered in Figures 4 & 5, meeting 1.2 bank full width and achieving $Q_{100} H_w/D \leq 1$.
