# Concord Gully Brook

SURVEY **NATERSHED**

Prepared for the Town of Freeport March 2013

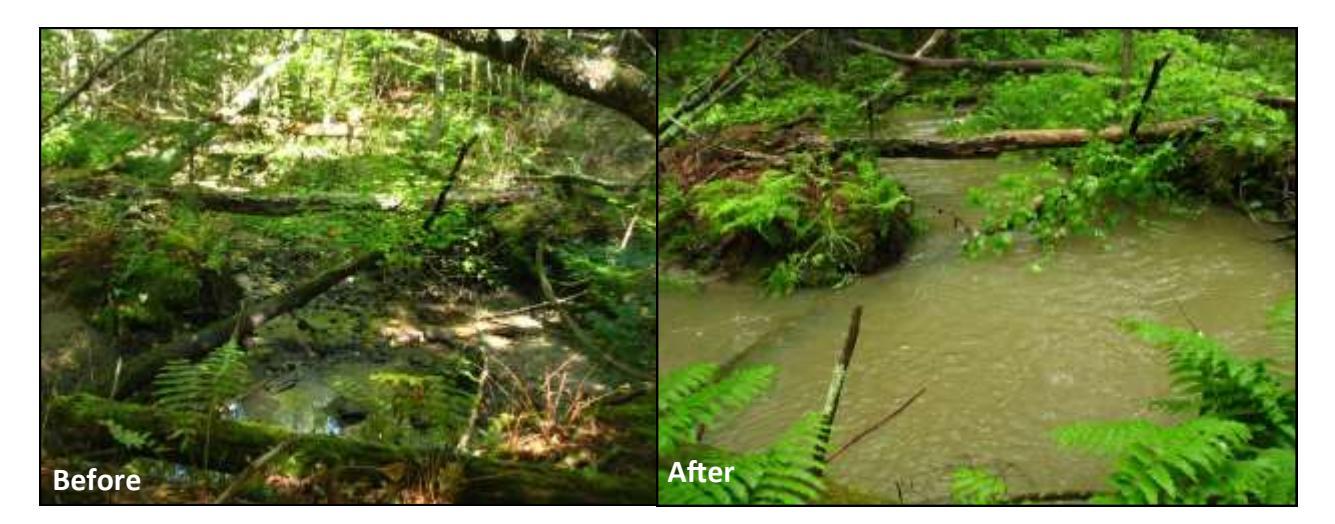
Figure 15. Effects of stormwater flashes from impervious surfaces following rain events. The resulting large volume and high energy flow can erode substrate and bank materials, destabilizing and destroying aquatic habitats within the stream and riparian area. Toxins contained within the stormwater can further stress organisms and ultimately threaten downstream habitats such as clam flats and estuaries. These photos are taken upstream on Tributary "B" during the 2012 season, before a rain event and after saturation.

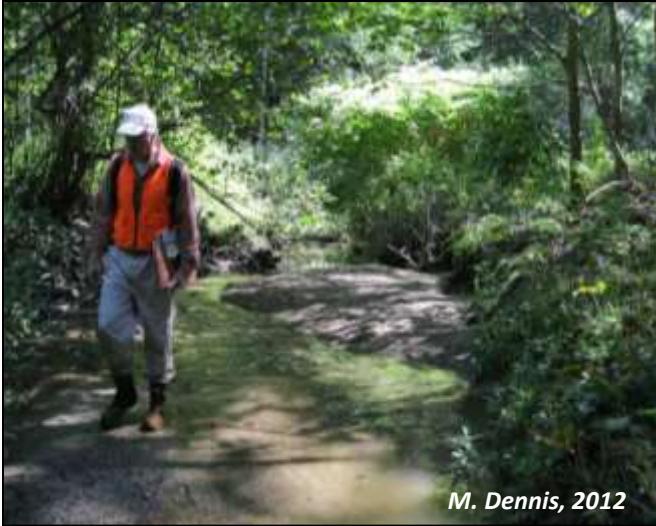
Figure 18. A good example of aggradation with deposition of sediment (point bar behind surveyor) and mid-channel bar underfoot. This occurs on the main stem of Concord Gully Brook prior to its outlet to Allen's Pond.

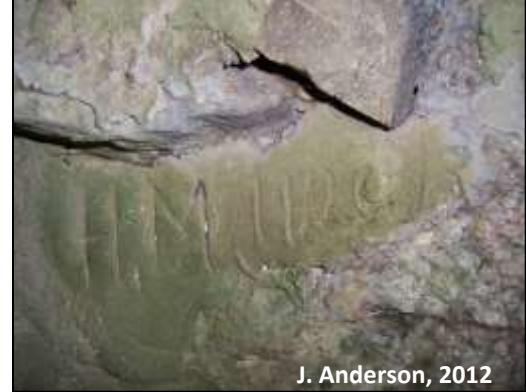
Figure 19. Inscription on old concrete culvert reading "H.M 11.20.13", presumably No-vember 20th, 1913.

been eroded away with a cut-face bank slope reaching 20' high on either side. The existing concrete culvert is no longer active and the thalweg (the line of the streambed that defines its deepest channel) has realigned north and now cuts into the banking causing further failure of the wall (Figure 20).

One area that should be prioritized for further study and possible restoration is the old electric trolley crossing south of Casco Road and the sanitary sewer line. In August, 2008, the Varney Road culvert crossing failed sending a large section of road and bank downstream in a massive rush of floodwater. Asphalt, twisted culverts, and riprap can be seen several hundred yards downstream. Floodwaters overwhelmed an old concrete culvert that served as the crossing for the Brunswick and Freeport line of the Androscoggin and Kennebec Railway. The line was opened in 1902 and provided freight and express operations as it was connected with the trackage of the Portland Railroad Company. Operations over the entire line between Brunswick and Yarmouth were abandoned in 1929 but the rail bed is still evident in areas

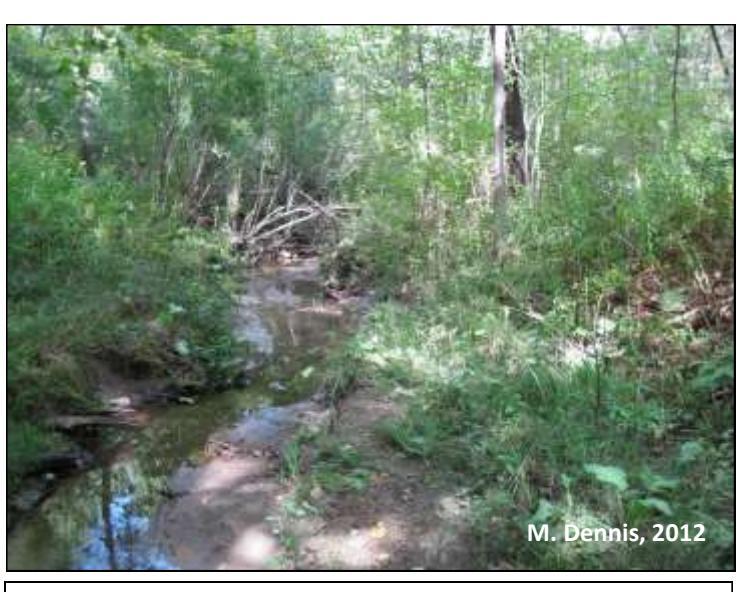
Figure 22. Typical stretch of Reach A1b

pea and coarse gravel. Large woody debris is plentiful along with naturally occurring in-stream organic material. The stream is clear with no odor. The stream bank is undercut suggesting degradation with garbage/debris found in and adjacent to the stream. Evidence of amphibians and mammals was found in the vicinity of the stream with potential barriers for migration found in the culvert areas of Concord Brook Condominium and Varney Road. This section of stream is 75% shaded with dense vegetation extending beyond 75 feet of the stream bank.

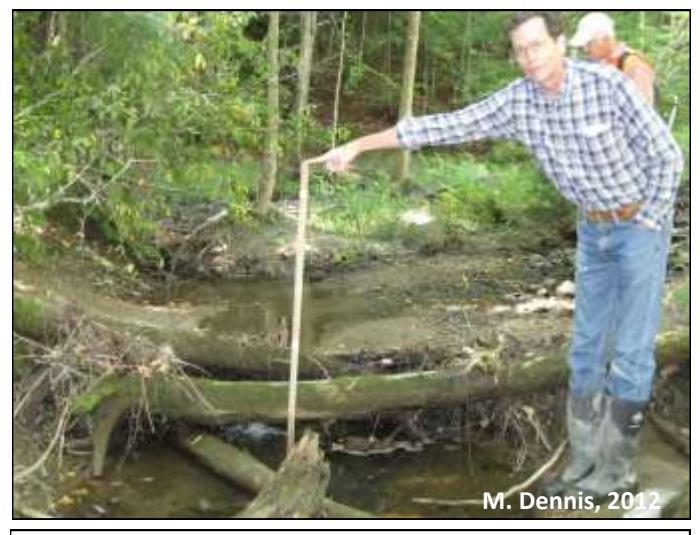
Figure 24. Typical stretch of Reach A2 with natural barrier and aggradation.

somewhat (2-25%) embedded. Large woody debris is plentiful along with occasional naturally occurring organic material in-stream. The stream is clear with no odor. The stream bank is undercut with rootwads and overhanging vegetation suggesting degradation with downstream portions showing aggradation with point bars and mid-channel bars. Garbage/debris found in and adjacent to the stream (including silt fence presumably left over from the upgrades to the sanitary sewer line). Evidence of amphibians and mammals were found in the vicinity of the stream with potential barriers for migration found in presence of large woody debris collapsed across stream. This section of stream is 75% shaded with dense vegetation extending beyond 75 feet of the stream bank.

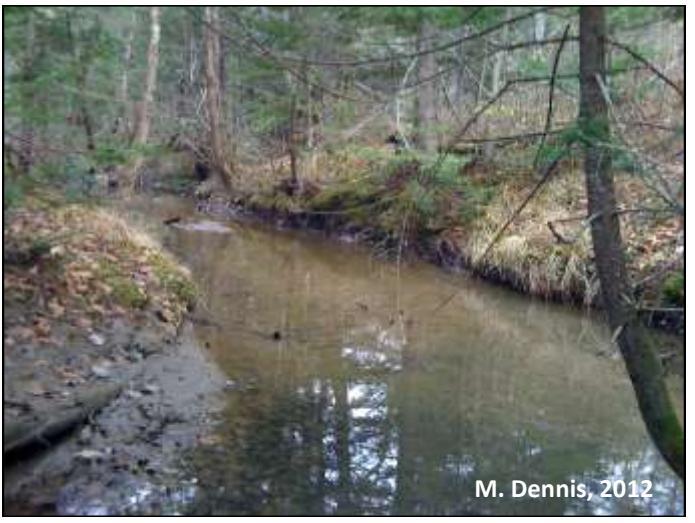
ders are somewhat (2-25%) embedded. Large woody debris is plentiful along with occasional naturally occurring organic material in-stream. The stream is clear with no odor. The stream bank is undercut with rootwads and overhanging vegetation suggesting degradation with significant portions showing aggradation with a widened channel and continuous homogenous runs. Minimal garbage/debris found in and adjacent to stream. Evidence of amphibians and mammals were found in the vicinity of the stream with potential barriers for migration found in presence of large woody debris collapsed across stream. This section of stream is 50% shaded with dense vegetation extending beyond 75 feet of stream bank in some areas.

Figure 25. Typical stretch of Reach A3 with continuous runs, bank widening, and aggradation (notice mid-channel bar in background).

Stream banking in proximity sanitary sewer is mowed annually and portions, though sparse, are vegetated but lack canopy shade.

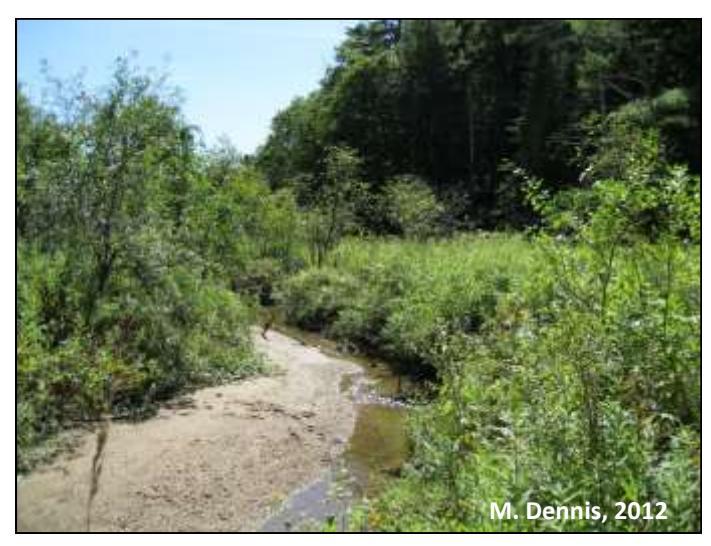
Figure 26. Typical stretch of Reach A4 as it enters the Allen's Pond wetland complex. Larger canopy gives way to shrubs and grasses with significant sediment deposition on point bars.

ded. Large woody debris is scarce yet naturally occurring organic material in-stream is plentiful. The stream is clear with no odor. The stream bank is vertical and undercut with overhanging vegetation suggesting degradation, yet, as with other reaches, significant portions show aggradation with a widened channel and a significant number of point and mid-channel bars. No garbage/debris was found in or adjacent to stream. Evidence of amphibians and mammals were found in the vicinity of the stream with potential barriers for migration found in presence of limited large woody debris collapsed across stream. This section of stream is 25% shaded with dense vegetation extending beyond 75 feet of stream

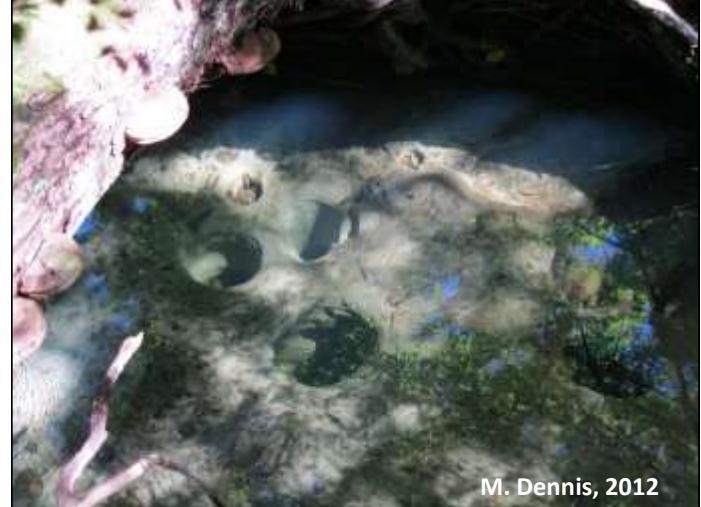
Figure 28. An interesting phenomenon of Reach C1 is the fluvial erosion into the glacial marine clay creating "potholes" in the substrate. The depth of the stream is 1.5' at this location.

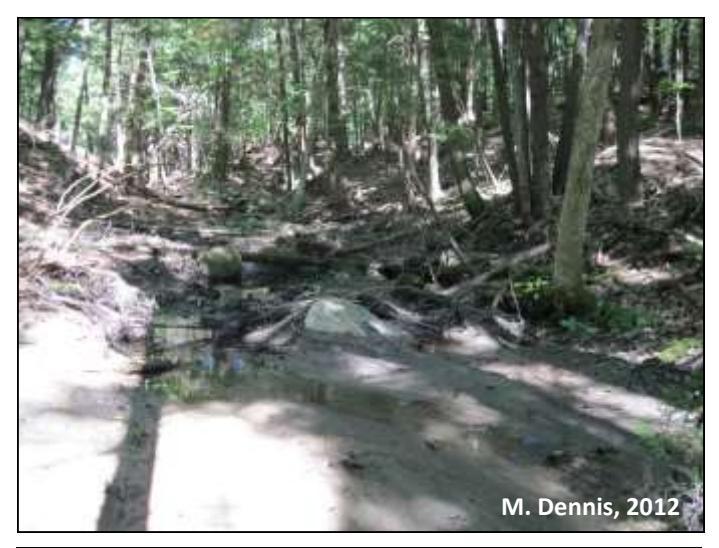
Figure 29. Typical stretch of Reach C2, wooded sections with substantial sediment deposition in foreground.

and riffles typically less than 1 foot deep with one pool over 2 feet deep. The distance between pools is 60 feet and the stream bottom is predominantly silt/clay/mud with sand and fine pea gravel at lower densities. Cobble and boulders are somewhat (2-25%) embedded. Large woody debris is plentiful along with occasional naturally occurring organic material found in-stream. The stream is clear with no odor. The stream bank is undercut with rootwads and overhanging vegetation, and downstream portions showing aggradation with mid-channel bars. Minimal garbage/debris is found in and adjacent to the stream . Evidence of amphibians and mammals were found in the vicinity of the stream with potential barriers for migration located at the culvert at the detention pond, chain link fencing around the pond, and large woody debris collapsed across stream. This section of stream is 75% shaded with dense vegetation extending beyond 75 feet of the stream bank. Reach C2 is stable when compared with other reaches within the network of tributaries. It is heavily influenced by stormwater structures related to the L.L. Bean complex and any further research should be focused on mitigating stormwater inputs.

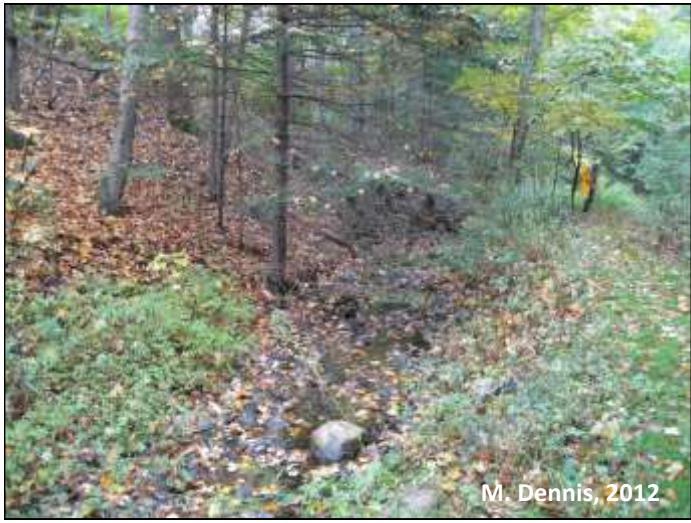
Figure 30. Typical stretch of Reach D1, wooded sections along the hiking trail connected to L.L. Bean facilities.

ring organic material in-stream. The stream is clear with no odor. The stream bank is undercut with garbage/debris found in and adjacent to the stream. Evidence of amphibians and mammals was found in the vicinity of the stream with potential barriers for migration found in the culvert areas of bridging for Casco Road and the culvert. A number of discharge pipes are located within the bridge area. This section of stream is 50% shaded with dense vegetation extending 75 feet beyond the stream bank. Though there are a number of discharge pipes which outlet to the stream, the overall appearance of the reach suggests stability but could benefit from stormwater mitigation efforts in the upper watershed.

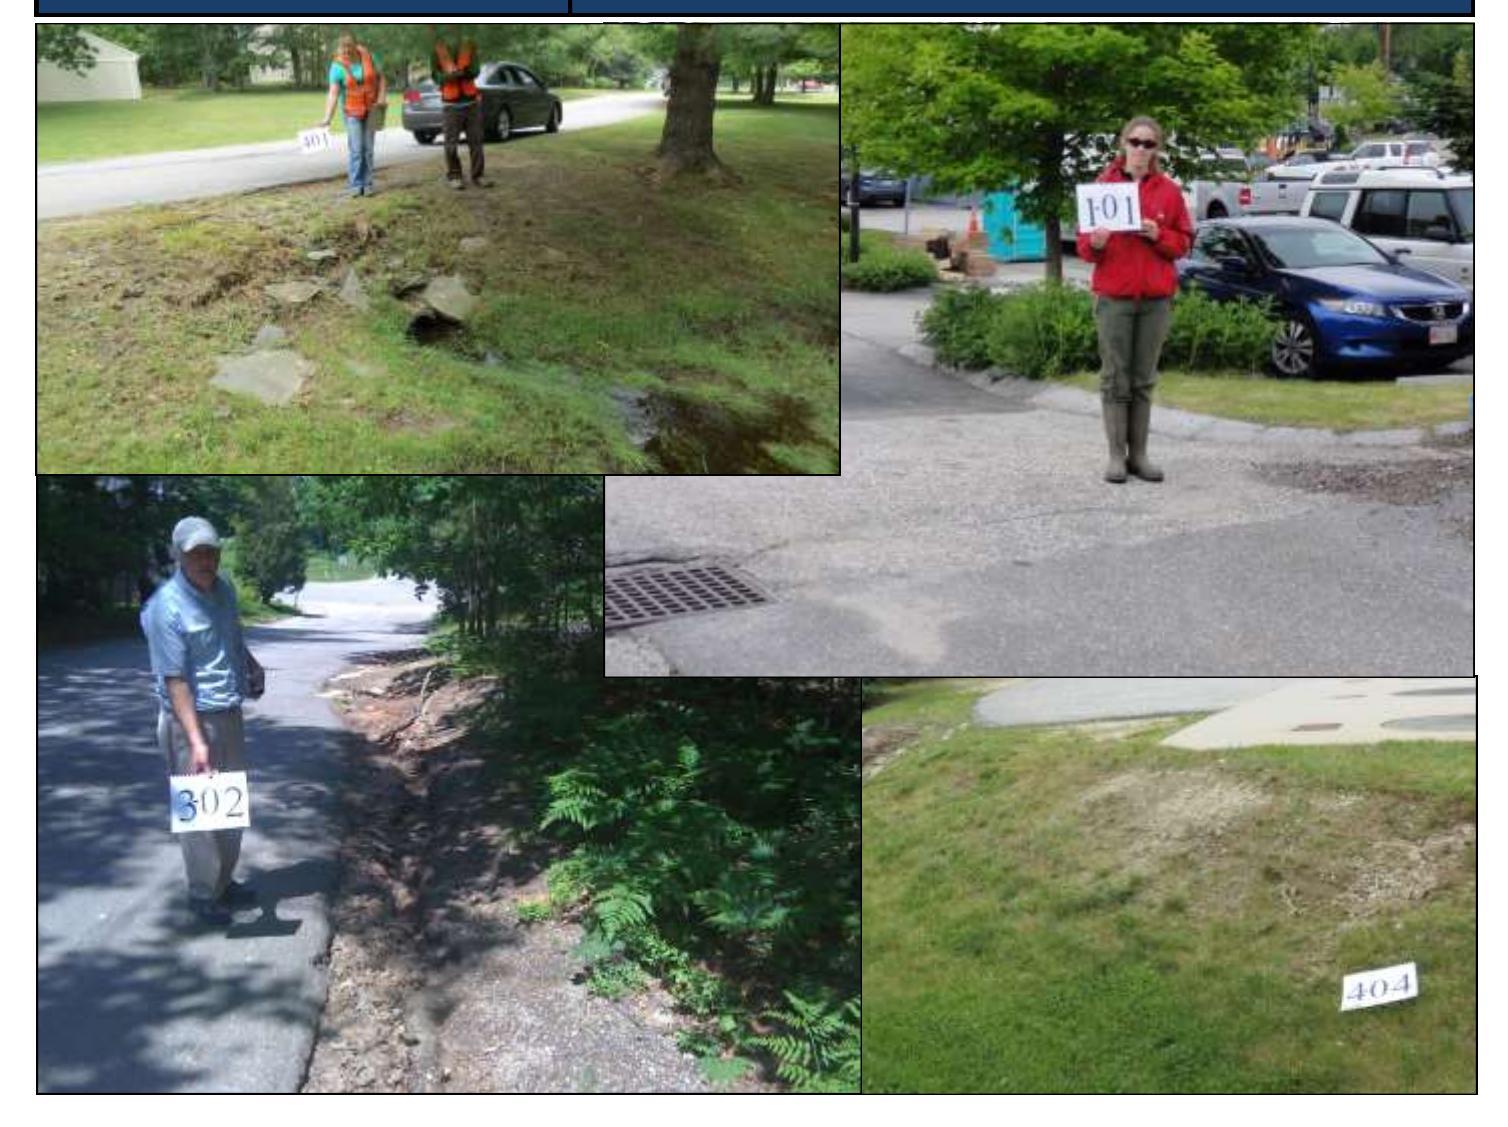
Town and private roads accounted for 15 of the total 46 sites. The Town of Freeport has been active replacing culverts and repairing ditching, especially on South Street, but roads can be a huge impact to Concord Gully Brook. Most road issues need expertise and often have a moderate to significant cost associated with them.

- Output: Out
- Road shoulder erosion
- ◊ Unstable ditching/erosion
- ◊ Clogged or rusted culverts

- Oclean out culverts and armor inlets/outlets with riprap
- ◊ Re-grade, vegetate to stabilize shoulders
- $\diamond$  Clean, re-shape and stabilize ditches
- Out and/or replace

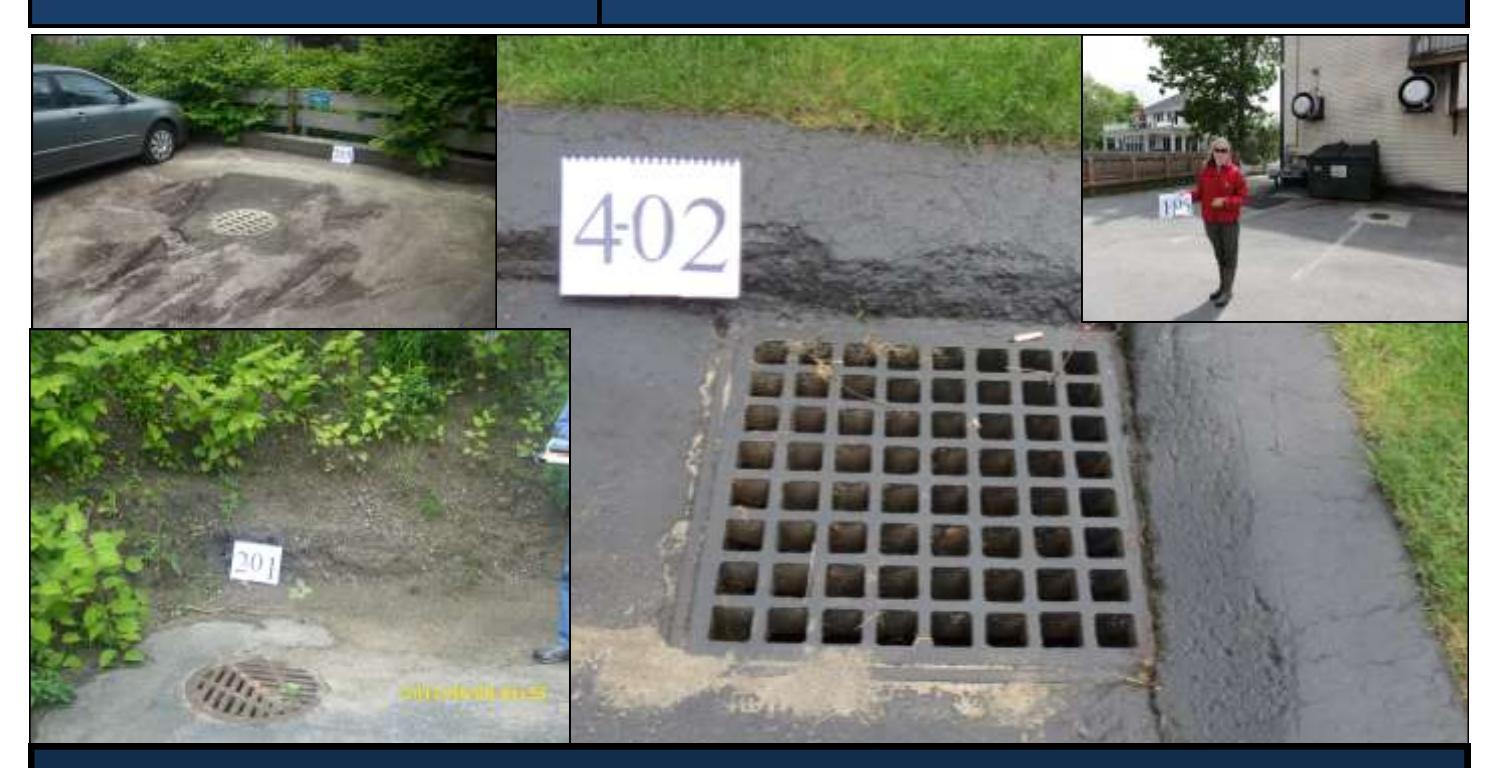
13 sites were associated with parking areas. Of these sites, only 3 were classified as erosion sites. The majority were the result of winter sand accumulated on the parking area, sealcoating over catch basins, or unmaintained ditching and culverts. It is very difficult to estimate the impact of these sources of pollution, but the cumulative effect of these numerous and large areas can send a multitude of pollutants to the Brook in a hurry.

- **\diamond** Winter sand filling catch basins
- Sealcoating near catch basins and wetland areas
- Excessively green grass and athletic fields
- ◊ Bare soils
- ◊ Leaking dumpsters

- ◊ Remove winter sand sweep monthly or as needed
- Use sealcoating that contain no coal tar or polycyclic aromatic hydrocarbons (PAHs)
- Use fertilizers and pesticides minimally or not all , look for labels that contain no phosphorous
- $\diamond$  Keep bare soils covered with vegetation, mulch, or grass
- ◊ Place dumpsters away from catch basin inlets

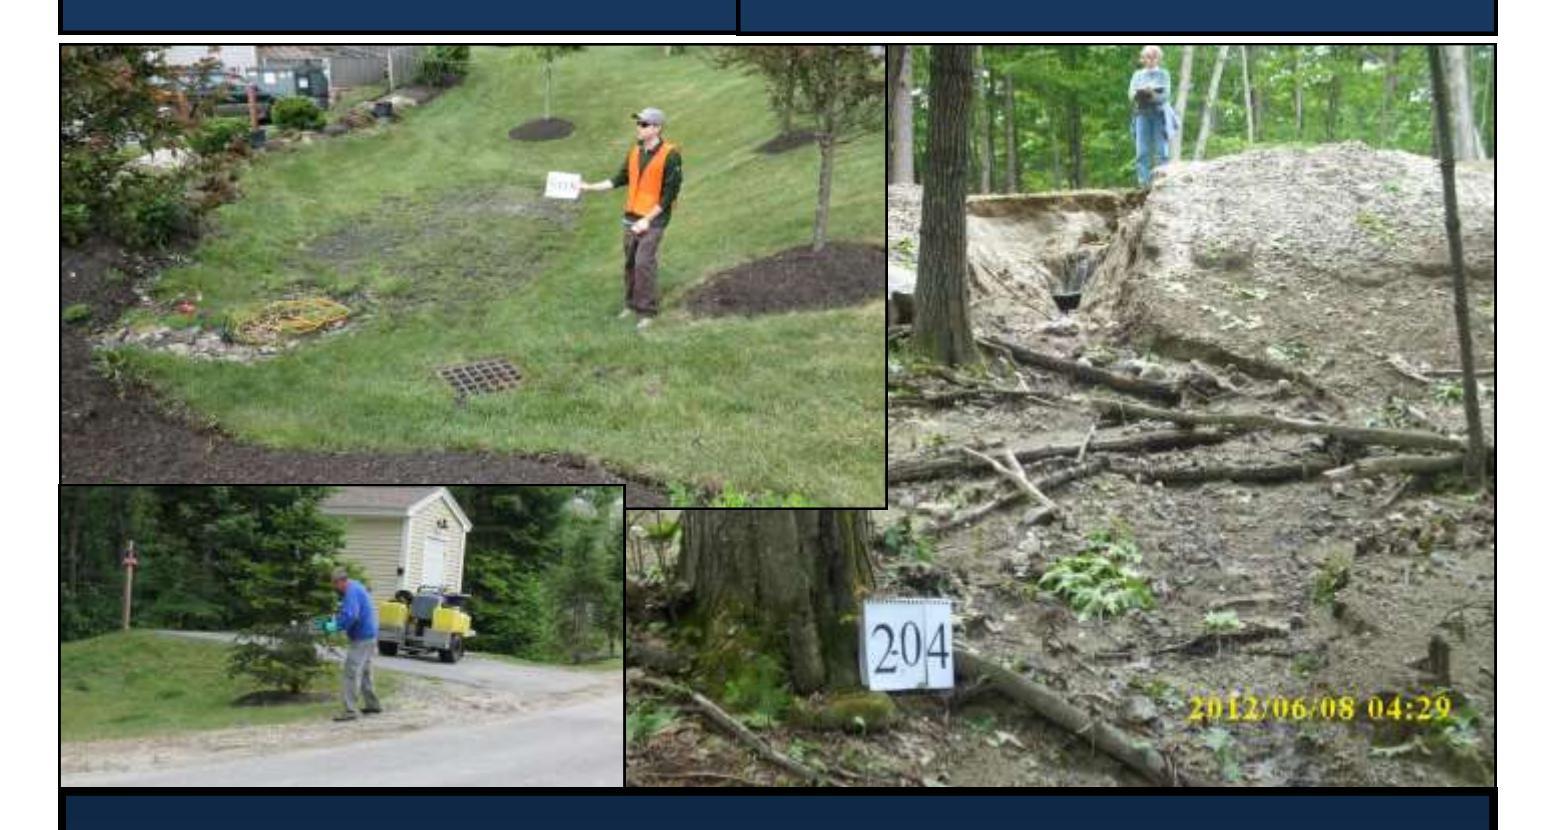
It's the cumulative impact of all the sites that can cause water quality to decline.

- Seed and mulch bare soil, use fertilizers and pesticides sparingly or not at all
- Plant a buffer of native gardens to keep stormwater out of the Brook
- Install drip line trench install a rain barrel to capture it and water you garden
- Dispose of toxic materials at hazardous waste drop off days at the municipal transfer station
