**HABITAT RESTORATION INVENTORY
SUMMARY REPORT
FOR THE
ROYAL RIVER, SPRUCE CREEK, AND LOWER KENNEBEC
RIVER ESTUARY
VOLUME I**

DECEMBER 2005

**Prepared by: Northern Ecological Associates, Inc.
451 Presumpscot Street
Portland, Maine 04103**

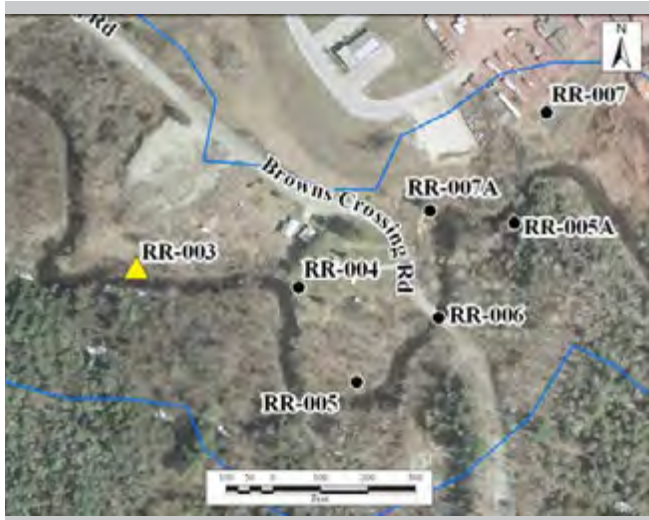
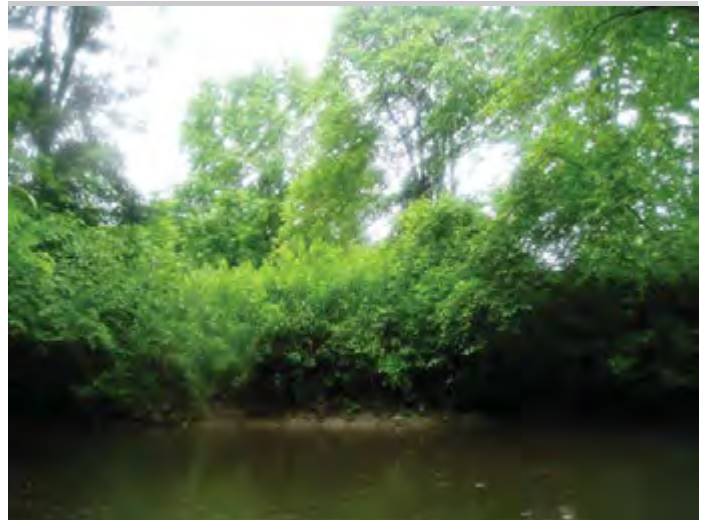
Narrow, low quality buffer. Existing shrubs and herbs are good, however more plantings are desirable.

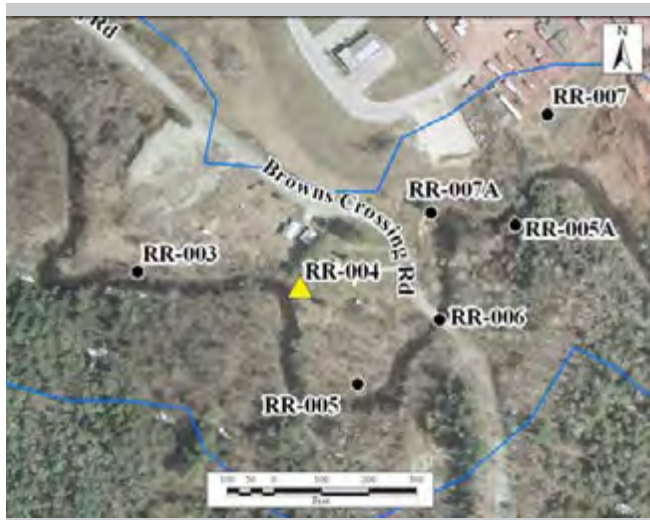
Narrow buffer of herbs to top of bank, then mowed lawn. No overstory vegetation. Eroding bank (10-foot high by 100-foot wide), vegetated in part with Japanese knotweed.

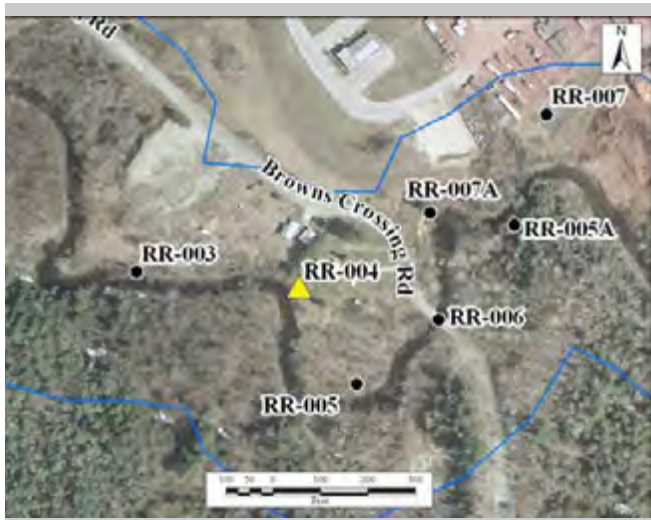
Japanese knotweed stand, approximately 75 x 10 feet.

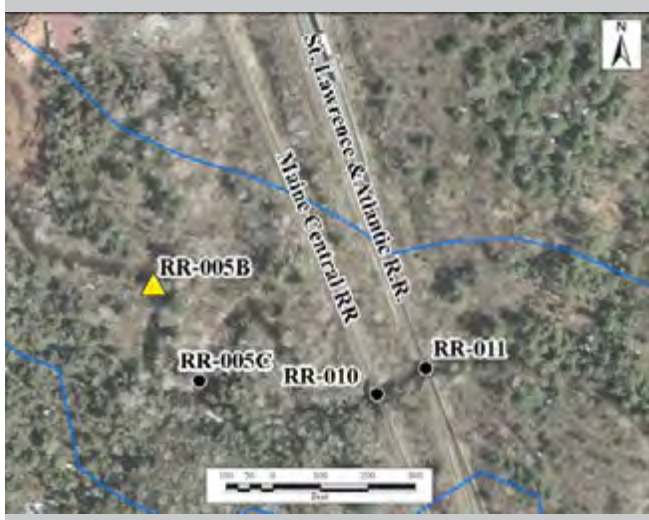
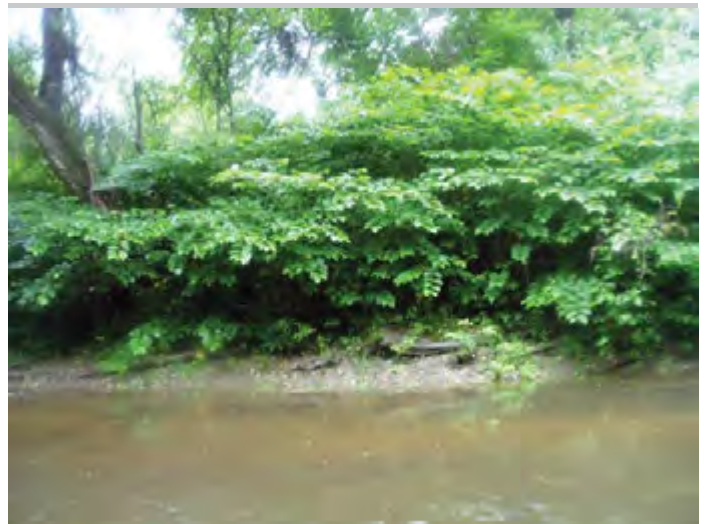
Japanese knotweed stand, approximately 75 x 10 feet.

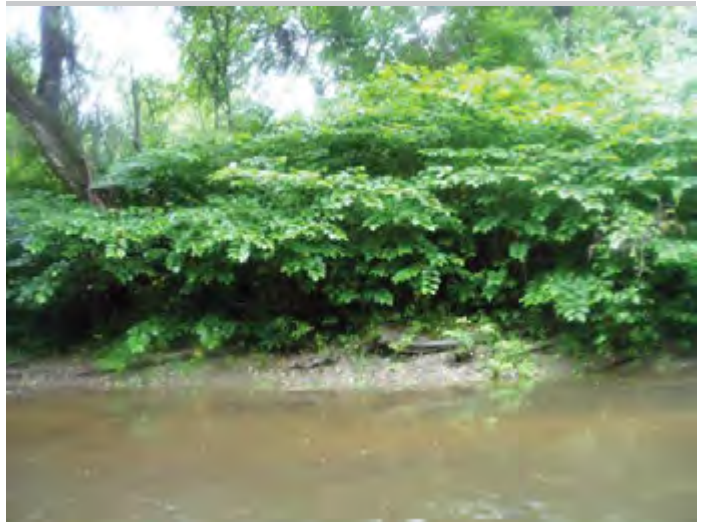
Japanese knotweed stand, approximately 40 x 10 feet.

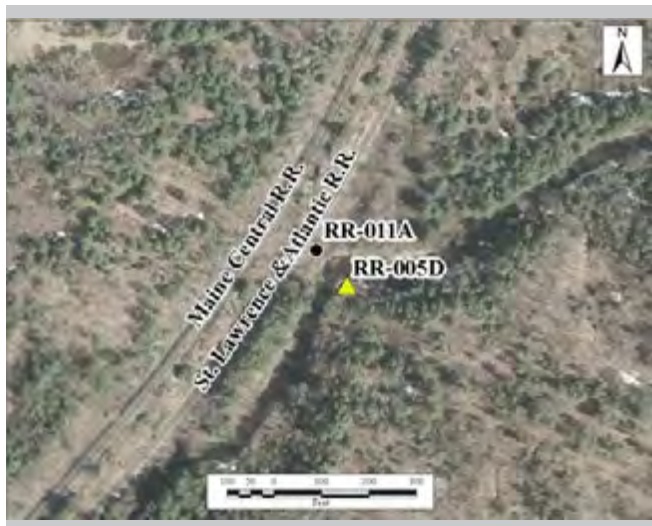
Japanese knotweed stand, approximately 20 x 6 feet.

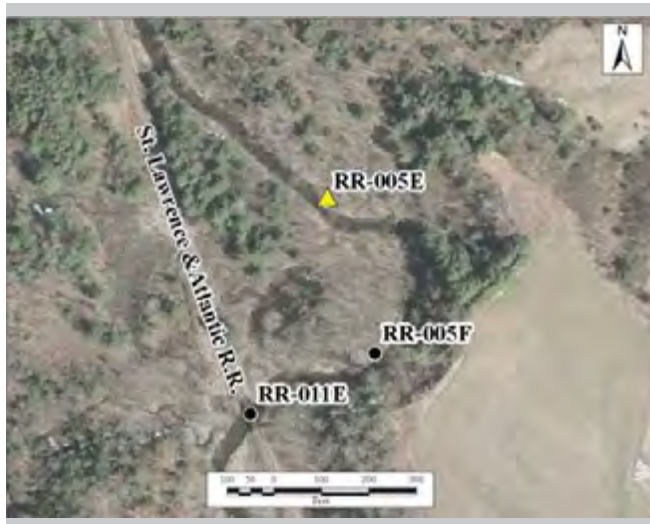
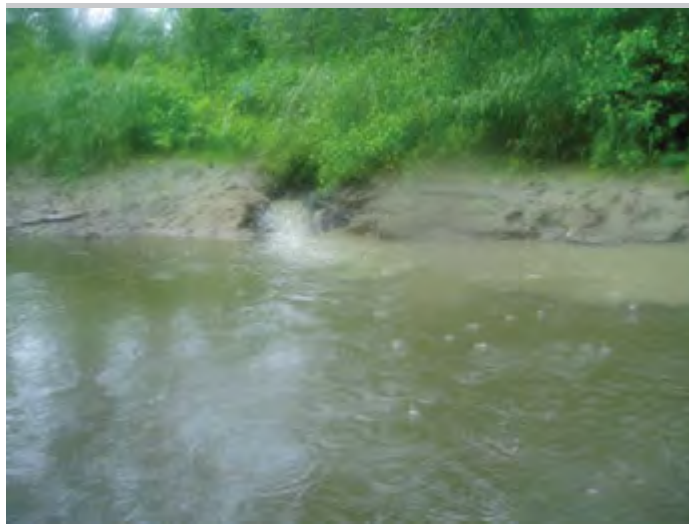
Japanese knotweed stand, approximately 50 x 10 feet. Tributary with high turbidity dumping into river.

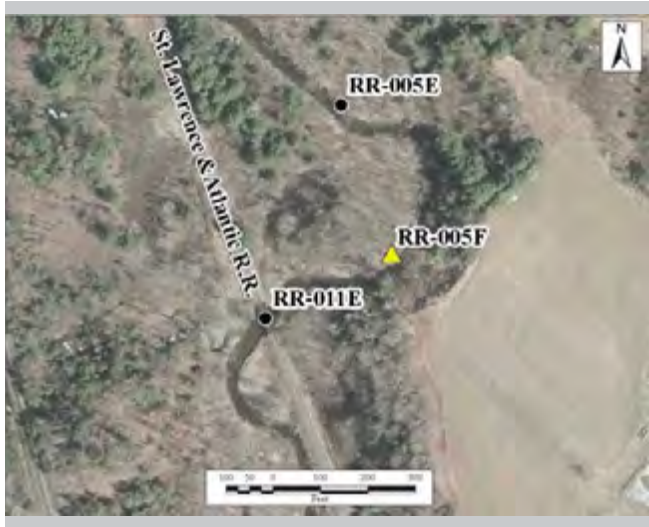
Trash/debris/old cars dumped on one side of the bank. Japanese knotweed along 75 foot section, and bank erosion along 25 foot section of other bank.

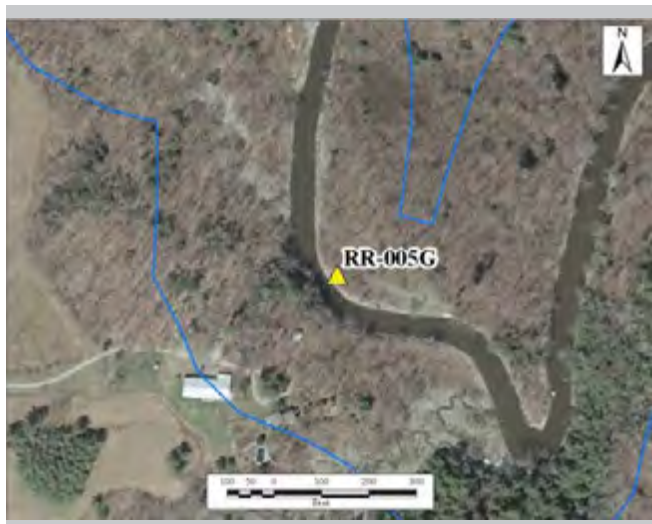
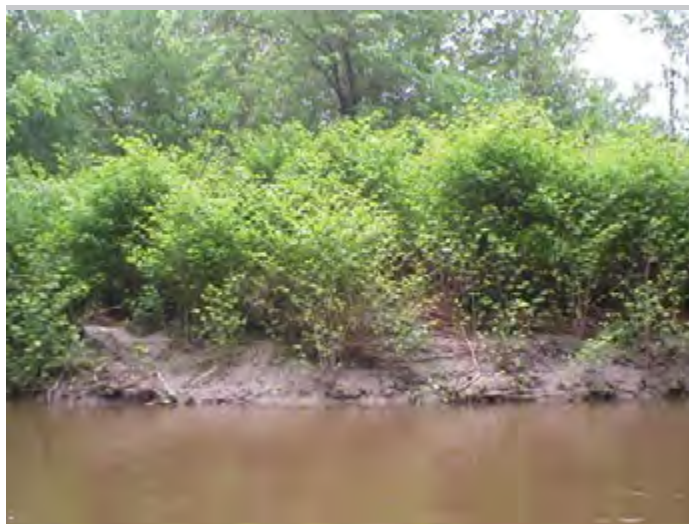
Japanese knotweed approximately 100 x 20 feet.

Sources of Degradation (13 possible): Invasive plant species

Total Degradation Score (higher score indicates a higher level of degradation): 0.50

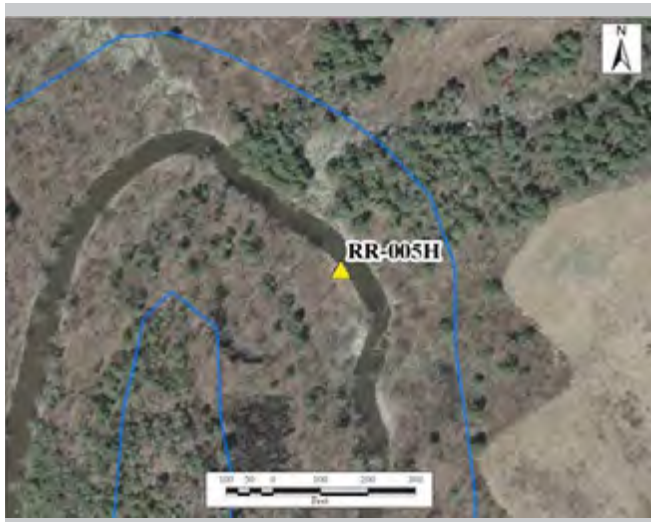
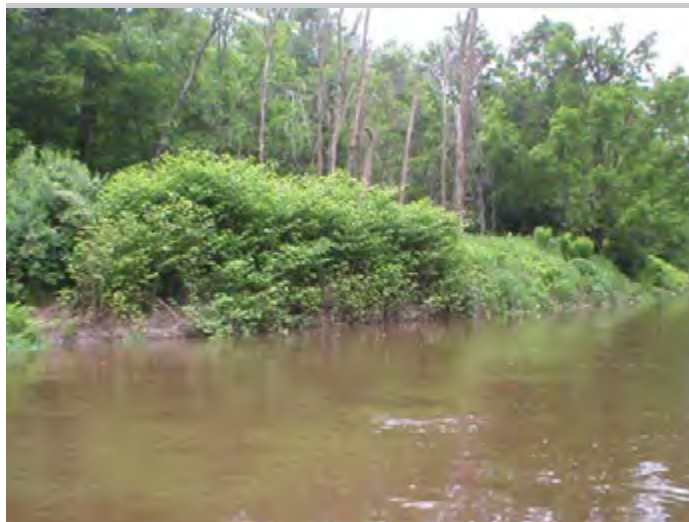
Japanese knotweed stand 40 x 15 feet.

Sources of Degradation (13 possible): Invasive plant species

Total Degradation Score (higher score indicates a higher level of degradation): 0.25

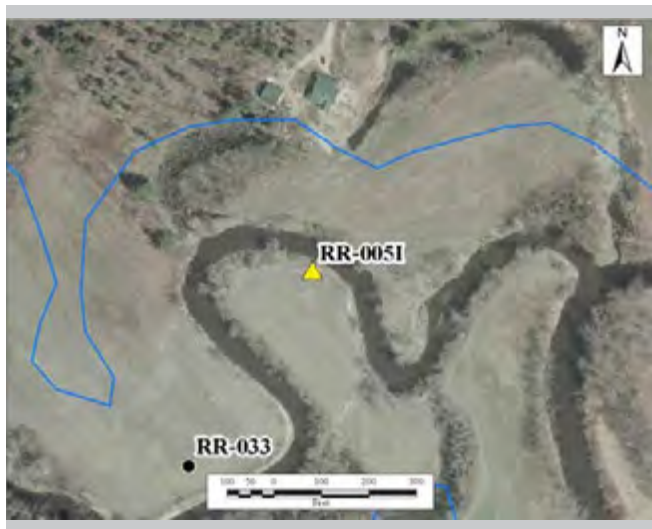
Japanese knotweed stand, approximately 10 x 75 feet.

Sources of Degradation (13 possible): Invasive plant species

Total Degradation Score (higher score indicates a higher level of degradation): 0.40

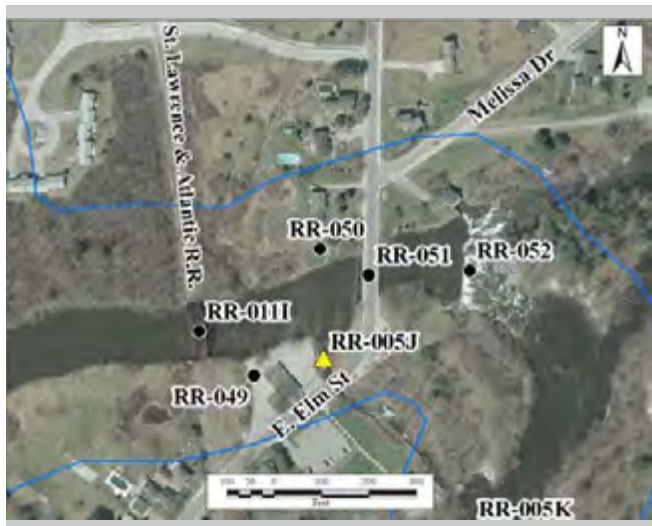
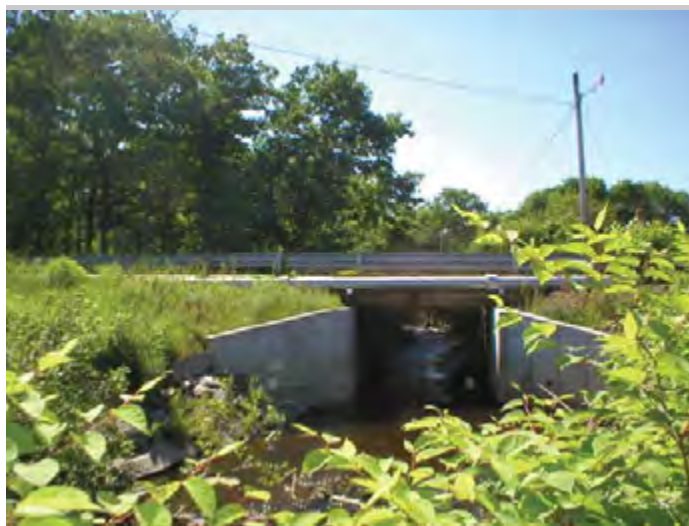
Japanese knotweed stand, approximately 10 x 60 feet located on north side of East Elm Street, Yarmouth.

Sources of Degradation (13 possible): Invasive plant species

Total Degradation Score (higher score indicates a higher level of degradation): 0.25

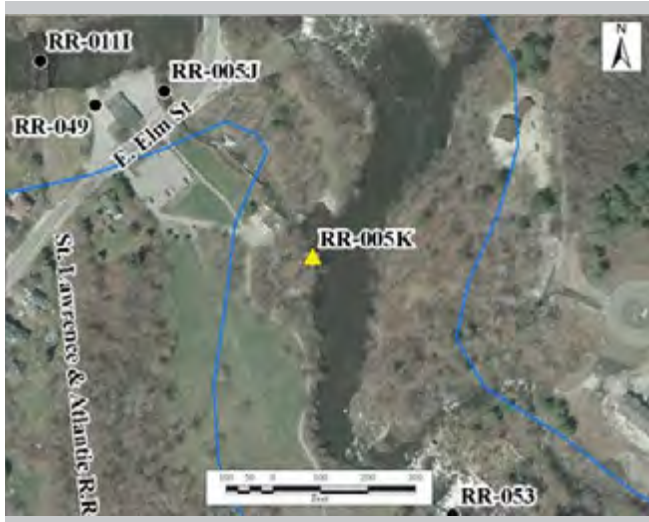
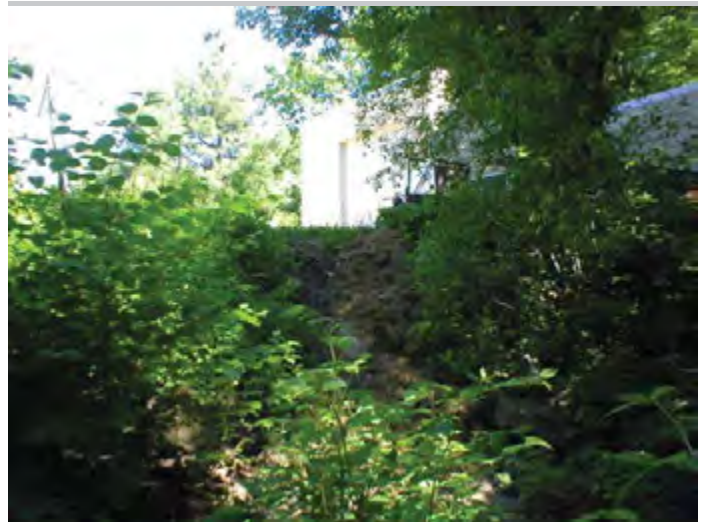
Japanese knotweed stand on west bank of the Royal River, approximately 15 x 40 feet. Dumped lawn clippings and debris impeding natural vegetation growth behind town park maintenance buildings.

Sources of Degradation (13 possible): Fill/debris/trash, Invasive plant species

Total Degradation Score (higher score indicates a higher level of degradation): 0.50

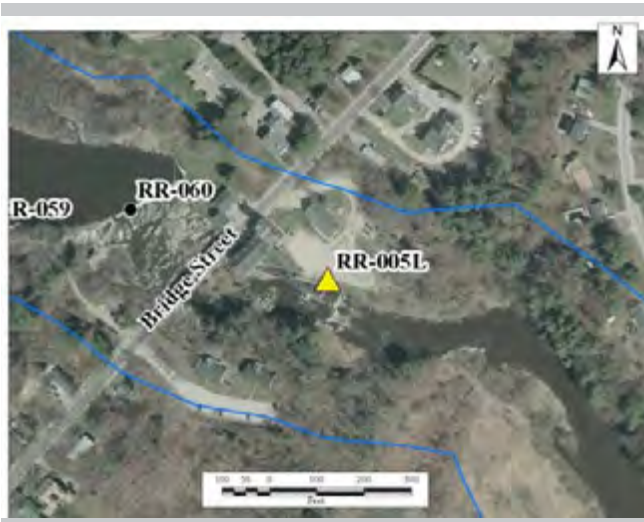
Japanese knotweed stand, approximately 6 x 60 feet. Lack of adequate buffer between dirt parking lot and river.

Sources of Degradation (13 possible): Invasive plant species, Land cleared

Total Degradation Score (higher score indicates a higher level of degradation): 1.20

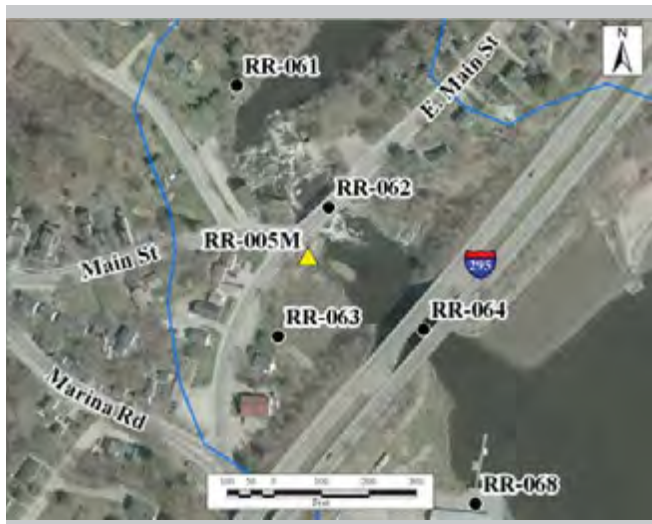
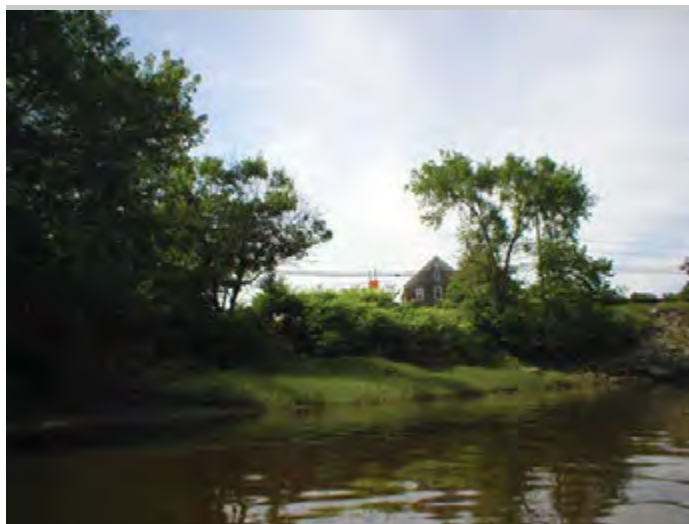
Japanese knotweed stand along road edge, approximately 75 x 15 feet. Lack of adequate buffer (herb/ shrub) along southeast side of road way.

Sources of Degradation (13 possible): Invasive plant species, Land cleared

Total Degradation Score (higher score indicates a higher level of degradation): 0.65

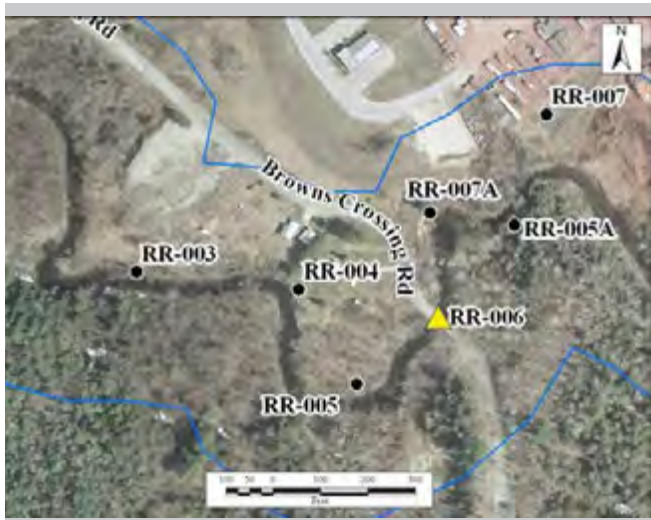
Browning Crossing Road bridge. Majority of stream flow on east side. Constriction is not a real issue. At high flow, water would flow on both sides of central cement block. Banks are generally stable with some rip-rap rocks placed. Some erosion on west side banks.

Sources of Degradation (13 possible): Land use activity a potential contaminant source, Right-of-way (highway, utility, railroad), Unstable bank

Total Degradation Score (higher score indicates a higher level of degradation): 0.30

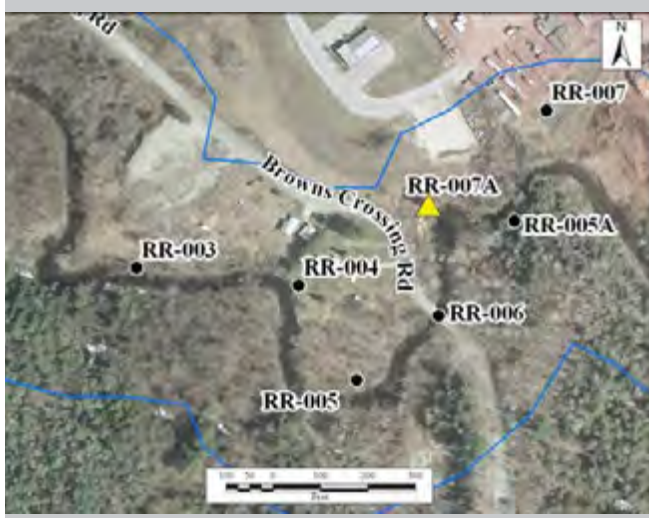
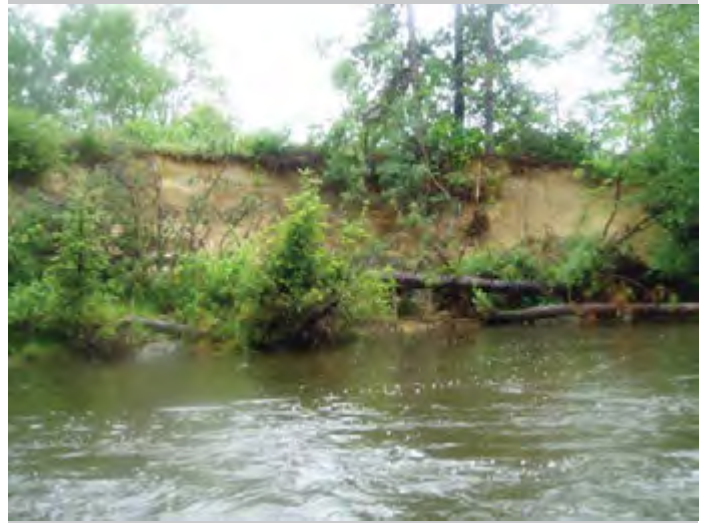
Severely eroding bank and substantial tree loss. Bare soil on banks with minimal buffer between river and Morin Brick Company parking area.

Sources of Degradation (13 possible): Impervious surface, Unstable bank

Total Degradation Score (higher score indicates a higher level of degradation): 2.00

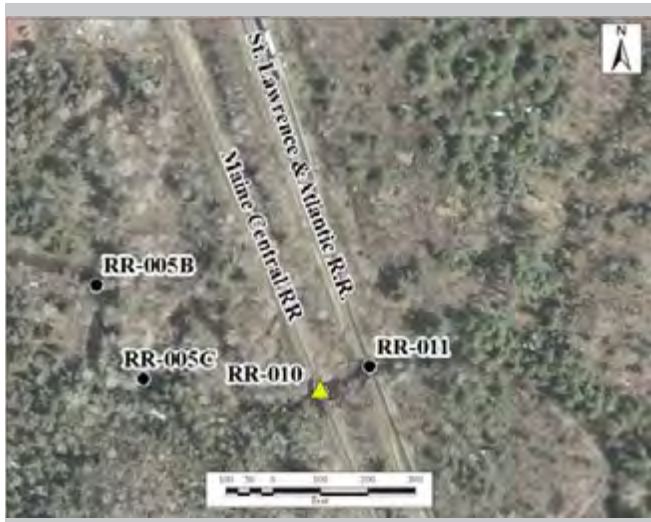
Railroad bridge crossing. Banks stable, no erosion; banks held in place with placed, cut stone. Banks well vegetated with herbs, shrubs, and trees, except for maintained ROW. Not a constriction.

Sources of Degradation (13 possible): Land use activity a potential contaminant source, Right-of-way (highway, utility, railroad), Rip-rap (or other artificial hard structure)

Total Degradation Score (higher score indicates a higher level of degradation): 0.40

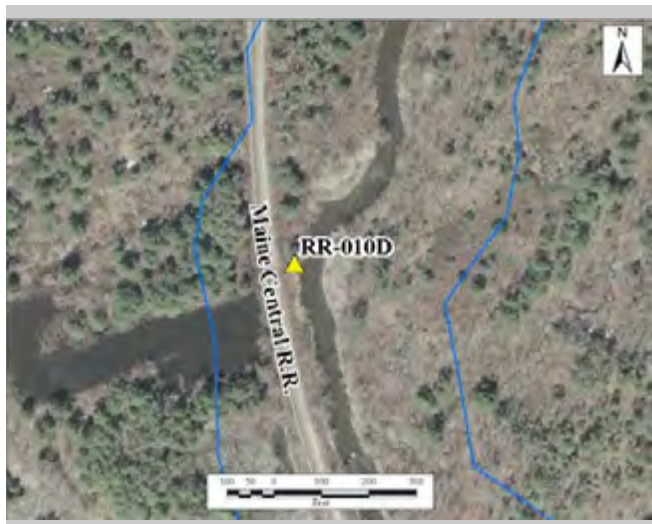
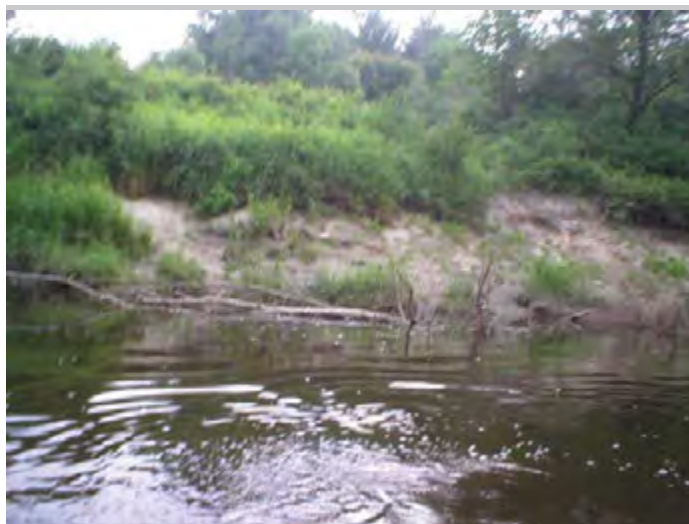
Eroding shoreline adjacent to railroad tracks. Erosion cutting toward railroad tracks and bank may eventually need significant stabilization. Narrow, maintained buffer between railroad tracks and river.

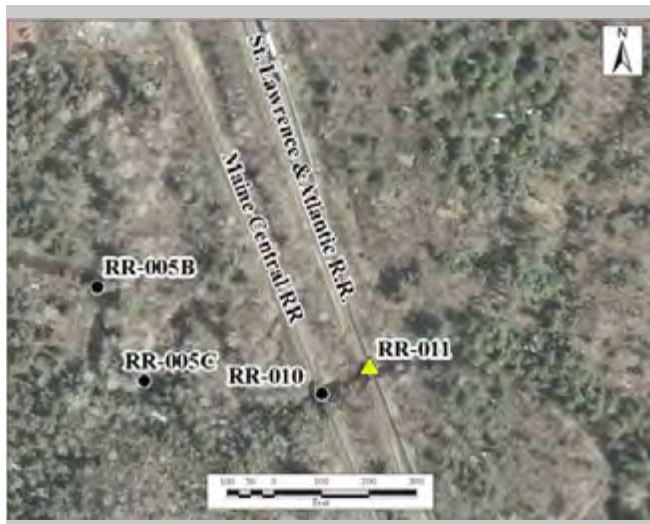
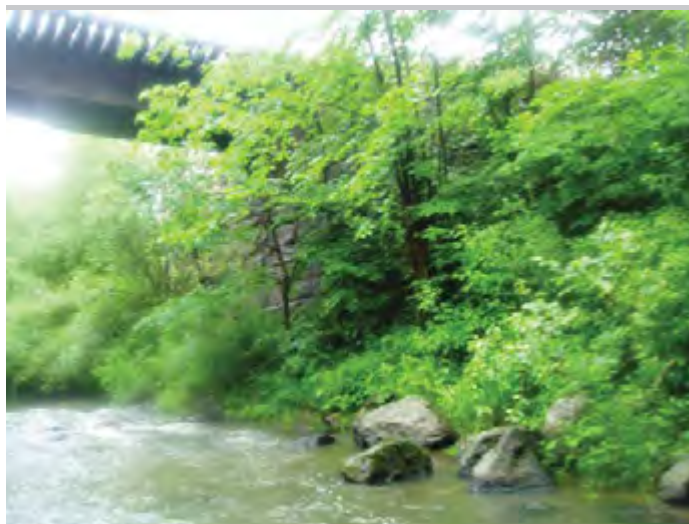
Railroad bridge crossing. Banks stable, no erosion; banks held in place with placed, cut stone. Banks well vegetated with herbs, shrubs, and trees, except for maintained ROW. Not a constriction.

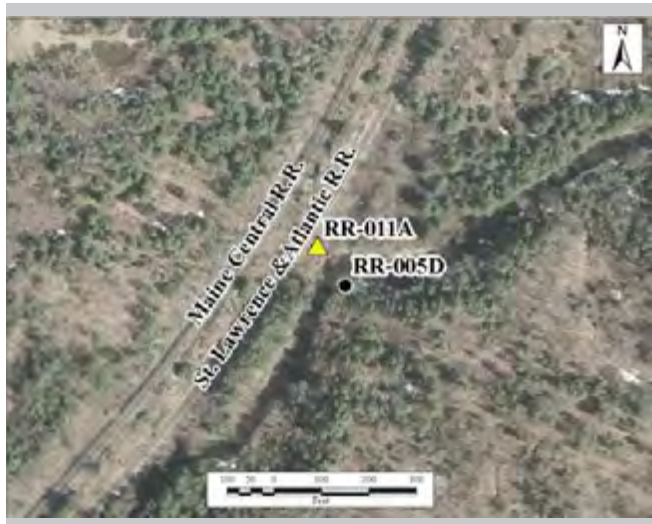
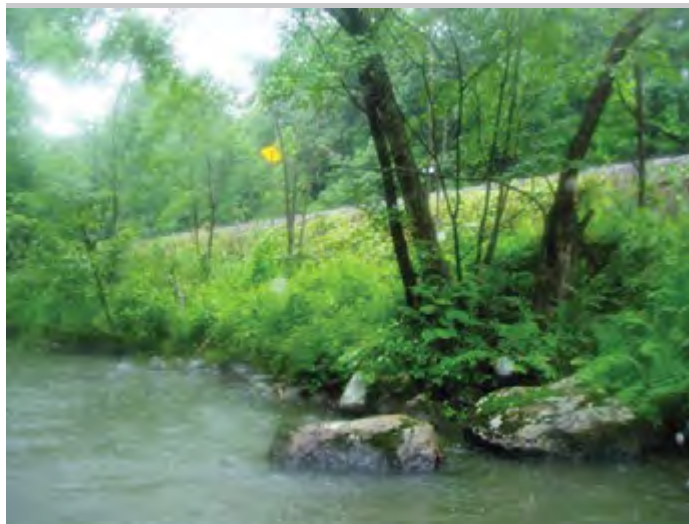
Railroad Right-of-way (ROW) maintained through cutting back of vegetation. Banks stable, not eroding. Lack of buffer is only issue. Shrubs and herbs, few trees.

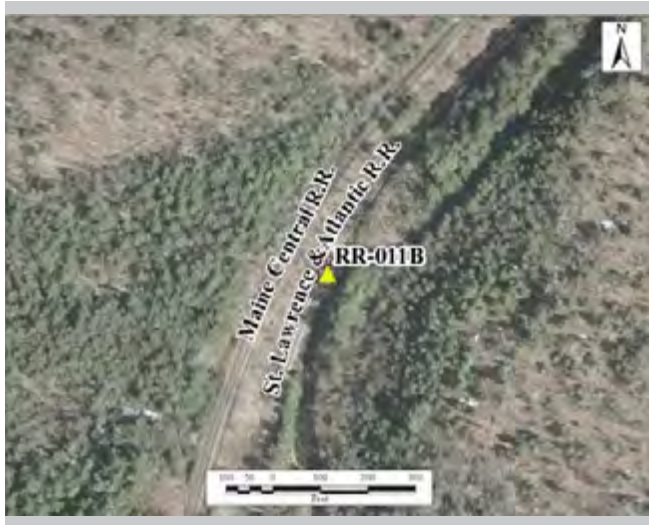
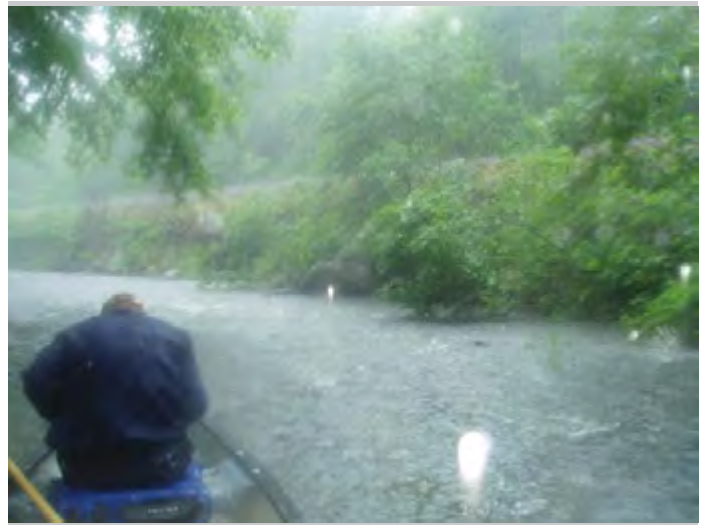
Railroad ROW maintained through cutting back of vegetation. Banks steep, but stable, not eroding. Lack of buffer is only issue.

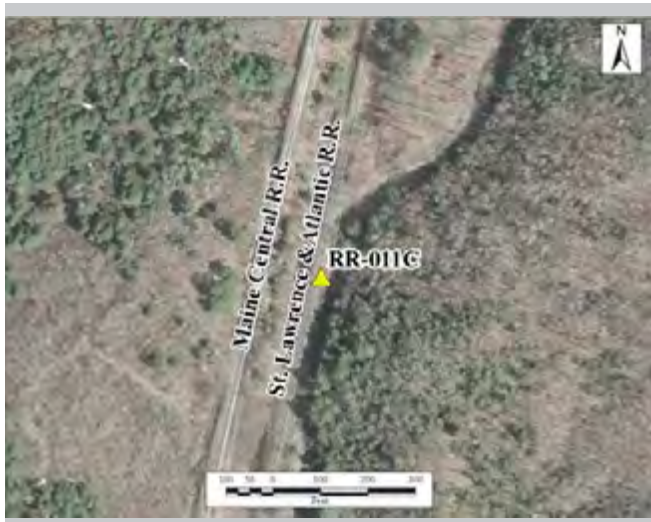
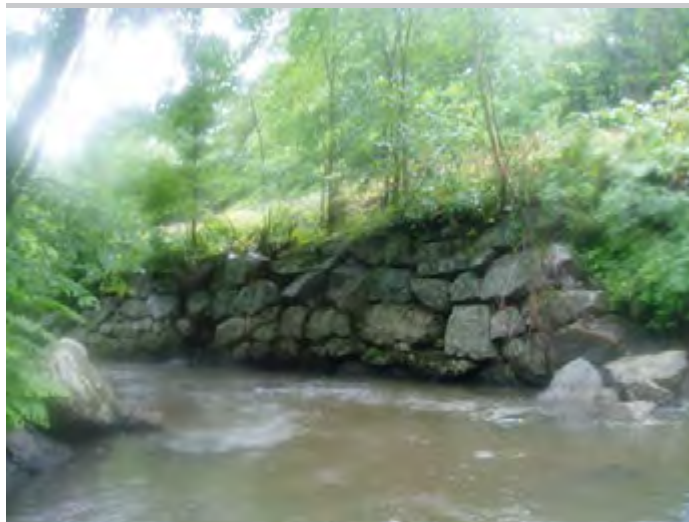
Railroad ROW maintained through cutting back of vegetation. Banks stable, not eroding. Placed, cut rock walls stabilize railroad bed, but also impede vegetation growth. Shrub and herb growth dense, despite cutting.

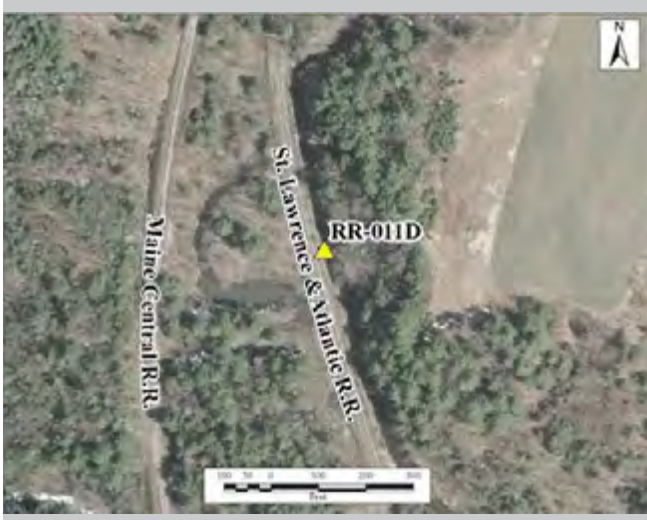
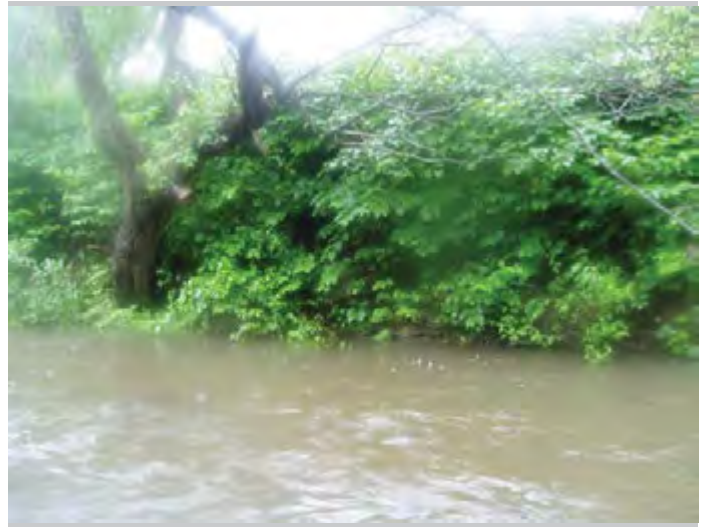
Railroad ROW maintained through cutting back of vegetation. Banks stable, not eroding. Well vegetated with shrubs and herbs.

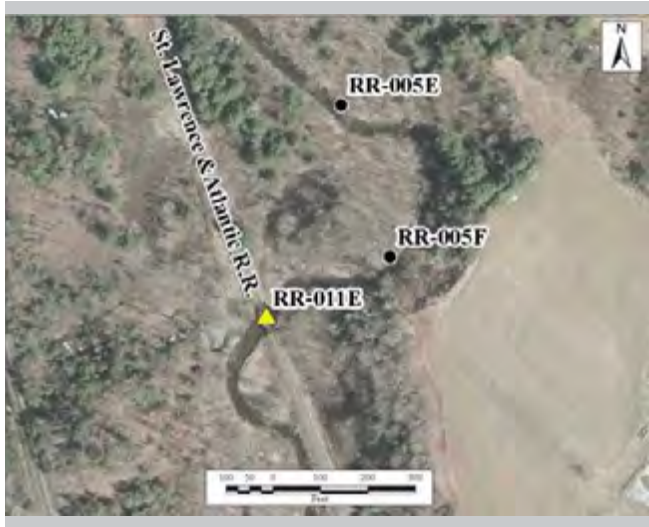
Railroad bridge crossing. ROW maintained through cutting back of vegetation. Banks stable, not eroding. Sediment deposition under bridge, with herbs revegetating in places. Banks stabilized with placed, cut rock.

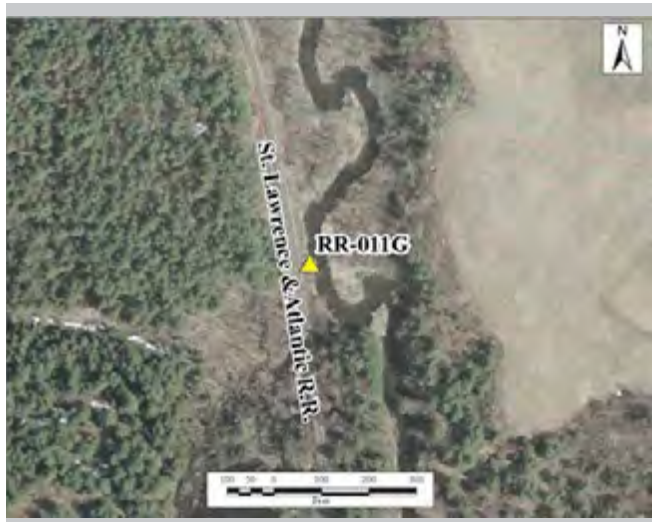
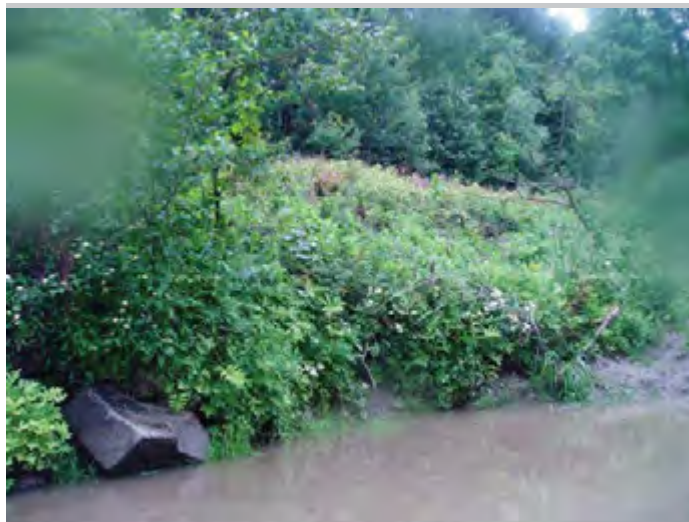
Railroad ROW maintained through cutting back of vegetation. Banks stable, not eroding. Narrow buffer (less than 10 feet) of herbs and shrubs.

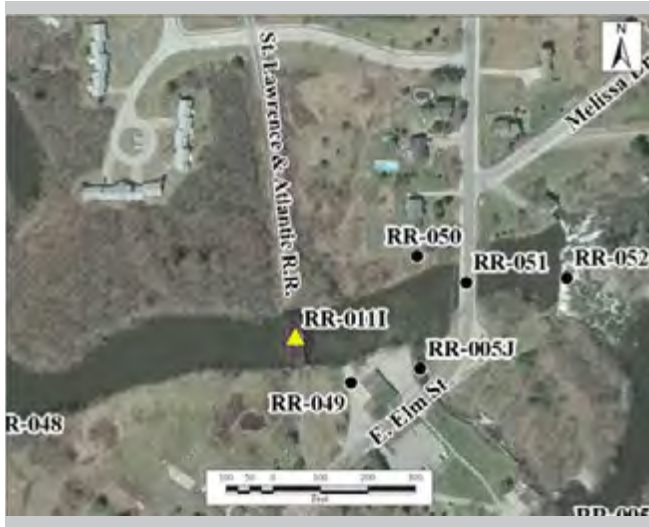
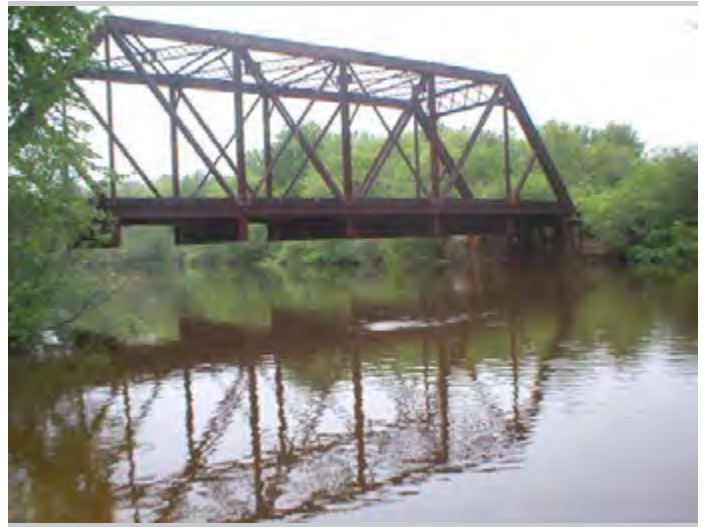
Railroad bridge crossing. ROW maintained through cutting back of vegetation. Placed, cut rock foundation.

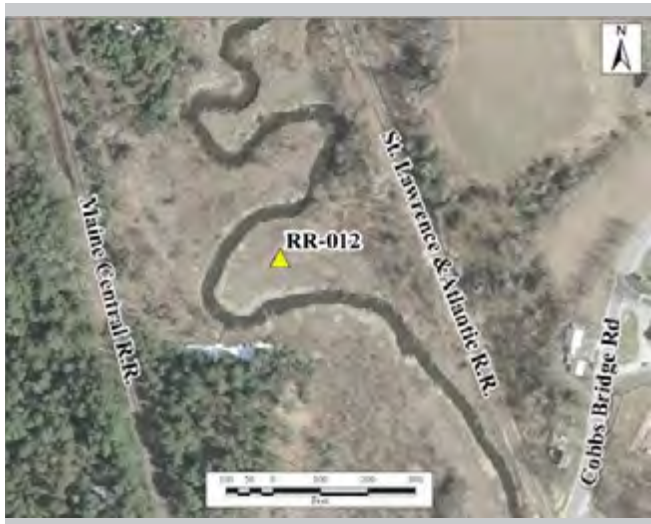
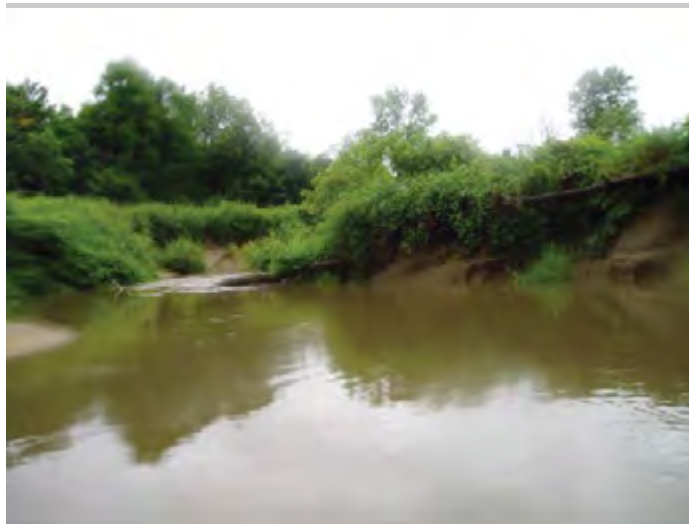
Buffer issue. Lack of shrubs and trees along river banks. Old pole leaning toward river.

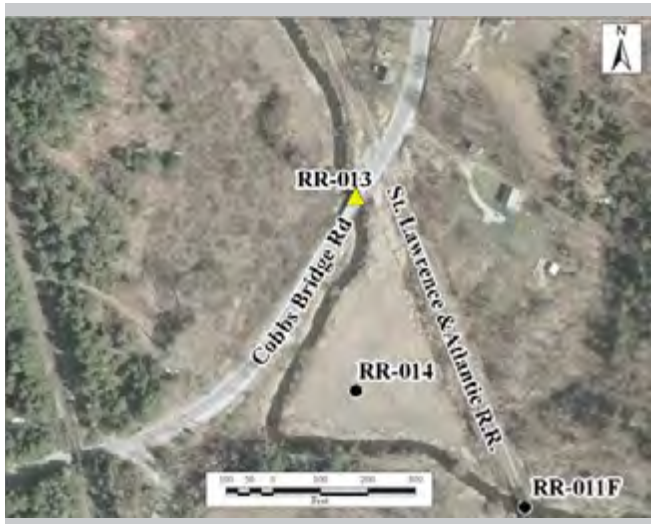
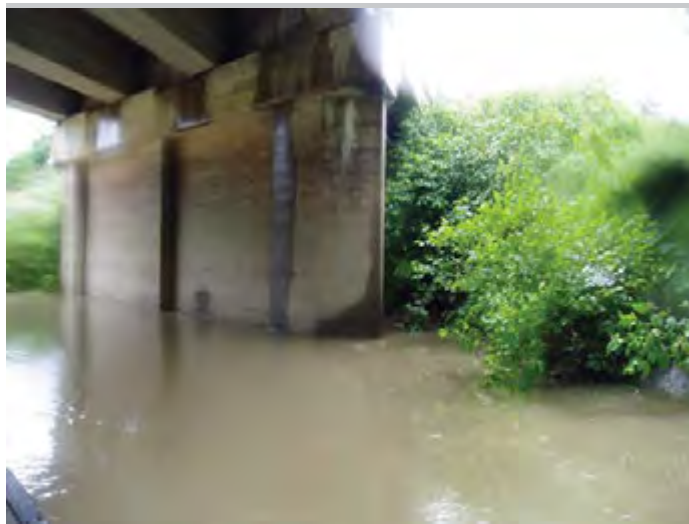
Cobbs Bridge Rd crossing. Cement bridge is a slight constriction of river. Banks are stable, not eroding. Buffer predominately herbs.

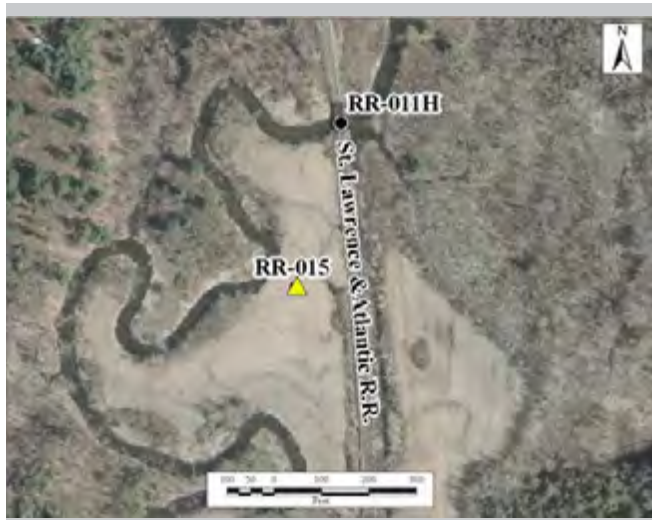
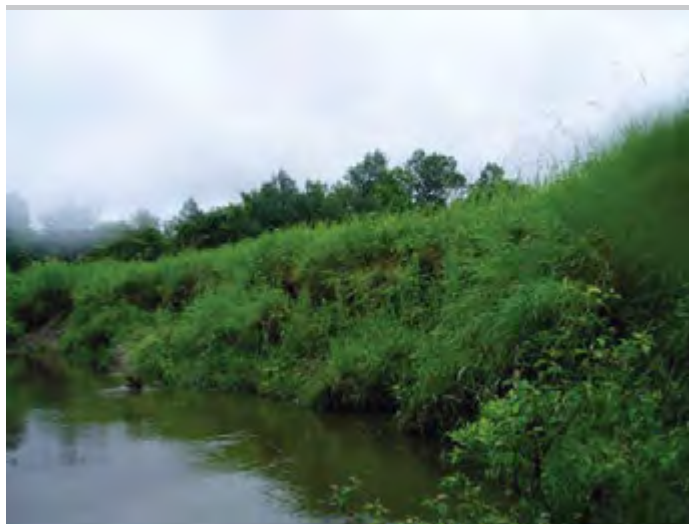
Buffer issue. Buffer comprised of herbs with few shrubs, eroding in places, but not necessarily unnaturally.

Sources of Degradation (13 possible): Land cleared

Total Degradation Score (higher score indicates a higher level of degradation): 0.85

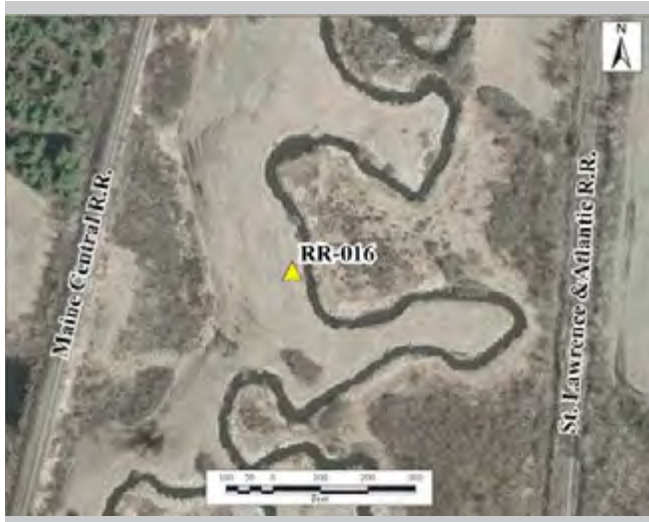
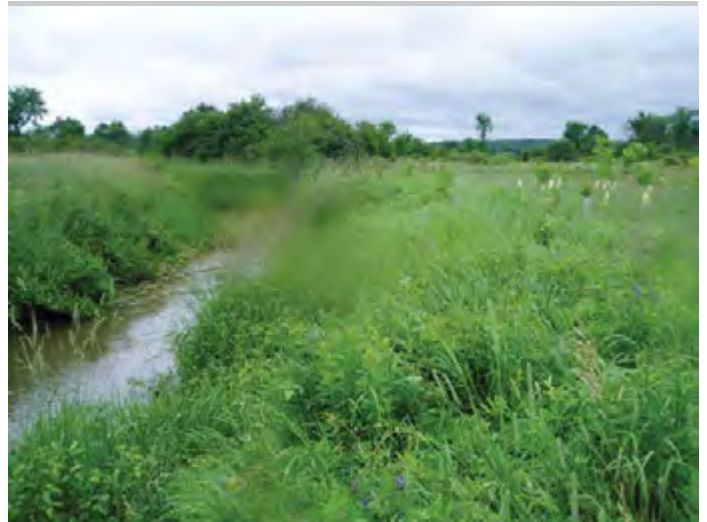
Tree farm with no real shrub/tree buffer - herbs only. Base of banks are stabilized with coir/coconut fiber matting on outside bank corners for approximately 700-feet in length.

Sources of Degradation (13 possible): Land cleared

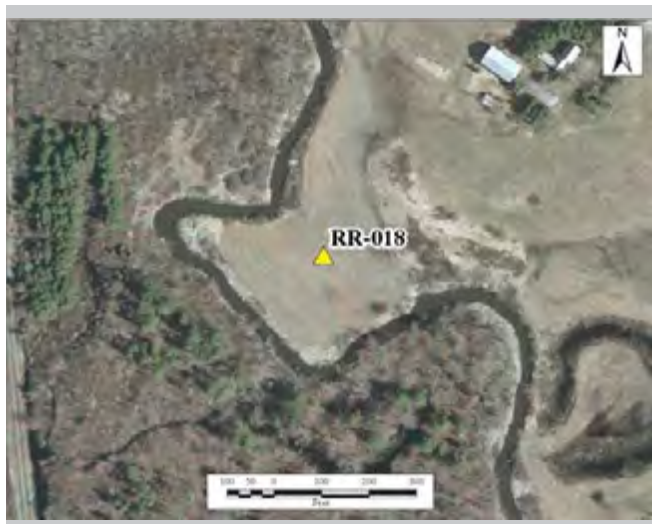
Narrow buffer of herbs, shrubs, and few trees, then agriculture. Steep banks (approx. 75% slope) are marginally vegetated leaving exposed ground, erosion, and slumping areas.

Sources of Degradation (13 possible): Land cleared, Unstable bank

Total Degradation Score (higher score indicates a higher level of degradation): 1.30

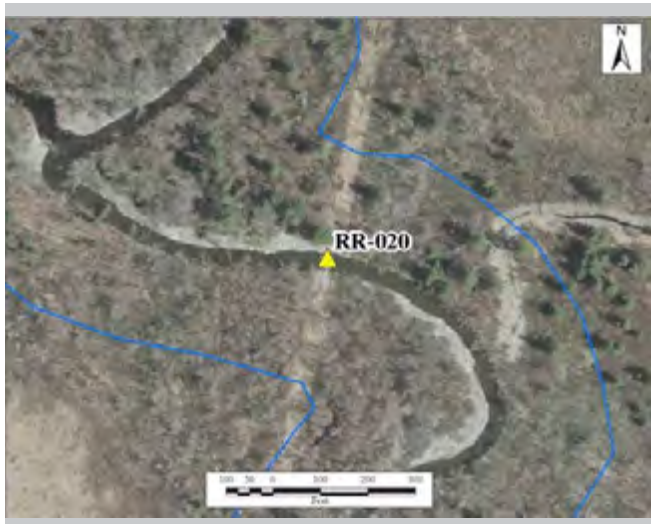
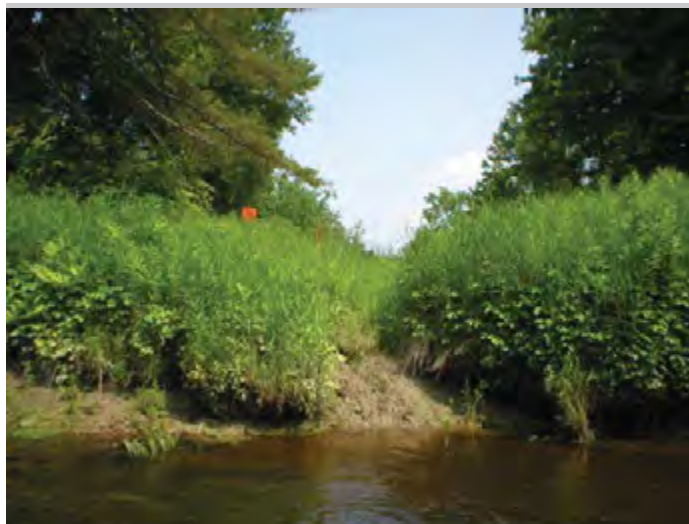
Pipeline right-of-way. Mostly dense vegetation cover of herbs only. Some minor exposed ground and erosion near water's edge, possibly due to animal trails. Banks approximately 5-foot high with slopes of about 25 to 50%.

Sources of Degradation (13 possible): Right-of-way (highway, utility, railroad), Unstable bank

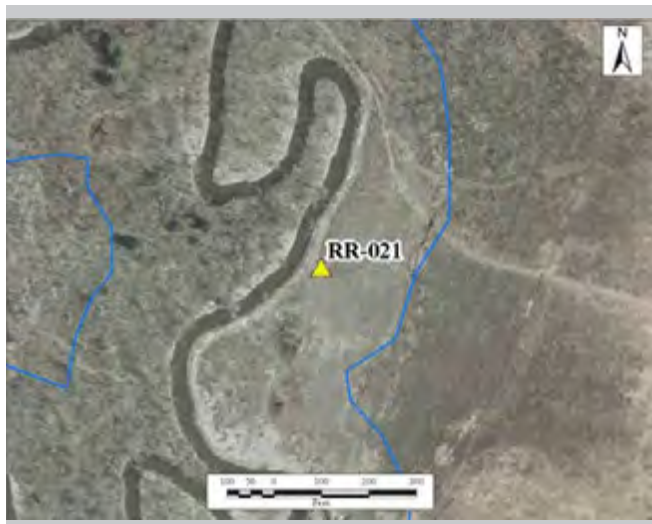
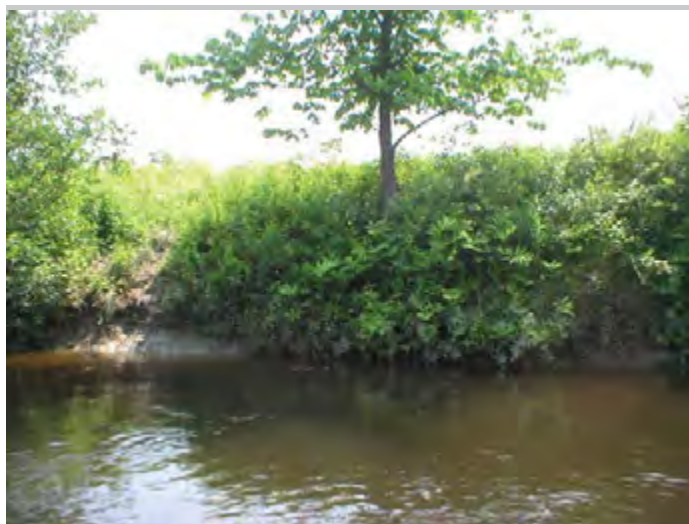
Narrow buffer (10 feet) of herbs, shrubs, and few trees, then open field. Bank slopes are steep, ranging from approximately 50 to 70%.

Sources of Degradation (13 possible): Land cleared

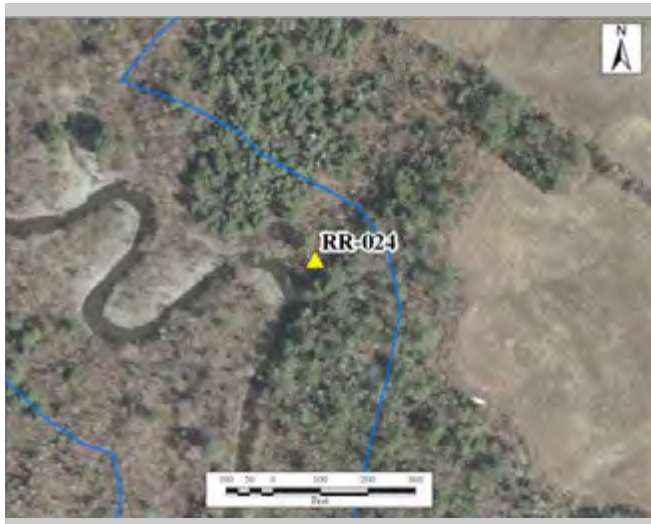
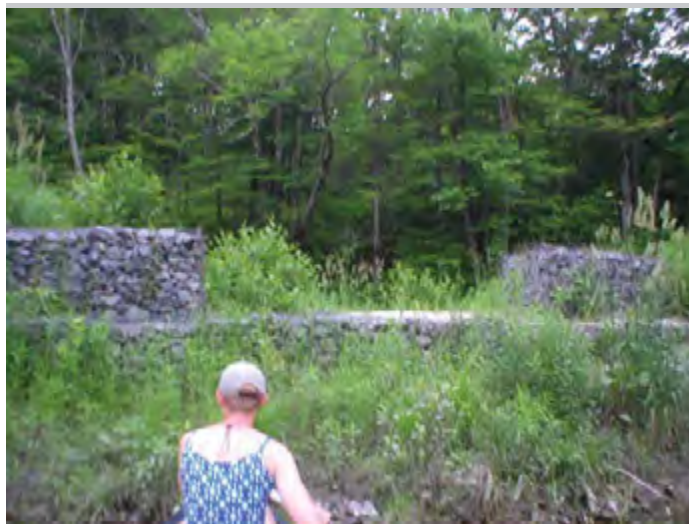
Wire rock bundles forming retaining wall (20-feet long by 2-feet wide). Cement holding tank behind wall (unknown purpose).

Sources of Degradation (13 possible): Rip-rap (or other artificial hard structure)
