**HABITAT RESTORATION INVENTORY
SUMMARY REPORT
FOR THE
ROYAL RIVER, SPRUCE CREEK, AND LOWER KENNEBEC
RIVER ESTUARY
VOLUME I**

DECEMBER 2005

**Prepared by: Northern Ecological Associates, Inc.
451 Presumpscot Street
Portland, Maine 04103**

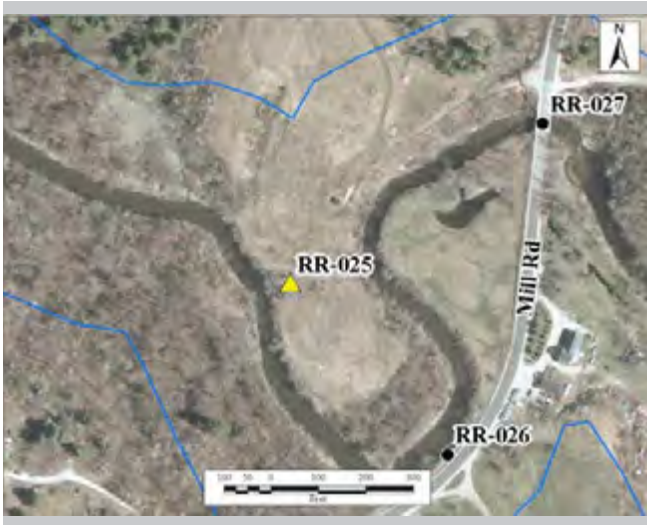
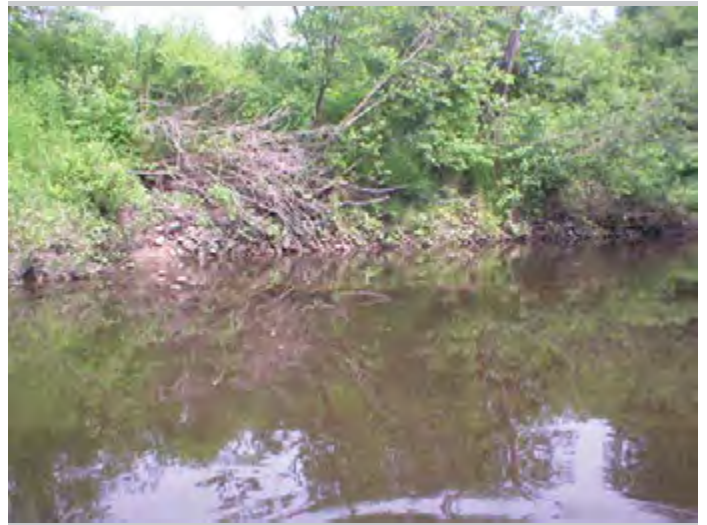
Narrow buffer (approximately 10 feet) of herbs and shrubs, few trees. Brick fill and trash/debris used to stabilize banks. Steep slopes about 10 feet high.

Sources of Degradation (13 possible): Fill/debris/trash, Rip-rap (or other artificial hard structure)

Total Degradation Score (higher score indicates a higher level of degradation): 1.70

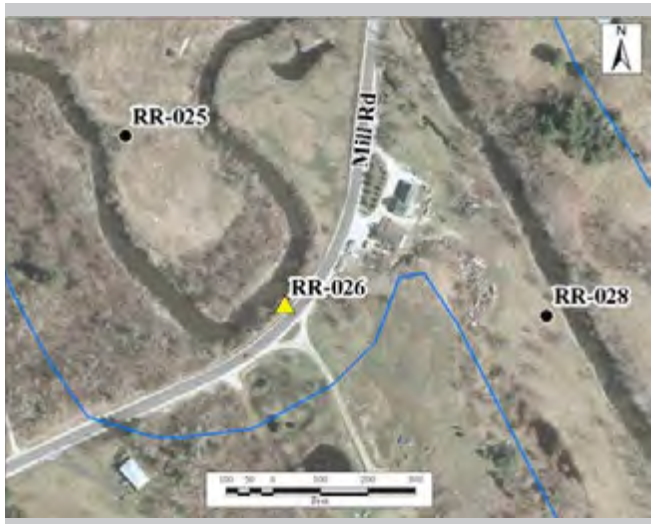
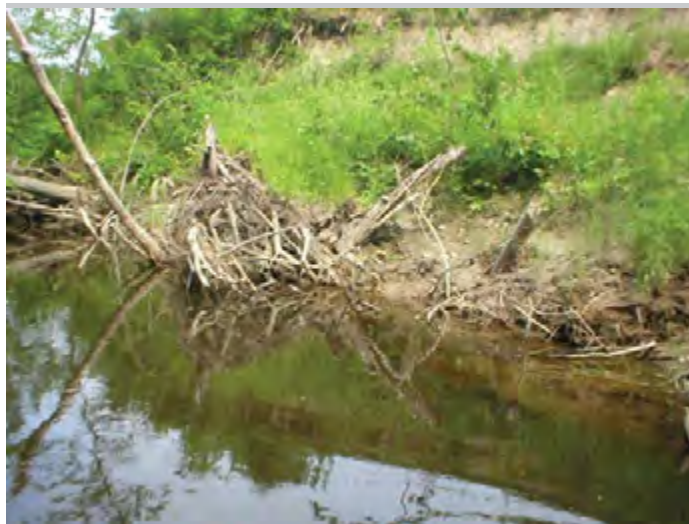
Mill Road runs adjacent to river. Banks are high (~ 20-feet), steep (~ 75%), eroding, slumping, and have bare ground areas.

Sources of Degradation (13 possible): Impervious surface, Land use activity a potential contaminant source, Right-of-way (highway, utility, railroad), Unstable bank

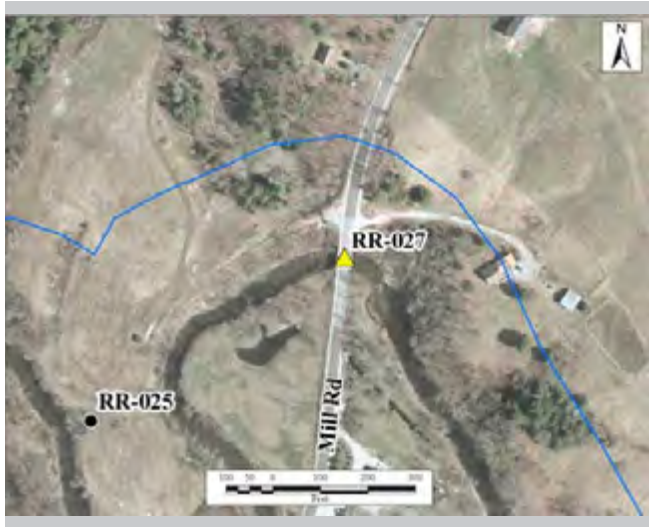
Mill Road bridge crossing. Most of buffer intact, comprised of herbs, shrubs, and trees. Some signs of erosion associated with mowed lawn to the south side of river / west of bridge.

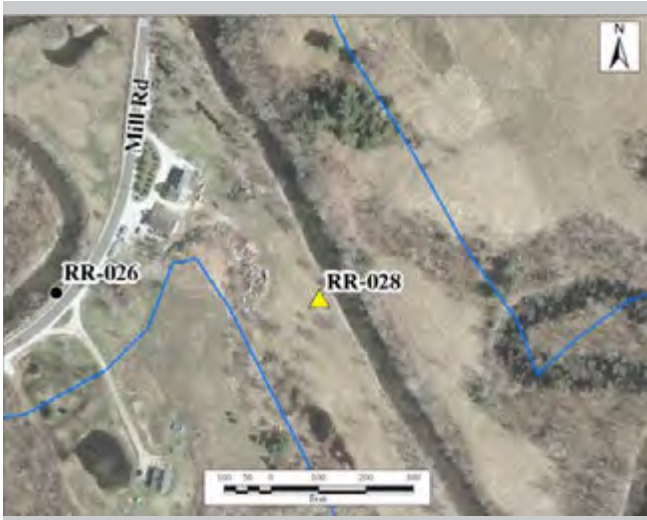
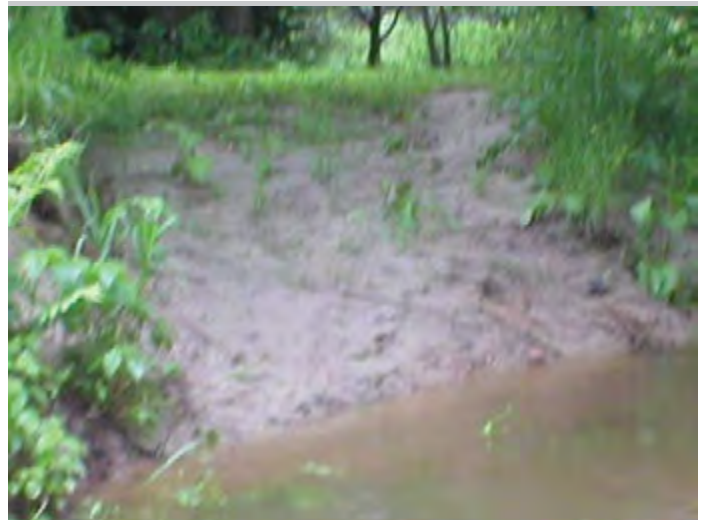
Narrow buffer of herbs, with few shrubs or trees, then mowed field. Access point to river is mowed lawn with dirt access road. Most of banks have steep slopes, with substantial erosion in places. Rubber hose leads from parcel into river. Some yard debris, erosion, and bare ground areas.

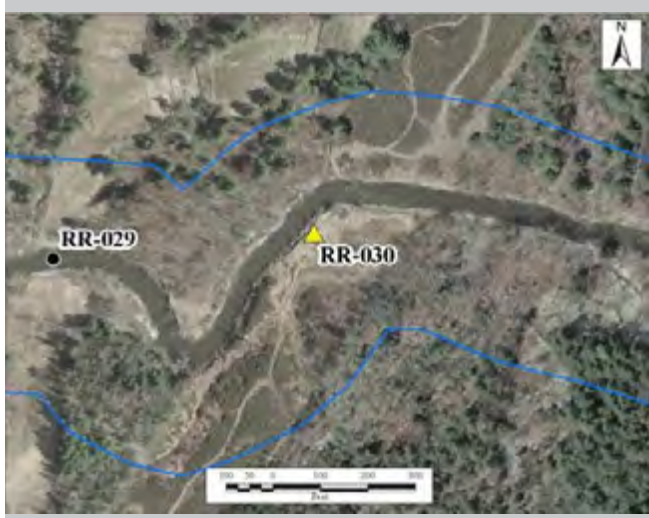
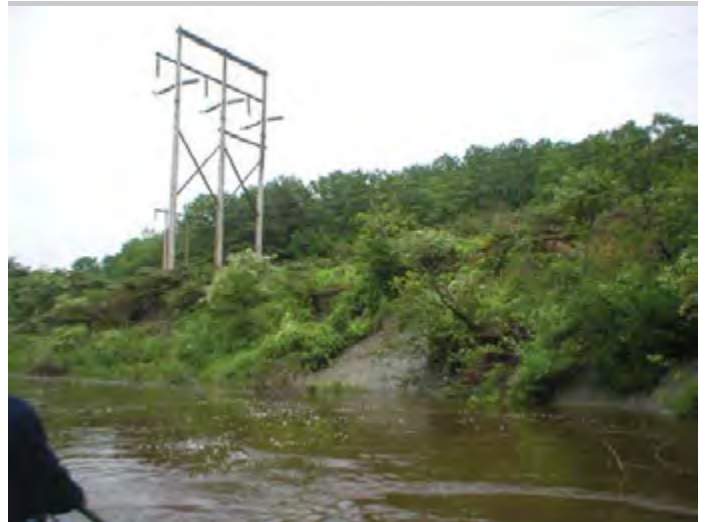
Powerline right-of-way. Buffer is comprised of herbaceous vegetation with some shrubs. Active major and minor erosion, which is impacting a power line structure in one area.

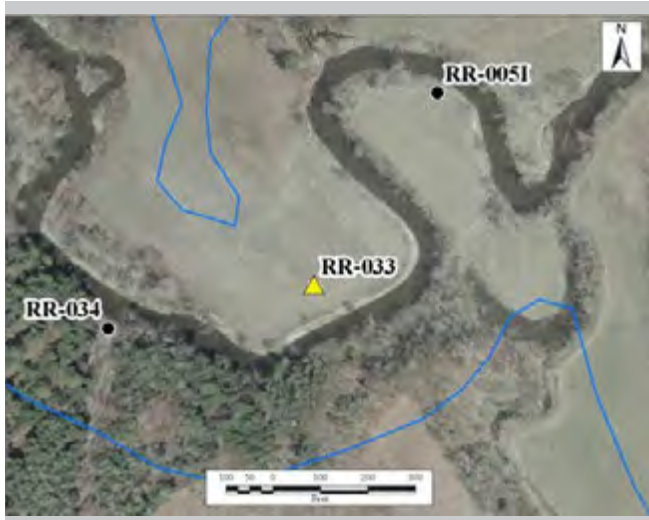
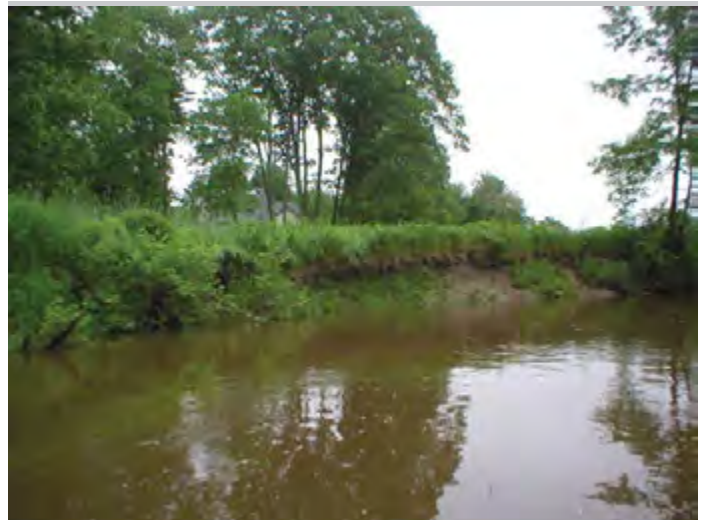
Mowed fields with narrow buffer (0-20 ft) of herbs, shrubs, and scattered trees to top of slope, then buffer widths varier. Some signs of erosion of slopes/banks, banks 10-15 feet with slope of 45 degrees. Some erosion causing over-hanging banks.

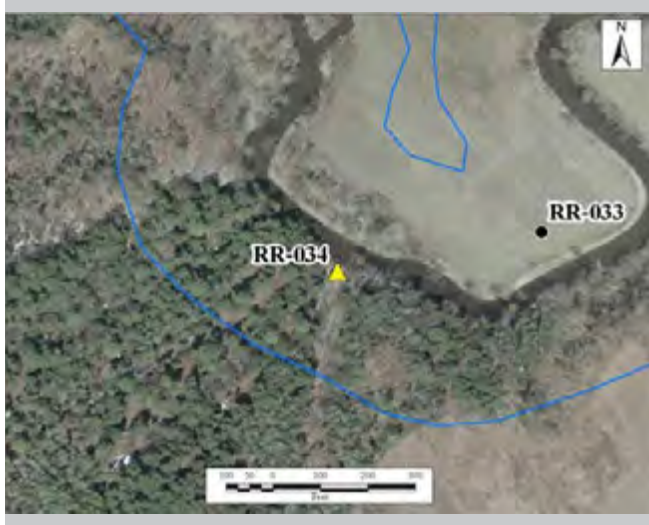
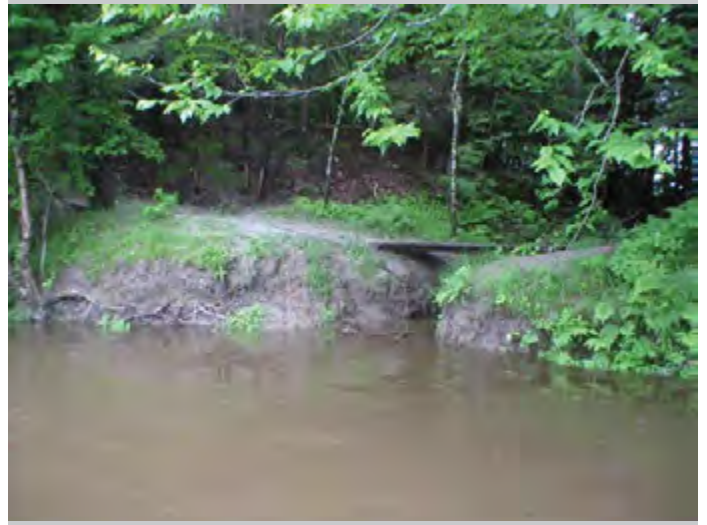
Walking trail has created erosion problem. Trail is too close to river.

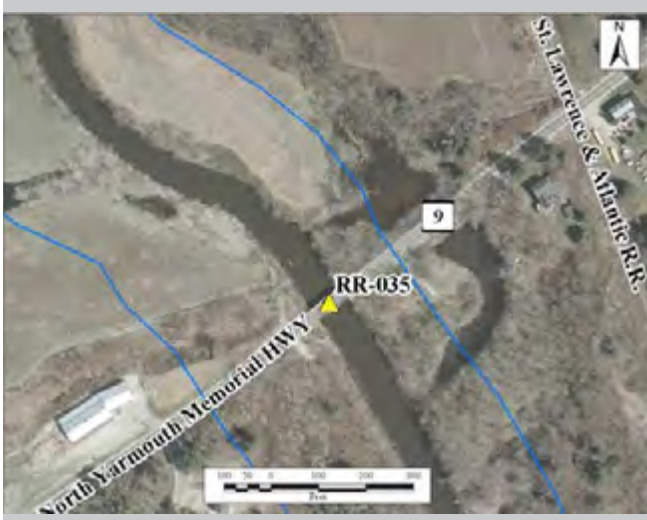
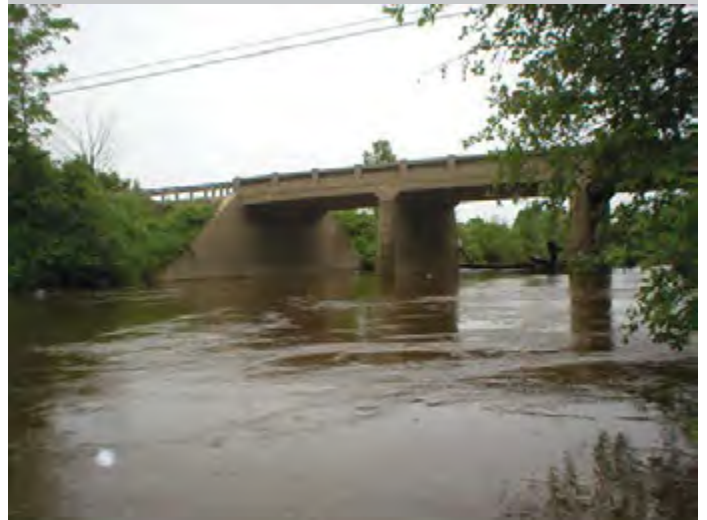
North Yarmouth Memorial Highway road crossing. Hardened cement bridge base and 2 supports. Floating logs and debris have formed a blockage on one side of bridge.

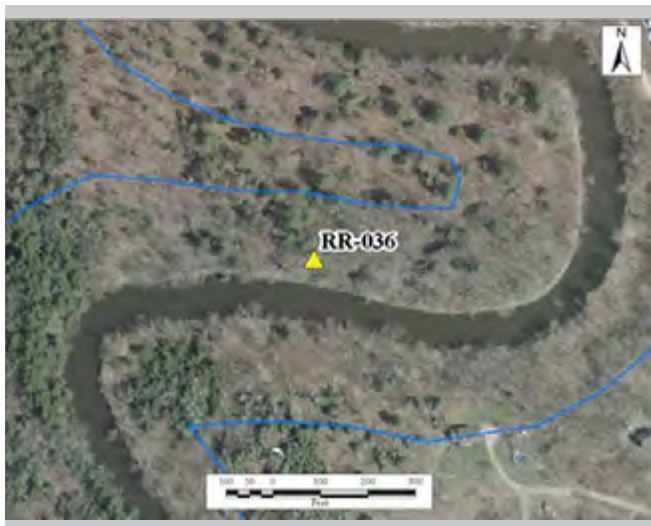
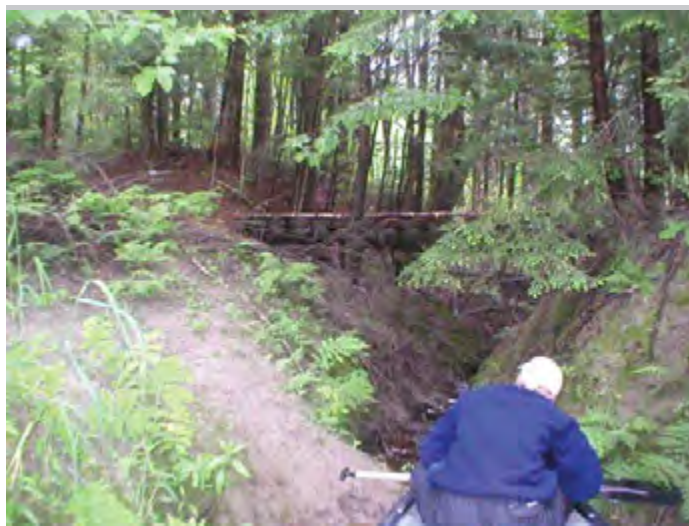
Old trail is a minor source of erosion due to unstable banks. Bridge crossing intermittent stream has eroding banks. Steep slopes >45 degrees are bare in many places.

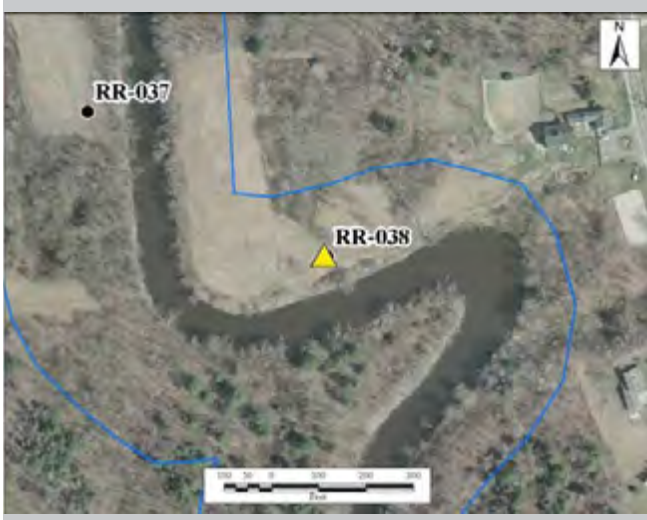
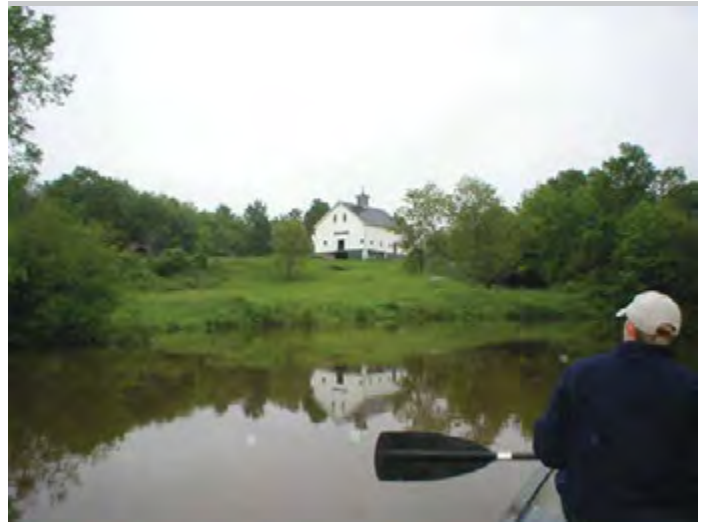
Narrow buffer (0-25 feet), then agricultural fields. Field grasses, not open filled fields.

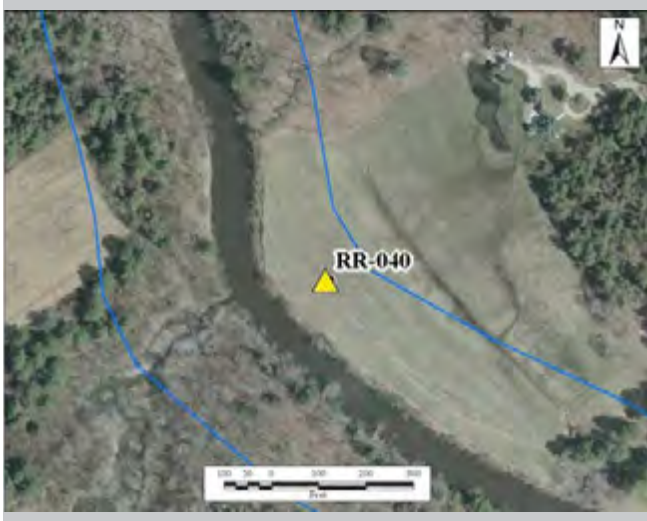
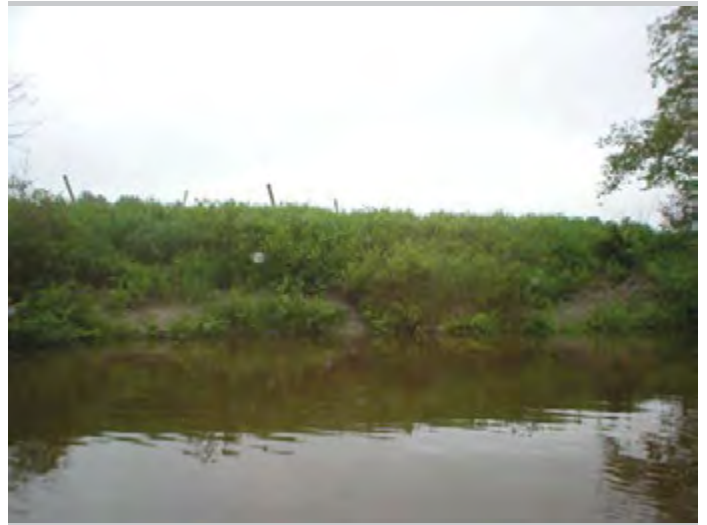
Narrow buffer (15-20 feet) vegetated with herbs, shrubs and trees to top of bank (approximately 15 - 20 feet high). Then agriculture field begins.

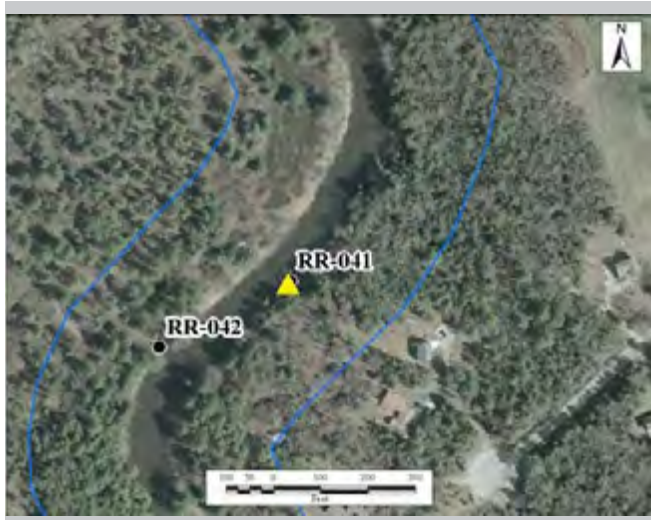
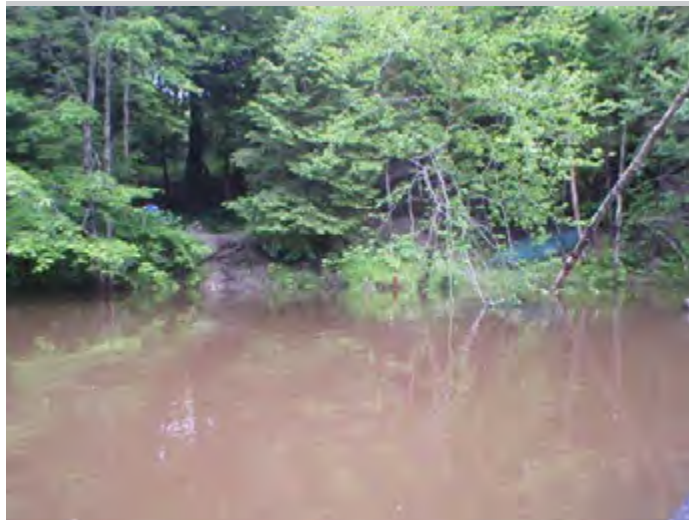
Campsite and canoe access point. Bank erosion evident next to fire pit, some bare ground. Chairs and canoe impeding on plant growth.

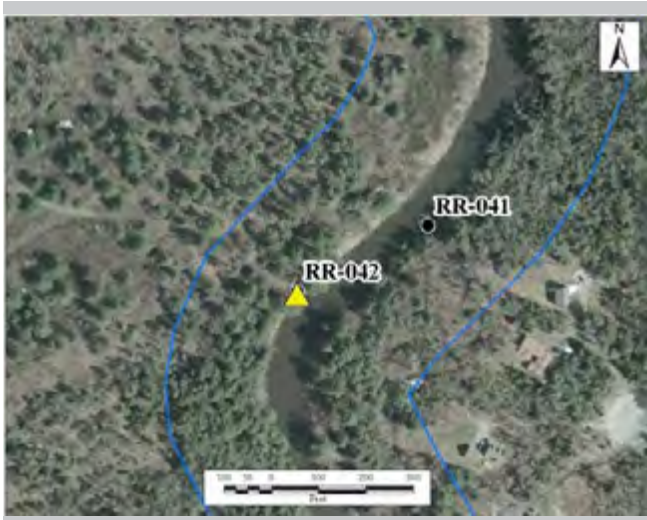
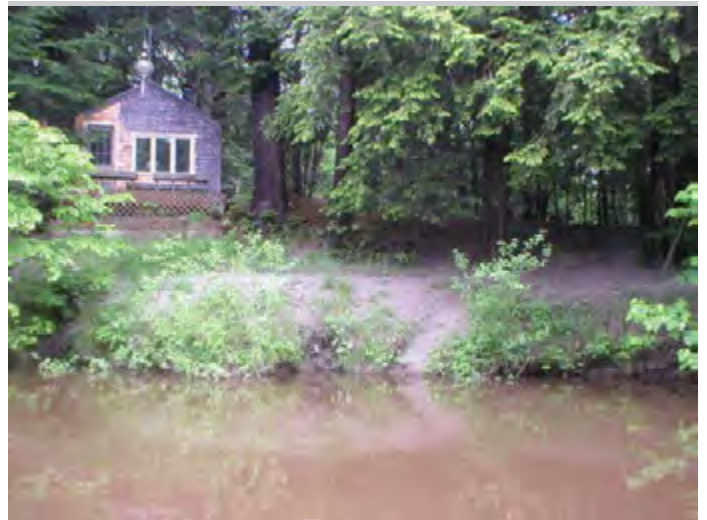
Small cottage with deck built on top of banks. Signs of erosion of banks in front and upstream of cottage probably from foot traffic. Slopes steep (75 degrees), and not well vegetated (herbs and few shrubs). Hemlock overstory with mosses and low, sparse herbs. Downstream are rope swings with bare ground underneath, potential erosion source.

Sources of Degradation (13 possible): Unstable bank

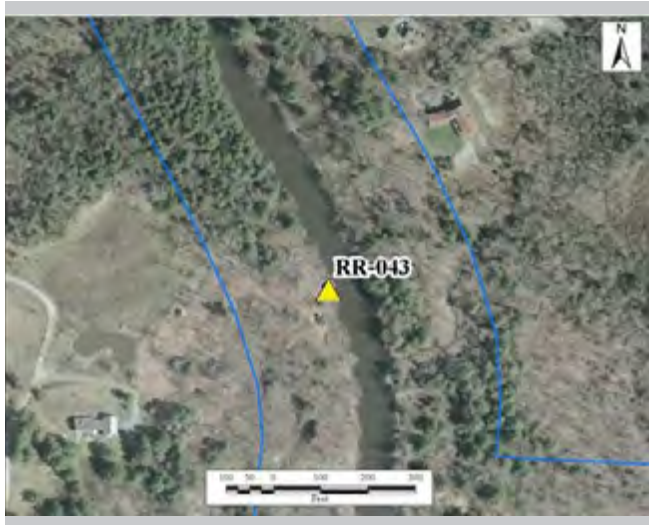
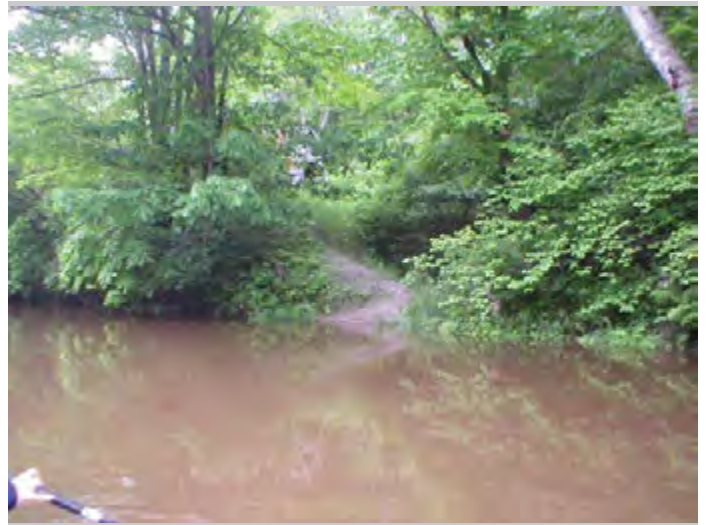
Eroding bank (approximately 25 feet wide) associated with access to river from old, apparently unused shack. Buffer intact with herbs, shrubs and trees.

Sources of Degradation (13 possible): Unstable bank

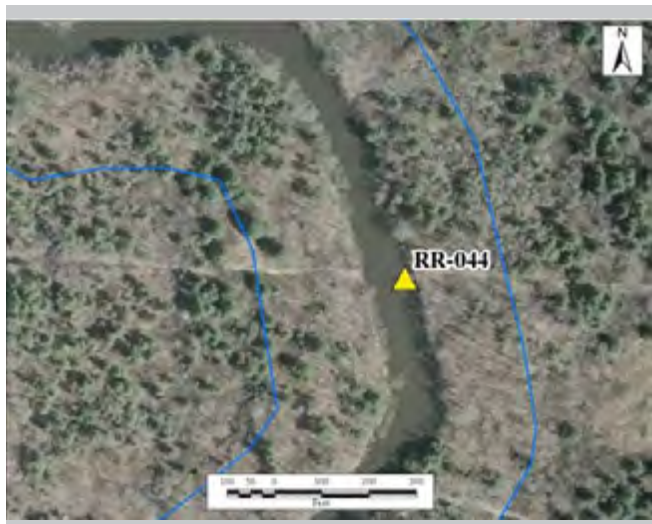
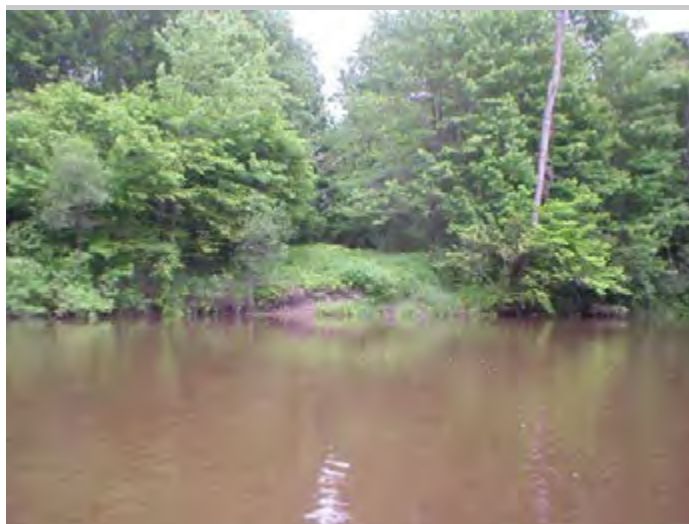
Water line right-of-way, Caldwell Boston water marker. Some bare ground, minor erosion occurring on both sides of river. Steep slopes (>45 deg) with herbaceous cover.

Sources of Degradation (13 possible): Right-of-way (highway, utility, railroad), Unstable bank

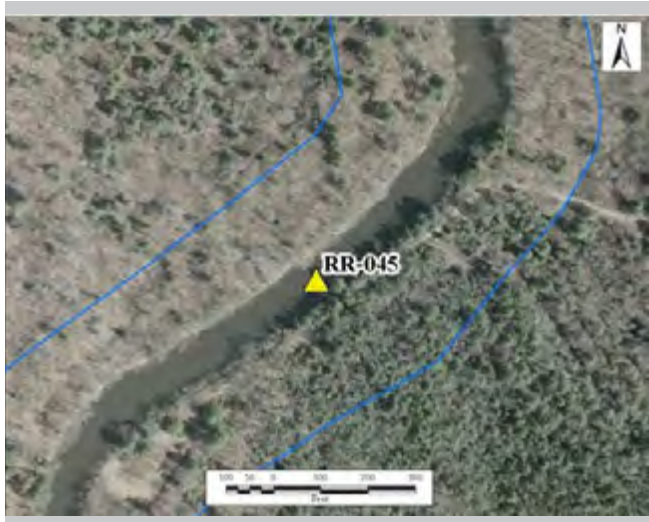
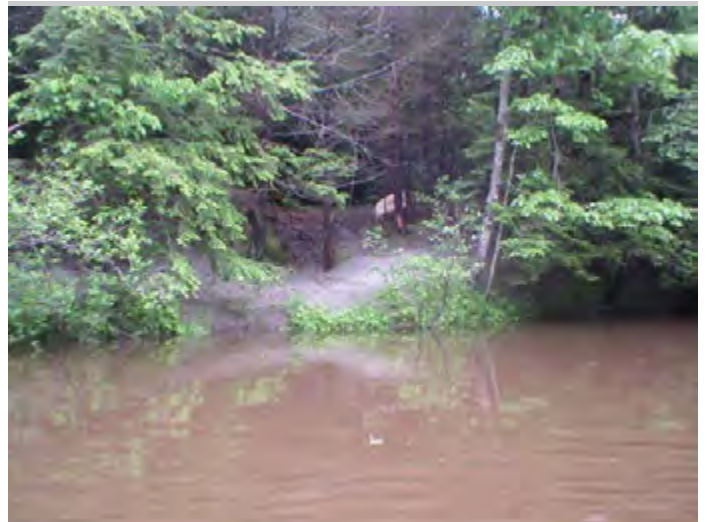
Appears to be an old canoe access point (approx 25 feet wide). Bare sandy soils, with some erosion potential.

Sources of Degradation (13 possible): Unstable bank

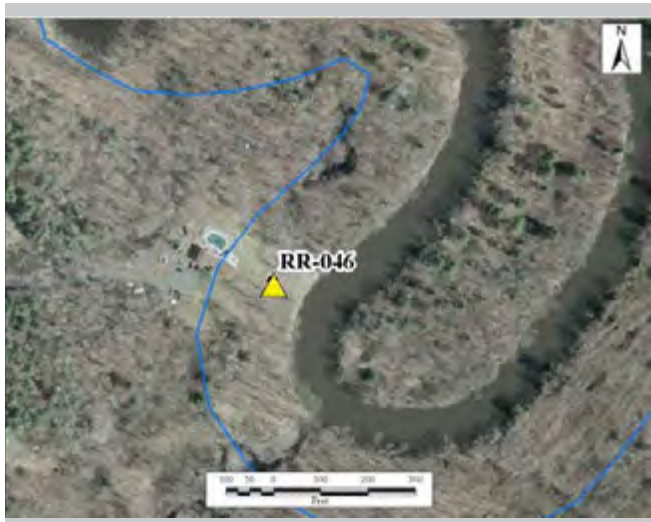
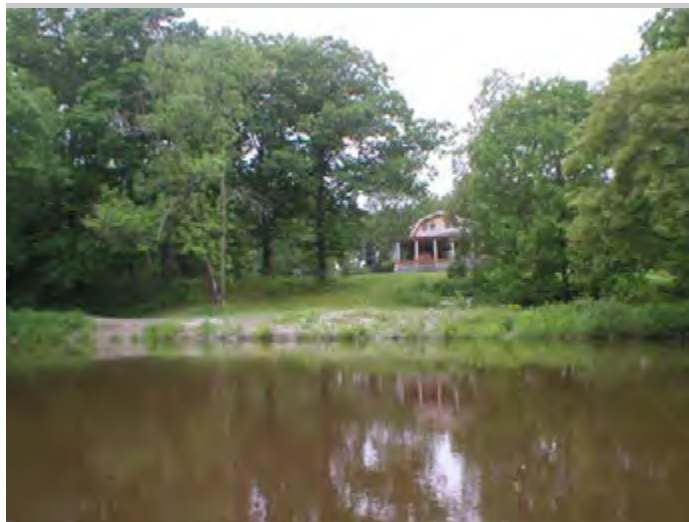
No real buffer; one of the worst residential sites. Mowed lawn to top of bank, some bare ground on bank and sparse herbs. Bank not steep 2 feet high, then sloping upwards towards house. All mowed.

Sources of Degradation (13 possible): Land cleared, Unstable bank

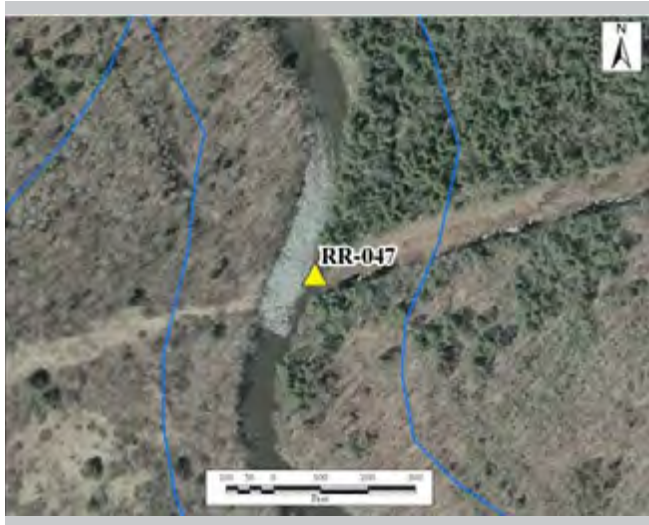
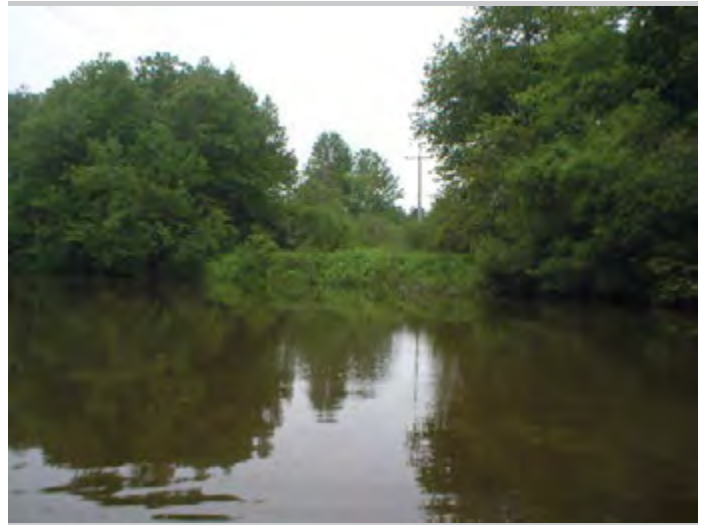
Powerline right-of-way. Maintained with herb and shrub cover. Few shrubs on west bank; some bare ground with minor erosion potential.

Sources of Degradation (13 possible): Right-of-way (highway, utility, railroad)

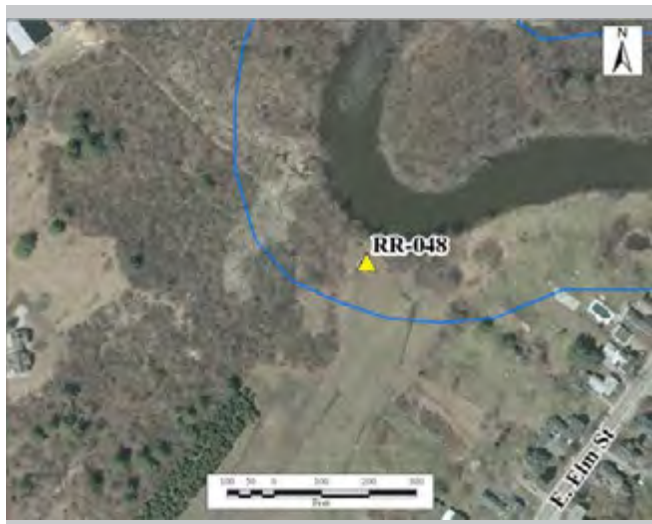
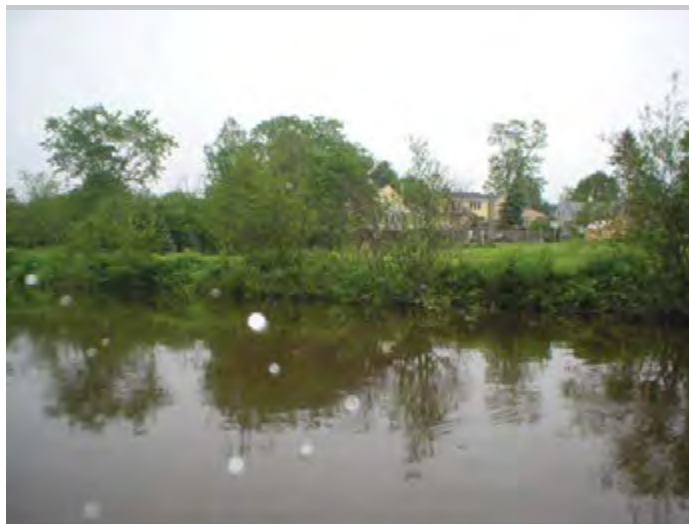
Narrow buffer (approx 5 feet) comprised of shrubs and herbs or only herbs, then mowed lawn. Some bare ground with minor erosion potential.

Sources of Degradation (13 possible): Land cleared, Unstable bank

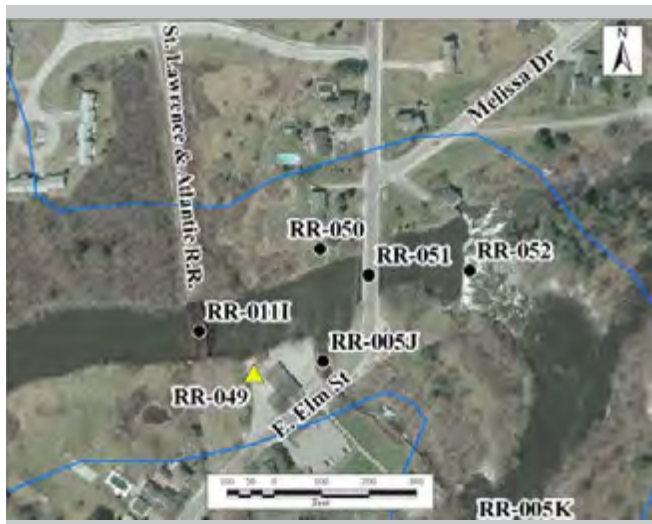
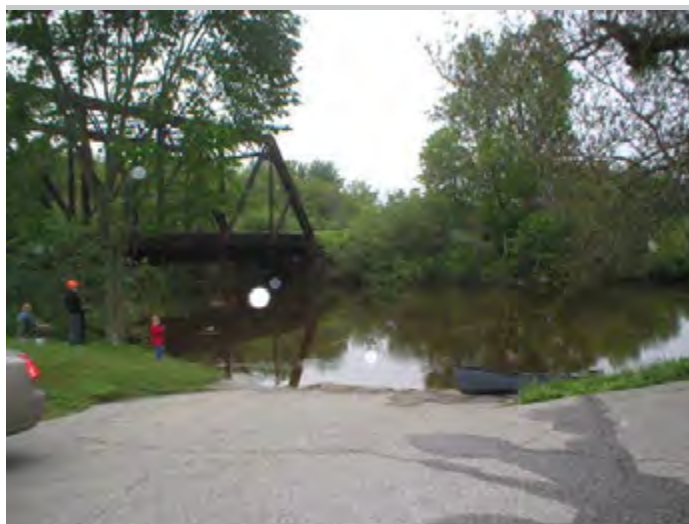
Boat launch at Yarmouth Water District. No real buffer, mowed lawn to top of bank. Hardined shoreline. Lots of sand on asphalt parking lot may wash into river.

Sources of Degradation (13 possible): Fill/debris/trash, Impervious surface, Land cleared, Land use activity a potential contaminant source

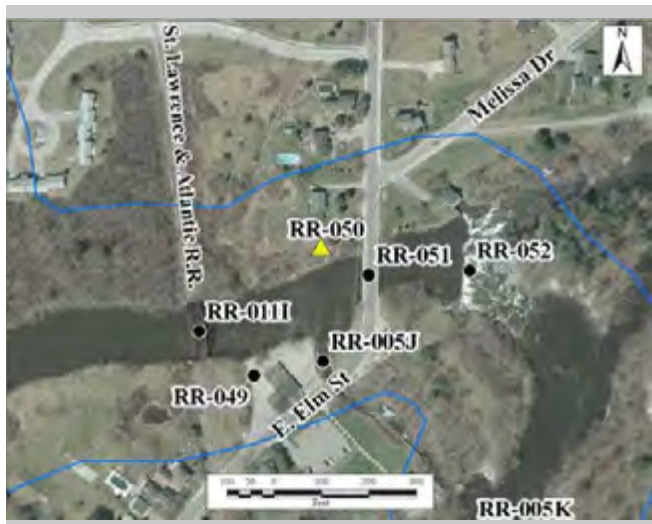
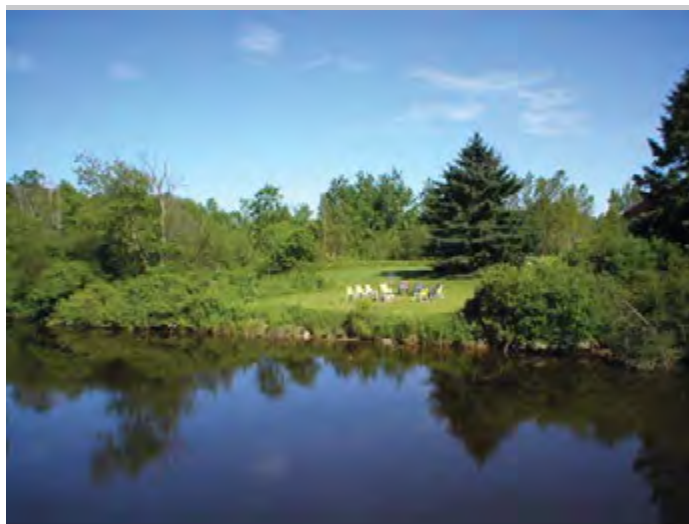
Narrow buffer (6 feet) of herbs and low shrubs, then mowed lawn.

Sources of Degradation (13 possible): Land cleared

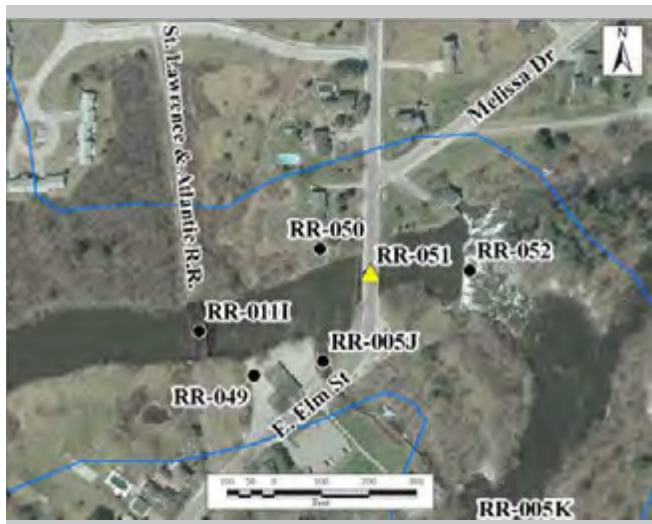
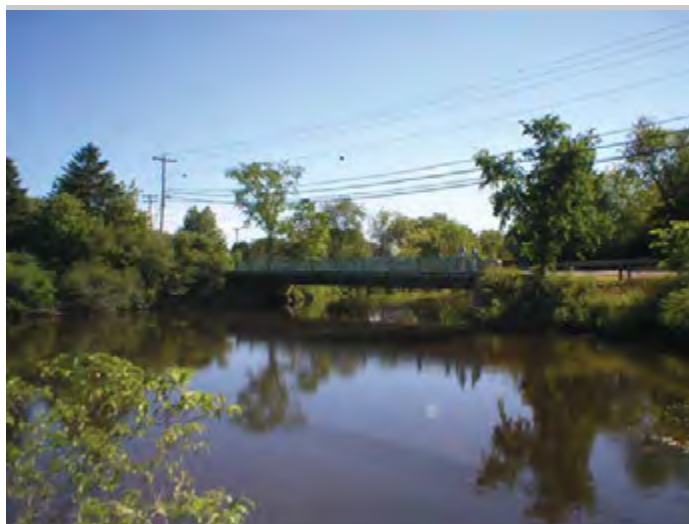
East Elm St bridge. Concrete on rock ledge and concrete footings, with riprap banks. Slight constriction of river. Buffer, where present, is comprised of shrubs and herbs. Road containments reach river directly via openings in roadway at sides of bridge.

Sources of Degradation (13 possible): Impervious surface, Land use activity a potential contaminant source, Rip-rap (or other artificial hard structure)

Bridge looks like it may be due to be replaced - rebar is exposed in many places.

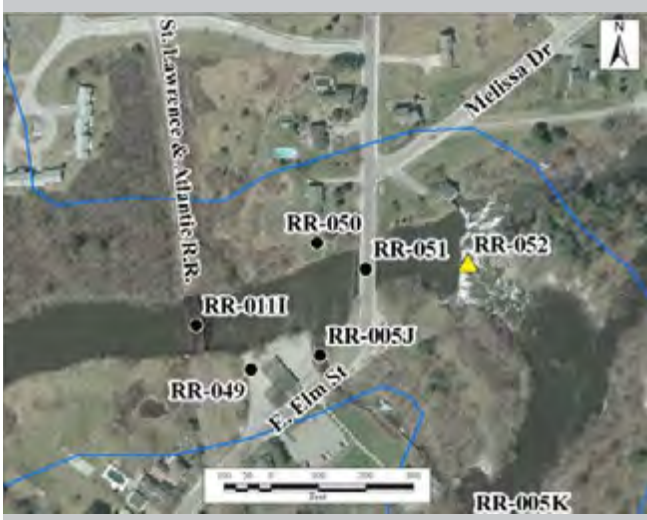
Dam near East Elm St, adjacent to Yarmouth Town Park. Buffer of herbs, shrubs, trees. Fish ladder intact, but tree limbs may be blocking lower entrance and debris is accumulated at top of fish ladder, and may impede fish passage.

Sources of Degradation (13 possible): Dam/obstruction, Fill/debris/trash, Impervious surface, Land cleared

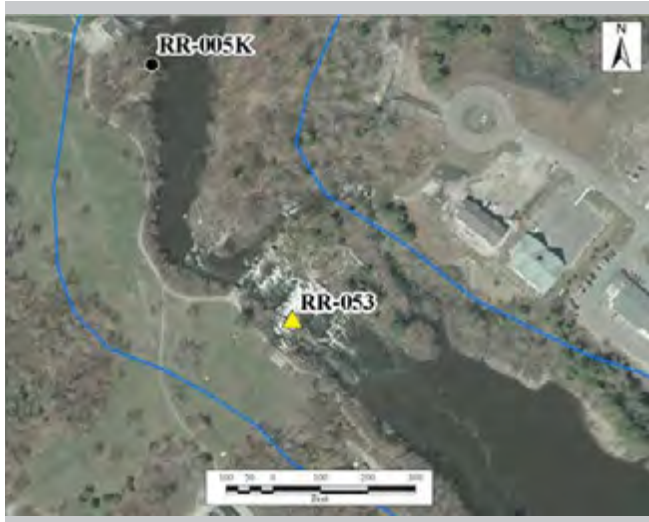
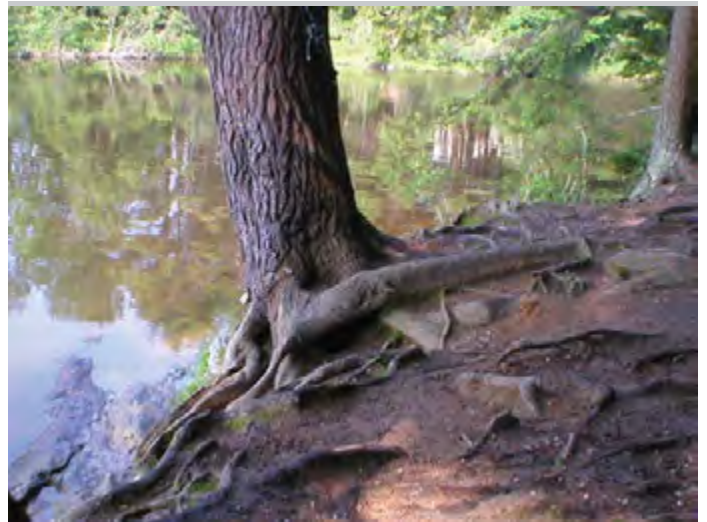
Royal River Park. Rip-rap hardened shoreline, culverts with ranges of erosion. Narrow buffer but high quality, mowed lawns. Erosion on several walkways near river. Historic mill structures. Japanese knotweed patches.

Sources of Degradation (13 possible): Culvert issue, Invasive plant species, Land cleared, Land use activity a potential contaminant source, Rip-rap (or other artificial hard structure), Unstable bank

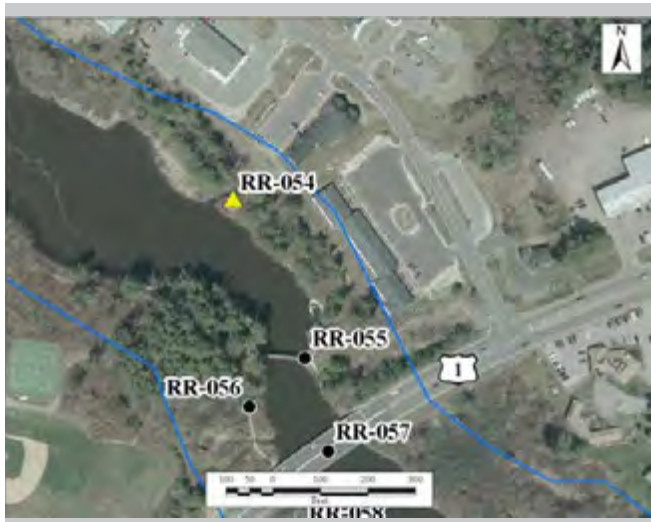
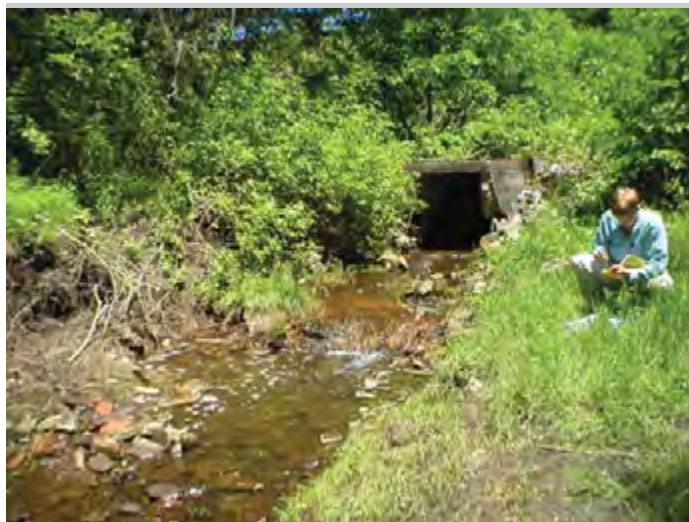
Box culvert that drains catch basins from parking lots at commercial/business complex. Note soap suds in water. Eroding banks, likely scoured during high velocity flow through culvert. Fill/debris present in channel.

Sources of Degradation (13 possible): Culvert issue, Fill/debris/trash, Unstable bank

Dumpster in parking lot leaking and staining asphalt, located near a catch basin above culvert of interest.

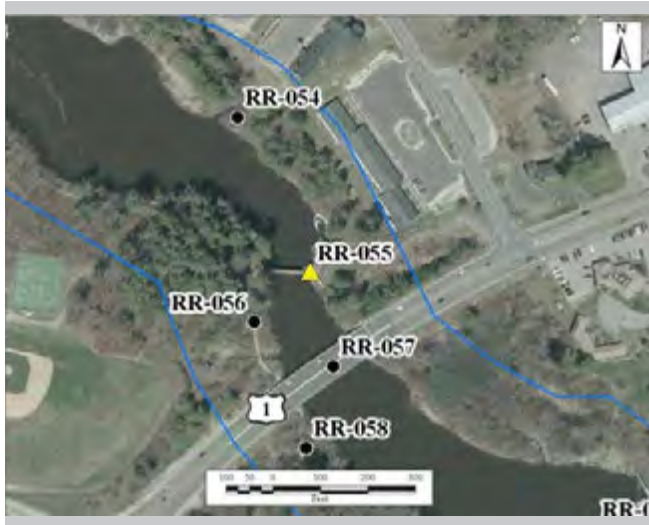
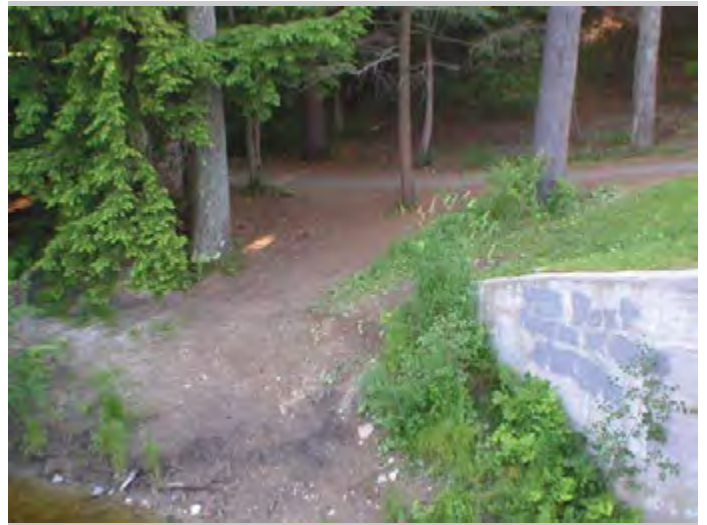
Foot bridge over Royal River. Not constricting. Banks lack solid vegetation layer, bare ground in places. Access point in southwest corner bare, potential erosion. Riprap swale next to bridge.

Sources of Degradation (13 possible): Land cleared, Rip-rap (or other artificial hard structure), Unstable bank

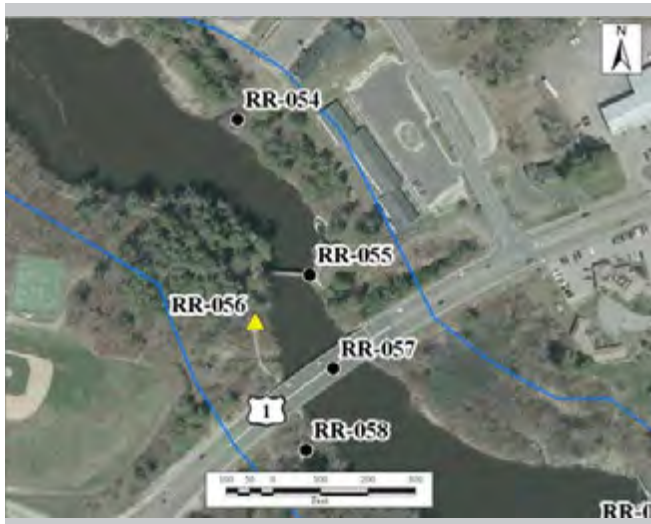
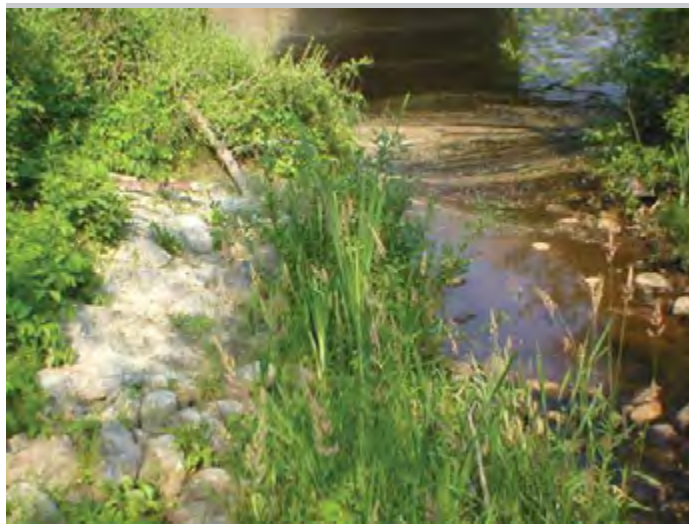
Large box culvert (4 x 4 feet) with in fenced enclosure; water of unknown origin. Water flow approximately 50 gallons/min. Filters over cobble/gravel, then under bridge and into river.

Sources of Degradation (13 possible): Culvert issue

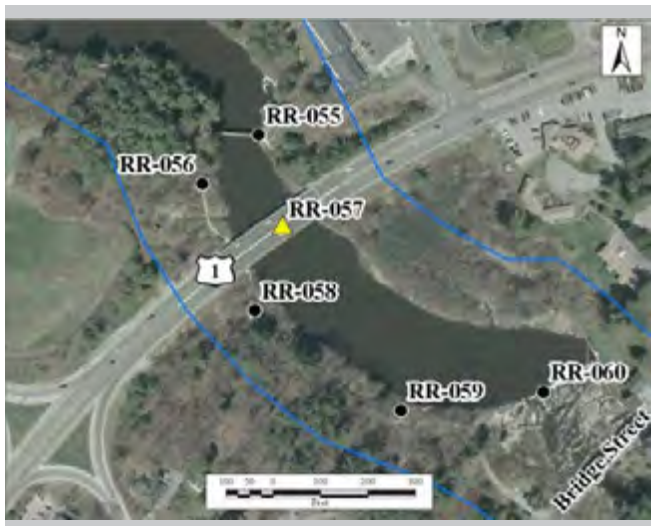
Route 1 bridge crossing. Not constricting flow. Banks stable, minimal erosion. Walking trail under bridge on southwest side has some minor erosion. Buffer of herbs, shrubs, and trees.

Sources of Degradation (13 possible): Land use activity a potential contaminant source, Right-of-way (highway, utility, railroad), Unstable bank

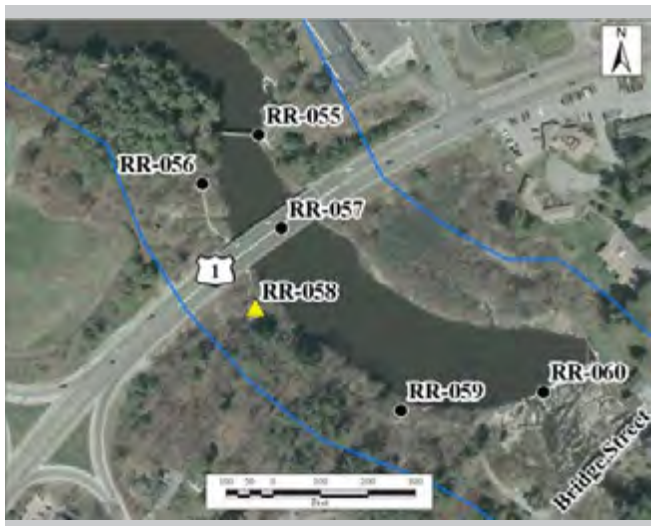
Iron leachate from unknown source. Runoff from direction of Route 1.

Sources of Degradation (13 possible): Land use activity a potential contaminant source,
Unknown

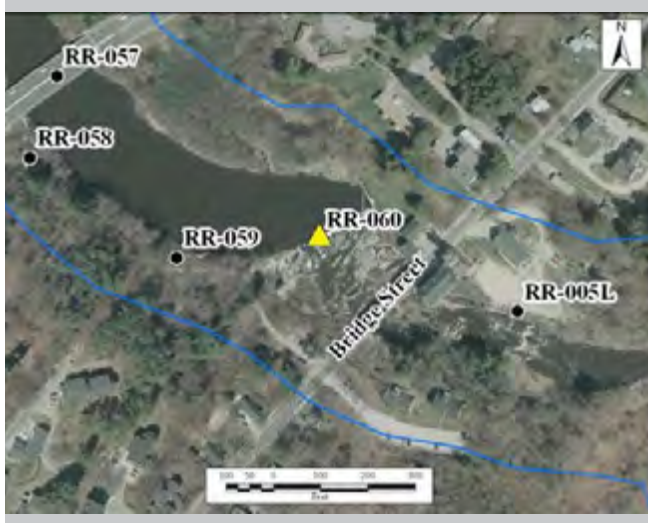
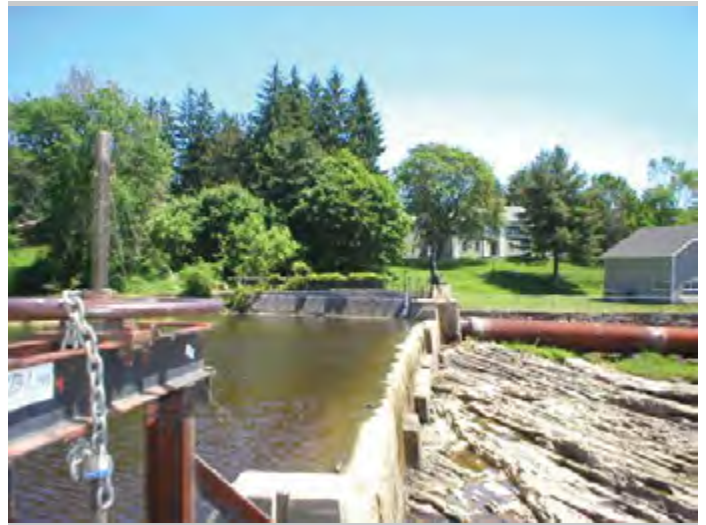
Sparhawk Mill dam with fish ladder. Cement dam with drainage pipe on east side, fish ladder on west side. Debris accumulated at top entrance to fish ladder. No water over dam currently, 8 foot drop to rock ledge. Sediment accumulated behind dam. Buffer of mowed lawn on east side.

Sources of Degradation (13 possible): Dam/obstruction, Land cleared, Land use activity a potential contaminant source, Rip-rap (or other artificial hard structure)

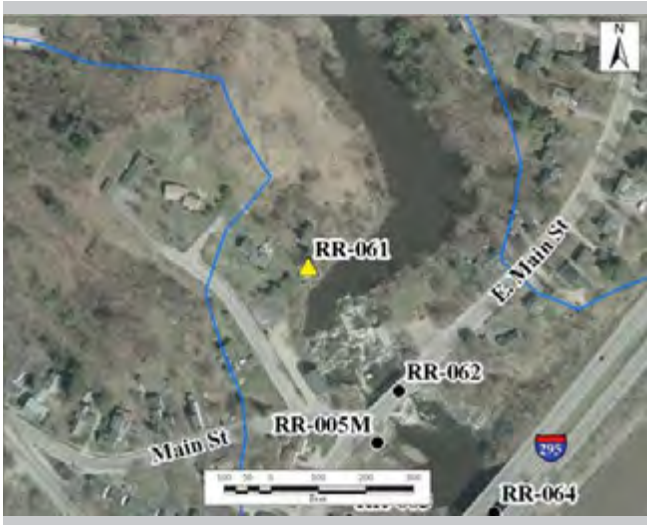
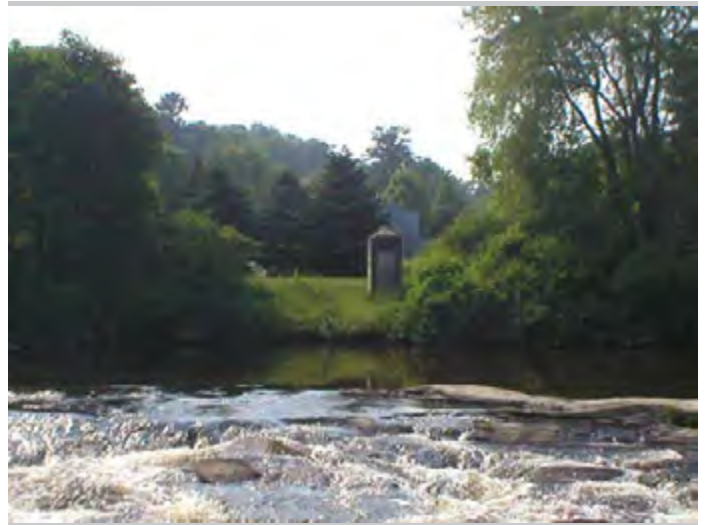
Buffer issue. Narrow, 12' wide mowed lawn section to edge of river.

Sources of Degradation (13 possible): Land cleared
