**HABITAT RESTORATION INVENTORY
SUMMARY REPORT
FOR THE
ROYAL RIVER, SPRUCE CREEK, AND LOWER KENNEBEC
RIVER ESTUARY
VOLUME I**

DECEMBER 2005

**Prepared by: Northern Ecological Associates, Inc.
451 Presumpscot Street
Portland, Maine 04103**

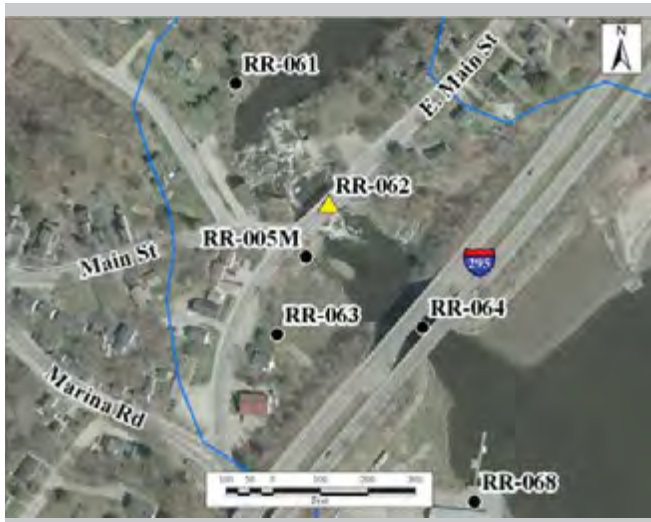
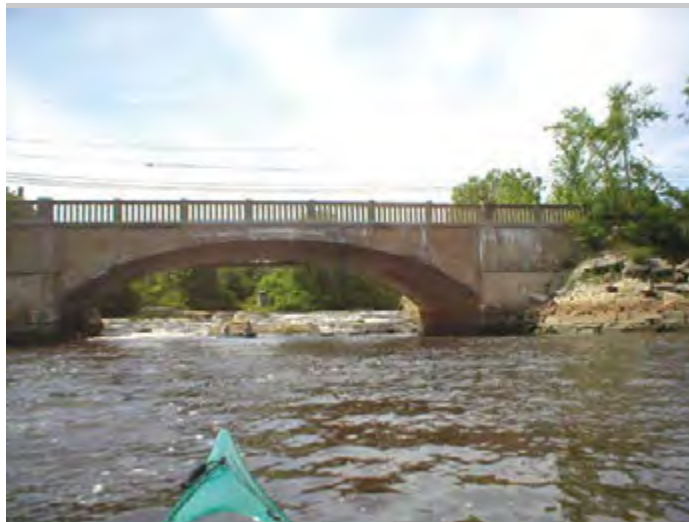
East Main St bridge. Old Grist Mill Site in buffer zone north of bridge, with some erosion issues. Riprap and cut, placed rock wall banks, cement bridge. Constriction of river. Some bare ground on banks on downstream sides, potential erosion. Culverts from road drain directly into river. Japanese knotweed along southeast bank.

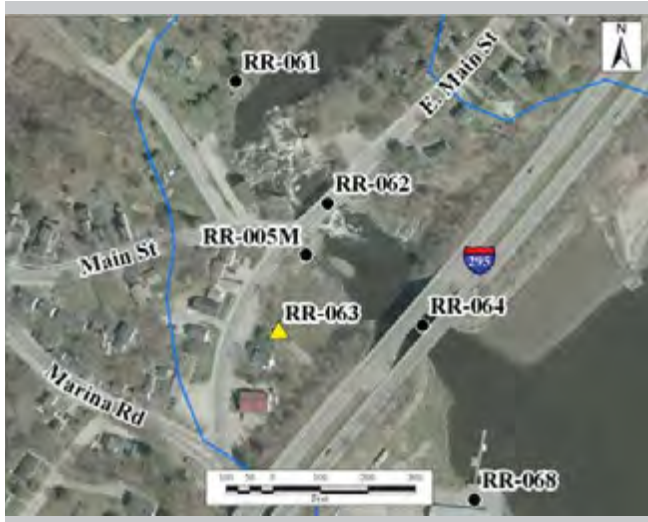
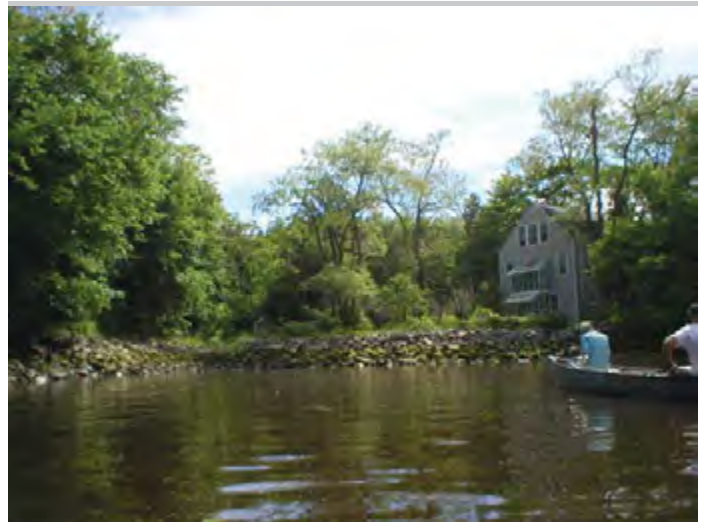
Lack of buffer. Hardened shoreline, with mowed lawn to edge of riprap, then cultivated shrubs and trees.

Sources of Degradation (13 possible): Land cleared, Rip-rap (or other artificial hard structure)

Total Degradation Score (higher score indicates a higher level of degradation): 1.35

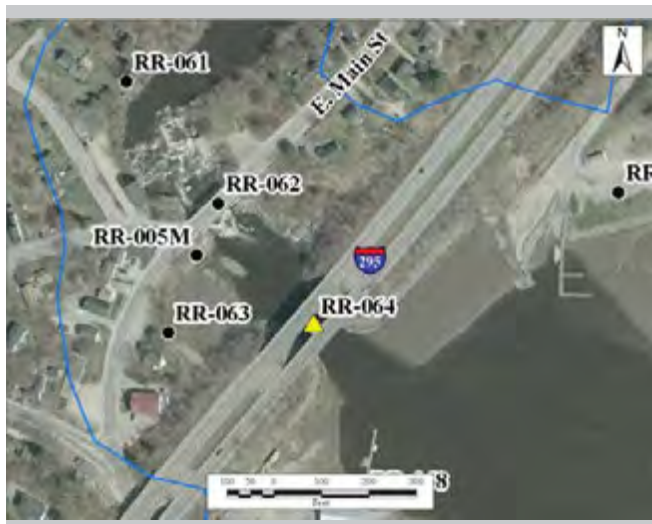
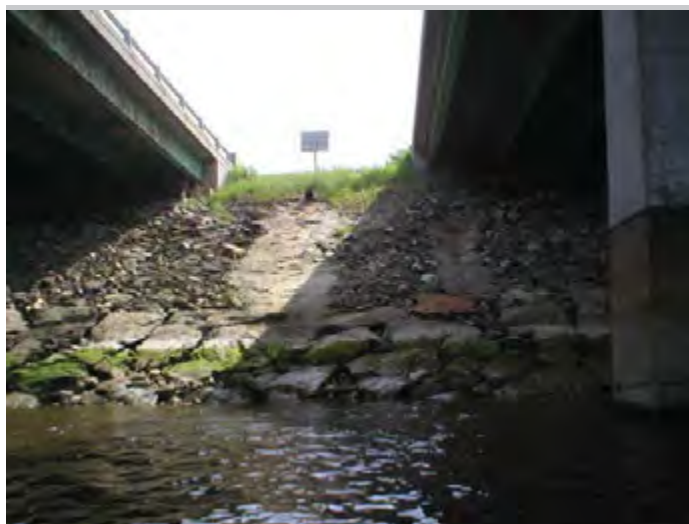
Route 95 bridge crossing. Riprap banks are stable, not eroding. Constriction of river. Vegetated with some herbs, shrubs, some trees. Culverts drain over steep, cement swale.

Sources of Degradation (13 possible): Culvert issue, Drainage issue, Impervious surface, Land use activity a potential contaminant source, Right-of-way (highway, utility, railroad), Rip-rap (or other artificial hard structure)

Total Degradation Score (higher score indicates a higher level of degradation): 3.90

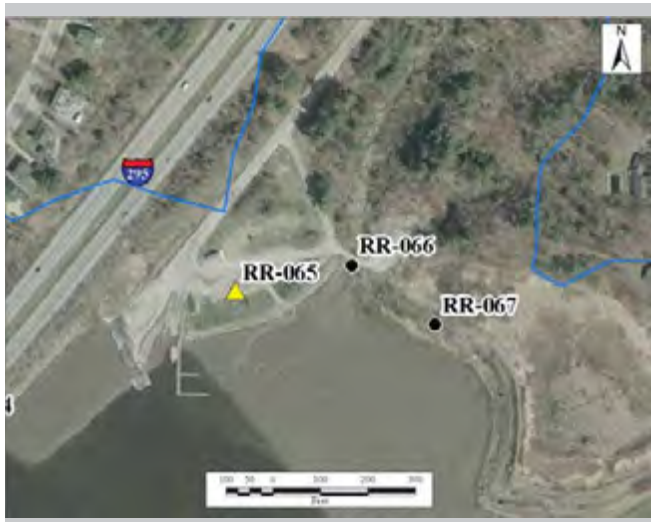
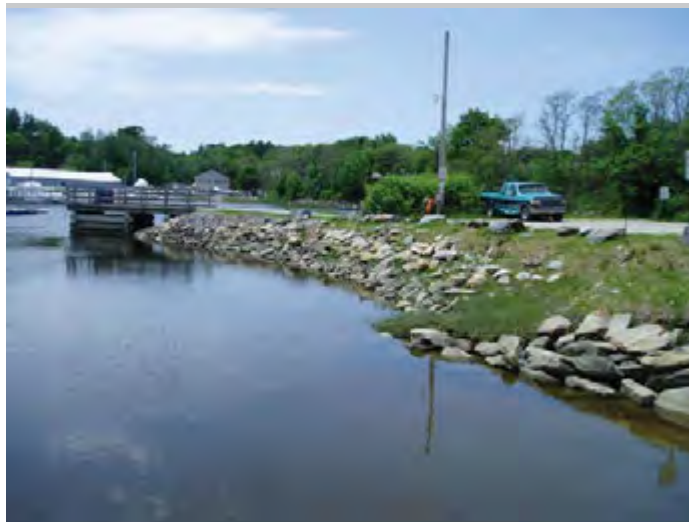
Yarmouth Public Boat Launch. Shoreline almost entirely riprap with some sparse vegetation, mowed lawn from top of slope. In places lawn is compromised by vehicle parking. Paved and gravel parking areas. Japanese knotweed. Active marina with docks.

Sources of Degradation (13 possible): Culvert issue, Dock/pier/jetty that extends out into channel, Impervious surface, Invasive plant species, Land cleared, Land use activity a potential contaminant source, Rip-rap (or other artificial hard structure), Unstable bank

Total Degradation Score (higher score indicates a higher level of degradation): 4.30

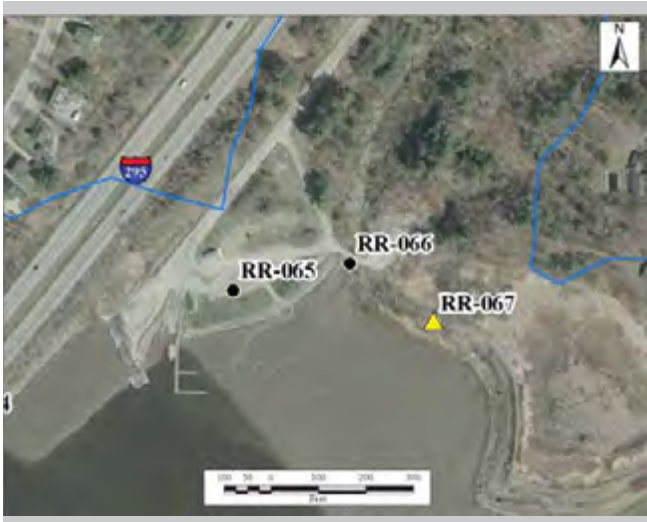
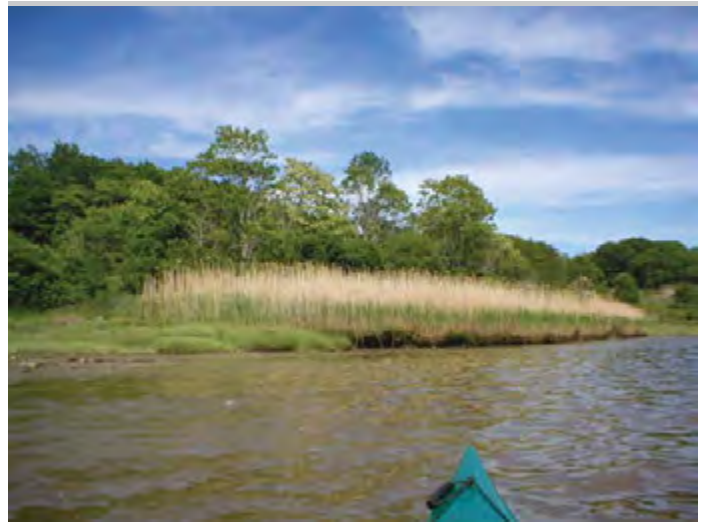
Phragmites stand, approximately 100 x 40 feet.

Sources of Degradation (13 possible): Invasive plant species

Total Degradation Score (higher score indicates a higher level of degradation): 0.90

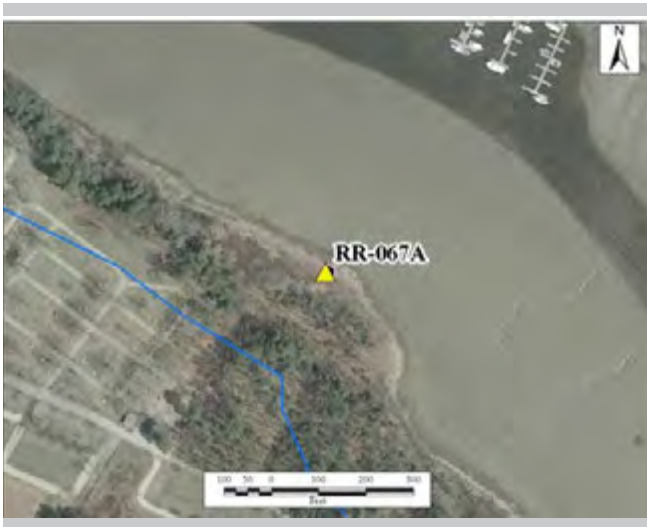
Two Phragmites stands in close proximity, approximately 150 x 30 feet and 60 x 12 feet.

Sources of Degradation (13 possible): Invasive plant species

Total Degradation Score (higher score indicates a higher level of degradation): 0.60

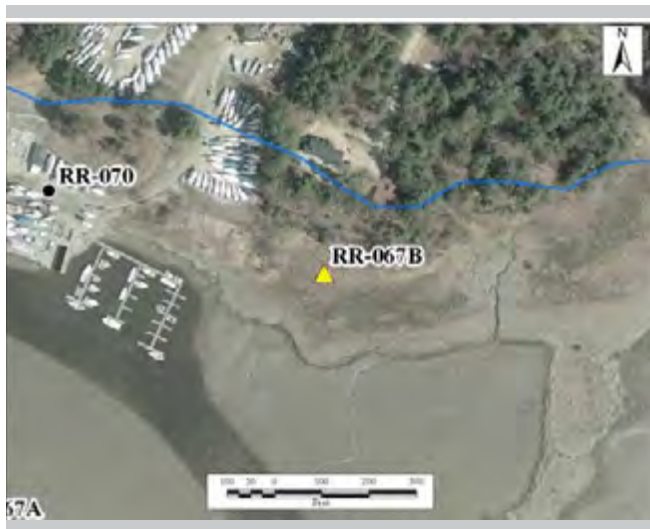
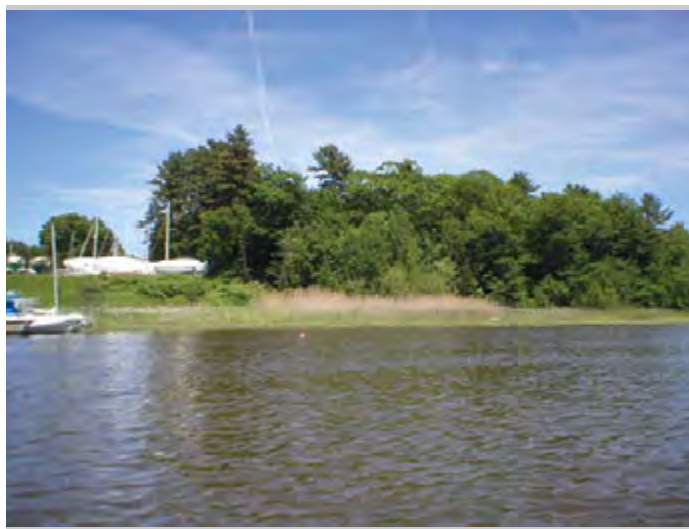
Phragmites stand, approximately 100 x 40 feet. Located adjacent to Royal River Boatyard Marina (RR-070).

Sources of Degradation (13 possible): Invasive plant species

Total Degradation Score (higher score indicates a higher level of degradation): 0.40

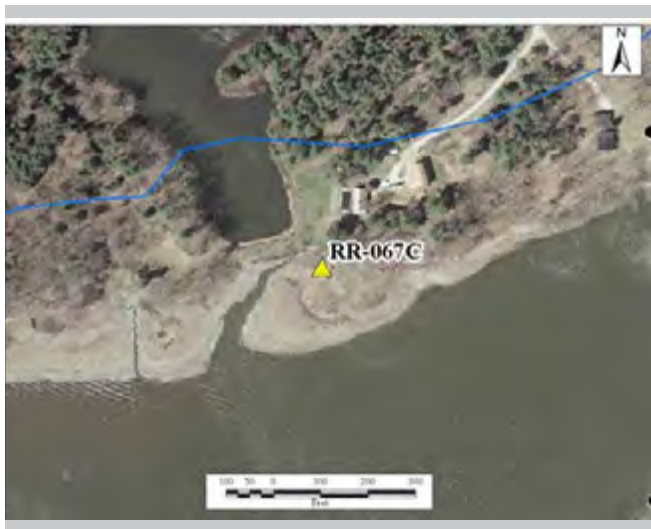
Three Phragmites stands in close proximity, approximately 30 x 50 feet, 40 x 40 feet and 30 x 80 feet.

Sources of Degradation (13 possible): Invasive plant species

Total Degradation Score (higher score indicates a higher level of degradation): 0.60

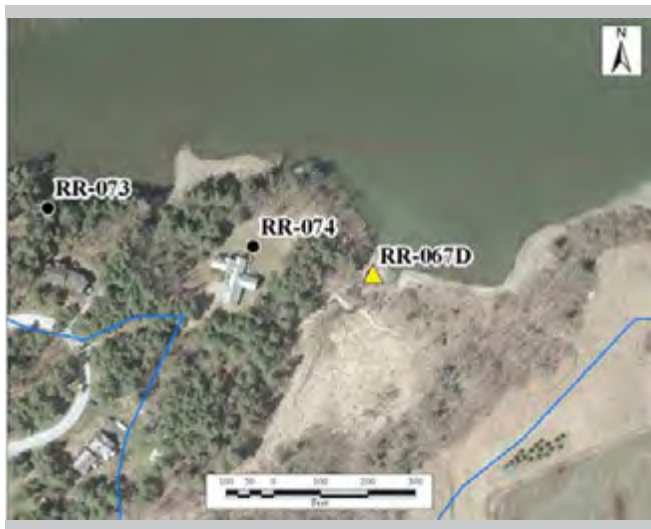
Phragmites stand approximately 15 x 50 feet. Old hay road with two corrugate metal culverts, set too high for tidal exchange and blocked with vegetation and silt. Behind hay road and Phrag is what appears to be a man-made berm with spotty patches of Phragmites (5-10% cover) across the area (approx. 500 x 200 feet).

Sources of Degradation (13 possible): Culvert issue, Drainage issue, Invasive plant species

Total Degradation Score (higher score indicates a higher level of degradation): 2.40

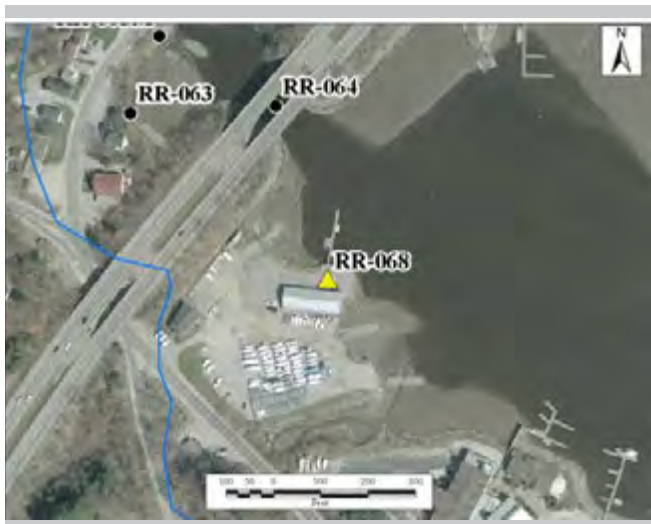
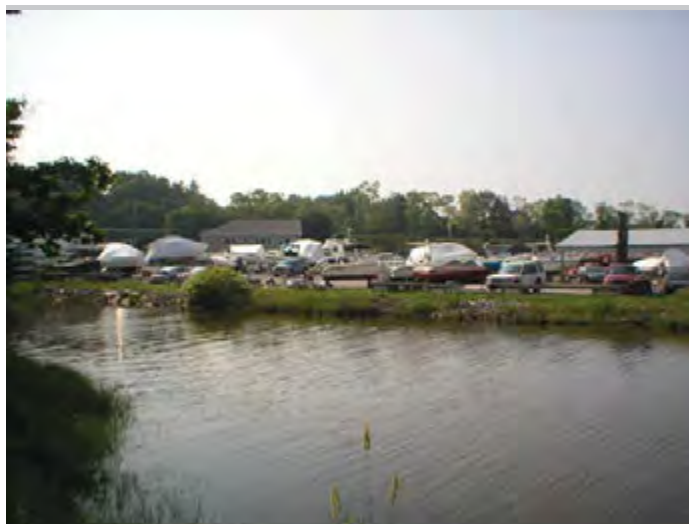
Yarmouth Marina and Boat Yard. Gravel parking areas. Docks with many boats. Parts of shoreline are riprap and parts vegetated with herbs. Some hardened shoreline (bulkhead). Shoreline appears stable, not eroding. Some paved areas.

Sources of Degradation (13 possible): Dock/pier/jetty that extends out into channel, Impervious surface, Land cleared, Land use activity a potential contaminant source, Rip-rap (or other artificial hard structure)

Total Degradation Score (higher score indicates a higher level of degradation): 3.95

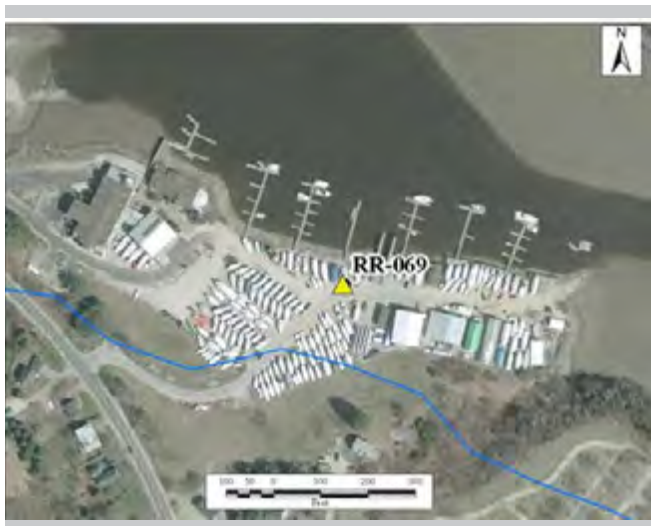
Lower Falls Landing Marina. Docks with lots of boats and moorings. Shoreline eroding in places, natural and riprap shorelines. Smell of gas and paint. Mowed lawn to top of bank. Then maintained herbs and scattered shrubs on shoreline where vegetation is present.

Sources of Degradation (13 possible): Dock/pier/jetty that extends out into channel, Fill/debris/trash, Impervious surface, Land cleared, Land use activity a potential contaminant source, Rip-rap (or other artificial hard structure), Unstable bank

Total Degradation Score (higher score indicates a higher level of degradation): 4.30

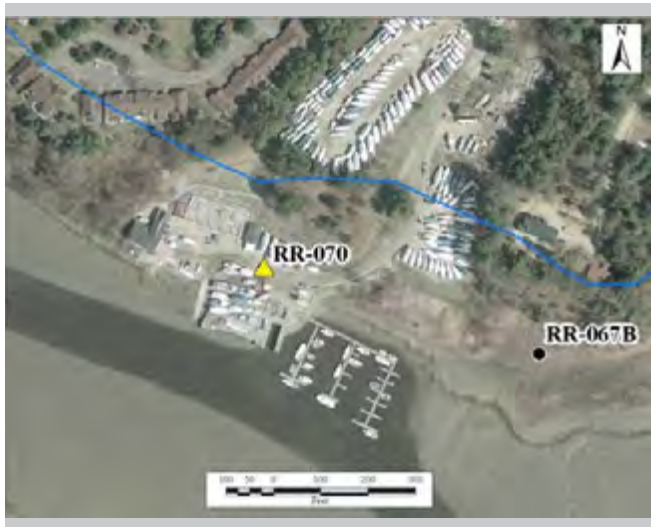
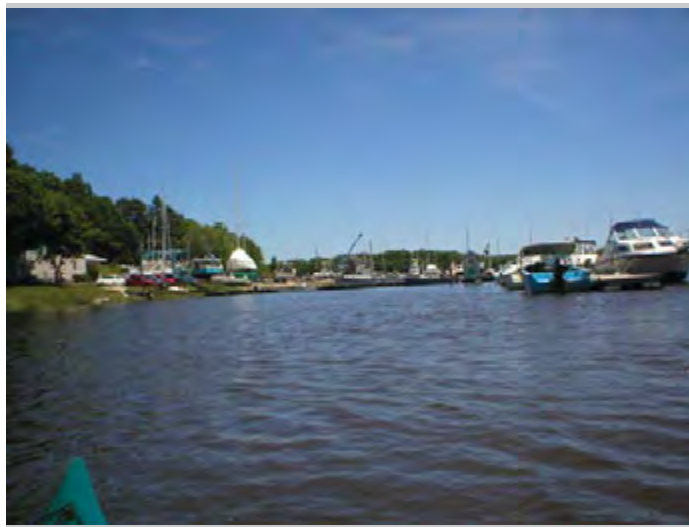
Royal River Boatyard Marina. Docks, boats, gas tank filling station. Gravel parking areas, rip-rap shoreline, some paved areas. Maintained buffer with herbs only. Banks stable, not eroding.

Sources of Degradation (13 possible): Dock/pier/jetty that extends out into channel, Impervious surface, Land cleared, Land use activity a potential contaminant source, Rip-rap (or other artificial hard structure)

Total Degradation Score (higher score indicates a higher level of degradation): 4.05

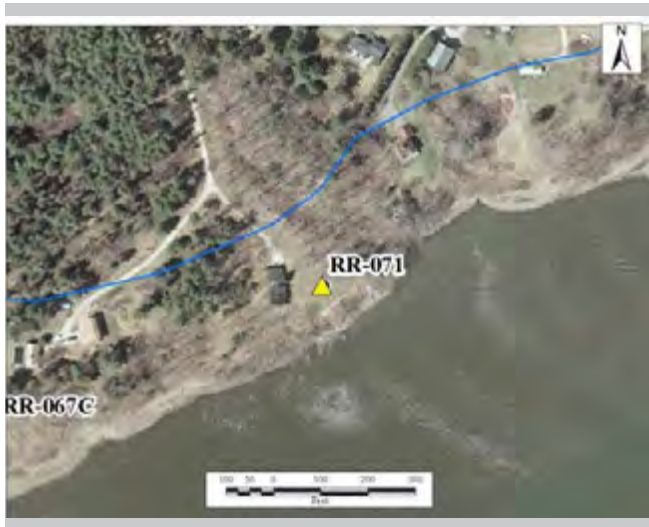
Slumping shoreline. Vegetated with forested buffer to top of slope, then mowed lawn. Large chunks of bank eroding away.

Sources of Degradation (13 possible): Land cleared, Unstable bank

Total Degradation Score (higher score indicates a higher level of degradation): 1.40

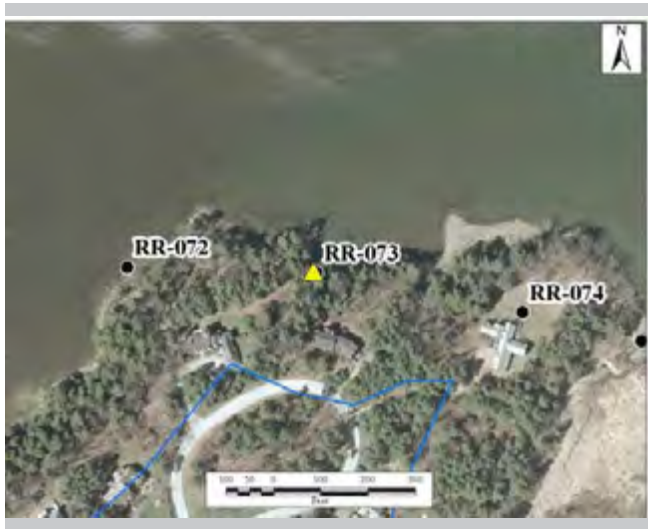
Path to access beach area has washed out. Appears that steps have been buried by debris.

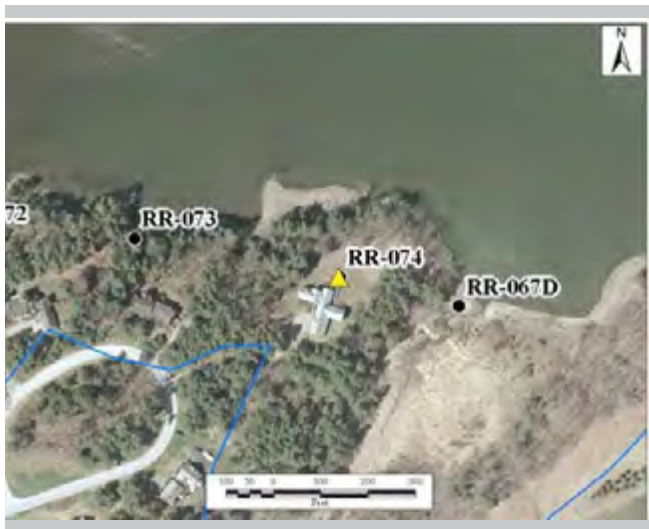
Severe erosion of banks. Large chunks of lawn have been undercut and fallen in. Mowed lawn to top of banks, then steep slope to river. Banks well vegetated with herbs, shrubs, trees, except where erosion has occurred.
