West Branch Piscataqua River Watershed Survey Report

Presumpscot River Watch

September 2008

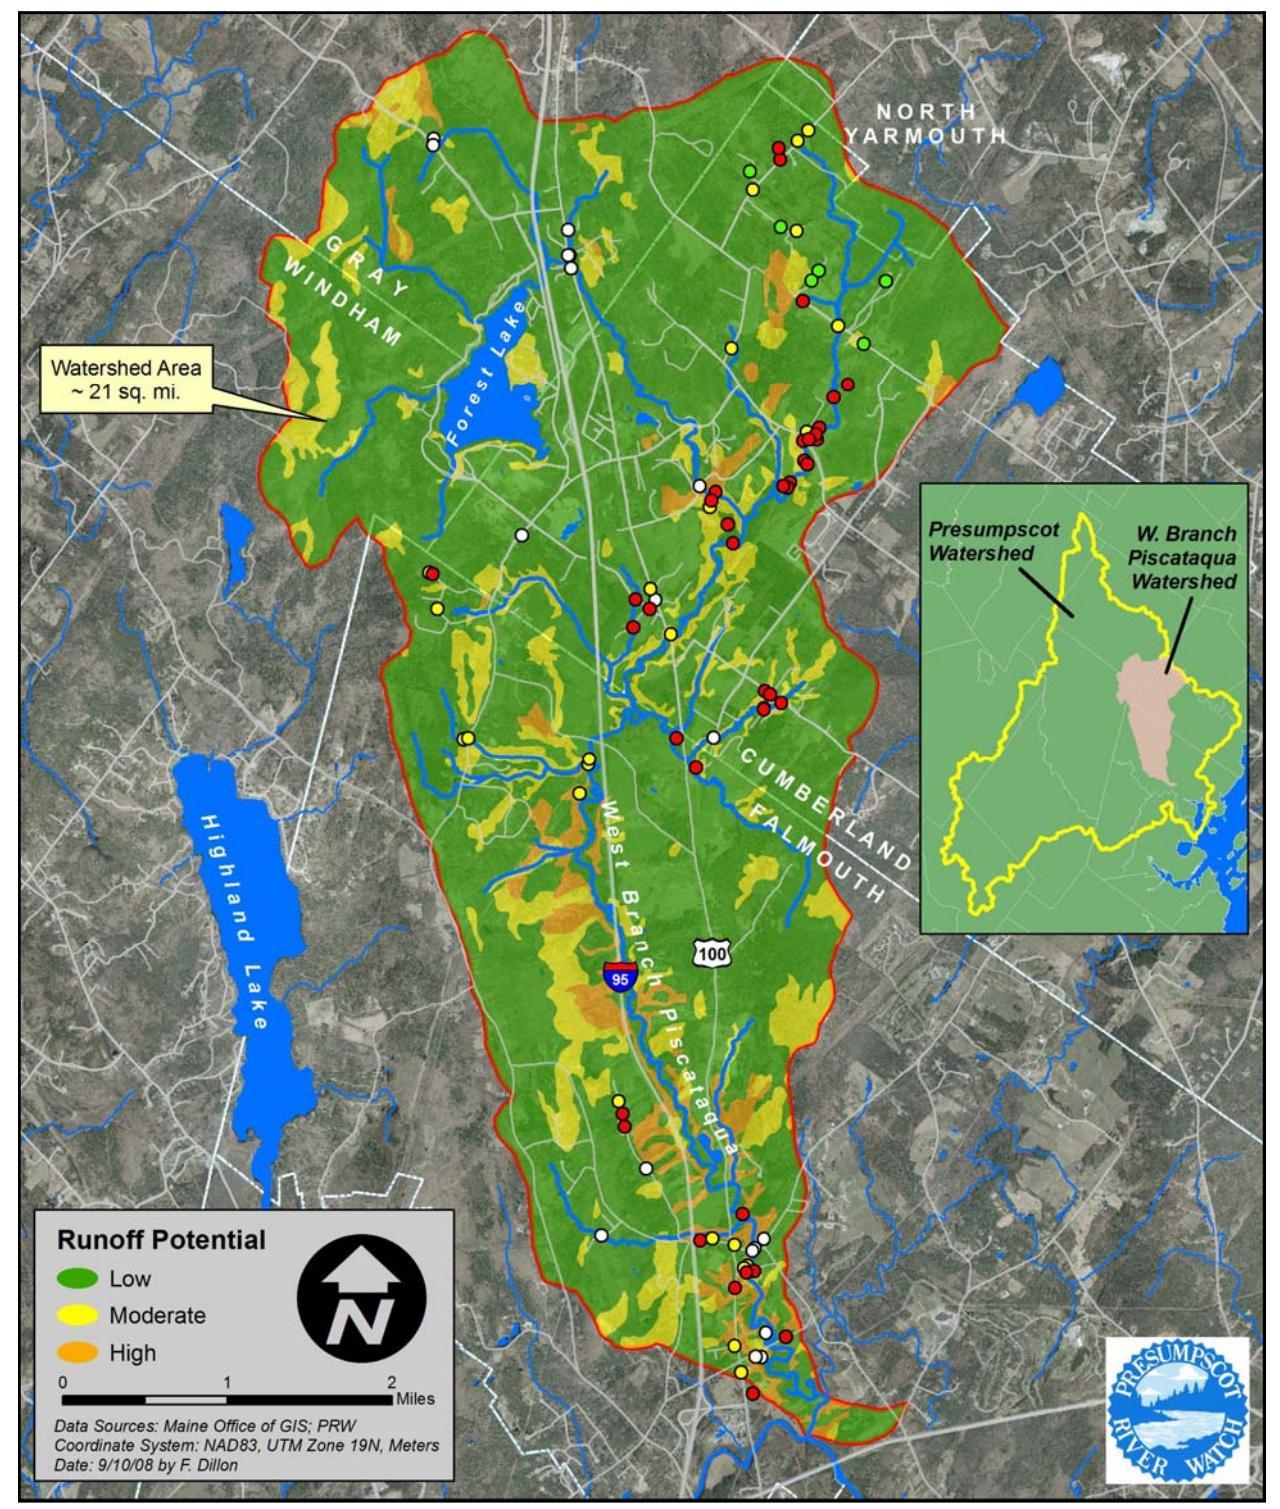
The findings from this limited assessment indicate that selected reaches in WBPR watershed are in relatively good condition from a geomorphological perspective due in large part to the presence of fairly wide forest buffers and the relatively low extent of impervious surfaces (Figure 14). However, other reaches of the river
